REPORT OF VISUAL INSPECTION

An inspection ("Inspection") of the Exterior Elevated Elements ("EEE") listed in Annex 1 (attached report), their load-bearing components ("LBC"), and associated waterproofing elements ("AWE") was performed at the property and on the date indicated below:

Autumn Pointe HOA/ 55488 Dobbns St.	Los Angeles	CA	
Date of Inspection:	2/22/2024

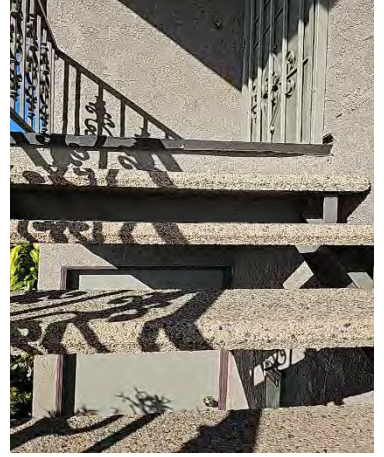
Building Name	5475-1
Apartment Name	108
Location Name	Stair
Visual Report	
Exterior Elements	Stairs, Railings
Water Proofing Elements	Flashings, Waterproofing, Coatings, Sealants
Visual Review	Fair
Any Visual Signs of leaks	No
Further Invasive Review Required	No
Condition Assessment	Pass
Additional Considerations or Concerns	<p>Railing at concrete Stairs are steel stringers attached to a wood structure with concrete treads.</p> <p>The railing attachment to the concrete structure is rusted. Repair as necessary to ensure a solid rust-free attachment.</p>
Life Expectancy (EEE)	1-4 Years
Life Expectancy (LBC)	4-7 Years
Life Expectancy (AWE)	1-4 Years
Visual Photos

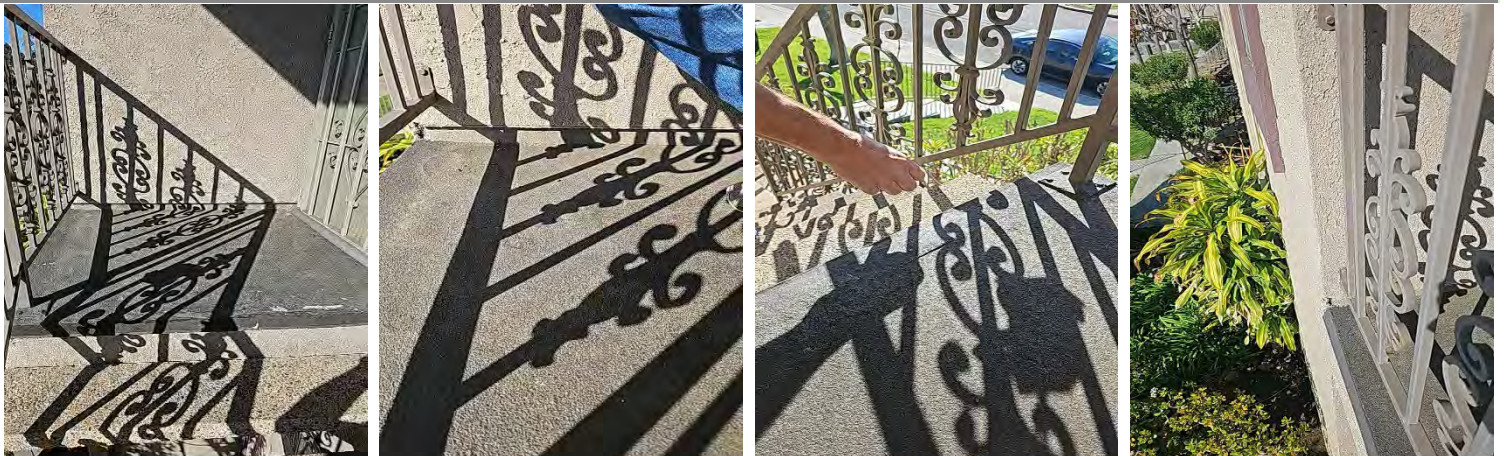
Building Name	5475-1
Apartment Name	108
Location Name	Entry Deck
Visual Report	
Exterior Elements	Decks, Railings, Integrations, Stucco Interface
Water Proofing Elements	Flashings, Waterproofing, Coatings, Sealants
Visual Review	Bad
Any Visual Signs of leaks	Yes
Further Invasive Review Required	No
Condition Assessment	Fail
Additional Considerations or Concerns	<p>Entry / Balcony / Walking Deck</p> <p>The deck is wood framed with waterproofing over the wood. The waterproofing is severely damaged. Replace the waterproofing, including all damaged wood with new waterproofing and wood structures.</p>
Life Expectancy (EEE)	0-1 Years
Life Expectancy (LBC)	0-1 Years
Life Expectancy (AWE)	0-1 Years

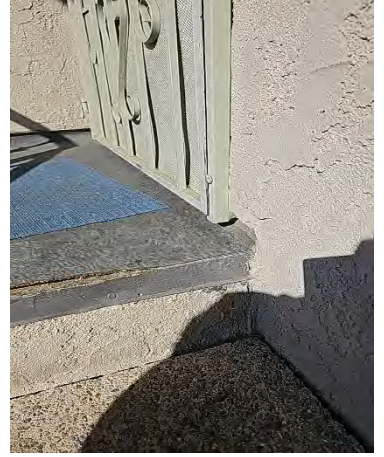
Building Name	5475-1
Apartment Name	110
Location Name	Entry deck
Visual Report	
Exterior Elements	Decks, Railings, Integrations, Porches/Entry, Stucco Interface, Door Threshold
Water Proofing Elements	Flashings, Waterproofing, Coatings, Sealants
Visual Review	Bad
Any Visual Signs of leaks	Yes
Further Invasive Review Required	Yes
Condition Assessment	Fail
Additional Considerations or Concerns	<p>Entry / Balcony / Walking Deck</p> <p>The deck is wood framed with waterproofing over the wood.</p> <p>The waterproofing is severely damaged. Replace the waterproofing, including all damaged wood with new waterproofing and wood structures.</p> <p>Handrails are metal and attached to the deck surface and visually in good condition</p>
Life Expectancy (EEE)	0-1 Years
Life Expectancy (LBC)	0-1 Years
Life Expectancy (AWE)	0-1 Years

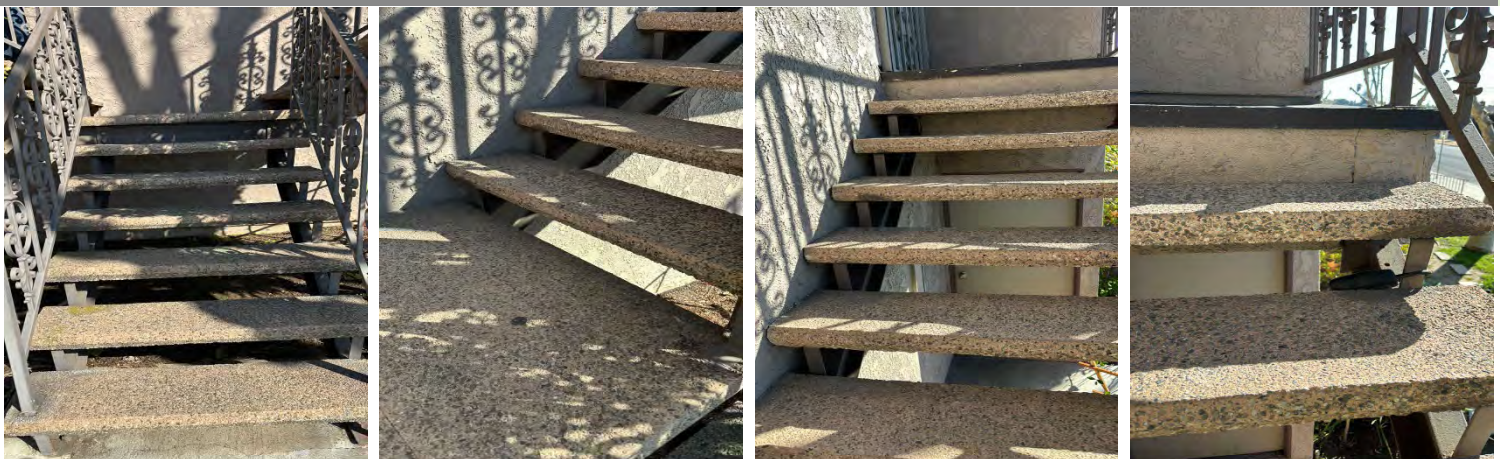
Building Name	5475-2
Apartment Name	109
Location Name	Stairs
Visual Report	
Exterior Elements	Stairs, Stairs Landing, Integrations, Stucco Interface
Water Proofing Elements	Flashings, Sealants, Waterproofing
Visual Review	Fair
Any Visual Signs of leaks	No
Further Invasive Review Required	No
Condition Assessment	Pass
Additional Considerations or Concerns	Stairs and handrail and fair condition
Life Expectancy (EEE)	1-4 Years
Life Expectancy (LBC)	4-7 Years
Life Expectancy (AWE)	1-4 Years

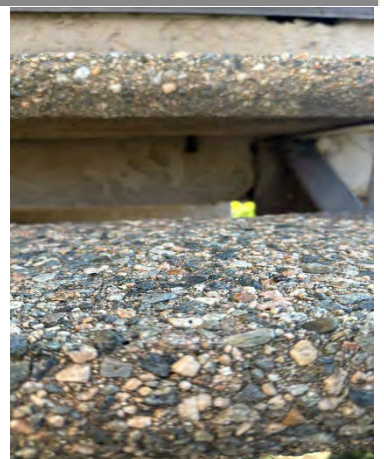
Building Name	5501
Apartment Name	48
Location Name	Stairs
Visual Report	
Exterior Elements	Stairs, Railings, Integrations
Water Proofing Elements	Flashings, Waterproofing, Coatings, Sealants
Visual Review	Good
Any Visual Signs of leaks	No
Further Invasive Review Required	No
Condition Assessment	Pass
Additional Considerations or Concerns	
Life Expectancy (EEE)	1-4 Years
Life Expectancy (LBC)	4-7 Years
Life Expectancy (AWE)	1-4 Years

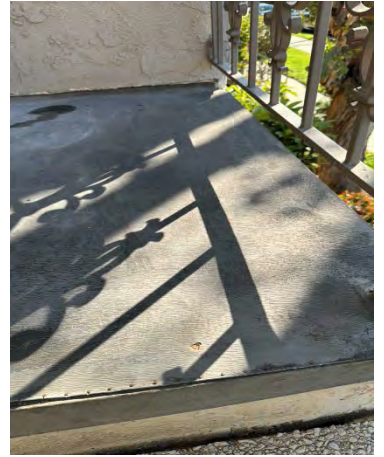
Exterior Elements	Decks, Railings, Integrations, Door Threshold, Stucco Interface
Water Proofing Elements	Flashings, Waterproofing, Coatings, Sealants
Visual Review	Bad
Any Visual Signs of leaks	Yes
Further Invasive Review Required	No
Condition Assessment	Fail
Additional Considerations or Concerns	Entry / Balcony / Walking Deck The deck is wood framed with waterproofing over the wood. Handrails are metal and attached to the deck surface and visually in good condition. The waterproofing is severely damaged. Remove waterproofing membrane and all framing assemblies as necessary. Install new waterproofing membrane.
Life Expectancy (EEE)	1-4 Years
Life Expectancy (LBC)	1-4 Years
Life Expectancy (AWE)	0-1 Years

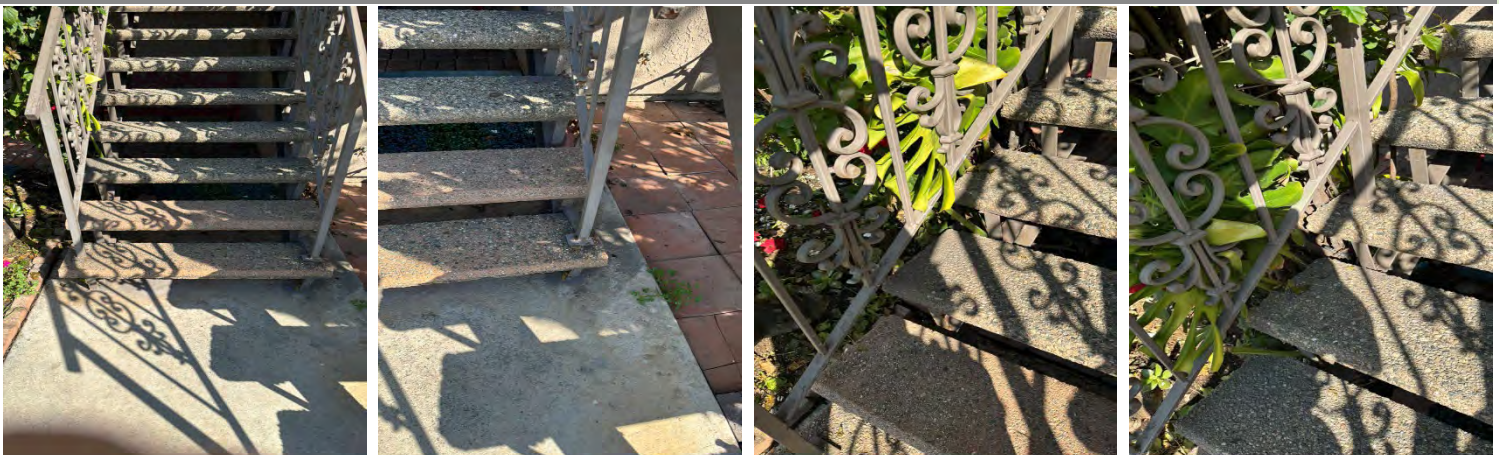
Exterior Elements	Stairs, Railings, Integrations
Water Proofing Elements	Flashings, Waterproofing, Coatings, Sealants
Visual Review	Good
Any Visual Signs of leaks	No
Further Invasive Review Required	No
Condition Assessment	Pass
Additional Considerations or Concerns	Handrails are metal and attached to the deck surface and visually in good condition.
Life Expectancy (EEE)	1-4 Years
Life Expectancy (LBC)	4-7 Years
Life Expectancy (AWE)	1-4 Years

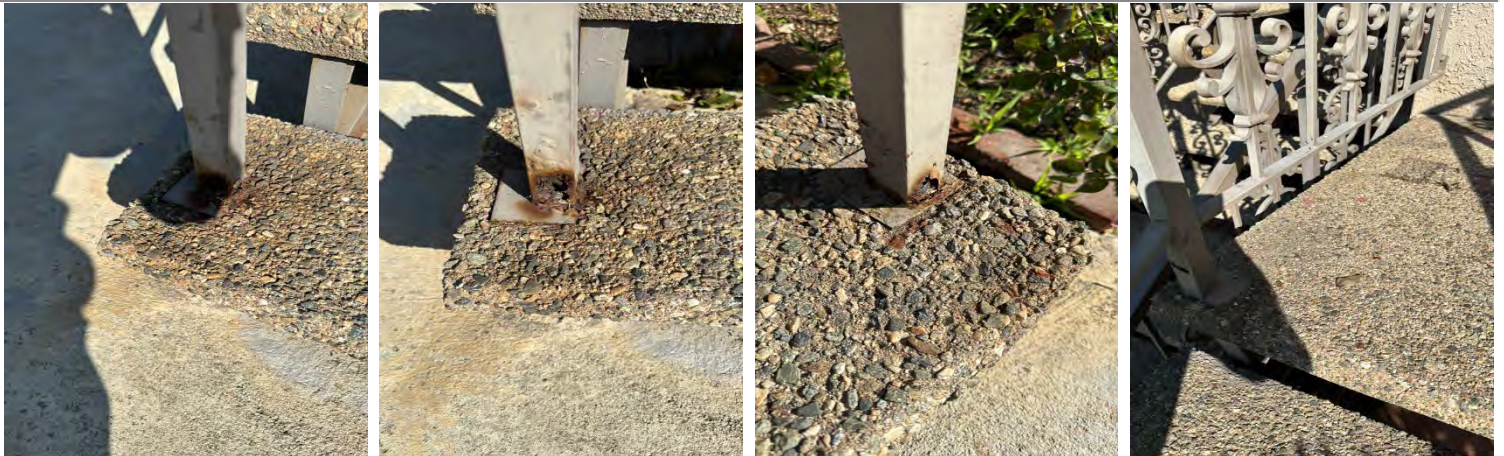
Building Name	5501
Apartment Name	45
Location Name	Stairs
Visual Report	
Exterior Elements	Stairs, Railings, Integrations
Water Proofing Elements	Flashings, Waterproofing, Coatings, Sealants
Visual Review	Fair
Any Visual Signs of leaks	No
Further Invasive Review Required	No
Condition Assessment	Pass
Additional Considerations or Concerns	<p>The railing attachment to the concrete structure is rusted.</p> <p>Repair as necessary to ensure a solid rust-free attachment.</p>
Life Expectancy (EEE)	0-1 Years
Life Expectancy (LBC)	4-7 Years
Life Expectancy (AWE)	1-4 Years

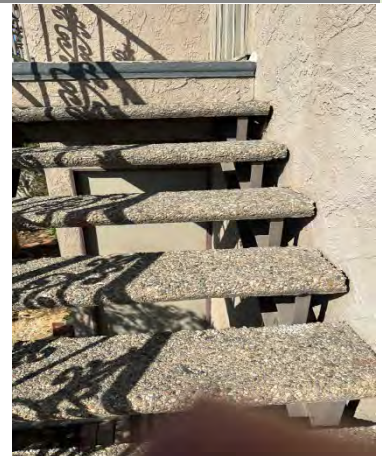
Exterior Elements	Stairs, Stairs Landing, Railings
Water Proofing Elements	Flashings, Waterproofing, Coatings, Sealants
Visual Review	Good
Any Visual Signs of leaks	No
Further Invasive Review Required	No
Condition Assessment	Pass
Additional Considerations or Concerns	<p>Railing at concrete</p> <p>Stairs are steel stringers attached to a wood structure with concrete treads.</p> <p>The handrails are visually in good condition</p>
Life Expectancy (EEE)	1-4 Years
Life Expectancy (LBC)	4-7 Years
Life Expectancy (AWE)	1-4 Years

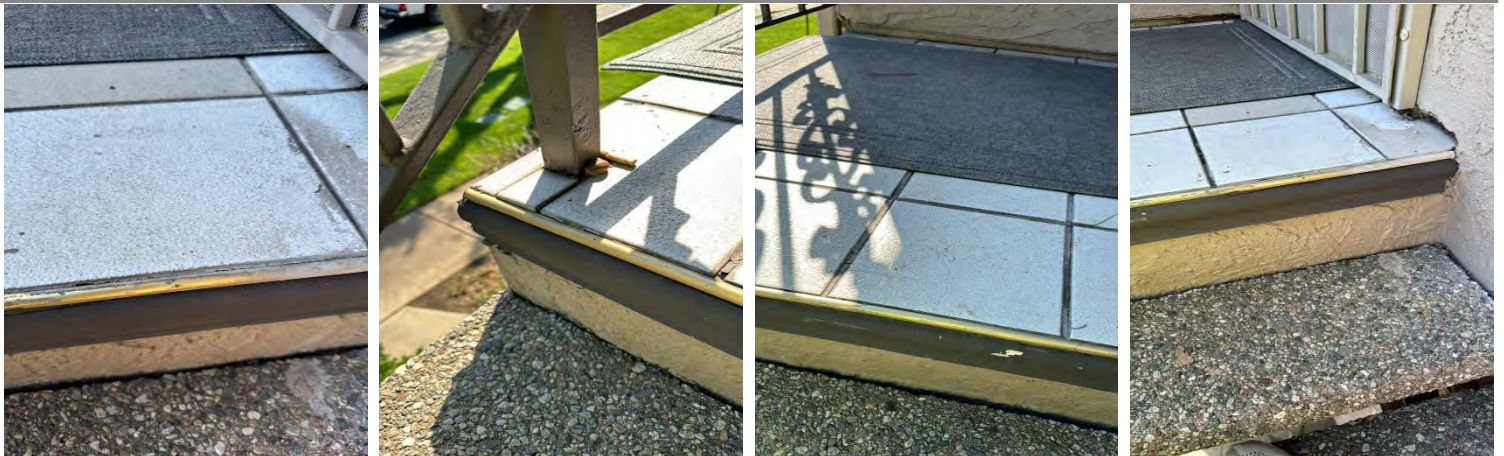
Exterior Elements	Decks, Railings, Integrations, Door Threshold, Stucco Interface
Water Proofing Elements	Flashings, Waterproofing, Coatings, Sealants
Visual Review	Bad
Any Visual Signs of leaks	Yes
Further Invasive Review Required	Yes
Condition Assessment	Fail
Additional Considerations or Concerns	Deck has tile overlay which appears to be failing. Tile is loose. Waterproofing is failed. Remove tile, replace with waterproof deck coating. Further investigation required.
Life Expectancy (EEE)	0-1 Years
Life Expectancy (LBC)	0-1 Years
Life Expectancy (AWE)	0-1 Years

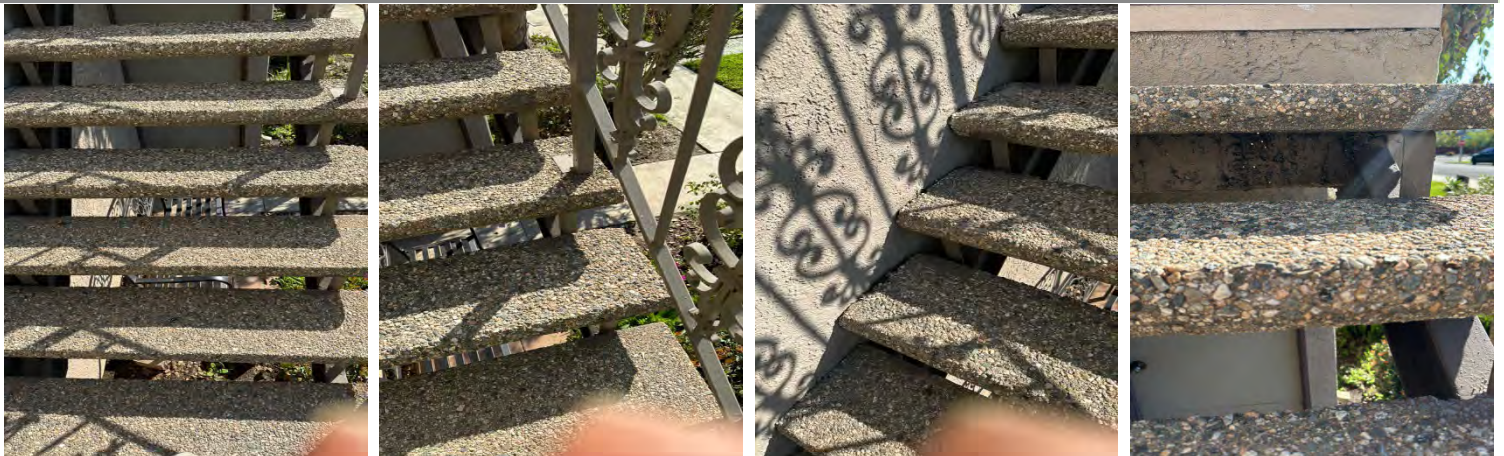
Building Name	5501
Apartment Name	43
Location Name	Stairs
Visual Report	
Exterior Elements	Stairs, Stairs Landing, Railings
Water Proofing Elements	Flashings, Waterproofing, Coatings, Sealants
Visual Review	Good
Any Visual Signs of leaks	No
Further Invasive Review Required	No
Condition Assessment	Pass
Additional Considerations or Concerns	<p>Railing at concrete</p> <p>Stairs are steel stringers attached to a wood structure with concrete treads.</p> <p>The handrails are visually in good condition</p>
Life Expectancy (EEE)	1-4 Years
Life Expectancy (LBC)	4-7 Years
Life Expectancy (AWE)	1-4 Years

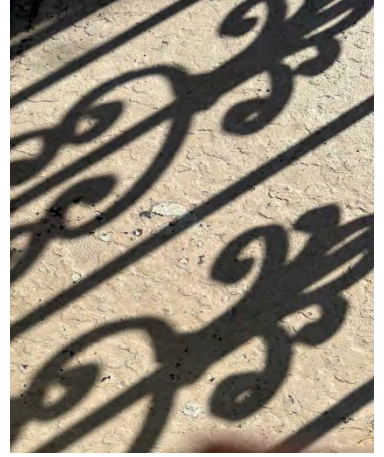
Building Name	5501
Apartment Name	43
Location Name	Entry deck
Visual Report	
Exterior Elements	Decks, Railings, Integrations, Door Threshold, Stucco Interface
Water Proofing Elements	Flashings, Waterproofing, Coatings, Sealants
Visual Review	Good
Any Visual Signs of leaks	No
Further Invasive Review Required	No
Condition Assessment	Pass
Additional Considerations or Concerns	<p>Entry / Balcony / Walking Deck</p> <p>The deck is wood framed with waterproofing over the wood.</p> <p>Handrails are metal and attached to the deck surface and visually in good condition. Maintenance coatings are required for the entry deck waterproofing.</p>
Life Expectancy (EEE)	1-4 Years
Life Expectancy (LBC)	4-7 Years
Life Expectancy (AWE)	1-4 Years
Visual Photos

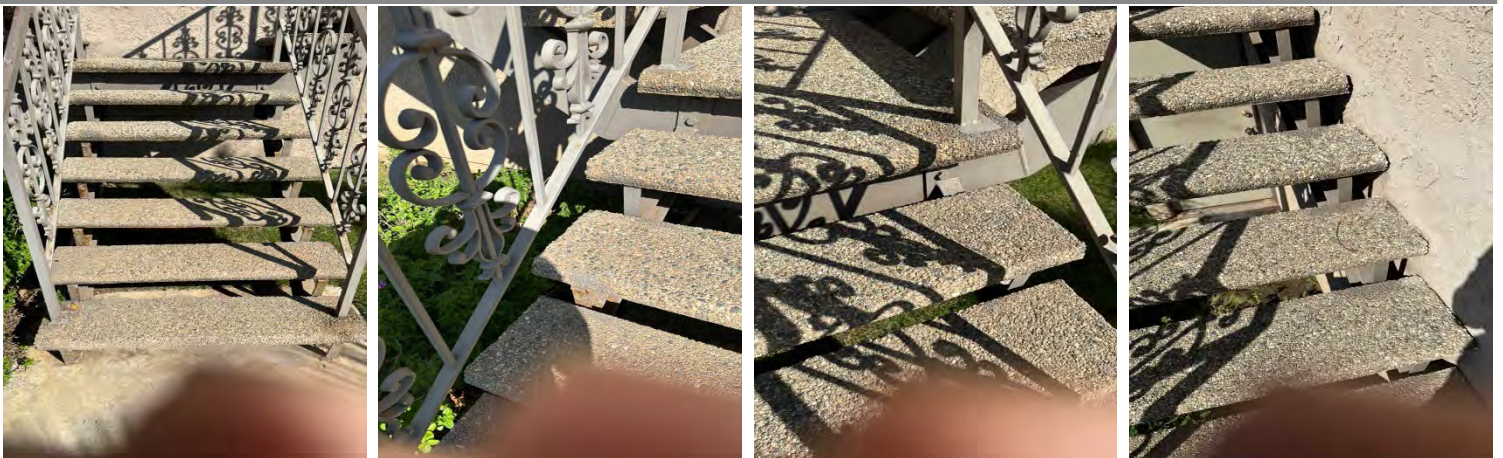
Exterior Elements	Stairs, Stairs Landing, Railings, Integrations
Water Proofing Elements	Flashings, Waterproofing, Coatings, Sealants
Visual Review	Bad
Any Visual Signs of leaks	Yes
Further Invasive Review Required	Yes
Condition Assessment	Fail
Additional Considerations or Concerns	Railing attachments to the front rim Joyce of the deck, appears to be failing lag bolts are pulling out further investigation required
Life Expectancy (EEE)	0-1 Years
Life Expectancy (LBC)	0-1 Years
Life Expectancy (AWE)	0-1 Years

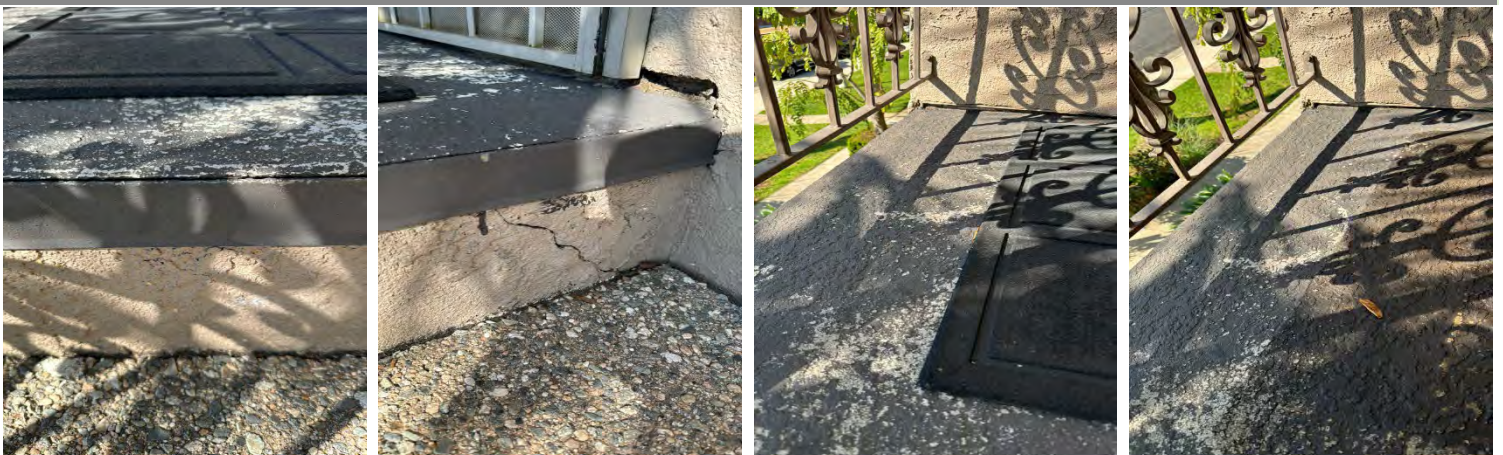
Building Name	5525
Apartment Name	38
Location Name	Entry deck
Visual Report	
Exterior Elements	Decks, Railings, Door Threshold, Integrations, Stucco Interface
Water Proofing Elements	Flashings, Waterproofing, Coatings, Sealants
Visual Review	Fair
Any Visual Signs of leaks	Yes
Further Invasive Review Required	Yes
Condition Assessment	Fail
Additional Considerations or Concerns	<p>This deck is attached to the failed stair system. An invasive investigation needs to occur at the failure. The deck coating is cracked and failing at the leading edge of the rim joist.</p> <p>Replace the deck.</p>
Life Expectancy (EEE)	0-1 Years
Life Expectancy (LBC)	0-1 Years
Life Expectancy (AWE)	0-1 Years

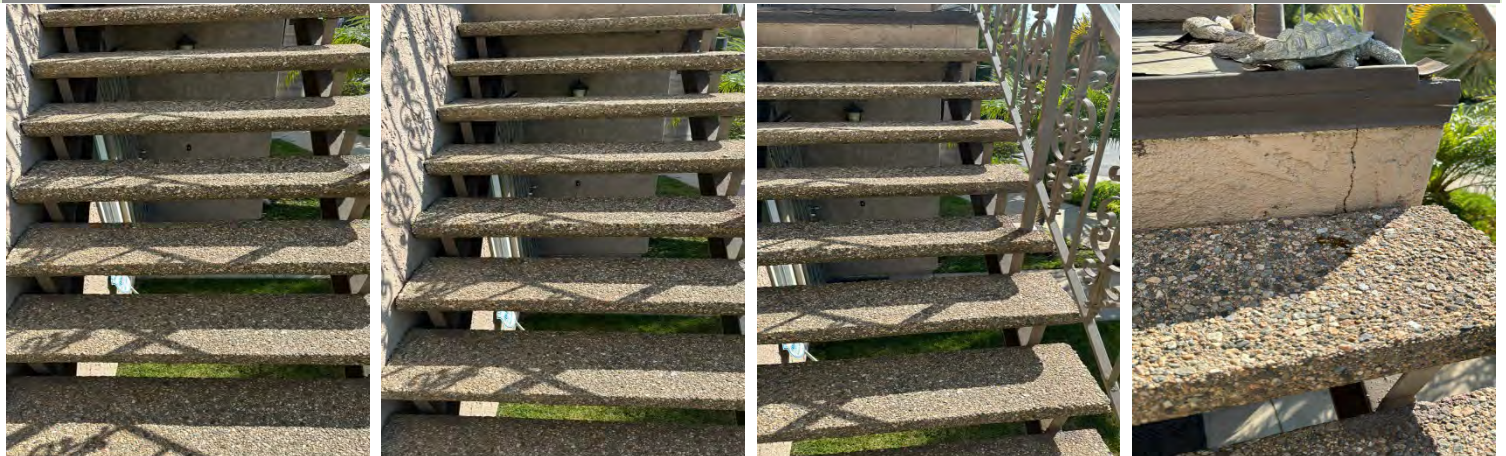
Building Name	5525
Apartment Name	37
Location Name	Stairs
Visual Report	
Exterior Elements	Stairs, Stairs Landing, Railings, Integrations
Water Proofing Elements	Flashings, Waterproofing, Coatings, Sealants
Visual Review	Good
Any Visual Signs of leaks	No
Further Invasive Review Required	No
Condition Assessment	Pass
Additional Considerations or Concerns	<p>Railing at concrete</p> <p>Stairs are steel stringers attached to a wood structure with concrete treads.</p> <p>The handrails are visually in good condition.</p>
Life Expectancy (EEE)	1-4 Years
Life Expectancy (LBC)	1-4 Years
Life Expectancy (AWE)	1-4 Years

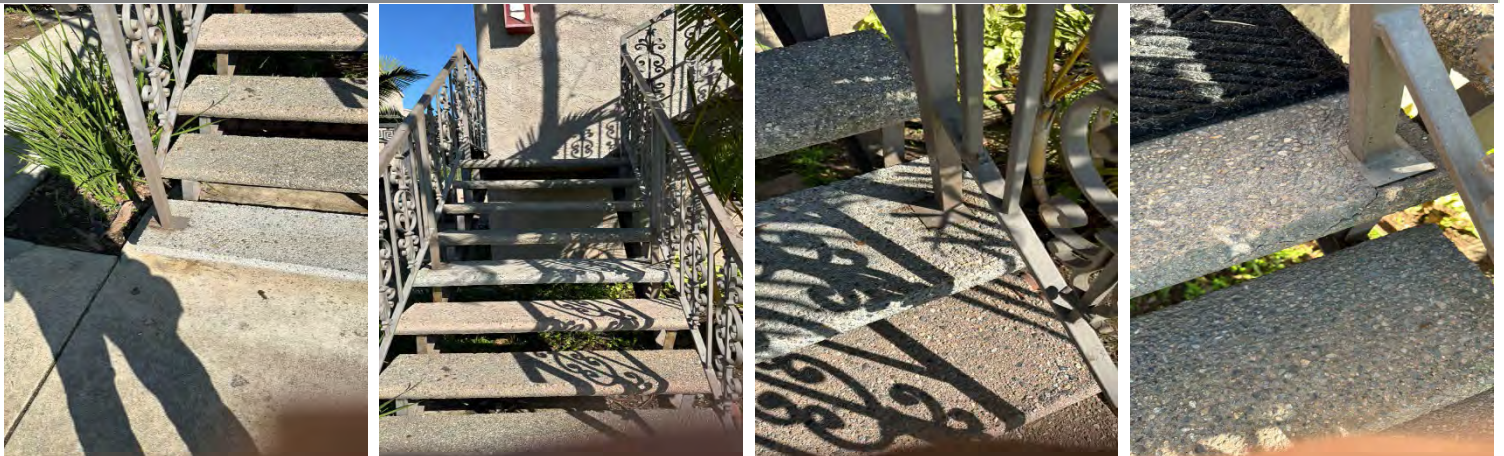
Exterior Elements	Stairs, Stairs Landing, Railings, Integrations
Water Proofing Elements	Flashings, Waterproofing, Coatings, Sealants
Visual Review	Good
Any Visual Signs of leaks	No
Further Invasive Review Required	No
Condition Assessment	Pass
Additional Considerations or Concerns	<p>Railing at concrete</p> <p>Stairs are steel stringers attached to a wood structure with concrete treads.</p> <p>The handrails are visually in good condition</p>
Life Expectancy (EEE)	1-4 Years
Life Expectancy (LBC)	4-7 Years
Life Expectancy (AWE)	1-4 Years

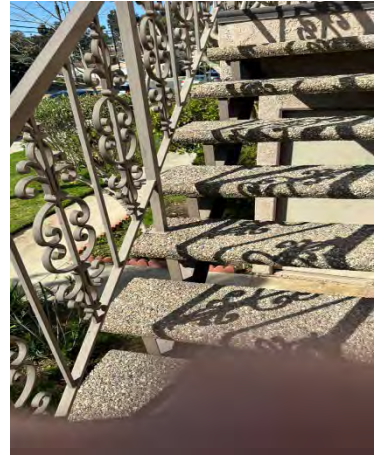
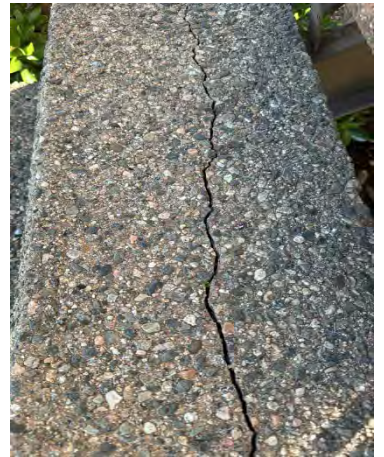
Building Name	5525
Apartment Name	40
Location Name	Stairs
Visual Report	
Exterior Elements	Stairs, Stairs Landing, Railings, Integrations
Water Proofing Elements	Flashings, Waterproofing, Coatings, Sealants
Visual Review	Bad
Any Visual Signs of leaks	No
Further Invasive Review Required	No
Condition Assessment	Fail
Additional Considerations or Concerns	<p>Railing at concrete Stairs are steel stringers attached to a wood structure with concrete treads.</p> <p>The handrails are visually in good condition. Large crack in the third tread on the stairs. Replace the damaged tread.</p>
Life Expectancy (EEE)	0-1 Years
Life Expectancy (LBC)	4-7 Years
Life Expectancy (AWE)	1-4 Years
Visual Photos

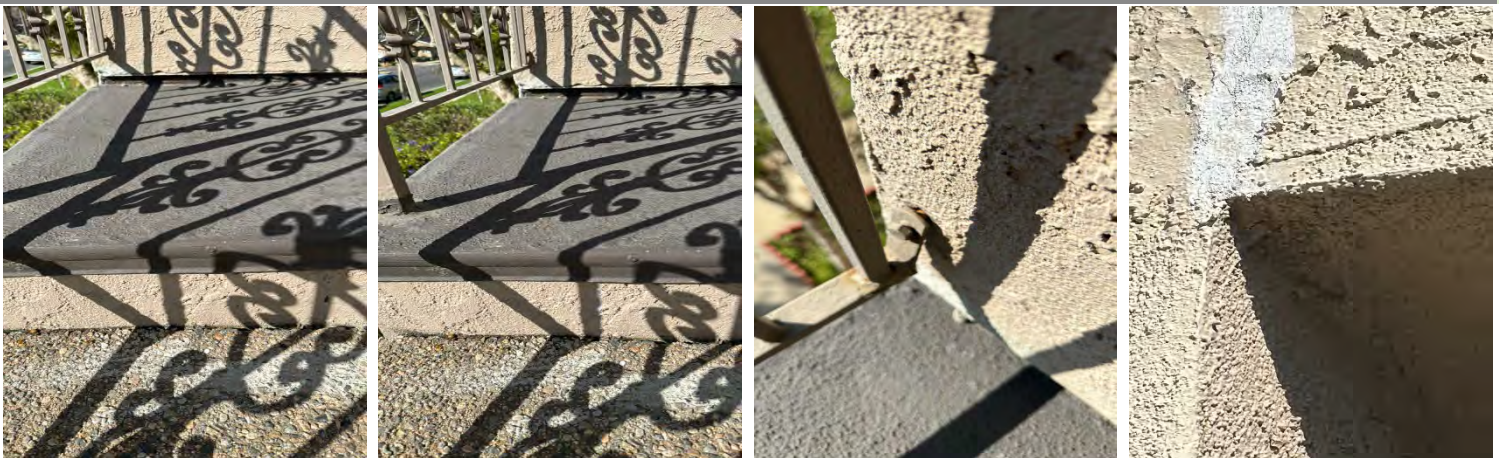
Exterior Elements	Decks, Railings, Integrations, Door Threshold, Stucco Interface
Water Proofing Elements	Flashings, Waterproofing, Coatings, Sealants
Visual Review	Good
Any Visual Signs of leaks	No
Further Invasive Review Required	No
Condition Assessment	Pass
Additional Considerations or Concerns	Crack on the outside of the building looks like stucco, crack, see no conditions that are alarming
Life Expectancy (EEE)	1-4 Years
Life Expectancy (LBC)	1-4 Years
Life Expectancy (AWE)	1-4 Years

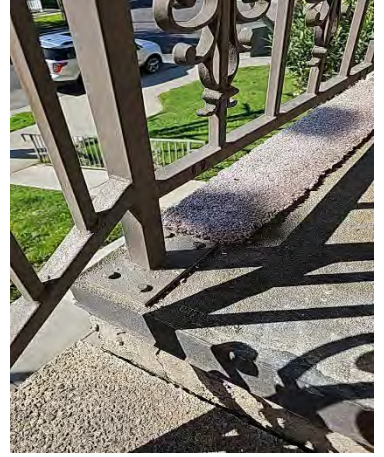
Building Name	5465-1
Apartment Name	114
Location Name	Entry deck
Visual Report	
Exterior Elements	Decks, Porches/Entry, Stairs Landing, Railings, Integrations, Stucco Interface
Water Proofing Elements	Flashings, Waterproofing, Coatings, Sealants
Visual Review	Bad
Any Visual Signs of leaks	Yes
Further Invasive Review Required	No
Condition Assessment	Pass
Additional Considerations or Concerns	<p>Entry / Balcony / Walking Deck</p> <p>The deck is wood framed with waterproofing over the wood.</p> <p>Handrails are metal and attached to the deck surface and visually in good condition.</p> <p>The waterproofing is severely damaged. Replace or repair the waterproofing, including all damaged wood with new waterproofing and wood structures.</p>
Life Expectancy (EEE)	0-1 Years
Life Expectancy (LBC)	0-1 Years
Life Expectancy (AWE)	0-1 Years

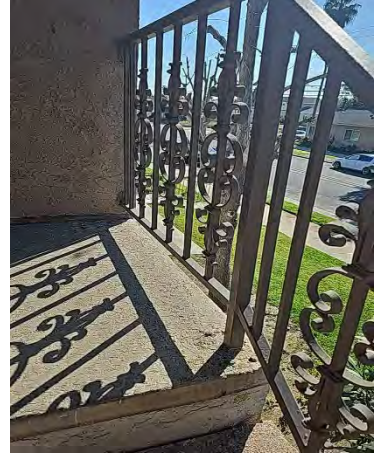
Exterior Elements	Decks, Porches/Entry, Stairs, Stairs Landing, Railings, Integrations, Stucco Interface
Water Proofing Elements	Flashings, Waterproofing, Coatings, Sealants
Visual Review	Fair
Any Visual Signs of leaks	No
Further Invasive Review Required	No
Condition Assessment	Pass
Additional Considerations or Concerns	<p>Railing at concrete Stairs are steel stringers attached to a wood structure with concrete treads.</p> <p>The handrails are visually in good condition.Damaged railing. Repair as necessary</p>
Life Expectancy (EEE)	0-1 Years
Life Expectancy (LBC)	0-1 Years
Life Expectancy (AWE)	0-1 Years

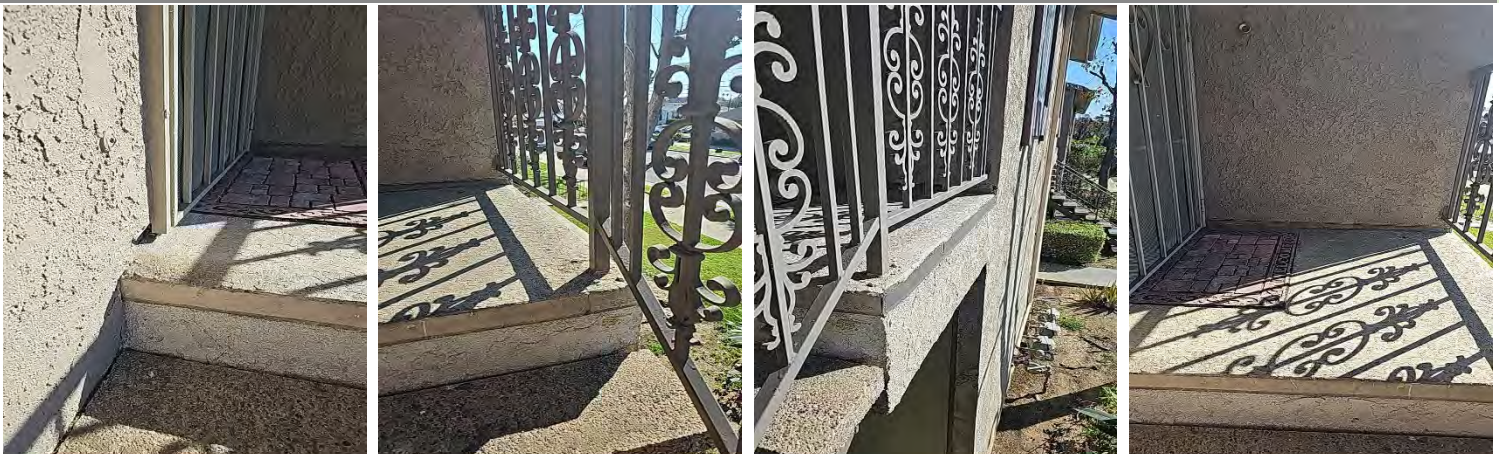
Exterior Elements	Decks, Porches/Entry, Stairs Landing, Integrations, Stucco Interface, Railings
Water Proofing Elements	Flashings, Waterproofing, Coatings, Sealants
Visual Review	Fair
Any Visual Signs of leaks	Yes
Further Invasive Review Required	No
Condition Assessment	Pass
Additional Considerations or Concerns	<p>The deck is wood framed with waterproofing over the wood.</p> <p>Handrails are metal and attached to the deck surface and visually in good condition. Deck coating is cracked and damaged. Repair as necessary</p>
Life Expectancy (EEE)	1-4 Years
Life Expectancy (LBC)	1-4 Years
Life Expectancy (AWE)	1-4 Years

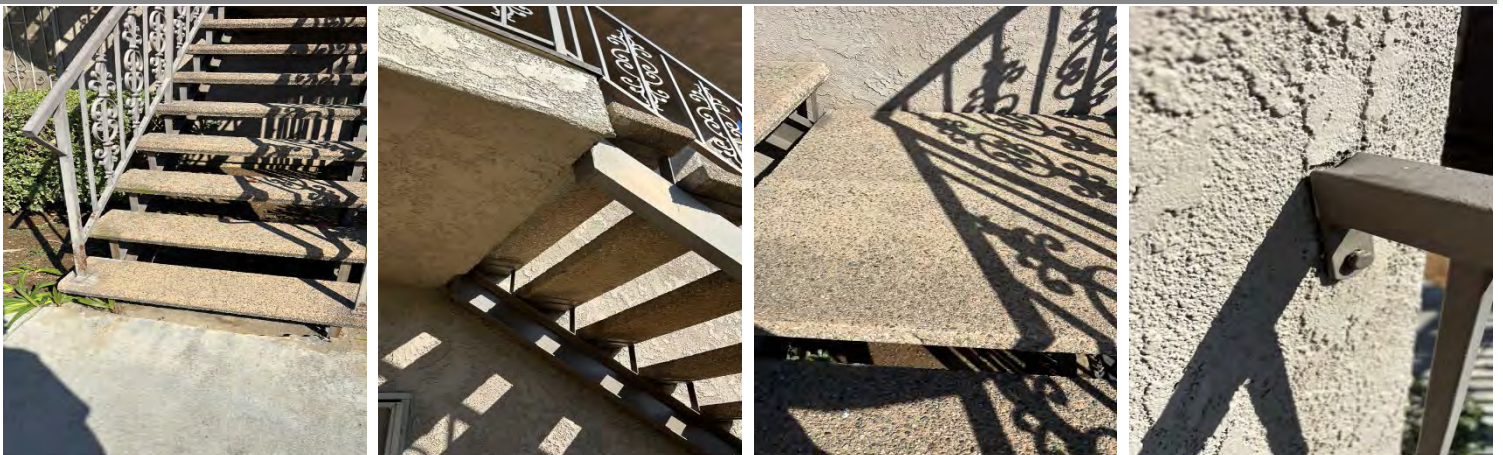
Building Name	5465-2
Apartment Name	111
Location Name	Stairs
Visual Report	
Exterior Elements	Stairs, Stairs Landing, Stucco Interface
Water Proofing Elements	Flashings, Waterproofing, Coatings, Sealants
Visual Review	Good
Any Visual Signs of leaks	No
Further Invasive Review Required	No
Condition Assessment	Pass
Additional Considerations or Concerns	Handrail attachment to the stucco is loose. Secure the attachment.
Life Expectancy (EEE)	1-4 Years
Life Expectancy (LBC)	4-7 Years
Life Expectancy (AWE)	1-4 Years

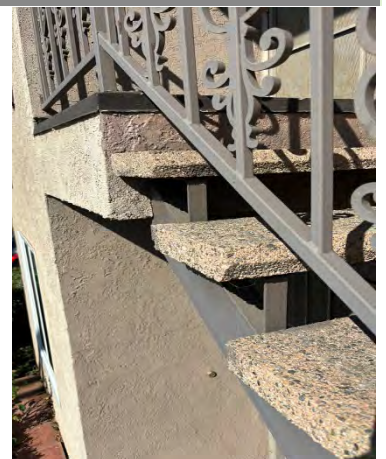
Exterior Elements	Stairs, Stairs Landing, Stucco Interface
Water Proofing Elements	Flashings, Waterproofing, Coatings, Sealants
Visual Review	Fair
Any Visual Signs of leaks	No
Further Invasive Review Required	No
Condition Assessment	Pass
Additional Considerations or Concerns	Stairs are in fair condition.
Life Expectancy (EEE)	1-4 Years
Life Expectancy (LBC)	4-7 Years
Life Expectancy (AWE)	1-4 Years

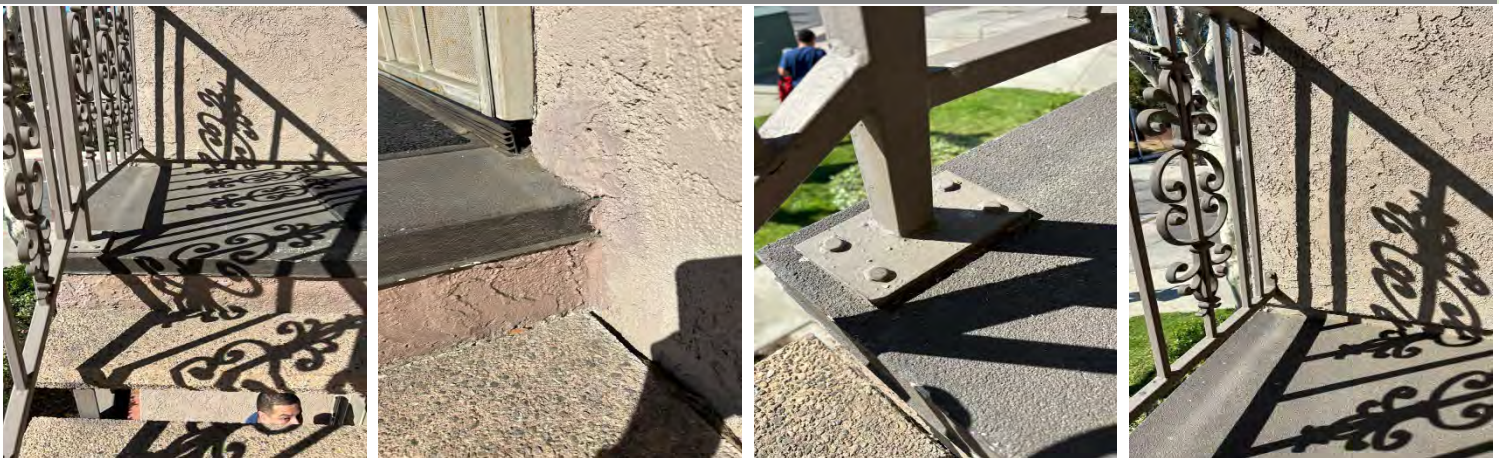
Exterior Elements	Decks, Railings, Integrations, Door Threshold, Stucco Interface
Water Proofing Elements	Flashings, Waterproofing, Coatings, Sealants
Visual Review	Fair
Any Visual Signs of leaks	No
Further Invasive Review Required	No
Condition Assessment	Pass
Additional Considerations or Concerns	Deck is in fair condition however the railing attachment at the deck is loose. Repair as necessary
Life Expectancy (EEE)	1-4 Years
Life Expectancy (LBC)	4-7 Years
Life Expectancy (AWE)	1-4 Years

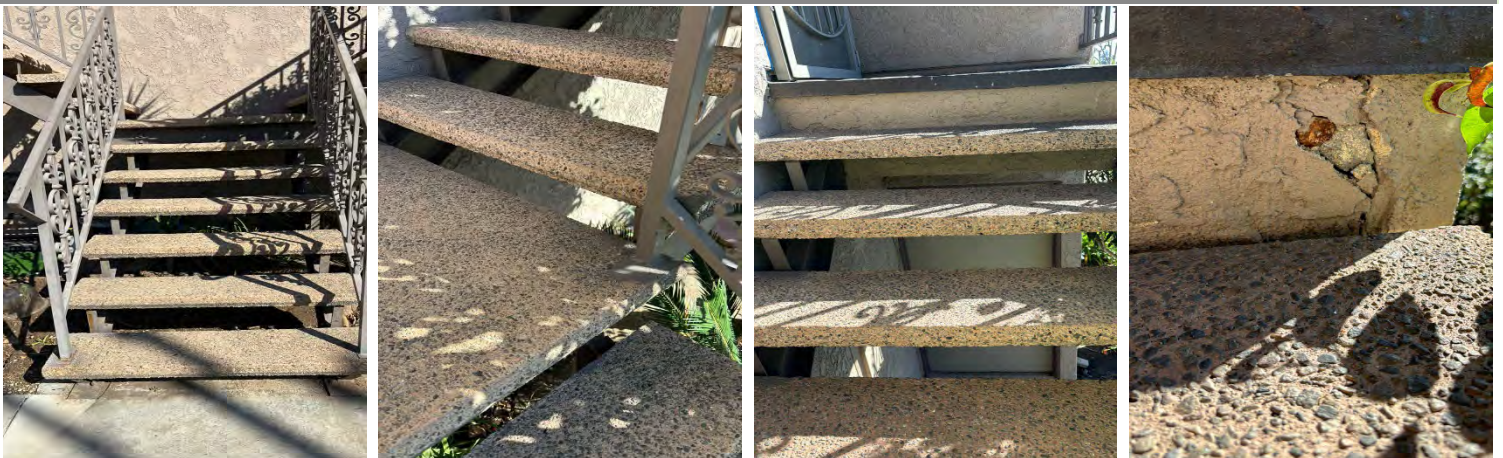
Exterior Elements	Stairs, Stairs Landing
Water Proofing Elements	Flashings, Waterproofing, Coatings, Sealants
Visual Review	Fair
Any Visual Signs of leaks	No
Further Invasive Review Required	No
Condition Assessment	Pass
Additional Considerations or Concerns	The stringer attachment in one location has stucco cracked. No visual signs of structural decay. repair as necessary.
Life Expectancy (EEE)	1-4 Years
Life Expectancy (LBC)	4-7 Years
Life Expectancy (AWE)	1-4 Years

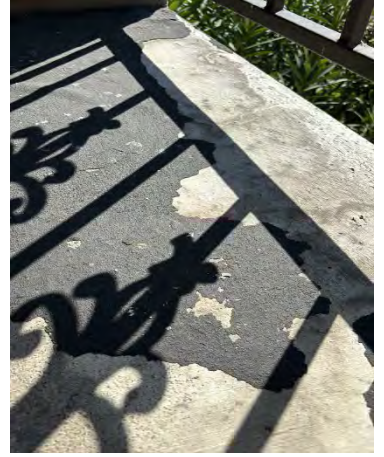
Building Name	5465-2
Apartment Name	115
Location Name	Entry deck
Visual Report	
Exterior Elements	Porches/Entry, Railings, Integrations, Door Threshold, Stucco Interface
Water Proofing Elements	Flashings, Waterproofing, Coatings, Sealants
Visual Review	Bad
Any Visual Signs of leaks	Yes
Further Invasive Review Required	No
Condition Assessment	Fail
Additional Considerations or Concerns	<p>Entry / Balcony / Walking Deck</p> <p>The deck is wood framed with waterproofing over the wood.</p> <p>Handrails are metal and attached to the deck surface and visually in good condition.</p> <p>The waterproofing is severely damaged. Replace or repair the waterproofing, including all damaged wood with new waterproofing and wood structures.</p>
Life Expectancy (EEE)	0-1 Years
Life Expectancy (LBC)	1-4 Years
Life Expectancy (AWE)	0-1 Years
Visual Photos

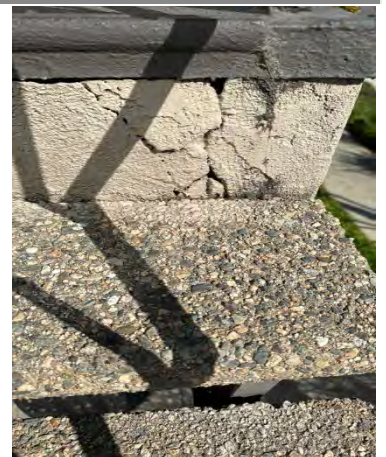
Exterior Elements	Stairs, Stairs Landing, Railings, Integrations
Water Proofing Elements	Flashings, Waterproofing, Coatings, Sealants
Visual Review	Bad
Any Visual Signs of leaks	No
Further Invasive Review Required	Yes
Condition Assessment	Fail
Additional Considerations or Concerns	Attachment of the state steel stringer to the rim, joist appears to be failing.
Life Expectancy (EEE)	0-1 Years
Life Expectancy (LBC)	0-1 Years
Life Expectancy (AWE)	1-4 Years

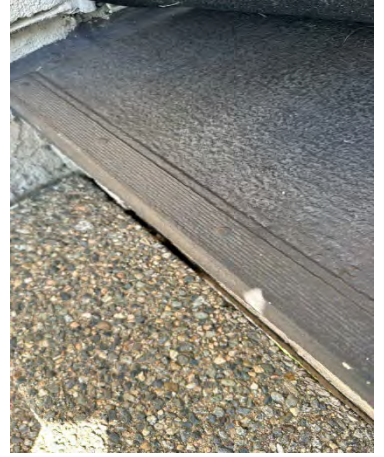
Building Name	2315
Apartment Name	32
Location Name	Entry deck
Visual Report	
Exterior Elements	Decks, Railings, Integrations, Door Threshold, Stucco Interface
Water Proofing Elements	Flashings, Waterproofing, Coatings, Sealants
Visual Review	Good
Any Visual Signs of leaks	No
Further Invasive Review Required	No
Condition Assessment	Pass
Additional Considerations or Concerns	<p>Entry / Balcony / Walking Deck</p> <p>The deck is wood framed with waterproofing over the wood.</p> <p>Handrails are metal and attached to the deck surface and visually in good condition</p>
Life Expectancy (EEE)	1-4 Years
Life Expectancy (LBC)	1-4 Years
Life Expectancy (AWE)	1-4 Years
Visual Photos

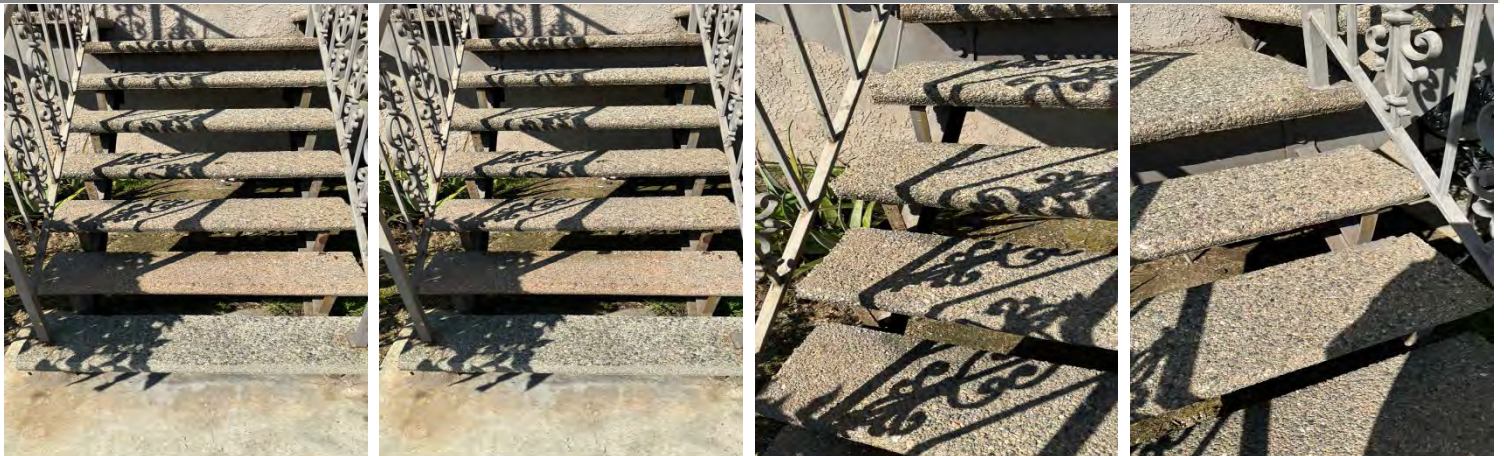
Building Name	2315
Apartment Name	31
Location Name	Stairs
Visual Report	
Exterior Elements	Stairs, Stairs Landing, Railings, Integrations
Water Proofing Elements	Flashings, Waterproofing, Coatings, Sealants
Visual Review	Good
Any Visual Signs of leaks	No
Further Invasive Review Required	No
Condition Assessment	Pass
Additional Considerations or Concerns	<p>Railing at concrete</p> <p>Stairs are steel stringers attached to a wood structure with concrete treads.</p> <p>The handrails are visually in good condition.</p>
Life Expectancy (EEE)	1-4 Years
Life Expectancy (LBC)	4-7 Years
Life Expectancy (AWE)	1-4 Years

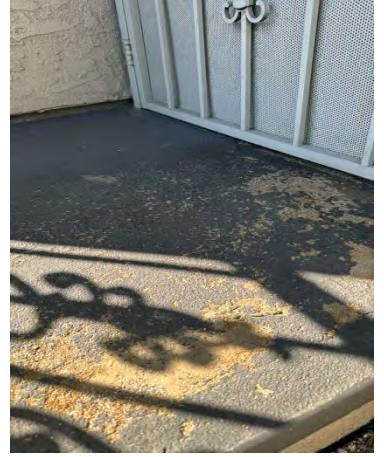
Exterior Elements	Decks, Railings, Integrations, Door Threshold, Stucco Interface
Water Proofing Elements	Flashings, Waterproofing, Coatings, Sealants
Visual Review	Bad
Any Visual Signs of leaks	Yes
Further Invasive Review Required	Yes
Condition Assessment	Fail
Additional Considerations or Concerns	Entry / Balcony / Walking Deck The deck is wood framed with waterproofing over the wood. Handrails are metal and attached to the deck surface and visually in good condition. The waterproofing is severely damaged. Replace or repair the waterproofing, including all damaged wood with new waterproofing and wood structures.
Life Expectancy (EEE)	0-1 Years
Life Expectancy (LBC)	0-1 Years
Life Expectancy (AWE)	0-1 Years

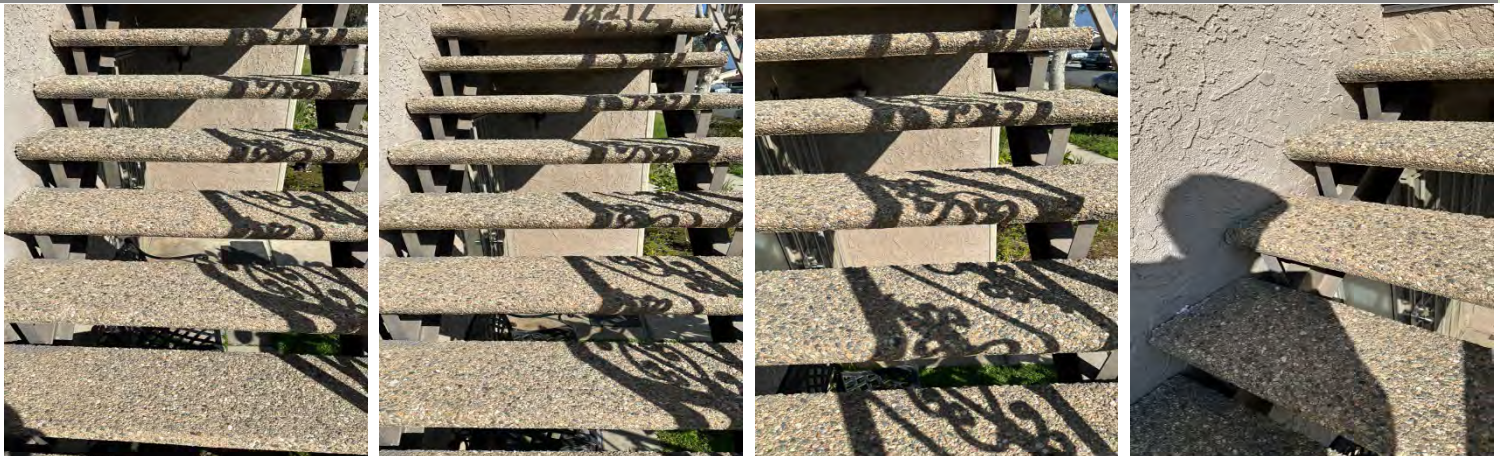
Building Name	2315
Apartment Name	30
Location Name	Stairs
Visual Report	
Exterior Elements	Stairs, Stairs Landing, Railings, Integrations
Water Proofing Elements	Flashings, Waterproofing, Coatings, Sealants
Visual Review	Good
Any Visual Signs of leaks	No
Further Invasive Review Required	No
Condition Assessment	Pass
Additional Considerations or Concerns	<p>Railing at concrete</p> <p>Stairs are steel stringers attached to a wood structure with concrete treads.</p> <p>The handrails are visually in good condition.</p>
Life Expectancy (EEE)	1-4 Years
Life Expectancy (LBC)	4-7 Years
Life Expectancy (AWE)	1-4 Years

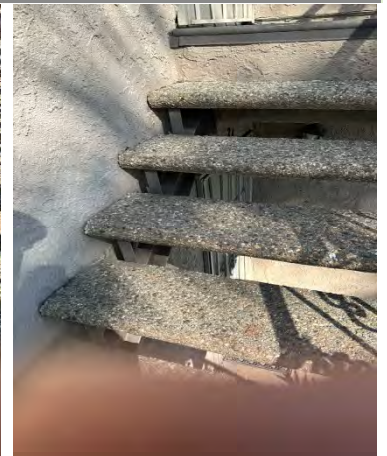
Building Name	2315
Apartment Name	35
Location Name	Stairs
Visual Report	
Exterior Elements	Stairs, Stairs Landing, Railings, Integrations
Water Proofing Elements	Flashings, Waterproofing, Coatings, Sealants
Visual Review	Good
Any Visual Signs of leaks	No
Further Invasive Review Required	No
Condition Assessment	Pass
Additional Considerations or Concerns	<p>Railing at concrete</p> <p>Stairs are steel stringers attached to a wood structure with concrete treads.</p> <p>The handrails are visually in good condition</p>
Life Expectancy (EEE)	1-4 Years
Life Expectancy (LBC)	4-7 Years
Life Expectancy (AWE)	1-4 Years

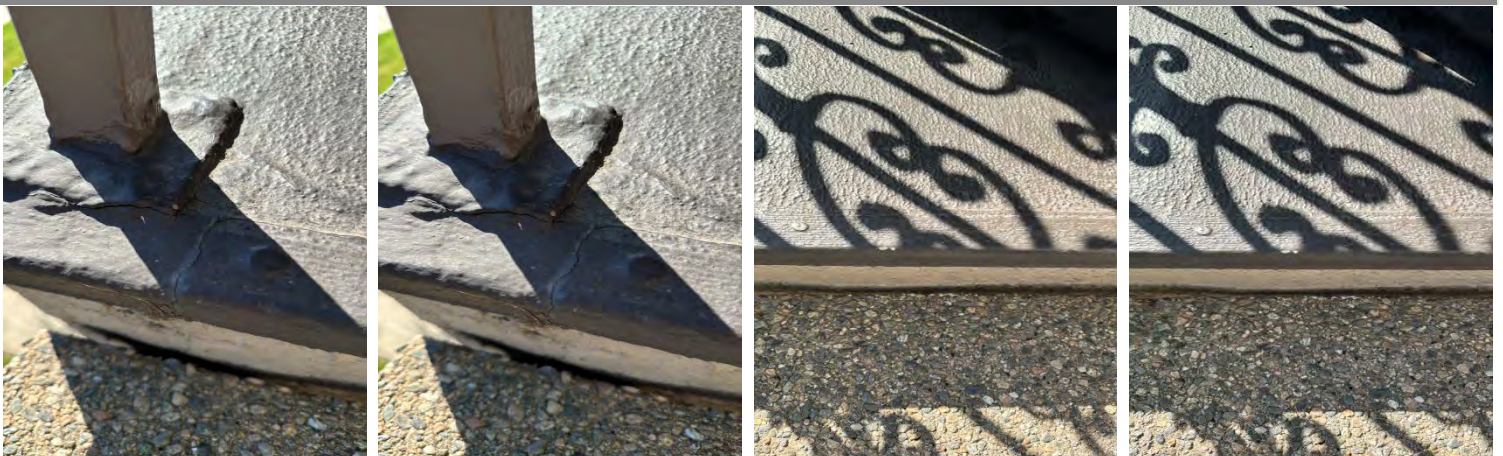
Exterior Elements	Decks, Railings, Integrations, Door Threshold, Stucco Interface
Water Proofing Elements	Flashings, Waterproofing, Coatings, Sealants
Visual Review	Fair
Any Visual Signs of leaks	No
Further Invasive Review Required	No
Condition Assessment	Pass
Additional Considerations or Concerns	A few cracks around the railing, post attachments, and in the center of the deck repair the deck. Repair or replace as necessary
Life Expectancy (EEE)	1-4 Years
Life Expectancy (LBC)	4-7 Years
Life Expectancy (AWE)	0-1 Years

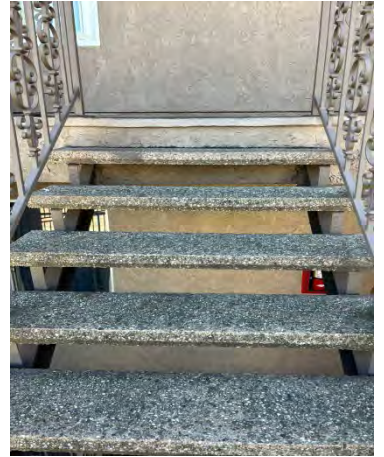
Building Name	2310-1
Apartment Name	121
Location Name	Stairs & Mid Landing
Visual Report	
Exterior Elements	Stairs, Stairs Landing, Railings
Water Proofing Elements	Flashings, Waterproofing, Coatings, Sealants
Visual Review	Bad
Any Visual Signs of leaks	Yes
Further Invasive Review Required	No
Condition Assessment	Fail
Additional Considerations or Concerns	<p>Entry / Balcony / Walking Deck</p> <p>The deck is wood framed with waterproofing over the wood.</p> <p>Mid Landing and Stairs Handrails are metal and attached to the deck surface and visually in good condition.</p> <p>The waterproofing is severely damaged. Replace or repair the waterproofing, including all damaged wood with new waterproofing and wood structures</p>
Life Expectancy (EEE)	0-1 Years
Life Expectancy (LBC)	1-4 Years
Life Expectancy (AWE)	0-1 Years

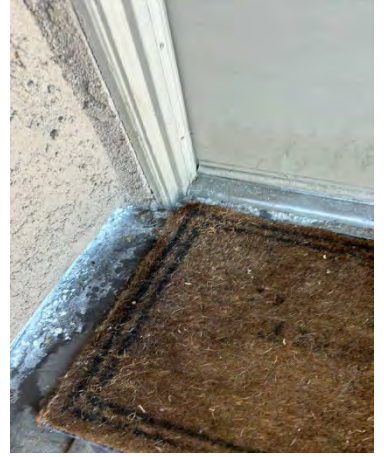
Exterior Elements	Decks, Integrations, Door Threshold, Stucco Interface, Railings
Water Proofing Elements	Flashings, Waterproofing, Coatings, Sealants
Visual Review	Fair
Any Visual Signs of leaks	Yes
Further Invasive Review Required	No
Condition Assessment	Fail
Additional Considerations or Concerns	<p>Entry / Balcony / Walking Deck</p> <p>The deck is wood framed with waterproofing over the wood.</p> <p>Handrails are metal and attached to the deck surface and visually in good condition.</p> <p>The waterproofing is severely damaged. Replace or repair the waterproofing, including all damaged wood with new waterproofing and wood structures.</p>
Life Expectancy (EEE)	0-1 Years
Life Expectancy (LBC)	1-4 Years
Life Expectancy (AWE)	0-1 Years

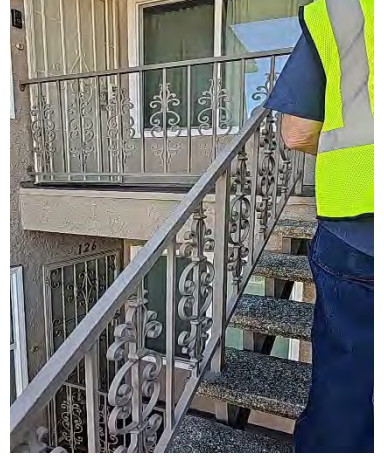
Building Name	2310-2
Apartment Name	127
Location Name	Stairs
Visual Report	
Exterior Elements	Stairs, Railings, Integrations, Stucco Interface, Decks
Water Proofing Elements	Flashings, Waterproofing, Coatings, Sealants
Visual Review	Good
Any Visual Signs of leaks	No
Further Invasive Review Required	No
Condition Assessment	Pass
Additional Considerations or Concerns	<p>Autum Pointe HOA</p> <p>Railing at concrete</p> <p>Stairs are steel stringers attached to a wood structure with concrete treads.</p> <p>The handrails are visually in good condition.</p>
Life Expectancy (EEE)	1-4 Years
Life Expectancy (LBC)	1-4 Years
Life Expectancy (AWE)	1-4 Years
Visual Photos
