## DECK INSPECTORS INC.

#### Part 2 of Visual Inspection:

Autumn Pointe HOA

55488 Dobbs St.

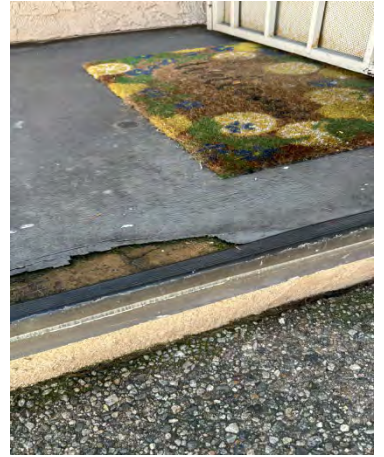
Building Name	5500
Apartment Name	8
Location Name	Entry deck

Exterior Elements	Decks, Stucco Interface, Door Threshold, Integrations, Railings
Water Proofing Elements	Flashings, Waterproofing, Coatings, Sealants
Visual Review	<b>Bad</b>
Any Visual Signs of leaks	<b>Yes</b>
Further Invasive Review Required	<b>Yes</b>
Condition Assessment	<b>Fail</b>
Additional Considerations or Concerns	<b>Entry / Balcony / Walking Deck</b>  <b>The deck is wood framed with waterproofing over the wood.</b>  <b>Handrails are metal and attached to the deck surface and visually in good condition.</b>  <b>The waterproofing is severely damaged. Replace or repair the waterproofing, including all damaged wood with new waterproofing and wood structures.</b>
Life Expectancy (EEE)	<b>1-4 Years</b>
Life Expectancy (LBC)	<b>1-4 Years</b>
Life Expectancy (AWE)	<b>0-1 Years</b>

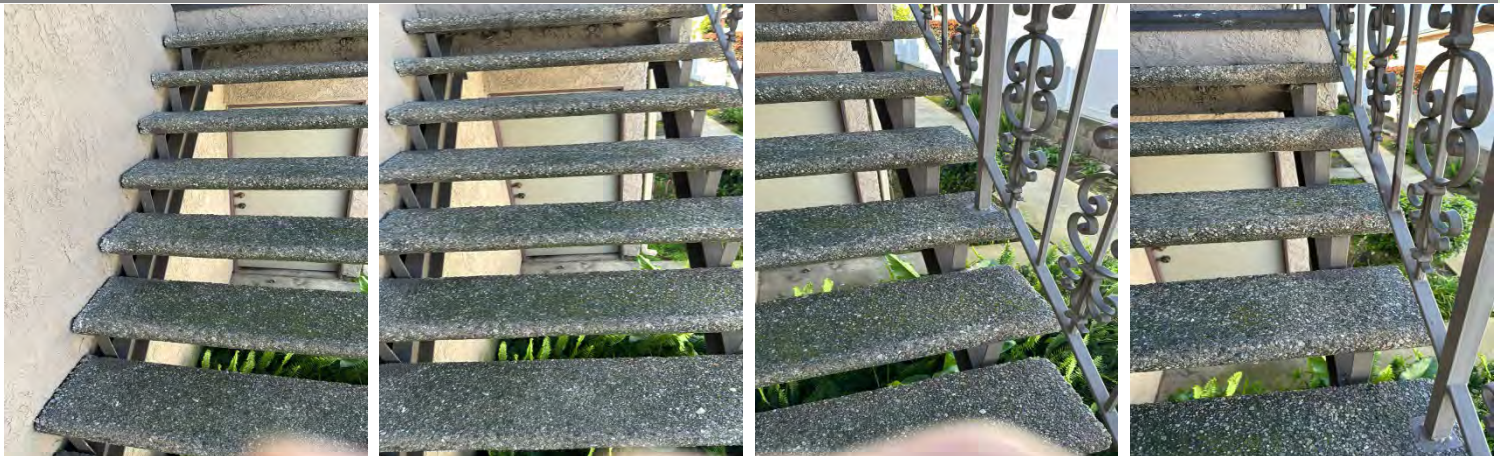
Building Name	5500
Apartment Name	6
Location Name	Stairs

Exterior Elements	Stairs, Stairs Landing, Railings
Water Proofing Elements	Flashings, Waterproofing, Coatings, Sealants
Visual Review	Good
Any Visual Signs of leaks	No
Further Invasive Review Required	No
Condition Assessment	Pass
Additional Considerations or Concerns	<p><b>Railing at concrete</b></p> <p><b>Stairs are steel stringers attached to a wood structure with concrete treads.</b></p> <p><b>The handrails are visually in good condition.</b></p>
Life Expectancy (EEE)	1-4 Years
Life Expectancy (LBC)	4-7 Years
Life Expectancy (AWE)	1-4 Years

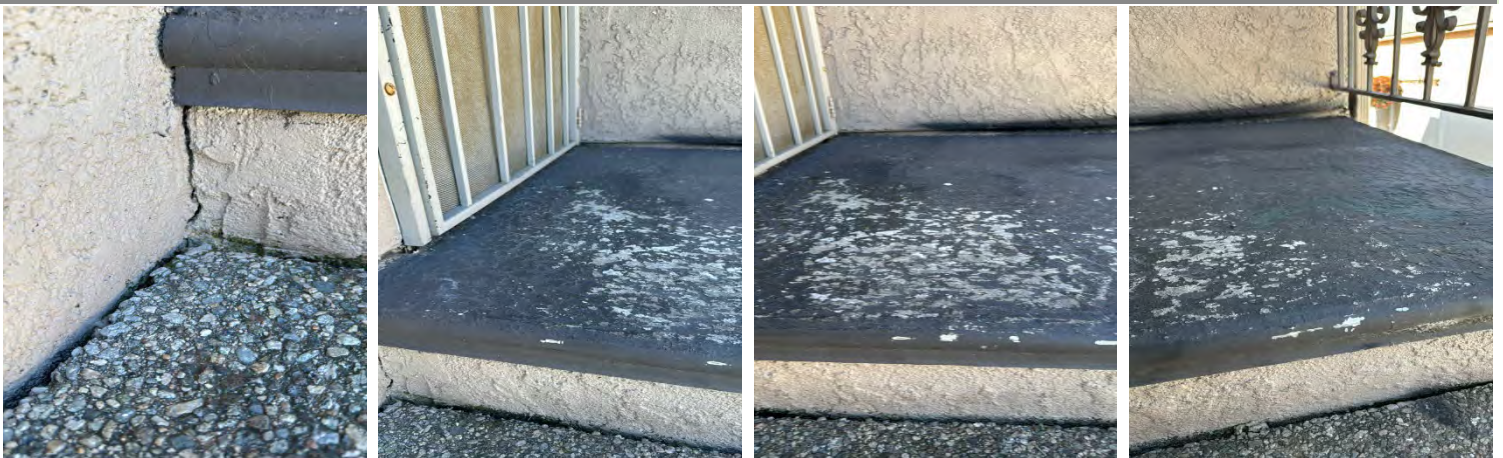
Building Name	5500
Apartment Name	6
Location Name	Entry deck

Exterior Elements	Decks, Railings, Integrations, Door Threshold, Stucco Interface
Water Proofing Elements	Flashings, Waterproofing, Coatings, Sealants
Visual Review	Fair
Any Visual Signs of leaks	No
Further Invasive Review Required	No
Condition Assessment	Pass
Additional Considerations or Concerns	Deck top coat deteriorated, however no signs of waterproofing leak. Refinish the deck waterproofing.
Life Expectancy (EEE)	1-4 Years
Life Expectancy (LBC)	4-7 Years
Life Expectancy (AWE)	0-1 Years

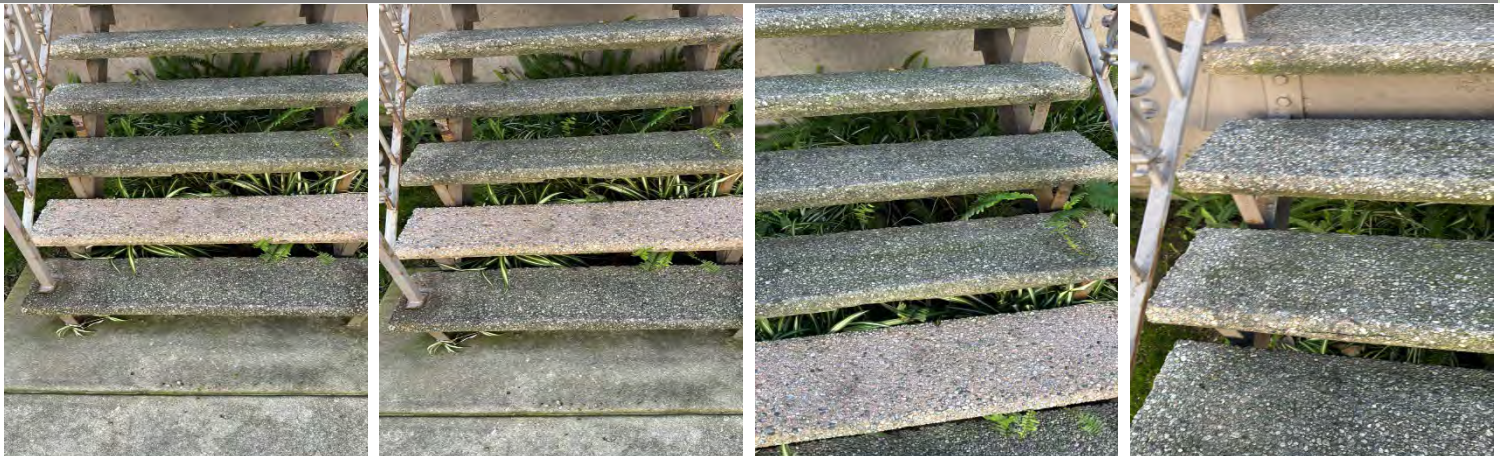
Exterior Elements	Stairs, Stairs Landing, Railings, Integrations
Water Proofing Elements	Flashings, Waterproofing, Coatings, Sealants
Visual Review	Good
Any Visual Signs of leaks	No
Further Invasive Review Required	No
Condition Assessment	Pass
Additional Considerations or Concerns	<p><b>Railing at concrete</b></p> <p><b>Stairs are steel stringers attached to a wood structure with concrete treads.</b></p> <p><b>The handrails are visually in good condition.</b></p>
Life Expectancy (EEE)	1-4 Years
Life Expectancy (LBC)	4-7 Years
Life Expectancy (AWE)	1-4 Years

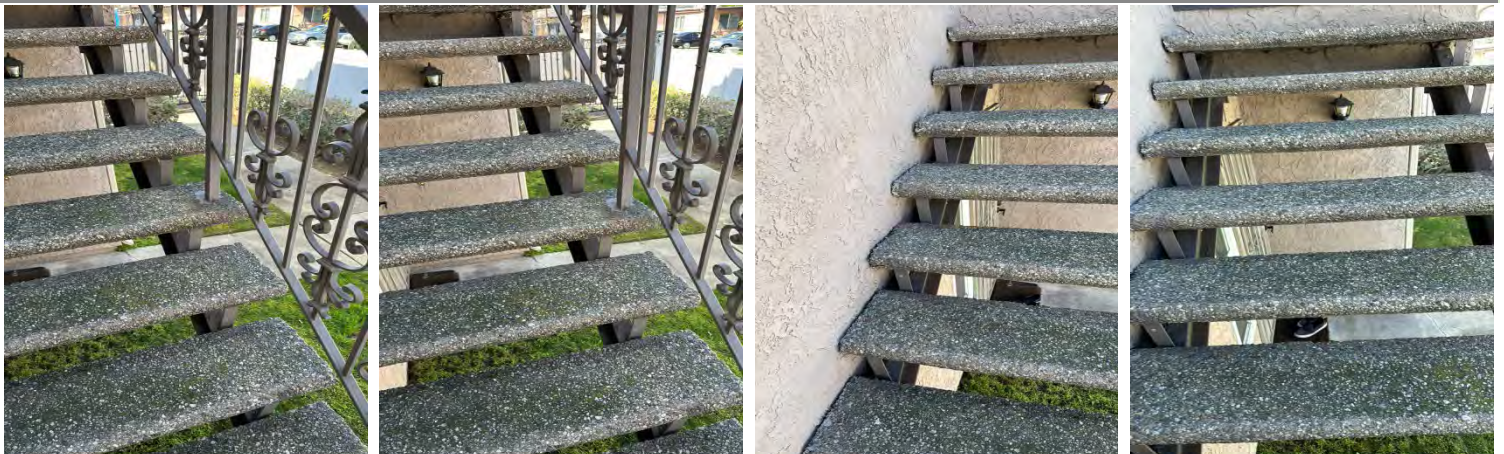
Exterior Elements	Stairs, Stairs Landing, Railings, Integrations
Water Proofing Elements	Flashings, Waterproofing, Coatings, Sealants
Visual Review	Good
Any Visual Signs of leaks	No
Further Invasive Review Required	No
Condition Assessment	Pass
Additional Considerations or Concerns	<p>Railing at concrete</p> <p>Stairs are steel stringers attached to a wood structure with concrete treads.</p> <p>The handrails are visually in good condition.</p>
Life Expectancy (EEE)	1-4 Years
Life Expectancy (LBC)	4-7 Years
Life Expectancy (AWE)	1-4 Years

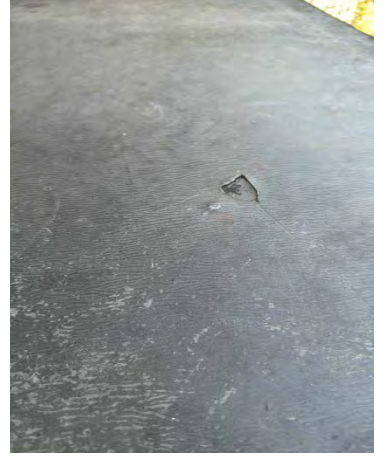
Exterior Elements	Decks, Railings, Integrations, Door Threshold, Stucco Interface
Water Proofing Elements	Flashings, Waterproofing, Coatings, Sealants
Visual Review	<b>Bad</b>
Any Visual Signs of leaks	<b>Yes</b>
Further Invasive Review Required	<b>No</b>
Condition Assessment	<b>Fail</b>
Additional Considerations or Concerns	<b>Entry / Balcony / Walking Deck</b>  <b>The deck is wood framed with waterproofing over the wood.</b>  <b>Handrails are metal and attached to the deck surface and visually in good condition.</b>  <b>The waterproofing is severely damaged. Replace or repair the waterproofing, including all damaged wood with new waterproofing and wood structures.</b>
Life Expectancy (EEE)	<b>1-4 Years</b>
Life Expectancy (LBC)	<b>1-4 Years</b>
Life Expectancy (AWE)	<b>0-1 Years</b>

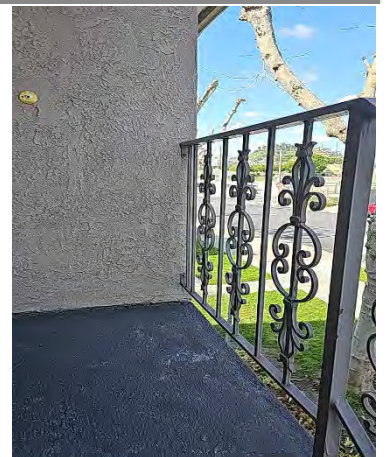
Exterior Elements	Stairs Landing, Railings, Stucco Interface, Integrations
Water Proofing Elements	Flashings, Waterproofing, Coatings, Sealants
Visual Review	Fair
Any Visual Signs of leaks	No
Further Invasive Review Required	No
Condition Assessment	Pass
Additional Considerations or Concerns	Surface rust on railings. Loose railing at first tread plate. Secure loose railing.
Life Expectancy (EEE)	0-1 Years
Life Expectancy (LBC)	1-4 Years
Life Expectancy (AWE)	0-1 Years

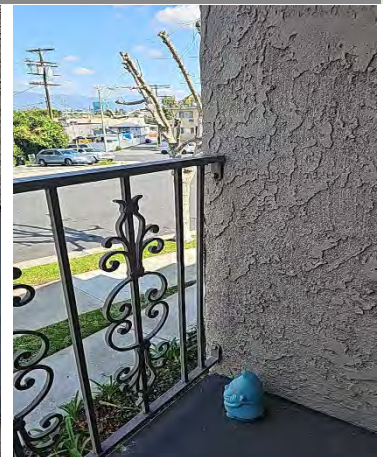
Exterior Elements	Stairs, Railings, Integrations, Stucco Interface
Water Proofing Elements	Flashings, Waterproofing, Coatings, Sealants
Visual Review	Fair
Any Visual Signs of leaks	No
Further Invasive Review Required	No
Condition Assessment	Pass
Additional Considerations or Concerns	Surface rust on railings.
Life Expectancy (EEE)	1-4 Years
Life Expectancy (LBC)	1-4 Years
Life Expectancy (AWE)	1-4 Years

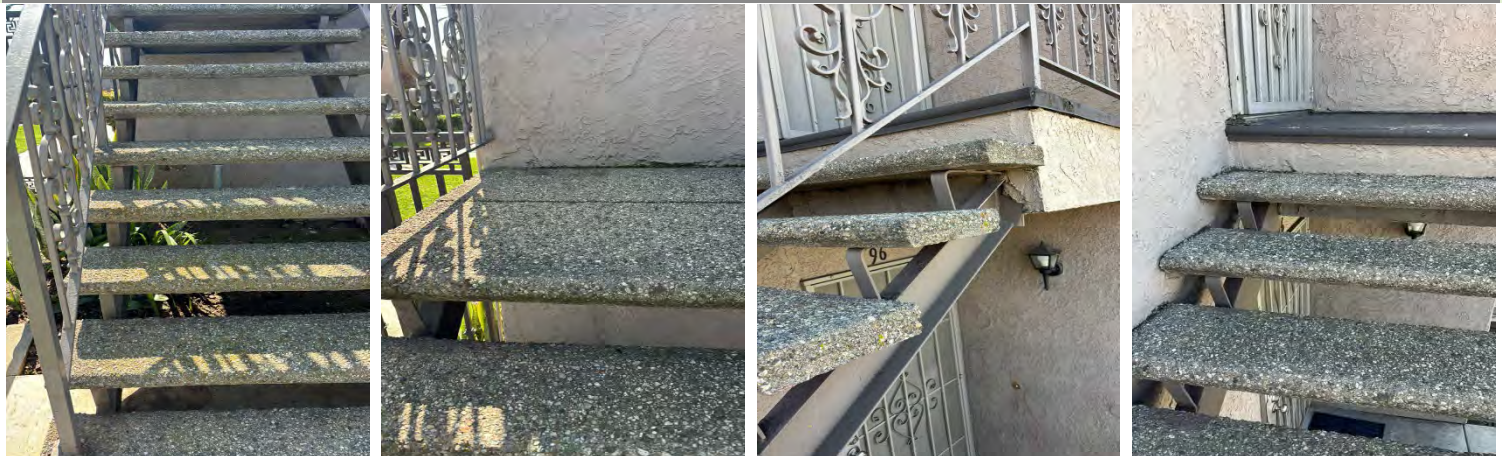
Building Name	5476-2
Apartment Name	97
Location Name	Stairs
Visual Report	
Exterior Elements	Stairs, Stairs Landing, Stucco Interface
Water Proofing Elements	Flashings, Waterproofing, Coatings, Sealants
Visual Review	Fair
Any Visual Signs of leaks	No
Further Invasive Review Required	No
Condition Assessment	Pass
Additional Considerations or Concerns	<p>Railing at concrete</p> <p>Stairs are steel stringers attached to a wood structure with concrete treads.</p> <p>The handrails are visually in good condition</p>
Life Expectancy (EEE)	1-4 Years
Life Expectancy (LBC)	4-7 Years
Life Expectancy (AWE)	1-4 Years

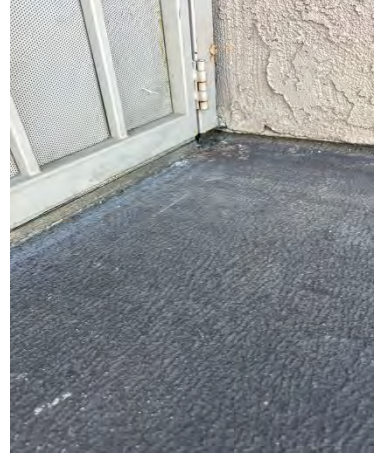
Building Name	5476-2
Apartment Name	97
Location Name	Entry deck
Visual Report	
Exterior Elements	Porches/Entry, Railings, Integrations, Door Threshold, Stucco Interface
Water Proofing Elements	Flashings, Waterproofing, Coatings, Sealants
Visual Review	Fair
Any Visual Signs of leaks	No
Further Invasive Review Required	No
Condition Assessment	Pass
Additional Considerations or Concerns	<p>Entry / Balcony / Walking Deck</p> <p>The deck is wood framed with waterproofing over the wood.</p> <p>Handrails are metal and attached to the deck surface and visually in good condition.</p>
Life Expectancy (EEE)	1-4 Years
Life Expectancy (LBC)	1-4 Years
Life Expectancy (AWE)	1-4 Years
Visual Photos

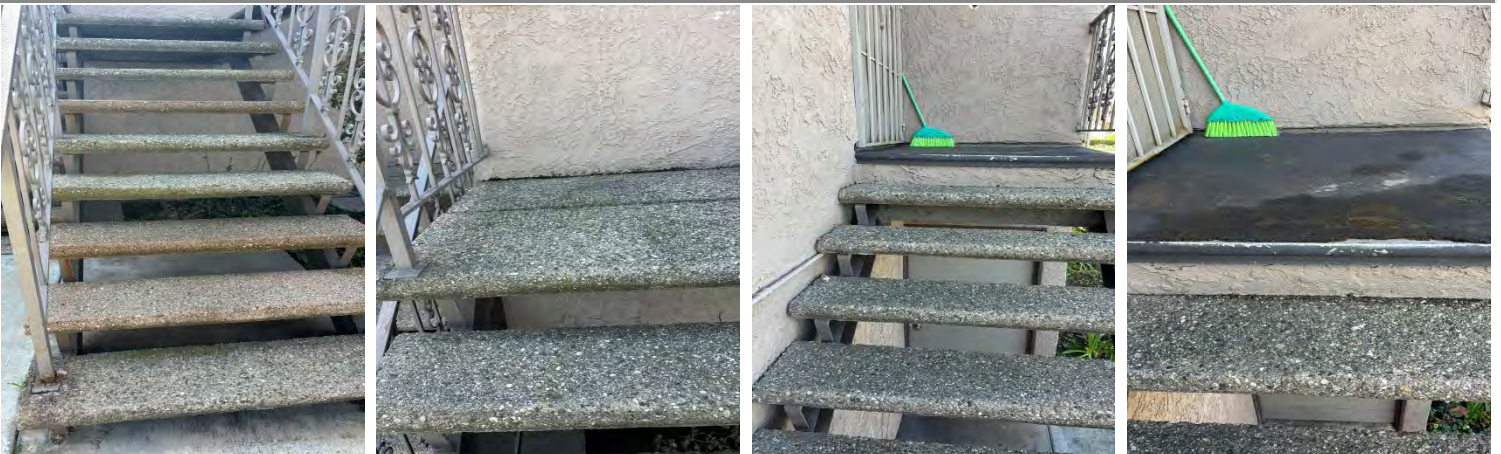
Exterior Elements	Stairs, Stairs Landing, Railings, Stucco Interface
Water Proofing Elements	Flashings, Waterproofing, Coatings, Sealants
Visual Review	Fair
Any Visual Signs of leaks	No
Further Invasive Review Required	No
Condition Assessment	Pass
Additional Considerations or Concerns	<p><b>Entry / Balcony / Walking Deck</b></p> <p>The deck is wood framed with waterproofing over the wood.</p> <p>Handrails are metal and attached to the deck surface and visually in good condition.</p>
Life Expectancy (EEE)	1-4 Years
Life Expectancy (LBC)	4-7 Years
Life Expectancy (AWE)	1-4 Years

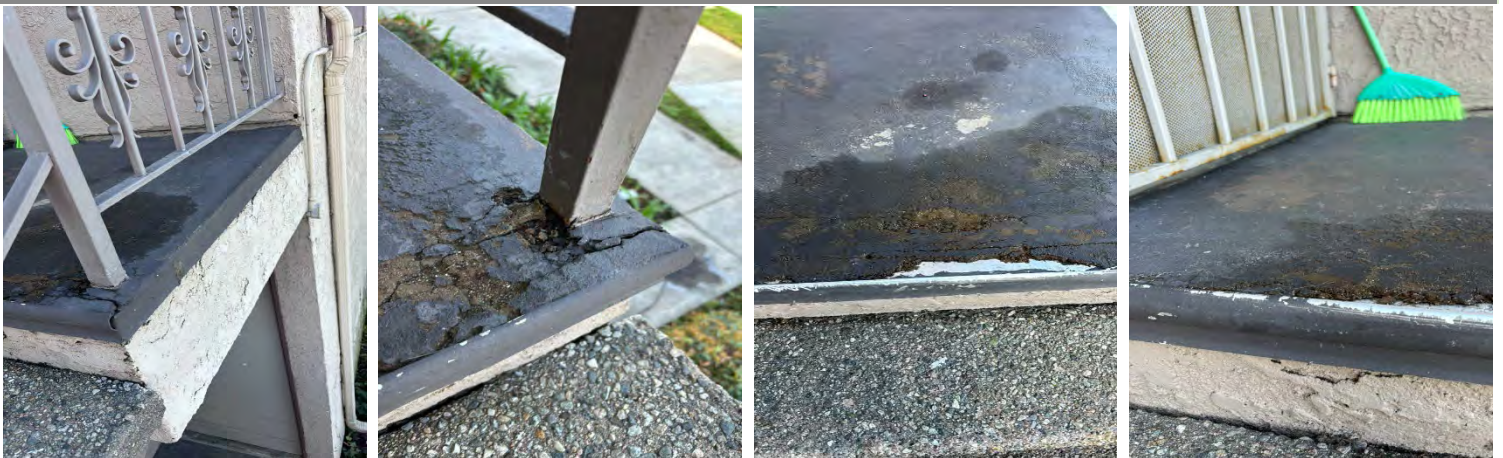
Exterior Elements	Porches/Entry, Railings, Integrations, Door Threshold, Stucco Interface
Water Proofing Elements	Flashings, Waterproofing, Coatings, Sealants
Visual Review	<b>Bad</b>
Any Visual Signs of leaks	<b>Yes</b>
Further Invasive Review Required	<b>Yes</b>
Condition Assessment	<b>Future Inspection</b>
Additional Considerations or Concerns	<b>Decking coating failure. Loose guardrail post. Recommend immediate repairs.</b>
Life Expectancy (EEE)	<b>0-1 Years</b>
Life Expectancy (LBC)	<b>0-1 Years</b>
Life Expectancy (AWE)	<b>0-1 Years</b>

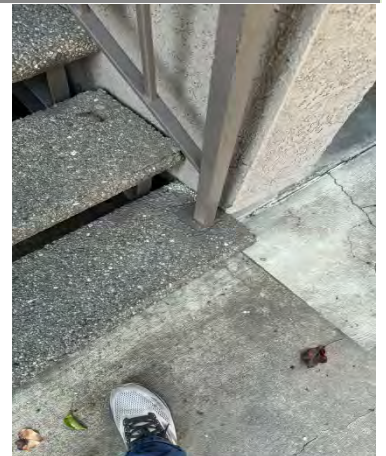
Exterior Elements	Stairs, Stairs Landing, Railings
Water Proofing Elements	Flashings, Waterproofing, Coatings, Sealants
Visual Review	Good
Any Visual Signs of leaks	No
Further Invasive Review Required	No
Condition Assessment	Pass
Additional Considerations or Concerns	<p><b>Railing at concrete</b></p> <p><b>Stairs are steel stringers attached to a wood structure with concrete treads.</b></p> <p><b>The handrails are visually in good condition.</b></p>
Life Expectancy (EEE)	1-4 Years
Life Expectancy (LBC)	4-7 Years
Life Expectancy (AWE)	1-4 Years

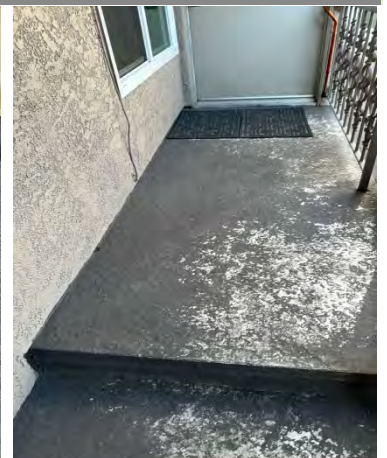
Exterior Elements	Decks, Stairs Landing, Railings, Integrations, Door Threshold, Stucco Interface
Water Proofing Elements	Flashings, Waterproofing, Coatings, Sealants
Visual Review	Fair
Any Visual Signs of leaks	No
Further Invasive Review Required	No
Condition Assessment	Pass
Additional Considerations or Concerns	The waterproofing is severely damaged. Replace or repair the waterproofing, including all damaged wood with new waterproofing and wood structures
Life Expectancy (EEE)	1-4 Years
Life Expectancy (LBC)	4-7 Years
Life Expectancy (AWE)	0-1 Years

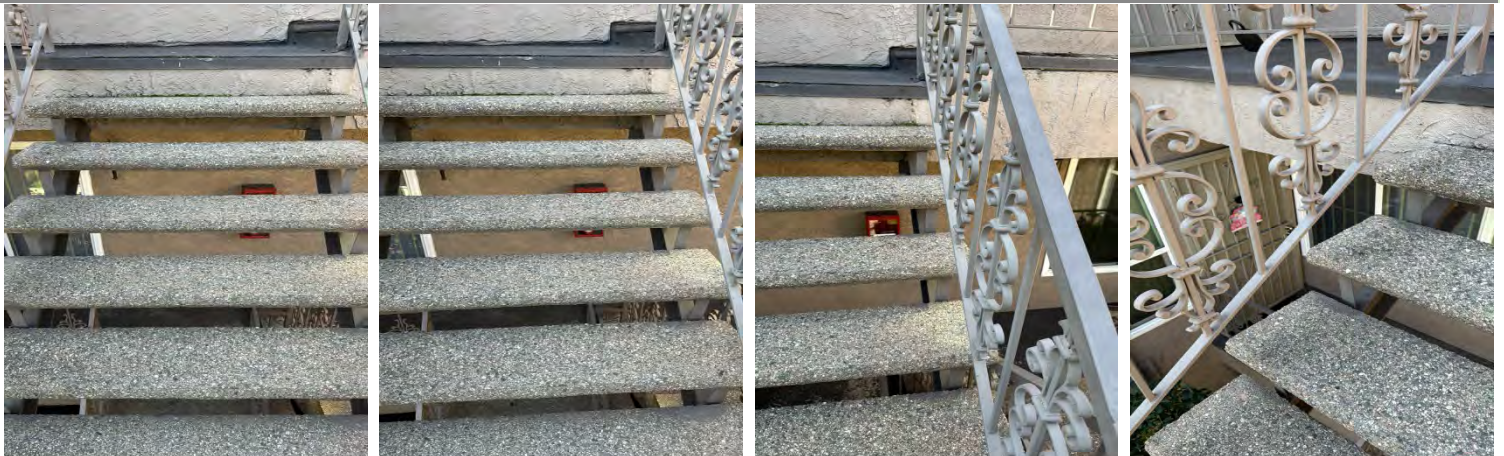
Building Name	5504
Apartment Name	82-84
Location Name	Stairs
Visual Report	
Exterior Elements	Stairs, Stairs Landing, Railings, Integrations
Water Proofing Elements	Flashings, Waterproofing, Coatings, Sealants
Visual Review	Good
Any Visual Signs of leaks	No
Further Invasive Review Required	No
Condition Assessment	Pass
Additional Considerations or Concerns	<p><b>Railing at concrete</b></p> <p><b>Stairs are steel stringers attached to a wood structure with concrete treads.</b></p> <p><b>The handrails are visually in good condition.</b></p>
Life Expectancy (EEE)	1-4 Years
Life Expectancy (LBC)	4-7 Years
Life Expectancy (AWE)	1-4 Years

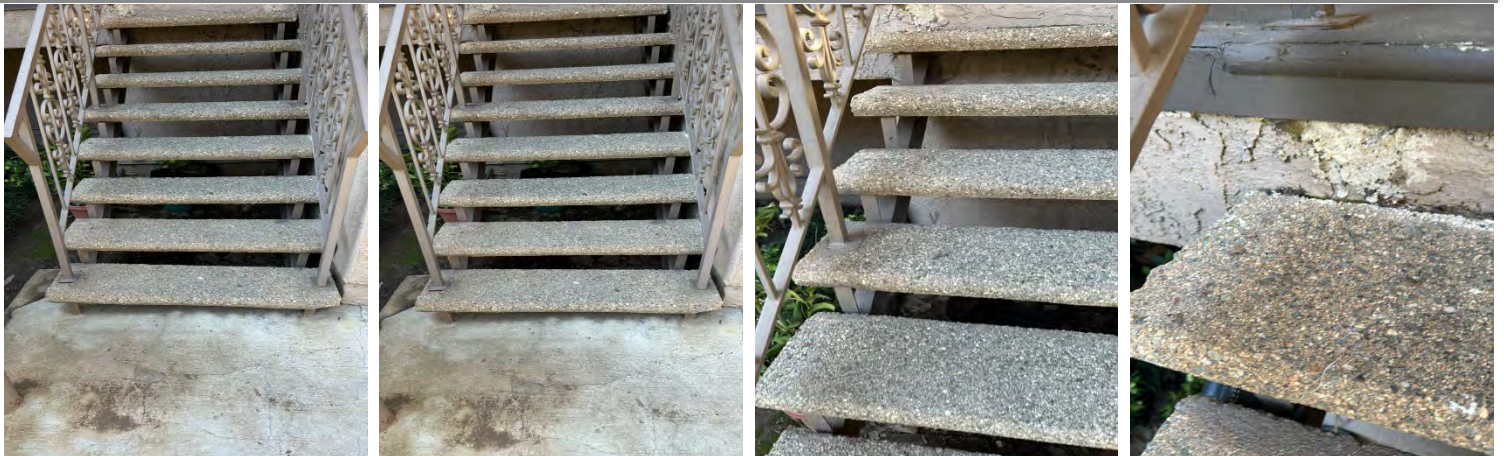
Building Name	5504
Apartment Name	77-79
Location Name	Stairs
Visual Report	
Exterior Elements	Stairs, Stairs Landing, Railings, Integrations
Water Proofing Elements	Flashings, Waterproofing, Coatings, Sealants
Visual Review	Good
Any Visual Signs of leaks	No
Further Invasive Review Required	No
Condition Assessment	Pass
Additional Considerations or Concerns	<p><b>Railing at concrete</b></p> <p><b>Stairs are steel stringers attached to a wood structure with concrete treads.</b></p> <p><b>The handrails are visually in good condition.</b></p>
Life Expectancy (EEE)	1-4 Years
Life Expectancy (LBC)	4-7 Years
Life Expectancy (AWE)	1-4 Years

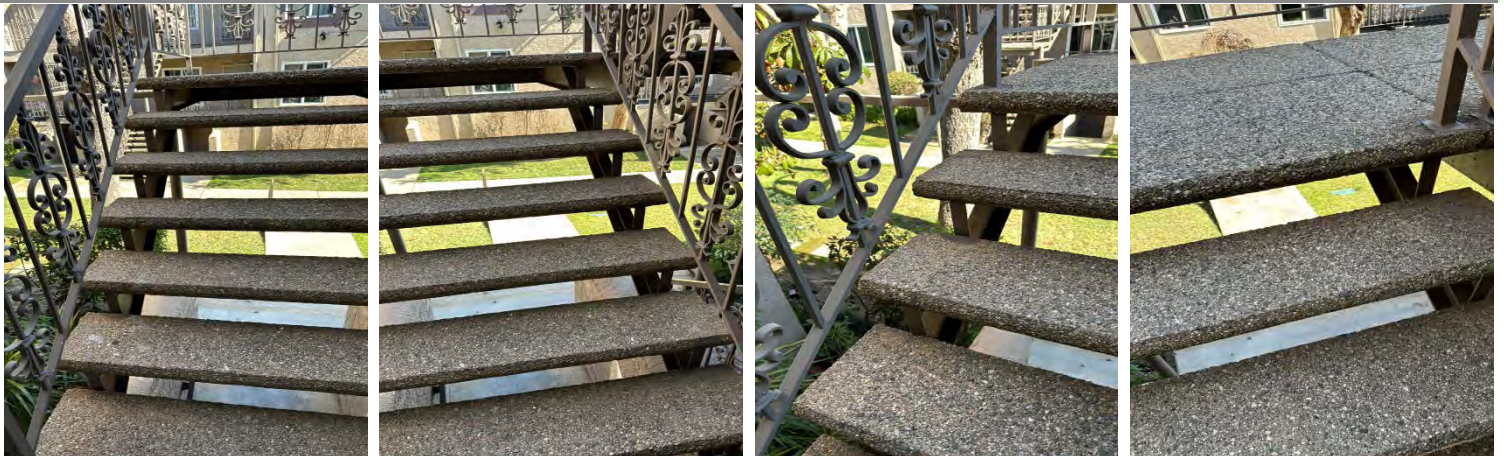
Exterior Elements	Stairs, Stairs Landing, Railings, Integrations
Water Proofing Elements	Flashings, Waterproofing, Coatings, Sealants
Visual Review	Good
Any Visual Signs of leaks	No
Further Invasive Review Required	No
Condition Assessment	Pass
Additional Considerations or Concerns	<p><b>Railing at concrete</b></p> <p><b>Stairs are steel stringers attached to a wood structure with concrete treads.</b></p> <p><b>The handrails are visually in good condition.</b></p>
Life Expectancy (EEE)	1-4 Years
Life Expectancy (LBC)	4-7 Years
Life Expectancy (AWE)	1-4 Years

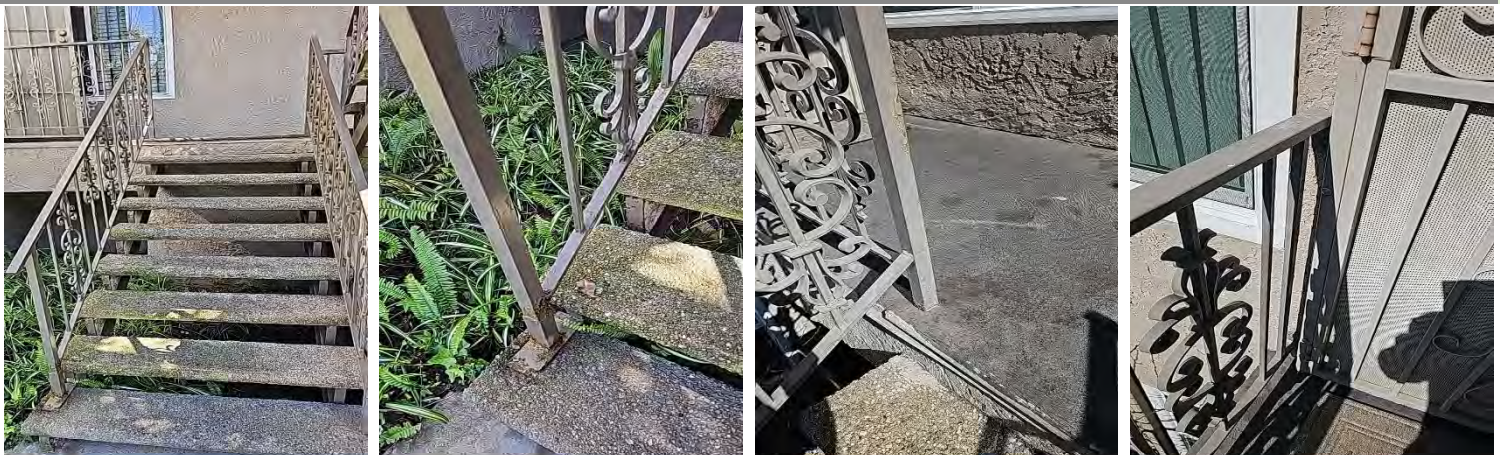
Building Name	5488-1
Apartment Name	103
Location Name	Stairs
Visual Report	
Exterior Elements	Stairs, Railings, Integrations, Stucco Interface
Water Proofing Elements	Flashings, Waterproofing, Coatings, Sealants
Visual Review	Fair
Any Visual Signs of leaks	No
Further Invasive Review Required	No
Condition Assessment	Pass
Additional Considerations or Concerns	Signs of deterioration on the handrails due to rust. Repair as necessary. Surface rust on handrail
Life Expectancy (EEE)	1-4 Years
Life Expectancy (LBC)	1-4 Years
Life Expectancy (AWE)	0-1 Years

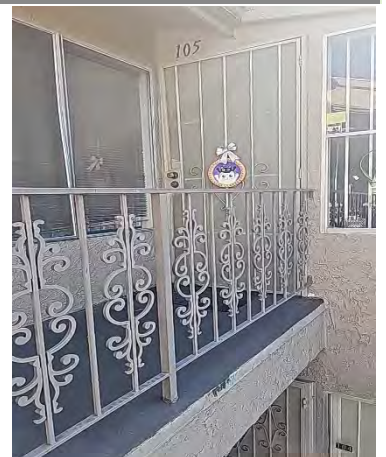
Exterior Elements	Stairs, Railings, Integrations, Stucco Interface
Water Proofing Elements	Flashings, Waterproofing, Coatings, Sealants
Visual Review	Fair
Any Visual Signs of leaks	No
Further Invasive Review Required	No
Condition Assessment	Pass
Additional Considerations or Concerns	Signs of rust at the hand rail attachments. Repair as necessary. Surface rust on handrail
Life Expectancy (EEE)	1-4 Years
Life Expectancy (LBC)	1-4 Years
Life Expectancy (AWE)	1-4 Years

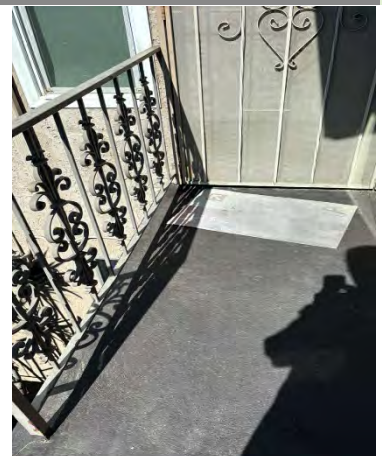
Exterior Elements	Porches/Entry, Railings, Integrations, Door Threshold, Stucco Interface
Water Proofing Elements	Flashings, Waterproofing, Coatings, Sealants
Visual Review	<b>Bad</b>
Any Visual Signs of leaks	<b>Yes</b>
Further Invasive Review Required	<b>Yes</b>
Condition Assessment	<b>Fail</b>
Additional Considerations or Concerns	<b>Deck has significant humps and bulges in the deck coating. Recommend further investigation at this locations.</b>
Life Expectancy (EEE)	<b>0-1 Years</b>
Life Expectancy (LBC)	<b>0-1 Years</b>
Life Expectancy (AWE)	<b>0-1 Years</b>

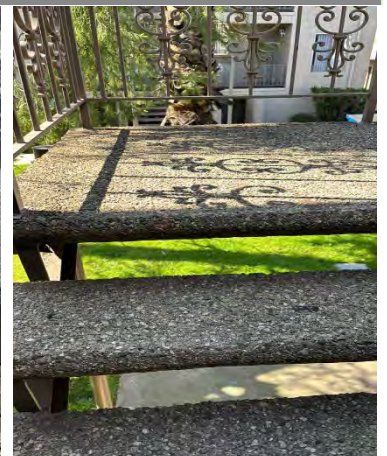
Exterior Elements	Stairs, Stairs Landing, Stucco Interface, Integrations, Railings
Water Proofing Elements	Flashings, Waterproofing, Coatings, Sealants
Visual Review	<b>Bad</b>
Any Visual Signs of leaks	<b>No</b>
Further Invasive Review Required	<b>Yes</b>
Condition Assessment	<b>Fail</b>
Additional Considerations or Concerns	<b>Delamination of the stucco around the bottom landing stringer attachment. Further investigation recommended.</b>
Life Expectancy (EEE)	<b>0-1 Years</b>
Life Expectancy (LBC)	<b>4-7 Years</b>
Life Expectancy (AWE)	<b>0-1 Years</b>

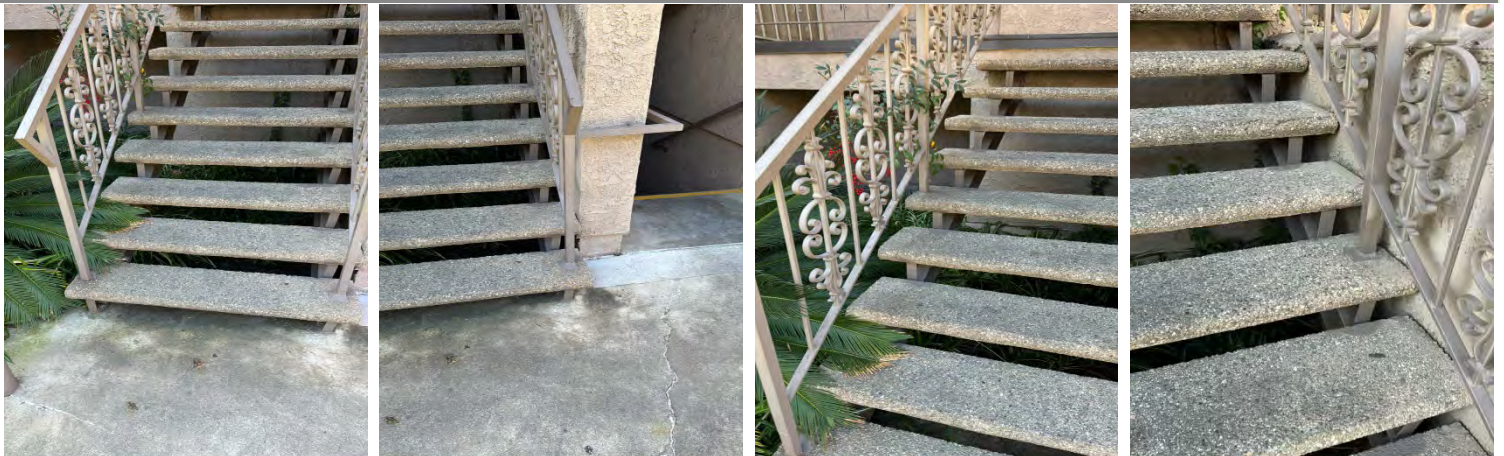
Exterior Elements	Stairs, Stairs Landing, Railings, Integrations
Water Proofing Elements	Flashings, Waterproofing, Coatings, Sealants
Visual Review	Good
Any Visual Signs of leaks	No
Further Invasive Review Required	No
Condition Assessment	Pass
Additional Considerations or Concerns	<p><b>Railing at concrete</b></p> <p><b>Stairs are steel stringers attached to a wood structure with concrete treads.</b></p> <p><b>The handrails are visually in good condition</b></p>
Life Expectancy (EEE)	1-4 Years
Life Expectancy (LBC)	4-7 Years
Life Expectancy (AWE)	1-4 Years

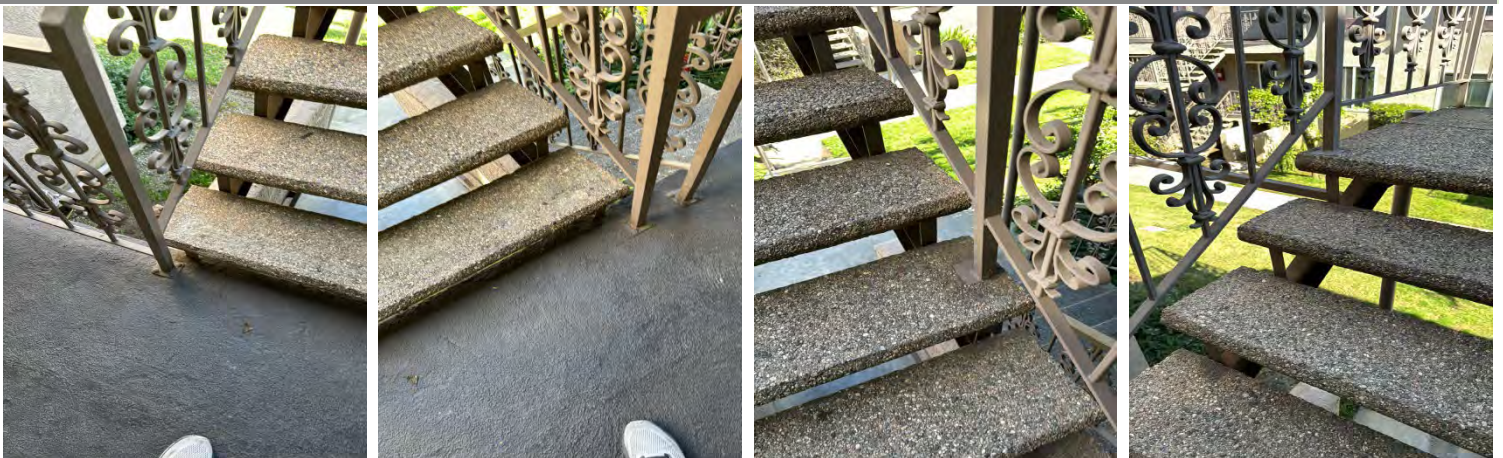
Exterior Elements	Stairs, Stairs Landing, Railings, Integrations
Water Proofing Elements	Flashings, Waterproofing, Coatings, Sealants
Visual Review	Good
Any Visual Signs of leaks	No
Further Invasive Review Required	No
Condition Assessment	Pass
Additional Considerations or Concerns	Railing at concrete Stairs are steel stringers attached to a wood structure with concrete treads. The handrails are visually in good condition
Life Expectancy (EEE)	1-4 Years
Life Expectancy (LBC)	4-7 Years
Life Expectancy (AWE)	1-4 Years

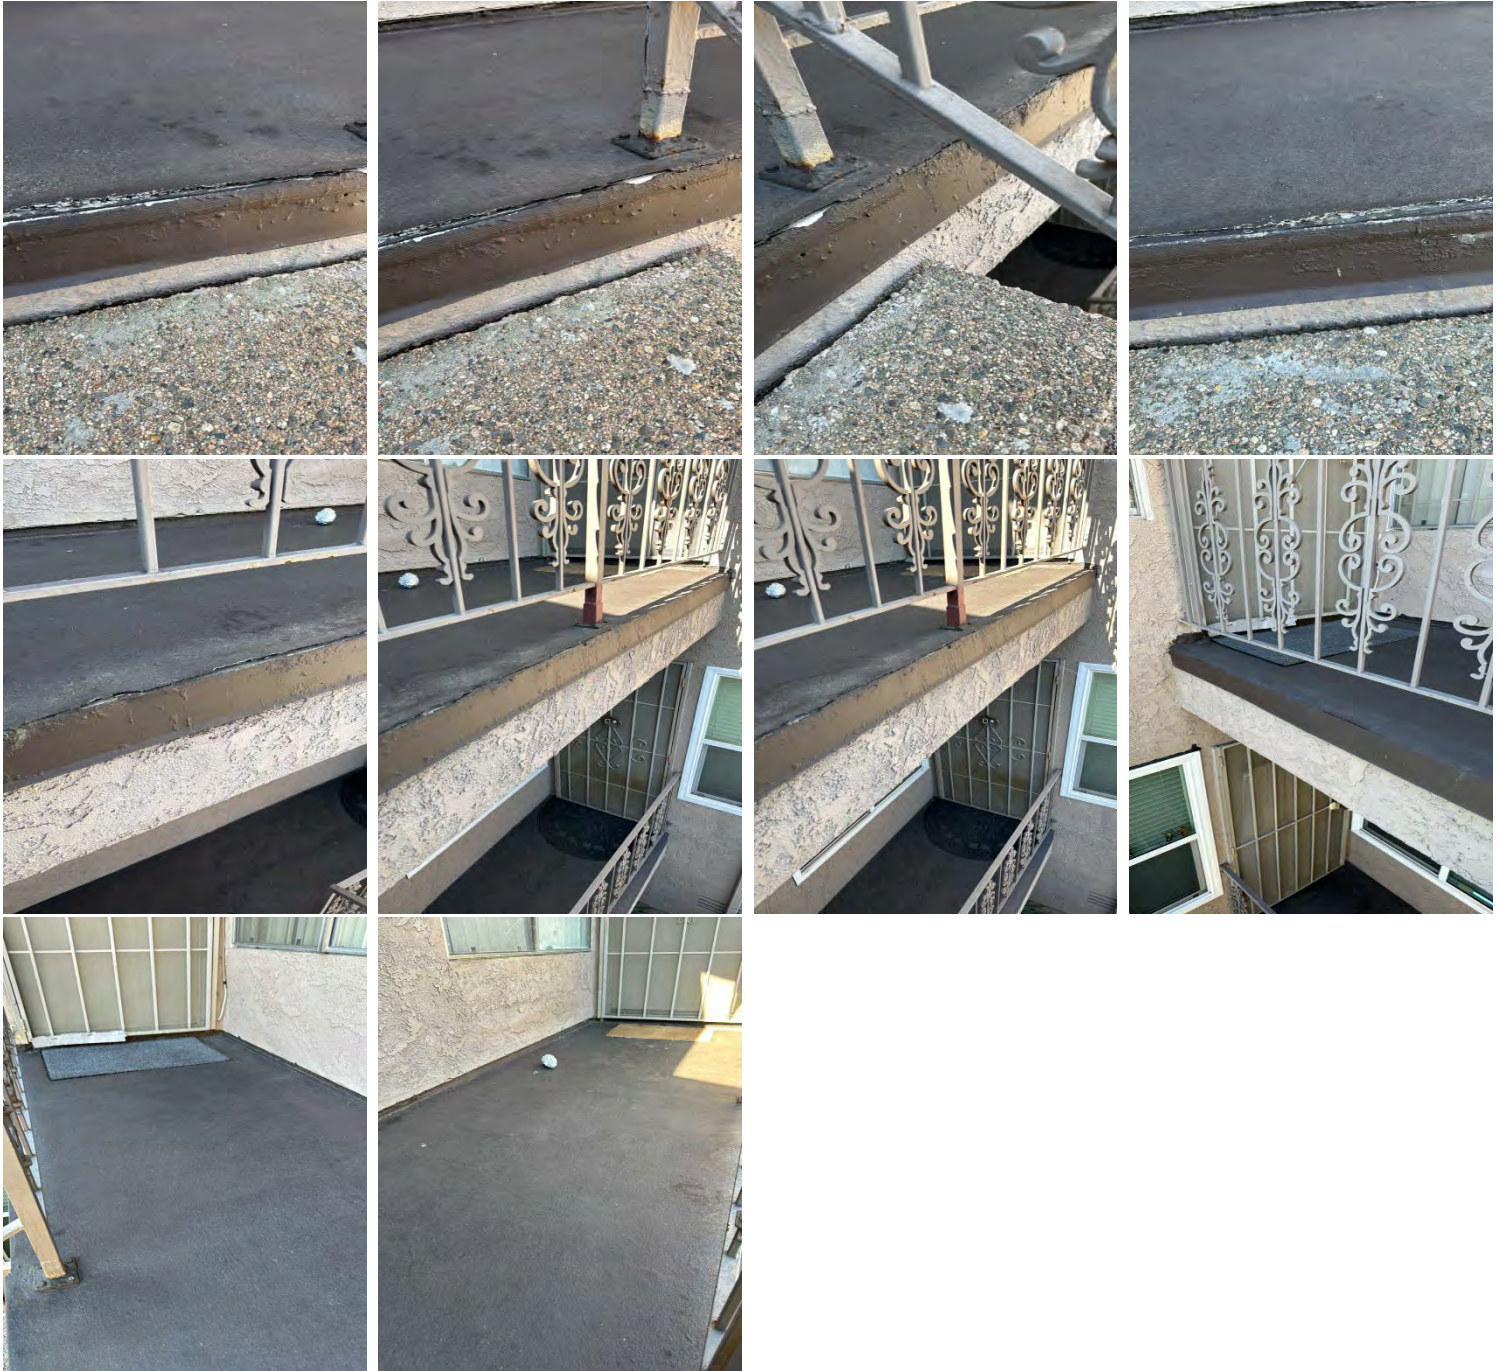
Building Name	5502
Apartment Name	74-76
Location Name	Entry deck
Visual Report	
Exterior Elements	Decks, Railings, Integrations, Door Threshold, Stucco Interface
Water Proofing Elements	Flashings, Waterproofing, Coatings, Sealants
Visual Review	Bad
Any Visual Signs of leaks	No
Further Invasive Review Required	No
Condition Assessment	Fail
Additional Considerations or Concerns	<p>Entry / Balcony / Walking Deck</p> <p>The deck is wood framed with waterproofing over the wood.</p> <p>Handrails are metal and attached to the deck surface and visually in good condition.</p> <p>The waterproofing is severely damaged. Replace or repair the waterproofing, including all damaged wood with new waterproofing and wood structures.</p>
Life Expectancy (EEE)	1-4 Years
Life Expectancy (LBC)	4-7 Years
Life Expectancy (AWE)	0-1 Years
Visual Photos

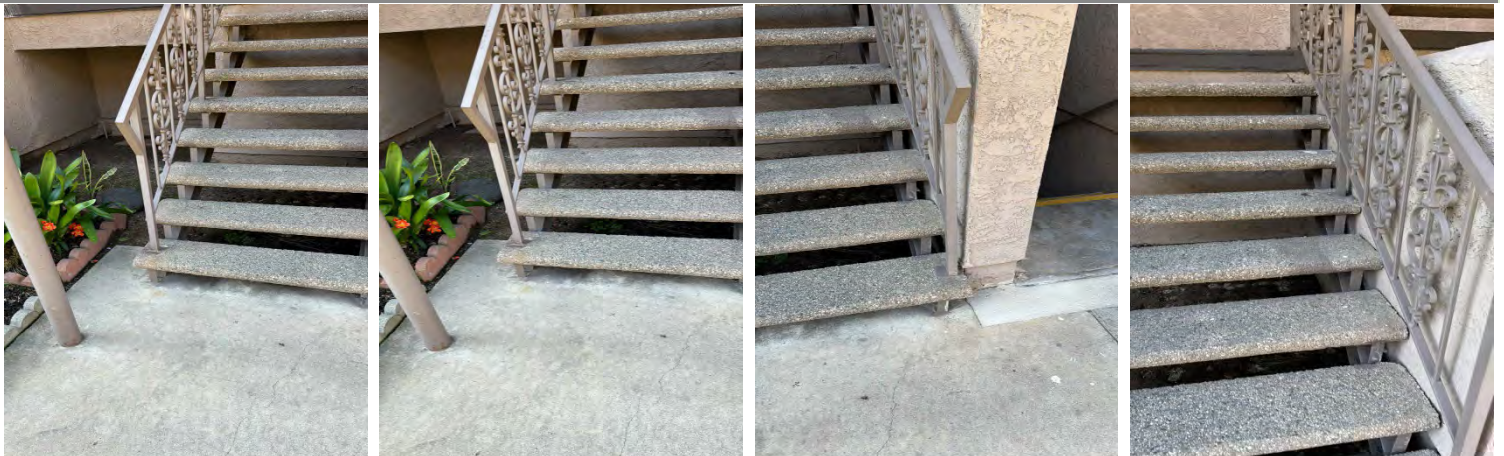
Exterior Elements	Stairs, Stairs Landing, Railings, Integrations
Water Proofing Elements	Flashings, Waterproofing, Coatings, Sealants
Visual Review	Good
Any Visual Signs of leaks	No
Further Invasive Review Required	No
Condition Assessment	Pass
Additional Considerations or Concerns	<p><b>Railing at concrete</b></p> <p><b>Stairs are steel stringers attached to a wood structure with concrete treads.</b></p> <p><b>The handrails are visually in good condition.</b></p>
Life Expectancy (EEE)	1-4 Years
Life Expectancy (LBC)	4-7 Years
Life Expectancy (AWE)	1-4 Years

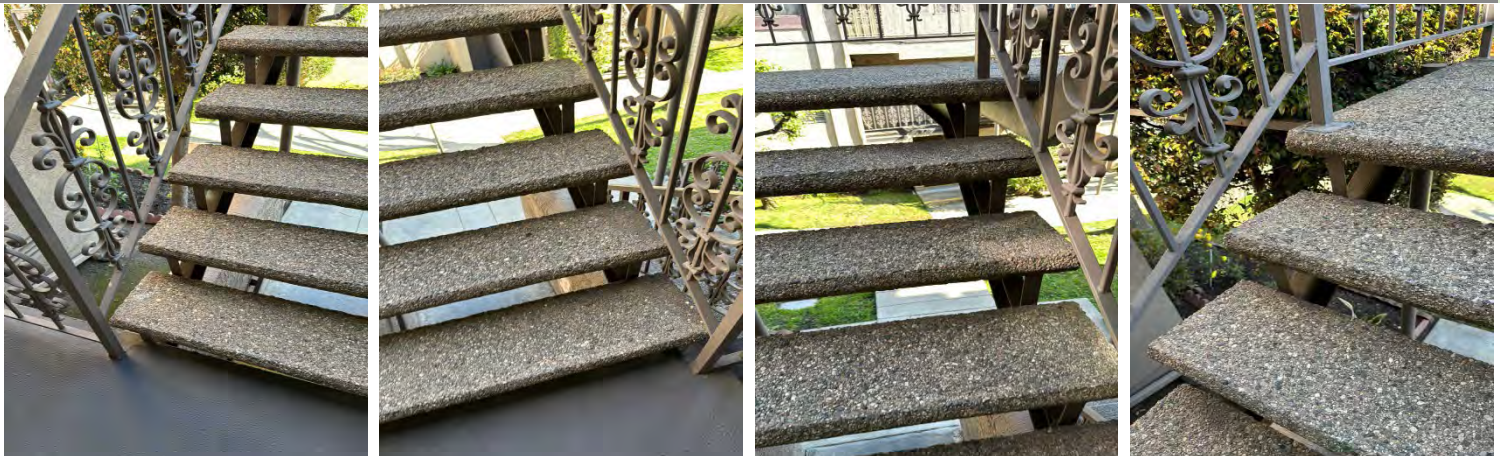
Building Name	5502
Apartment Name	70-72
Location Name	Stairs
Visual Report	
Exterior Elements	Porches/Entry, Stairs, Stairs Landing, Railings
Water Proofing Elements	Flashings, Waterproofing, Coatings, Sealants
Visual Review	Good
Any Visual Signs of leaks	No
Further Invasive Review Required	No
Condition Assessment	Pass
Additional Considerations or Concerns	<p><b>Railing at concrete</b></p> <p><b>Stairs are steel stringers attached to a wood structure with concrete treads.</b></p> <p><b>The handrails are visually in good condition.</b></p>
Life Expectancy (EEE)	1-4 Years
Life Expectancy (LBC)	4-7 Years
Life Expectancy (AWE)	1-4 Years

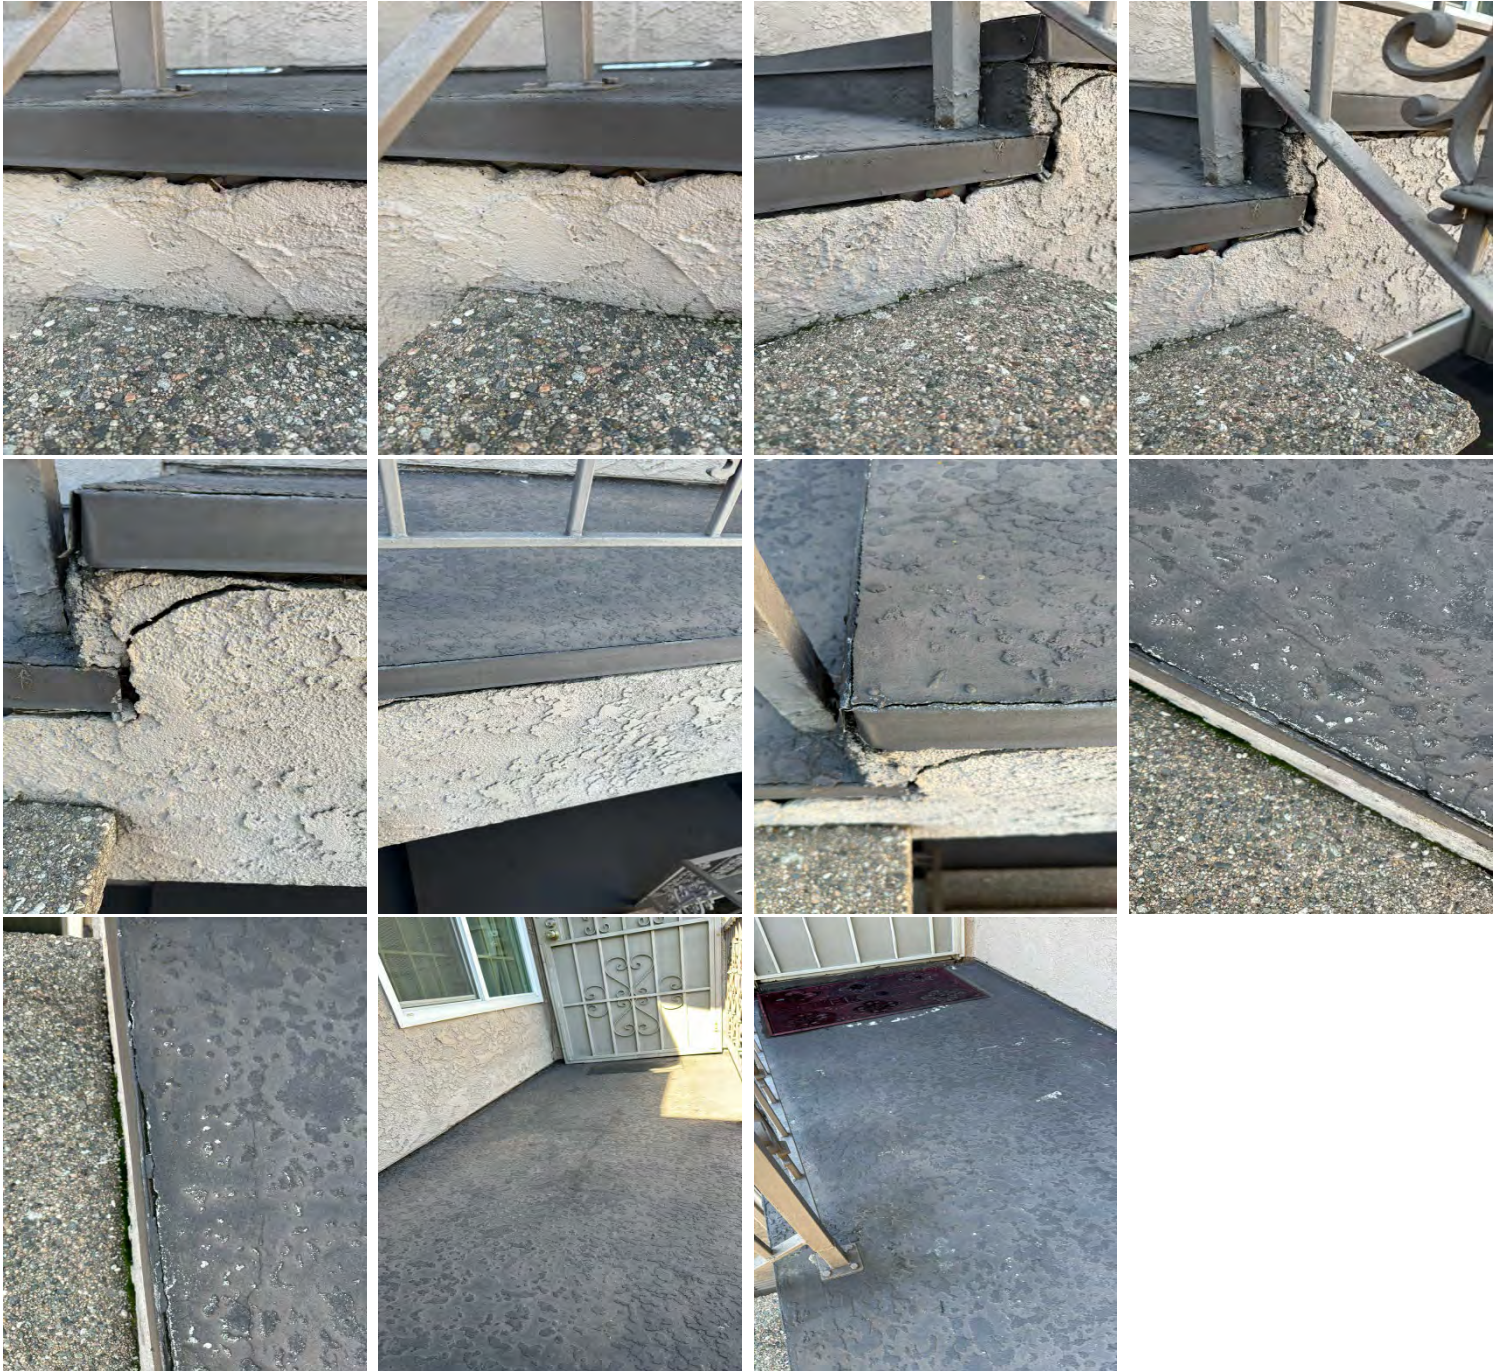
Building Name	5502
Apartment Name	70-72
Location Name	Entry deck
Visual Report	
Exterior Elements	Decks, Railings, Integrations, Door Threshold, Stucco Interface
Water Proofing Elements	Flashings, Waterproofing, Coatings, Sealants
Visual Review	Good
Any Visual Signs of leaks	No
Further Invasive Review Required	No
Condition Assessment	Fail
Additional Considerations or Concerns	<p>Entry / Balcony / Walking Deck</p> <p>The deck is wood framed with waterproofing over the wood.</p> <p>Handrails are metal and attached to the deck surface and visually in good condition.</p> <p>The waterproofing is severely damaged. Replace or repair the waterproofing, including all damaged wood with new waterproofing and wood structures.</p>
Life Expectancy (EEE)	1-4 Years
Life Expectancy (LBC)	4-7 Years
Life Expectancy (AWE)	0-1 Years

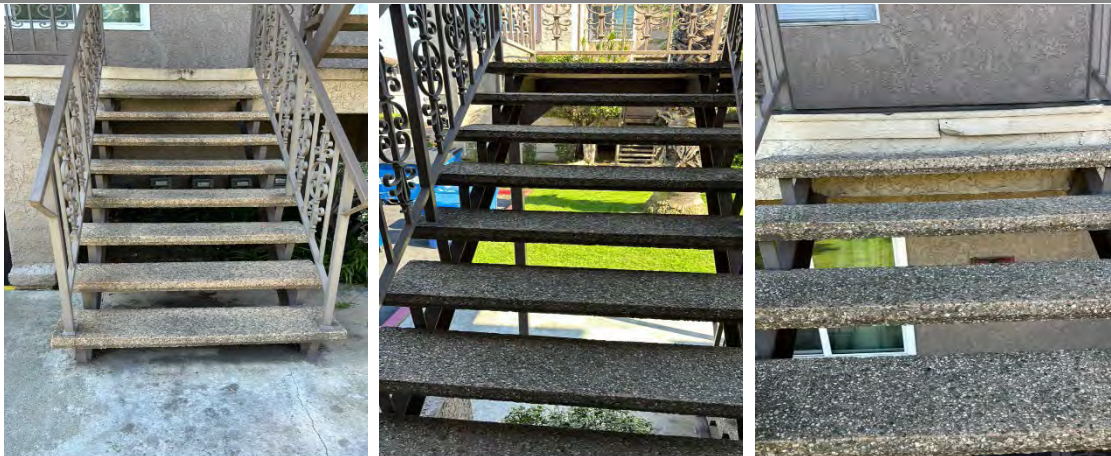
Building Name	5484-1
Apartment Name	139
Location Name	Stairs
Visual Report	
Exterior Elements	Stairs, Stairs Landing, Stucco Interface
Water Proofing Elements	Flashings, Waterproofing, Coatings, Sealants
Visual Review	Fair
Any Visual Signs of leaks	No
Further Invasive Review Required	No
Condition Assessment	Pass
Additional Considerations or Concerns	<p><b>Railing at concrete</b></p> <p><b>Stairs are steel stringers attached to a wood structure with concrete treads.</b></p> <p><b>The handrails are visually in good condition.</b></p>
Life Expectancy (EEE)	1-4 Years
Life Expectancy (LBC)	4-7 Years
Life Expectancy (AWE)	1-4 Years

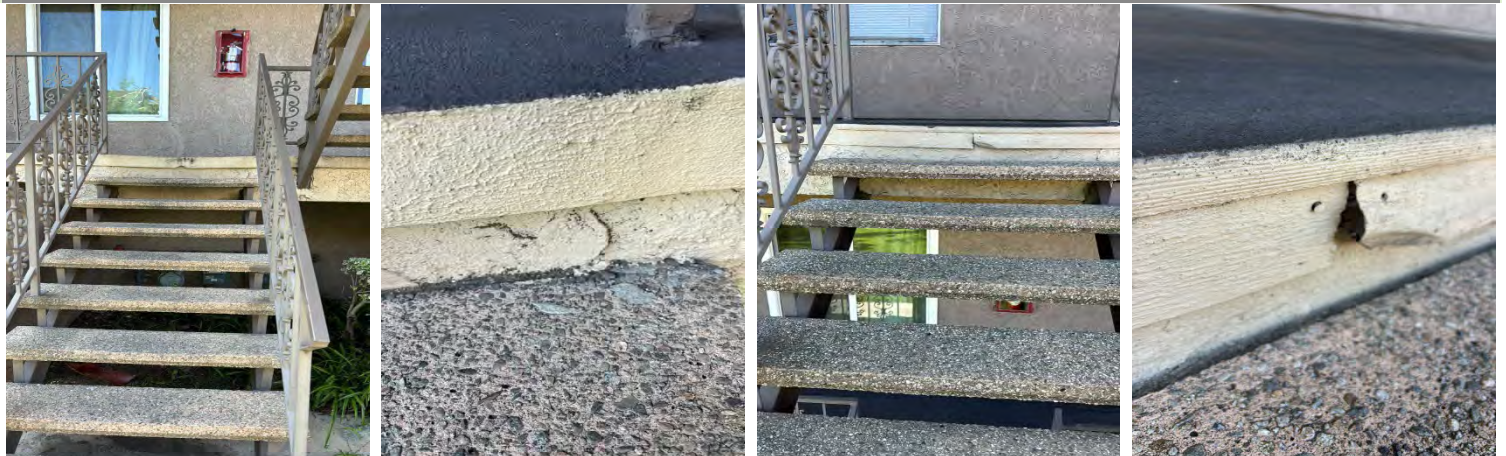
Building Name	5484-1
Apartment Name	137
Location Name	Stairs
Visual Report	
Exterior Elements	Stairs, Stairs Landing, Integrations, Stucco Interface
Water Proofing Elements	Flashings, Waterproofing, Coatings, Sealants
Visual Review	Fair
Any Visual Signs of leaks	No
Further Invasive Review Required	No
Condition Assessment	Pass
Additional Considerations or Concerns	<p>Railing at concrete</p> <p>Stairs are steel stringers attached to a wood structure with concrete treads.</p> <p>The handrails are visually in good condition.</p>
Life Expectancy (EEE)	1-4 Years
Life Expectancy (LBC)	4-7 Years
Life Expectancy (AWE)	1-4 Years
