## DECK INSPECTORS INC.

#### Part 2 of Visual Inspection:

Autumn Pointe HOA

55488 Dobbs St.

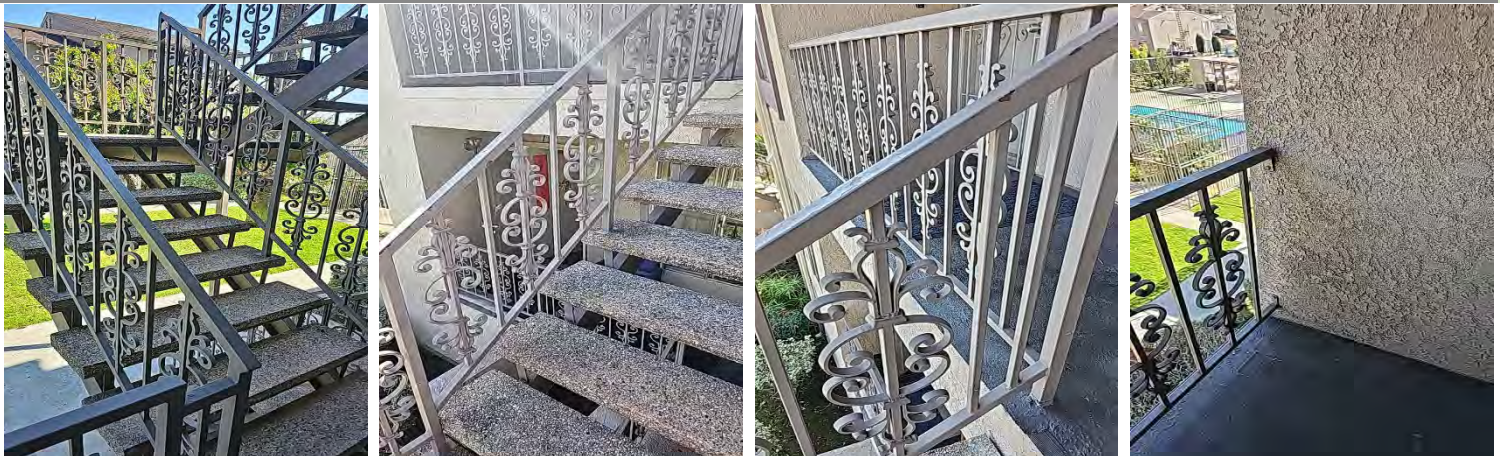
Exterior Elements	Stairs, Railings, Stucco Interface, Integrations
Water Proofing Elements	Flashings, Waterproofing, Coatings, Sealants
Visual Review	Fair
Any Visual Signs of leaks	No
Further Invasive Review Required	No
Condition Assessment	Pass
Additional Considerations or Concerns	<p><b>Railing at concrete</b></p> <p><b>Stairs are steel stringers attached to a wood structure with concrete treads.</b></p> <p><b>The handrails are visually in good condition.</b></p>
Life Expectancy (EEE)	1-4 Years
Life Expectancy (LBC)	1-4 Years
Life Expectancy (AWE)	1-4 Years

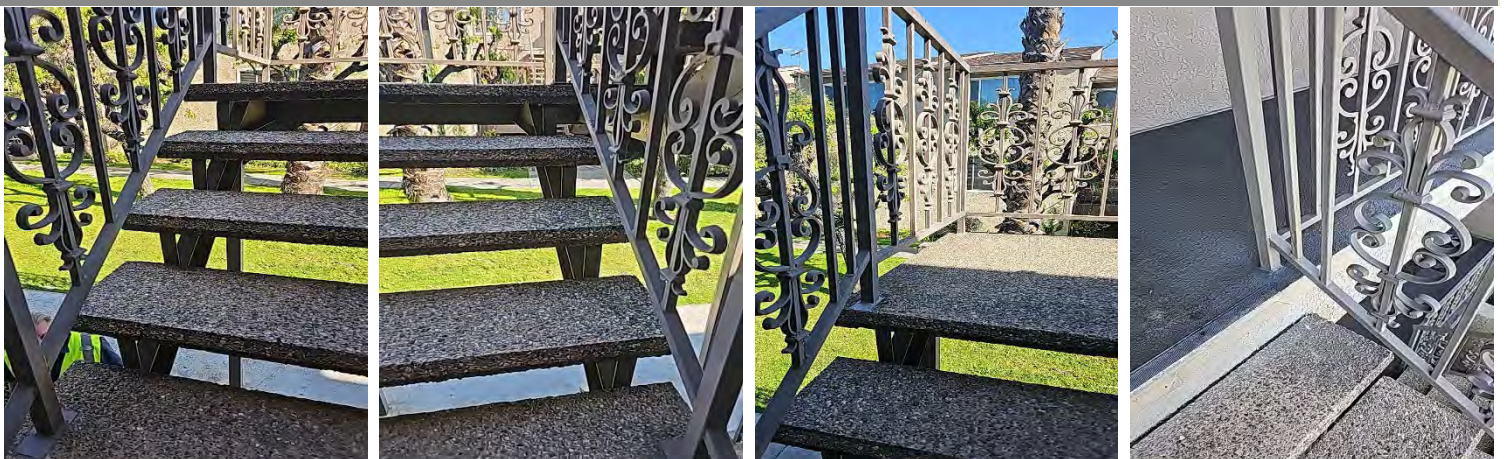
Building Name	5484-2
Apartment Name	135
Location Name	Stairs
Visual Report	
Exterior Elements	Stairs, Railings, Integrations, Stucco Interface
Water Proofing Elements	Flashings, Waterproofing, Coatings, Sealants
Visual Review	Fair
Any Visual Signs of leaks	No
Further Invasive Review Required	No
Condition Assessment	Pass
Additional Considerations or Concerns	Surface rust on metal post
Life Expectancy (EEE)	0-1 Years
Life Expectancy (LBC)	1-4 Years
Life Expectancy (AWE)	0-1 Years

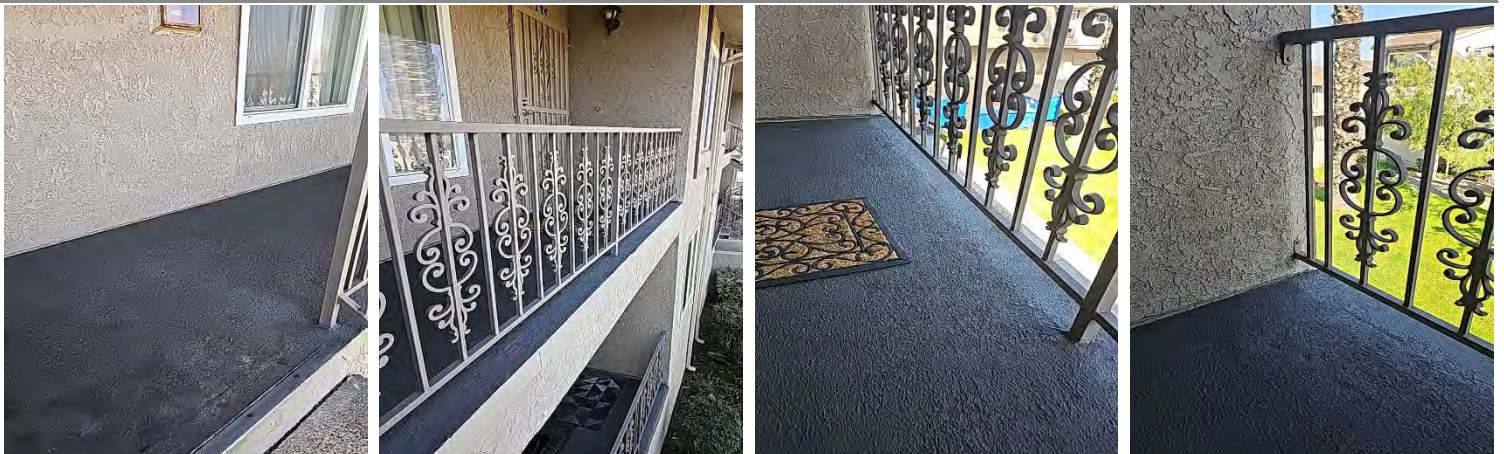
Building Name	5484-2
Apartment Name	135
Location Name	Entry deck
Visual Report	
Exterior Elements	Stairs Landing, Railings, Integrations, Stucco Interface
Water Proofing Elements	Flashings, Waterproofing, Coatings, Sealants
Visual Review	Good
Any Visual Signs of leaks	No
Further Invasive Review Required	No
Condition Assessment	Pass
Additional Considerations or Concerns	<p><b>Entry / Balcony / Walking Deck</b></p> <p>The deck is wood framed with waterproofing over the wood.</p> <p>Handrails are metal and attached to the deck surface and visually in good condition.</p>
Life Expectancy (EEE)	1-4 Years
Life Expectancy (LBC)	1-4 Years
Life Expectancy (AWE)	1-4 Years

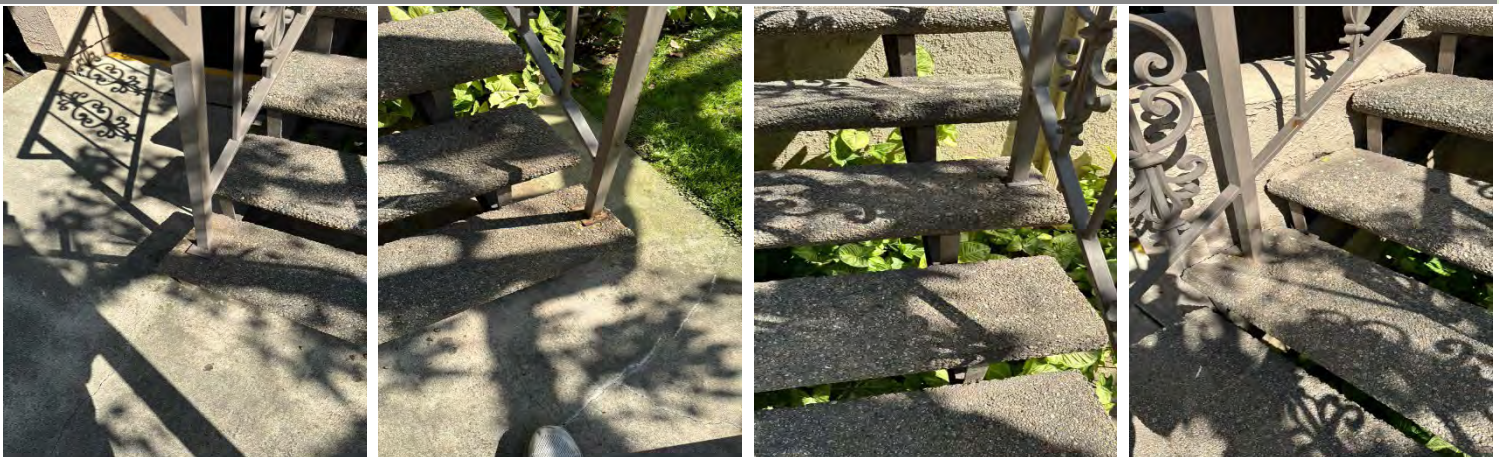
Exterior Elements	Decks, Railings, Integrations, Door Threshold, Stucco Interface
Water Proofing Elements	Flashings, Waterproofing, Coatings, Sealants
Visual Review	Good
Any Visual Signs of leaks	No
Further Invasive Review Required	No
Condition Assessment	Pass
Additional Considerations or Concerns	None
Life Expectancy (EEE)	1-4 Years
Life Expectancy (LBC)	4-7 Years
Life Expectancy (AWE)	1-4 Years

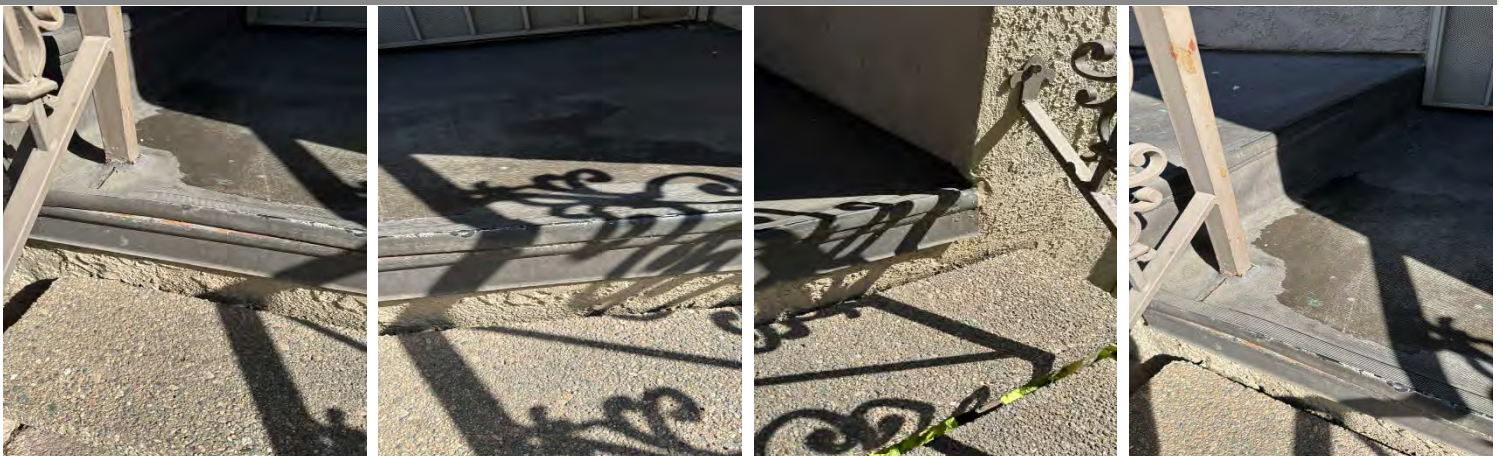
Exterior Elements	Decks, Railings, Integrations, Door Threshold, Stucco Interface
Water Proofing Elements	Flashings, Waterproofing, Coatings, Sealants
Visual Review	<b>Bad</b>
Any Visual Signs of leaks	<b>Yes</b>
Further Invasive Review Required	<b>No</b>
Condition Assessment	<b>Fail</b>
Additional Considerations or Concerns	<b>The waterproofing is severely damaged. Replace or repair the waterproofing, including all damaged wood with new waterproofing and wood structures</b>
Life Expectancy (EEE)	<b>1-4 Years</b>
Life Expectancy (LBC)	<b>4-7 Years</b>
Life Expectancy (AWE)	<b>0-1 Years</b>

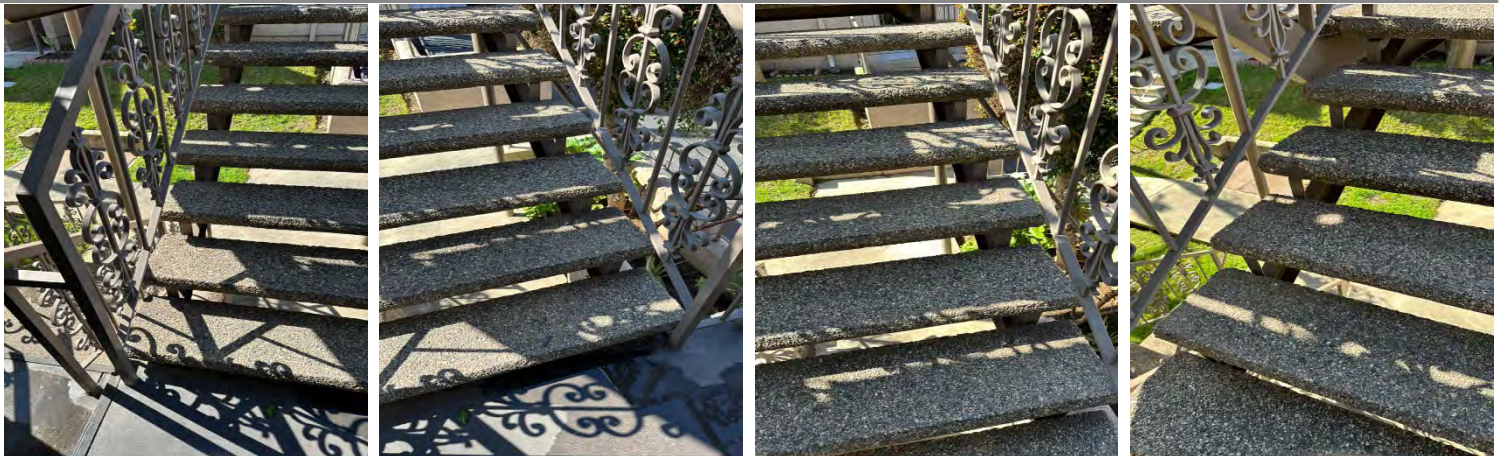
Exterior Elements	Stairs, Stairs Landing, Railings, Integrations
Water Proofing Elements	Flashings, Waterproofing, Coatings, Sealants
Visual Review	Good
Any Visual Signs of leaks	No
Further Invasive Review Required	No
Condition Assessment	Pass
Additional Considerations or Concerns	<p><b>Railing at concrete</b></p> <p><b>Stairs are steel stringers attached to a wood structure with concrete treads.</b></p> <p><b>The handrails are visually in good condition.</b></p>
Life Expectancy (EEE)	1-4 Years
Life Expectancy (LBC)	4-7 Years
Life Expectancy (AWE)	1-4 Years

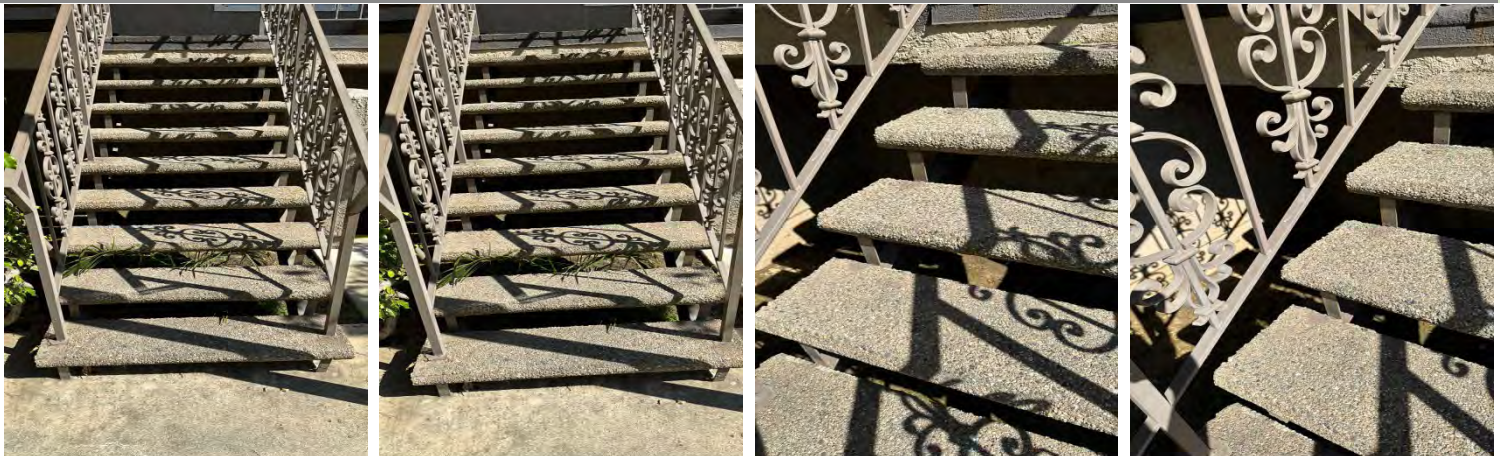
Building Name	2325
Apartment Name	63-65
Location Name	Stairs
Visual Report	
Exterior Elements	Stairs, Stairs Landing, Railings, Integrations
Water Proofing Elements	Flashings, Waterproofing, Coatings, Sealants
Visual Review	Good
Any Visual Signs of leaks	No
Further Invasive Review Required	No
Condition Assessment	Pass
Additional Considerations or Concerns	<p><b>Railing at concrete</b></p> <p><b>Stairs are steel stringers attached to a wood structure with concrete treads.</b></p> <p><b>The handrails are visually in good condition.</b></p>
Life Expectancy (EEE)	1-4 Years
Life Expectancy (LBC)	4-7 Years
Life Expectancy (AWE)	1-4 Years

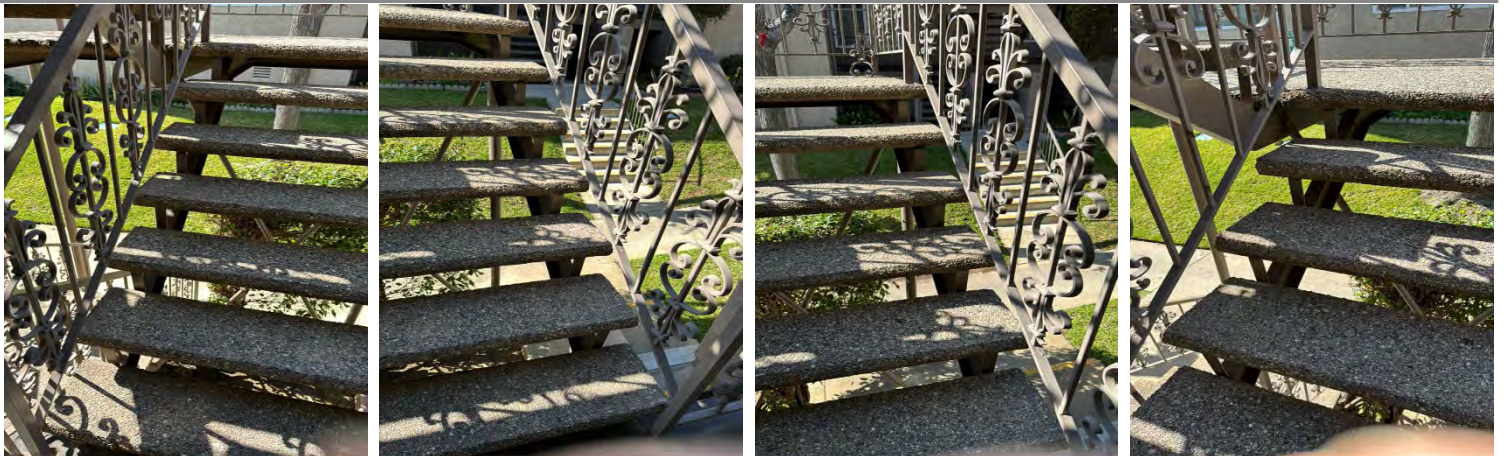
Exterior Elements	Stairs, Stairs Landing, Railings, Integrations
Water Proofing Elements	Flashings, Waterproofing, Coatings, Sealants
Visual Review	Good
Any Visual Signs of leaks	No
Further Invasive Review Required	No
Condition Assessment	Pass
Additional Considerations or Concerns	<p><b>Railing at concrete</b></p> <p><b>Stairs are steel stringers attached to a wood structure with concrete treads.</b></p> <p><b>The handrails are visually in good condition.</b></p>
Life Expectancy (EEE)	1-4 Years
Life Expectancy (LBC)	4-7 Years
Life Expectancy (AWE)	1-4 Years

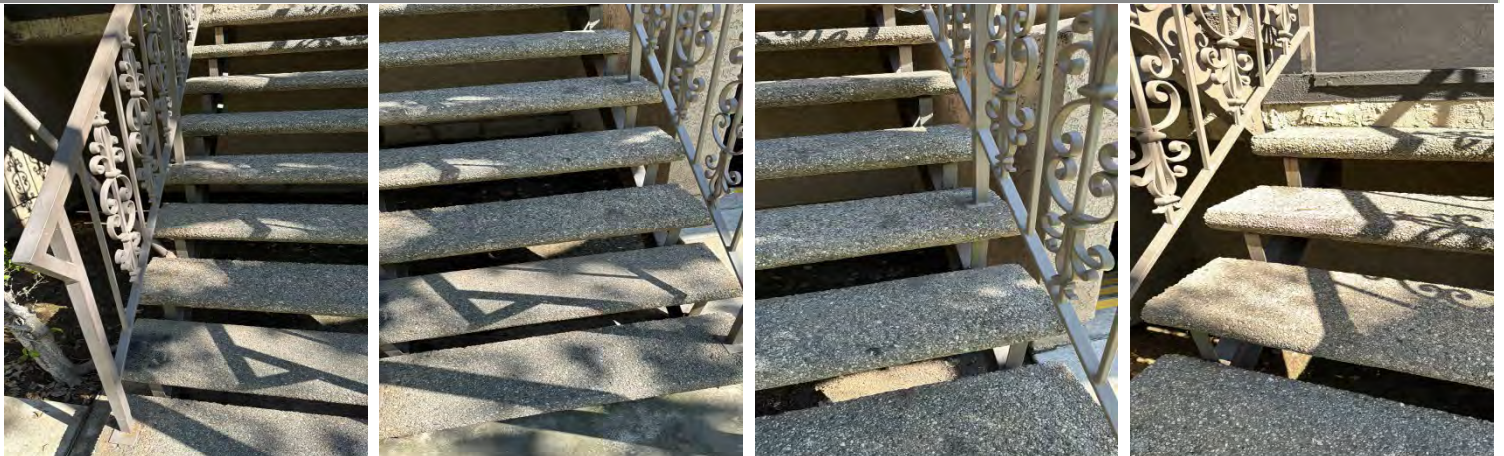
Building Name	2325
Apartment Name	59-61
Location Name	Stairs
Visual Report	
Exterior Elements	Stairs, Stairs Landing, Railings, Integrations
Water Proofing Elements	Flashings, Waterproofing, Coatings, Sealants
Visual Review	Good
Any Visual Signs of leaks	No
Further Invasive Review Required	No
Condition Assessment	Pass
Additional Considerations or Concerns	<p><b>Railing at concrete</b></p> <p><b>Stairs are steel stringers attached to a wood structure with concrete treads.</b></p> <p><b>The handrails are visually in good condition.</b></p>
Life Expectancy (EEE)	1-4 Years
Life Expectancy (LBC)	4-7 Years
Life Expectancy (AWE)	1-4 Years

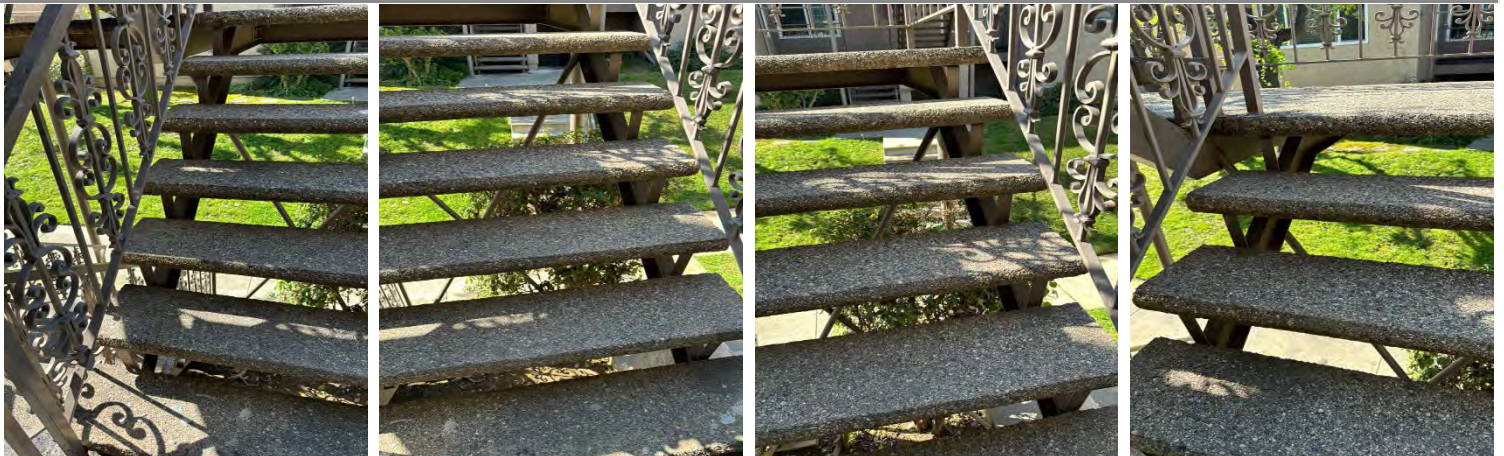
Exterior Elements	Stairs, Stairs Landing, Railings, Integrations
Water Proofing Elements	Flashings, Waterproofing, Coatings, Sealants
Visual Review	Good
Any Visual Signs of leaks	No
Further Invasive Review Required	No
Condition Assessment	Pass
Additional Considerations or Concerns	<p><b>Railing at concrete</b></p> <p><b>Stairs are steel stringers attached to a wood structure with concrete treads.</b></p> <p><b>The handrails are visually in good condition.</b></p>
Life Expectancy (EEE)	1-4 Years
Life Expectancy (LBC)	4-7 Years
Life Expectancy (AWE)	1-4 Years

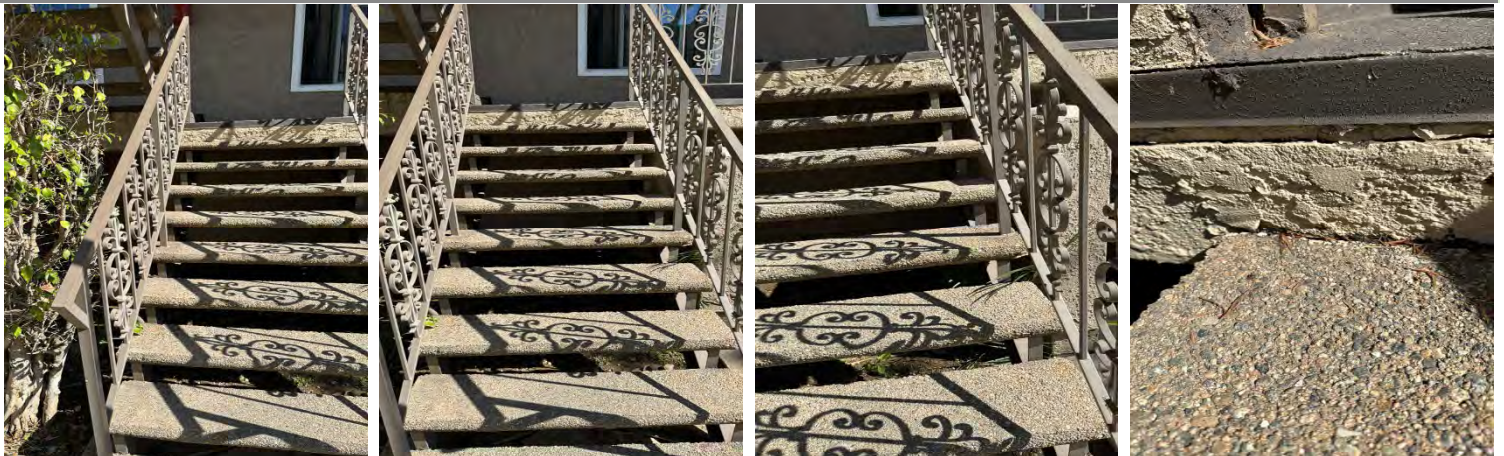
Building Name	2321
Apartment Name	55-57
Location Name	Stairs
Visual Report	
Exterior Elements	Stairs, Stairs Landing, Railings, Integrations
Water Proofing Elements	Flashings, Waterproofing, Coatings, Sealants
Visual Review	Good
Any Visual Signs of leaks	No
Further Invasive Review Required	No
Condition Assessment	Pass
Additional Considerations or Concerns	<p><b>Railing at concrete</b></p> <p><b>Stairs are steel stringers attached to a wood structure with concrete treads.</b></p> <p><b>The handrails are visually in good condition.</b></p>
Life Expectancy (EEE)	1-4 Years
Life Expectancy (LBC)	4-7 Years
Life Expectancy (AWE)	1-4 Years

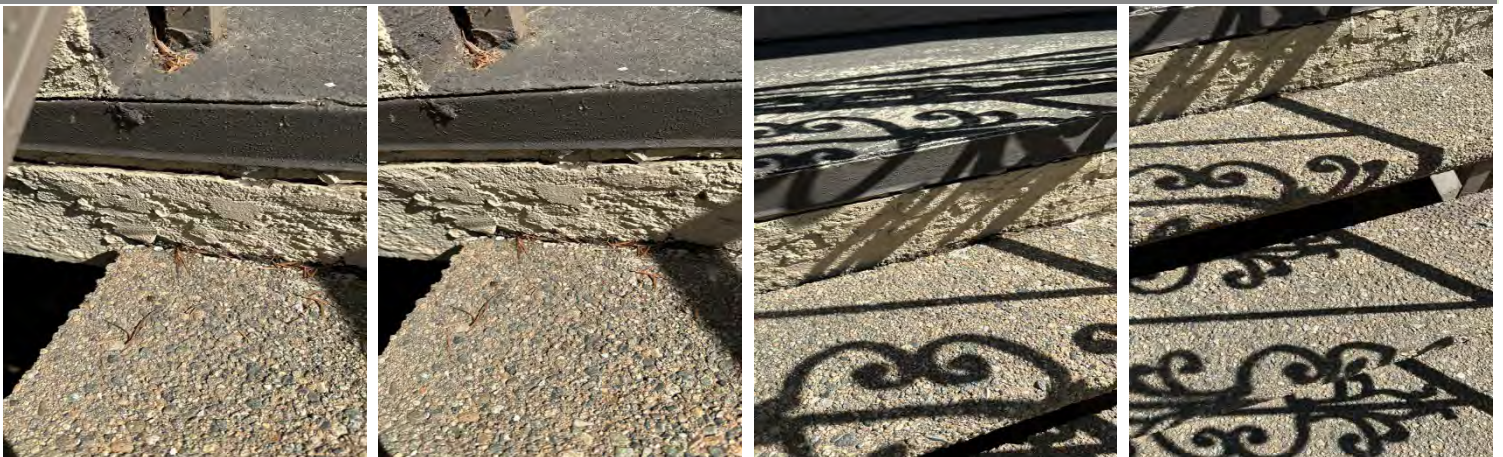
Exterior Elements	Decks, Railings, Integrations, Door Threshold, Stucco Interface
Water Proofing Elements	Flashings, Waterproofing, Coatings, Sealants
Visual Review	Fair
Any Visual Signs of leaks	No
Further Invasive Review Required	No
Condition Assessment	Pass
Additional Considerations or Concerns	Minor delamination of stucco at landing.
Life Expectancy (EEE)	1-4 Years
Life Expectancy (LBC)	4-7 Years
Life Expectancy (AWE)	0-1 Years

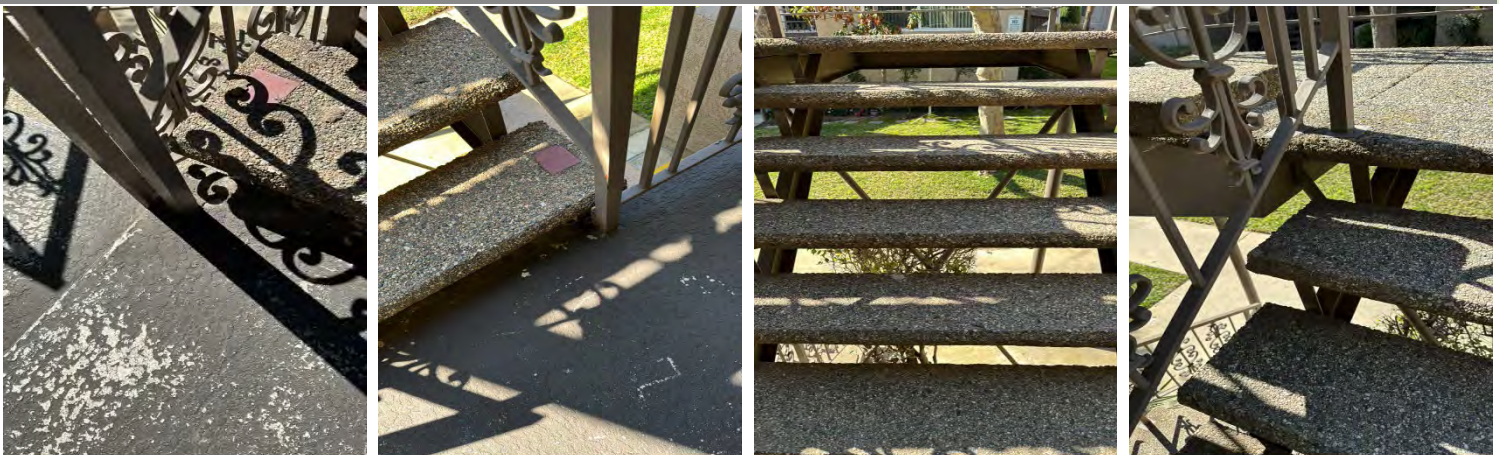
Exterior Elements	Stairs, Stairs Landing, Railings, Integrations
Water Proofing Elements	Flashings, Waterproofing, Coatings, Sealants
Visual Review	<b>Bad</b>
Any Visual Signs of leaks	<b>No</b>
Further Invasive Review Required	<b>No</b>
Condition Assessment	<b>Fail</b>
Additional Considerations or Concerns	<b>Corroded guardrail post at landing. Secure the railing attachments.</b>
Life Expectancy (EEE)	<b>0-1 Years</b>
Life Expectancy (LBC)	<b>4-7 Years</b>
Life Expectancy (AWE)	<b>1-4 Years</b>
