REPORT OF VISUAL INSPECTION

An inspection ("Inspection") of the Exterior Elevated Elements ("EEE") listed in Annex 1 (attached report), their load-bearing components ("LBC"), and associated waterproofing elements ("AWE") was performed at the property and on the date indicated below:

Autumn Pointe HOA/ 55488 Dobbns St.	Los Angeles	CA	
Date of Inspection:	2/22/2024

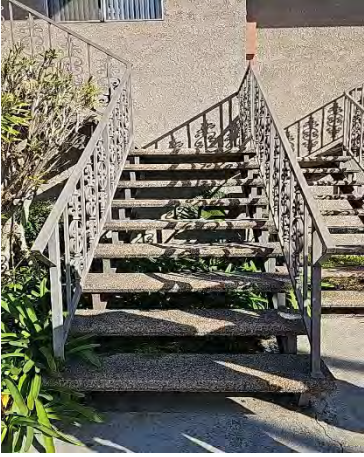
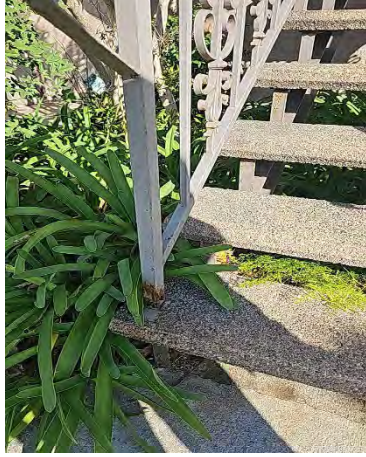
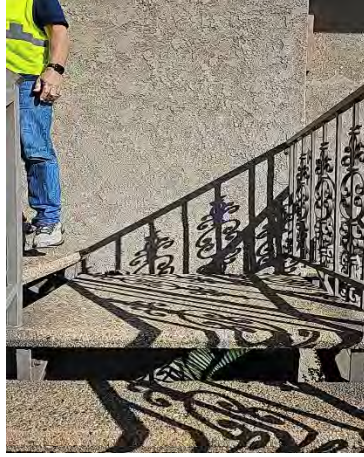
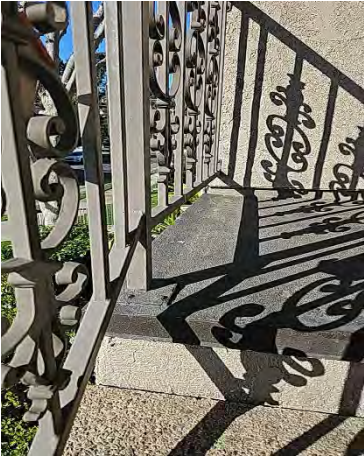
Building Name	5475-1
Apartment Name	108
Location Name	Stair
Visual Report	
Exterior Elements	Stairs, Railings
Water Proofing Elements	Flashings, Waterproofing, Coatings, Sealants
Visual Review	Fair
Any Visual Signs of leaks	No
Further Invasive Review Required	No
Condition Assessment	Pass
Additional Considerations or Concerns	<p>Railing at concrete Stairs are steel stringers attached to a wood structure with concrete treads.</p> <p>The railing attachment to the concrete structure is rusted. Repair as necessary to ensure a solid rust-free attachment.</p>
Life Expectancy (EEE)	1-4 Years
Life Expectancy (LBC)	4-7 Years
Life Expectancy (AWE)	1-4 Years
Visual Photos

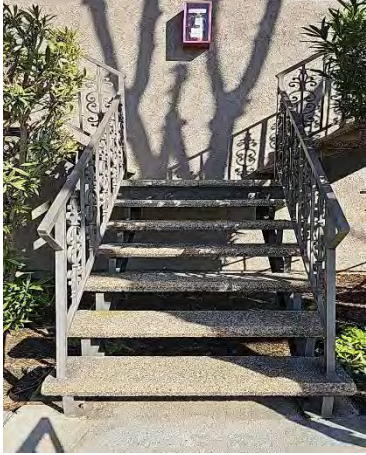
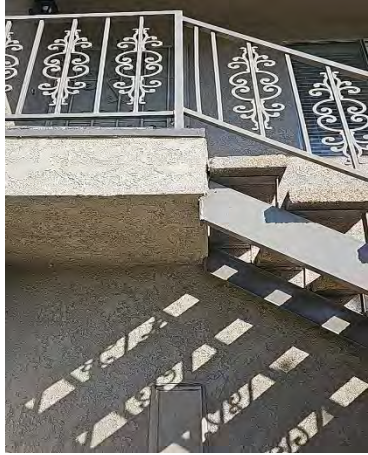
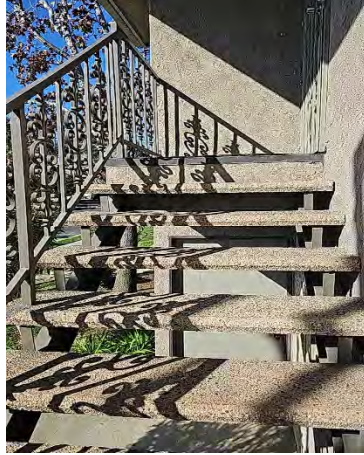
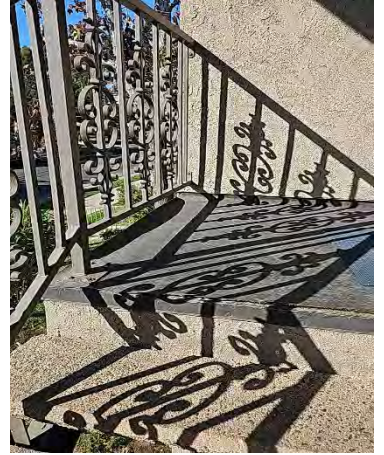
Building Name	5475-1
Apartment Name	110
Location Name	Stairs,
Visual Report	
Exterior Elements	Stairs, Stairs Landing, Railings, Integrations, Stucco Interface
Water Proofing Elements	Flashings, Waterproofing, Coatings, Sealants
Visual Review	Fair
Any Visual Signs of leaks	No
Further Invasive Review Required	No
Condition Assessment	Pass
Additional Considerations or Concerns	<p>Railing at concrete</p> <p>Stairs are steel stringers attached to a wood structure with concrete treads.</p> <p>The handrails are visually in good condition</p>
Life Expectancy (EEE)	1-4 Years
Life Expectancy (LBC)	1-4 Years
Life Expectancy (AWE)	1-4 Years
Visual Photos

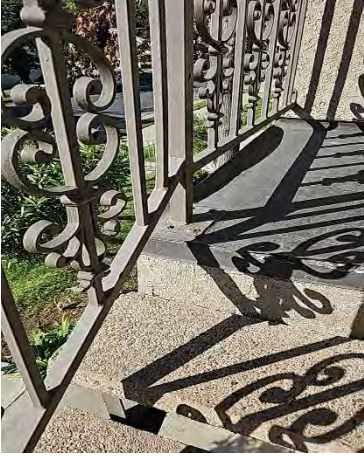
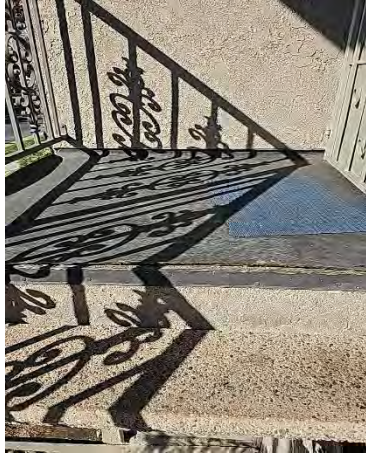
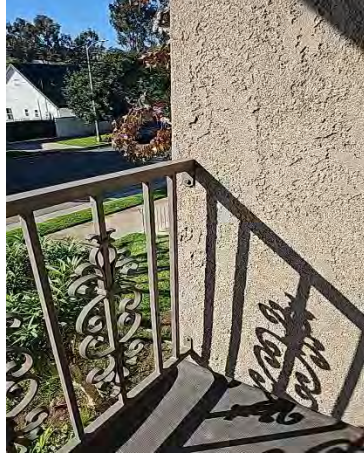
Building Name	5475-1
Apartment Name	110
Location Name	Entry deck
Visual Report	
Exterior Elements	Decks, Railings, Integrations, Porches/Entry, Stucco Interface, Door Threshold
Water Proofing Elements	Flashings, Waterproofing, Coatings, Sealants
Visual Review	Bad
Any Visual Signs of leaks	Yes
Further Invasive Review Required	Yes
Condition Assessment	Fail
Additional Considerations or Concerns	<p>Entry / Balcony / Walking Deck</p> <p>The deck is wood framed with waterproofing over the wood.</p> <p>The waterproofing is severely damaged. Replace the waterproofing, including all damaged wood with new waterproofing and wood structures.</p> <p>Handrails are metal and attached to the deck surface and visually in good condition</p>
Life Expectancy (EEE)	0-1 Years
Life Expectancy (LBC)	0-1 Years
Life Expectancy (AWE)	0-1 Years

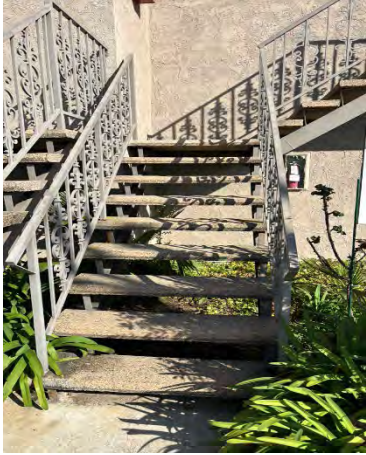
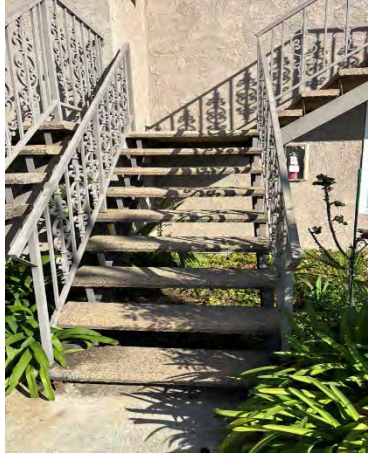
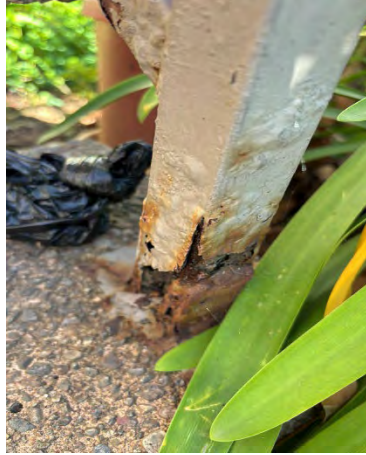
Building Name	5475-2
Apartment Name	107
Location Name	Stairs
Visual Report	
Exterior Elements	Stairs
Water Proofing Elements	Flashings, Waterproofing, Coatings, Sealants
Visual Review	Fair
Any Visual Signs of leaks	No
Further Invasive Review Required	No
Condition Assessment	Pass
Additional Considerations or Concerns	<p>Autum Pointe HOA</p> <p>Railing at concrete</p> <p>Stairs are steel stringers attached to a wood structure with concrete treads.</p> <p>The handrails are visually in good condition.</p> <p>The railing attachment to the concrete structure is rusted.</p> <p>Repair as necessary to ensure a solid rust-free attachment.</p>
Life Expectancy (EEE)	0-1 Years
Life Expectancy (LBC)	4-7 Years
Life Expectancy (AWE)	1-4 Years
Visual Photos

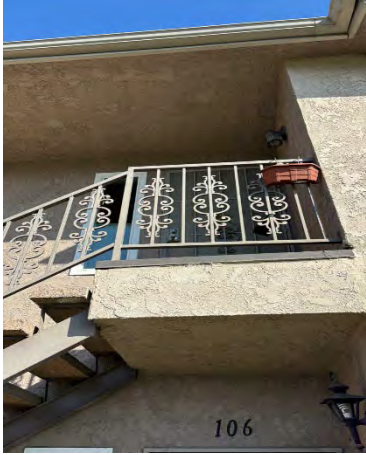
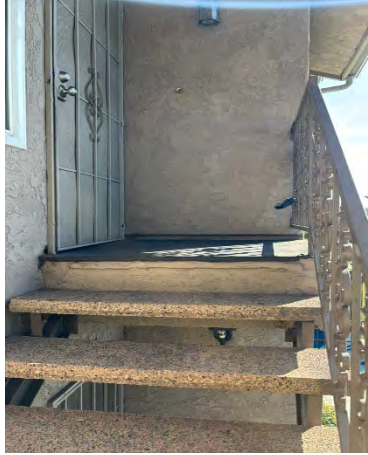
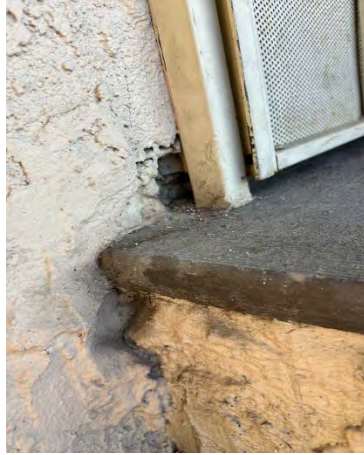
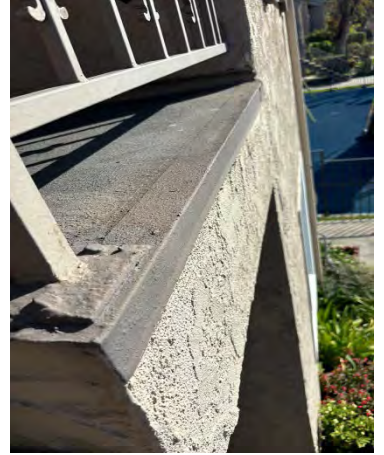
Building Name	5475-2
Apartment Name	107
Location Name	Entry deck
Visual Report	
Exterior Elements	Decks, Railings, Integrations, Door Threshold, Stucco Interface
Water Proofing Elements	Flashings, Waterproofing, Coatings, Sealants
Visual Review	Fair
Any Visual Signs of leaks	No
Further Invasive Review Required	No
Condition Assessment	Pass
Additional Considerations or Concerns	<p>Entry / Balcony / Walking Deck</p> <p>The deck is wood framed with waterproofing over the wood.</p> <p>Handrails are metal and attached to the deck surface and visually in good condition.</p>
Life Expectancy (EEE)	1-4 Years
Life Expectancy (LBC)	4-7 Years
Life Expectancy (AWE)	1-4 Years
Visual Photos

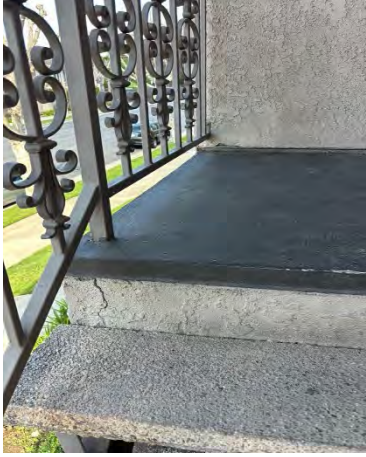
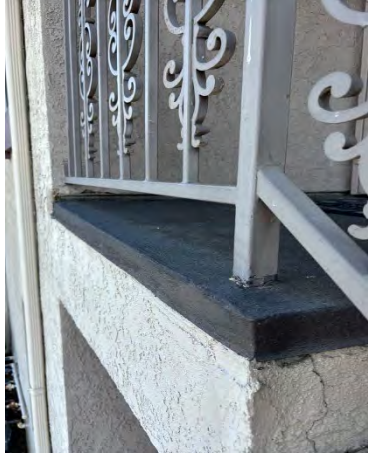
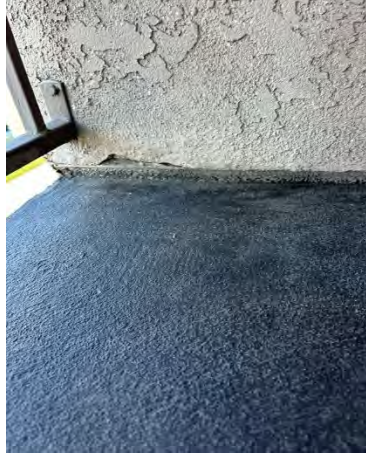
Exterior Elements	Decks, Railings, Integrations, Door Threshold, Stucco Interface, Porches/Entry
Water Proofing Elements	Flashings, Waterproofing, Coatings, Sealants
Visual Review	Bad
Any Visual Signs of leaks	Yes
Further Invasive Review Required	Yes
Condition Assessment	Fail
Additional Considerations or Concerns	<p>The drip edge at the nosing is coming loose and has several exposed unsealed fast Nurse . Plywood is visible through the worn out coating. Deck sheeting is soft.</p> <p>Repair or repalce the waterproof deck coating and all damaged wood.</p>
Life Expectancy (EEE)	0-1 Years
Life Expectancy (LBC)	0-1 Years
Life Expectancy (AWE)	0-1 Years

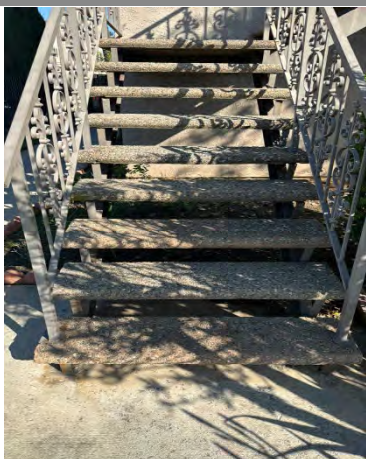
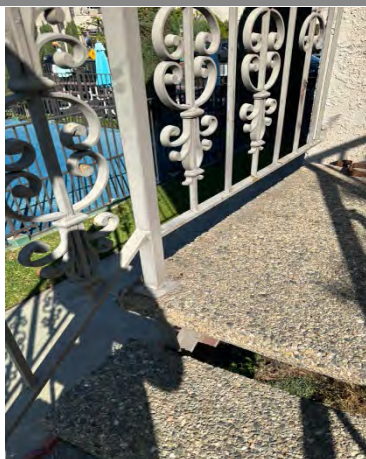
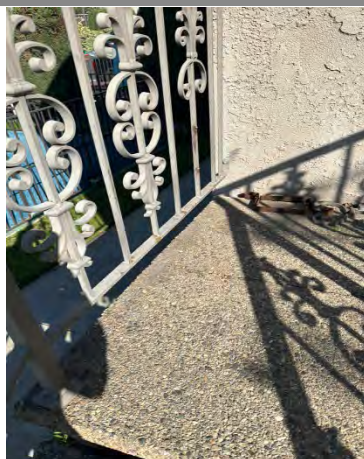
Building Name	5501
Apartment Name	48
Location Name	Stairs
Visual Report	
Exterior Elements	Stairs, Railings, Integrations
Water Proofing Elements	Flashings, Waterproofing, Coatings, Sealants
Visual Review	Good
Any Visual Signs of leaks	No
Further Invasive Review Required	No
Condition Assessment	Pass
Additional Considerations or Concerns	
Life Expectancy (EEE)	1-4 Years
Life Expectancy (LBC)	4-7 Years
Life Expectancy (AWE)	1-4 Years

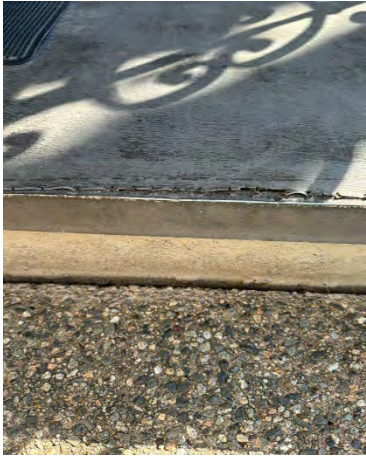
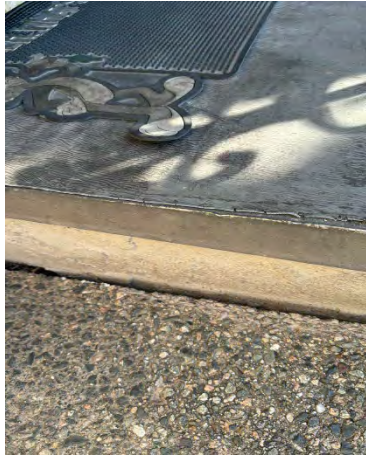
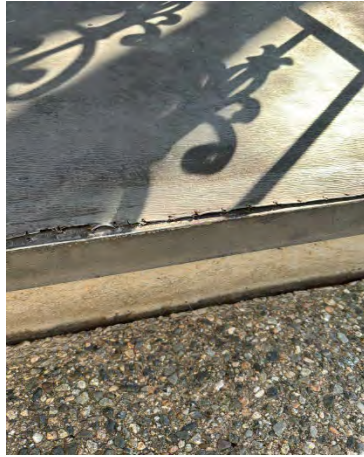
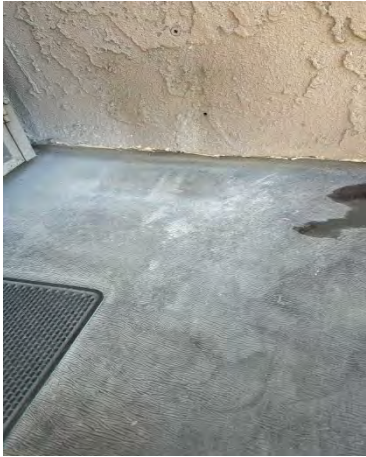
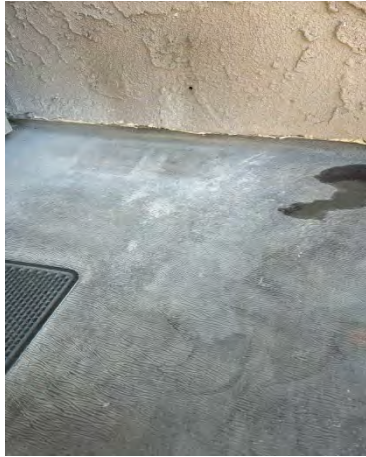
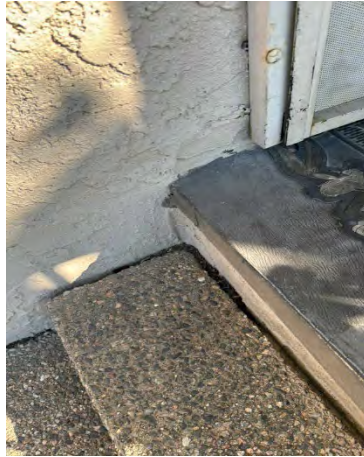
Exterior Elements	Decks, Railings, Integrations, Door Threshold, Stucco Interface
Water Proofing Elements	Flashings, Waterproofing, Coatings, Sealants
Visual Review	Bad
Any Visual Signs of leaks	Yes
Further Invasive Review Required	No
Condition Assessment	Fail
Additional Considerations or Concerns	Entry / Balcony / Walking Deck The deck is wood framed with waterproofing over the wood. Handrails are metal and attached to the deck surface and visually in good condition. The waterproofing is severely damaged. Remove waterproofing membrane and all framing assemblies as necessary. Install new waterproofing membrane.
Life Expectancy (EEE)	1-4 Years
Life Expectancy (LBC)	1-4 Years
Life Expectancy (AWE)	0-1 Years

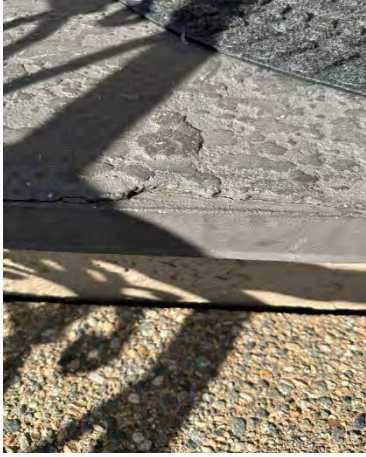
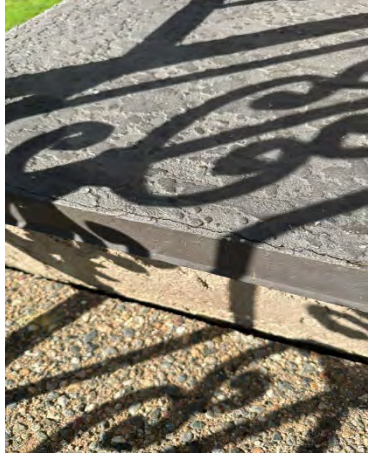
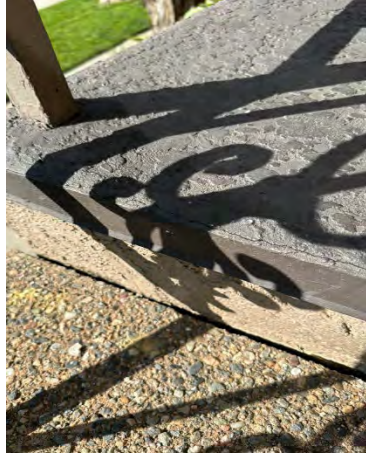
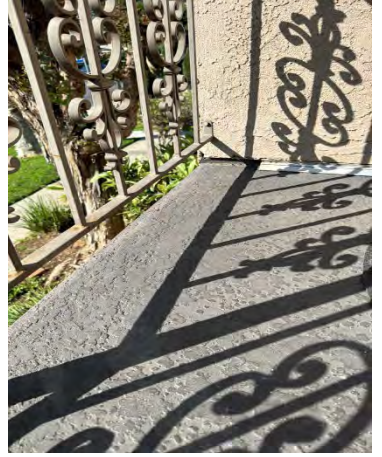
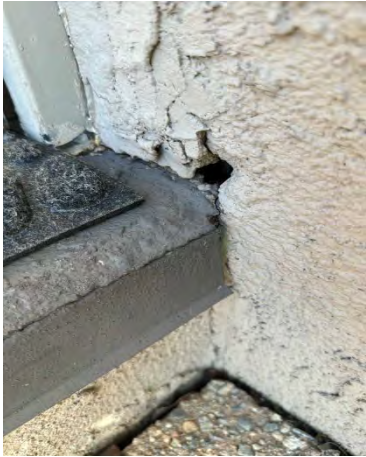
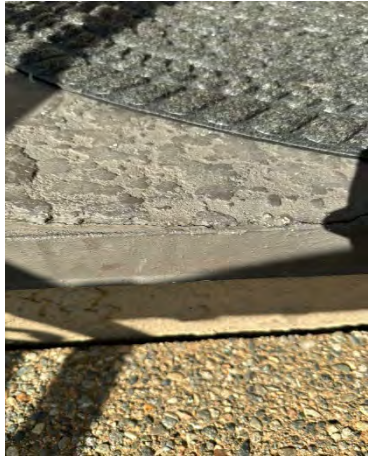
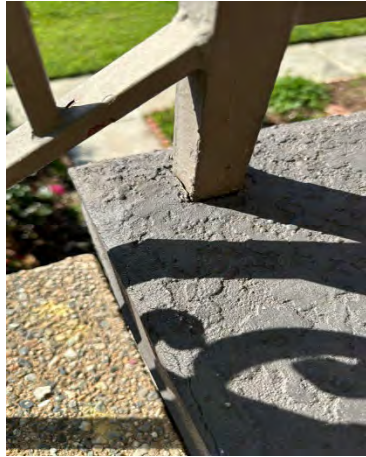
Exterior Elements	Decks, Porches/Entry, Railings, Integrations, Door Threshold, Stucco Interface
Water Proofing Elements	Flashings, Waterproofing, Coatings, Sealants
Visual Review	Bad
Any Visual Signs of leaks	Yes
Further Invasive Review Required	No
Condition Assessment	Fail
Additional Considerations or Concerns	Entry / Balcony / Walking Deck The deck is wood framed with waterproofing over the wood. Handrails are metal and attached to the deck surface and visually in good condition. The waterproofing is severely damaged. Remove waterproofing membrane and all framing assemblies as necessary. Install new waterproofing membrane.
Life Expectancy (EEE)	0-1 Years
Life Expectancy (LBC)	0-1 Years
Life Expectancy (AWE)	0-1 Years

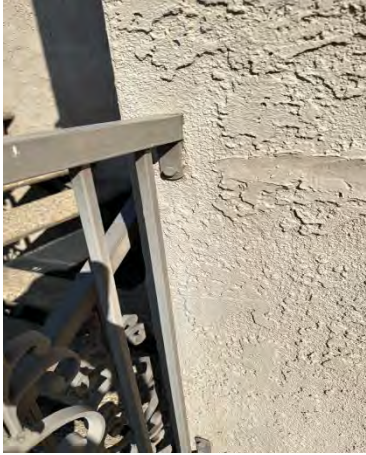
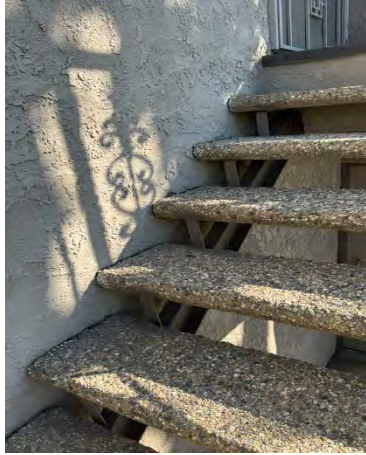
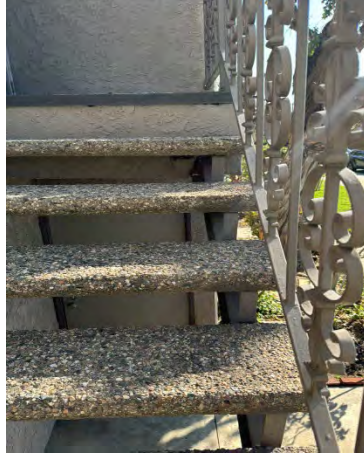
Building Name	5501
Apartment Name	45
Location Name	Stairs
Visual Report	
Exterior Elements	Stairs, Railings, Integrations
Water Proofing Elements	Flashings, Waterproofing, Coatings, Sealants
Visual Review	Fair
Any Visual Signs of leaks	No
Further Invasive Review Required	No
Condition Assessment	Pass
Additional Considerations or Concerns	<p>The railing attachment to the concrete structure is rusted.</p> <p>Repair as necessary to ensure a solid rust-free attachment.</p>
Life Expectancy (EEE)	0-1 Years
Life Expectancy (LBC)	4-7 Years
Life Expectancy (AWE)	1-4 Years

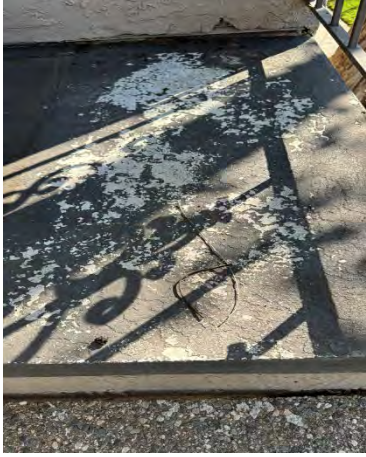
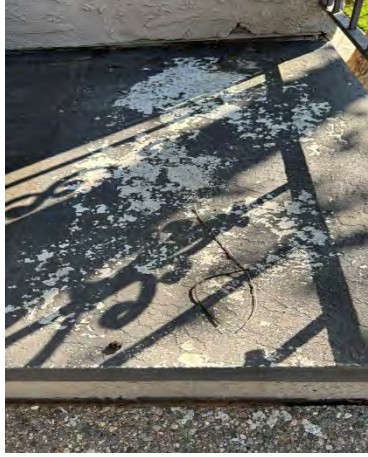
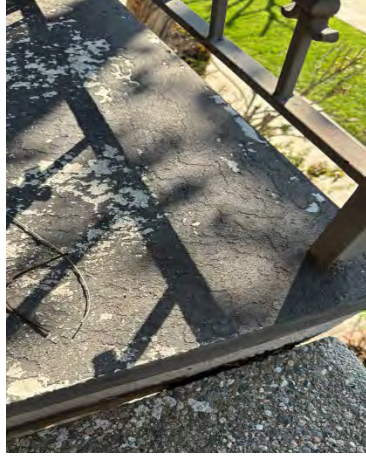
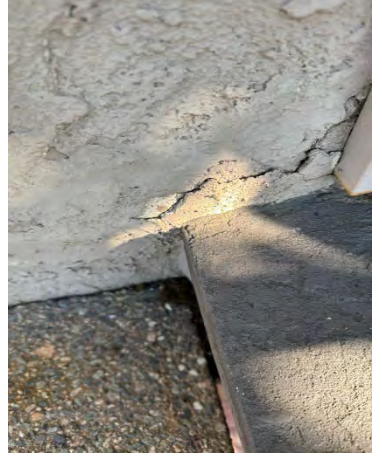
Exterior Elements	Decks, Railings, Integrations, Door Threshold, Stucco Interface
Water Proofing Elements	Flashings, Waterproofing, Coatings, Sealants
Visual Review	Bad
Any Visual Signs of leaks	Yes
Further Invasive Review Required	No
Condition Assessment	Fail
Additional Considerations or Concerns	Entry / Balcony / Walking Deck The deck is wood framed with waterproofing over the wood. Handrails are metal and attached to the deck surface and visually in good condition. The waterproofing is severely damaged. Replace or repair the waterproofing, including all damaged wood with new waterproofing and wood structures.
Life Expectancy (EEE)	1-4 Years
Life Expectancy (LBC)	4-7 Years
Life Expectancy (AWE)	0-1 Years

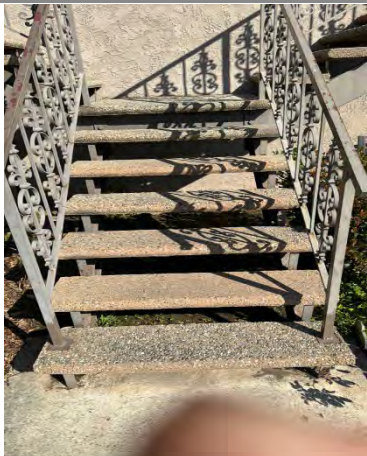
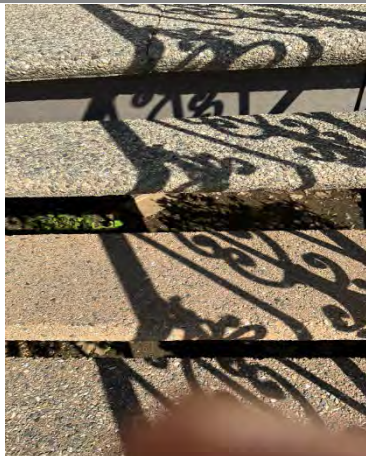
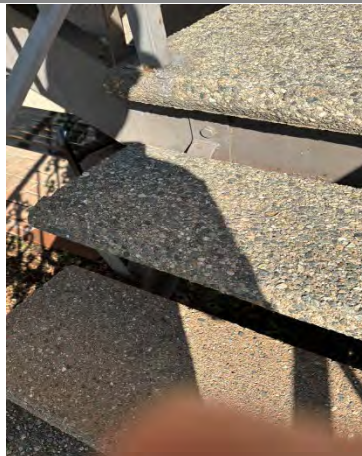
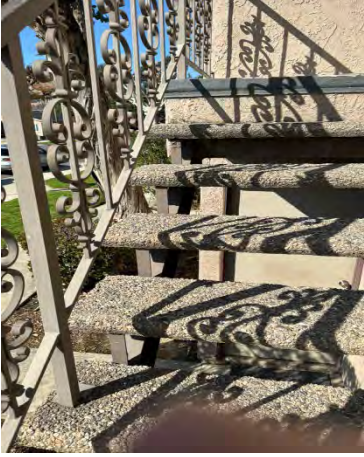
Exterior Elements	Stairs, Stairs Landing, Railings
Water Proofing Elements	Flashings, Waterproofing, Coatings, Sealants
Visual Review	Good
Any Visual Signs of leaks	No
Further Invasive Review Required	No
Condition Assessment	Pass
Additional Considerations or Concerns	<p>Railing at concrete</p> <p>Stairs are steel stringers attached to a wood structure with concrete treads.</p> <p>The handrails are visually in good condition</p>
Life Expectancy (EEE)	1-4 Years
Life Expectancy (LBC)	4-7 Years
Life Expectancy (AWE)	1-4 Years

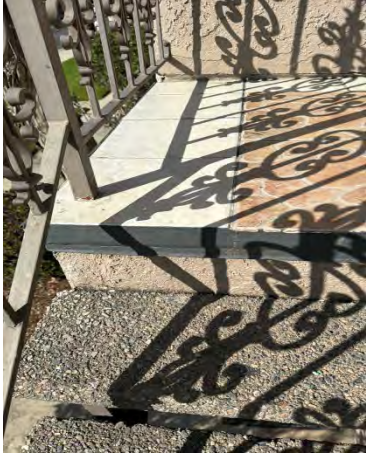
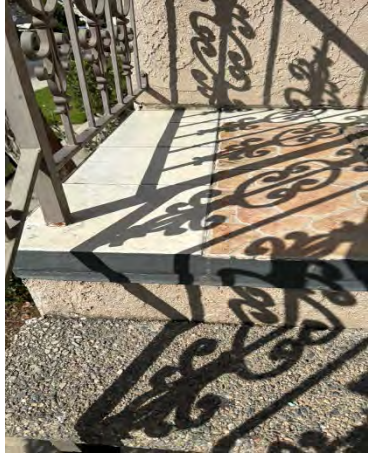
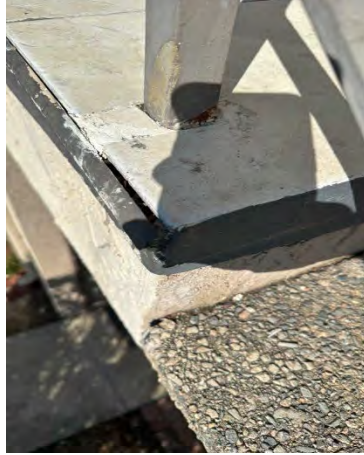
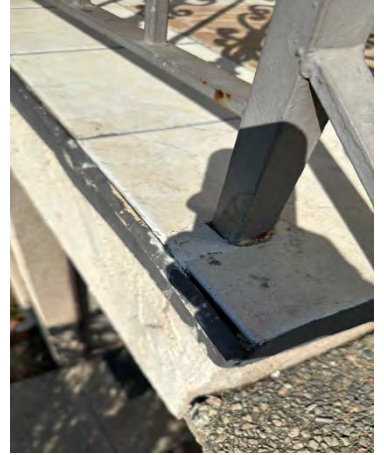
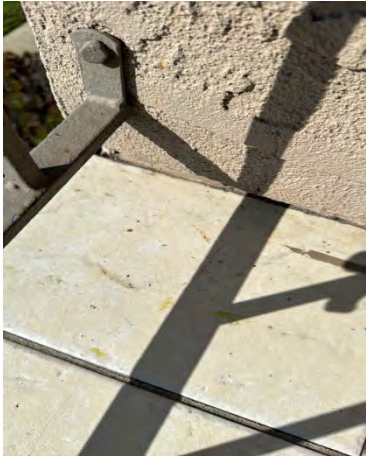
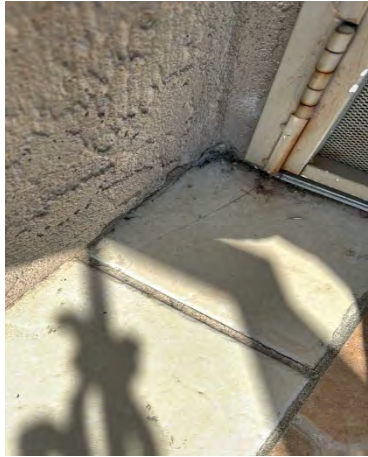
Building Name	5501
Apartment Name	44
Location Name	Entry deck
Visual Report	
Exterior Elements	Decks, Walkways, Railings, Integrations, Door Threshold, Stucco Interface
Water Proofing Elements	Flashings, Waterproofing, Coatings, Sealants
Visual Review	Fair
Any Visual Signs of leaks	No
Further Invasive Review Required	No
Condition Assessment	Fail
Additional Considerations or Concerns	<p>Entry / Balcony / Walking Deck</p> <p>The deck is wood framed with waterproofing over the wood.</p> <p>Handrails are metal and attached to the deck surface and visually in good condition.</p> <p>Remove the improperly installed tile and replace or repair the waterproofing, including all damaged wood with new waterproofing and wood structures. Tile should not be installed over deck coatings.</p>
Life Expectancy (EEE)	0-1 Years
Life Expectancy (LBC)	1-4 Years
Life Expectancy (AWE)	0-1 Years

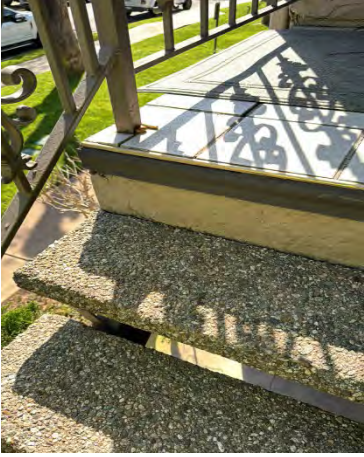
Exterior Elements	Decks, Railings, Integrations, Door Threshold, Stucco Interface
Water Proofing Elements	Flashings, Waterproofing, Coatings, Sealants
Visual Review	Bad
Any Visual Signs of leaks	Yes
Further Invasive Review Required	Yes
Condition Assessment	Fail
Additional Considerations or Concerns	Deck has tile overlay which appears to be failing. Tile is loose. Waterproofing is failed. Remove tile, replace with waterproof deck coating. Further investigation required.
Life Expectancy (EEE)	0-1 Years
Life Expectancy (LBC)	0-1 Years
Life Expectancy (AWE)	0-1 Years

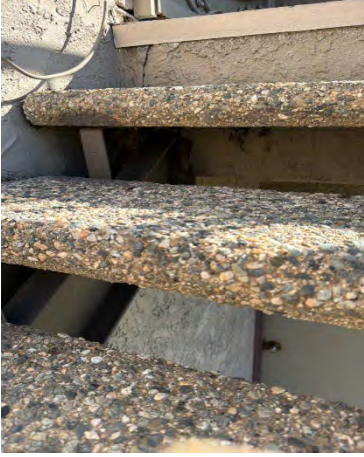
Building Name	5501
Apartment Name	43
Location Name	Stairs
Visual Report	
Exterior Elements	Stairs, Stairs Landing, Railings
Water Proofing Elements	Flashings, Waterproofing, Coatings, Sealants
Visual Review	Good
Any Visual Signs of leaks	No
Further Invasive Review Required	No
Condition Assessment	Pass
Additional Considerations or Concerns	<p>Railing at concrete</p> <p>Stairs are steel stringers attached to a wood structure with concrete treads.</p> <p>The handrails are visually in good condition</p>
Life Expectancy (EEE)	1-4 Years
Life Expectancy (LBC)	4-7 Years
Life Expectancy (AWE)	1-4 Years

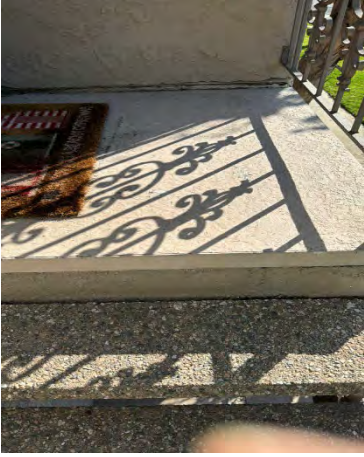
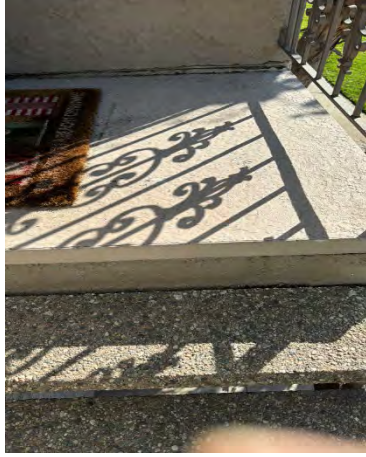
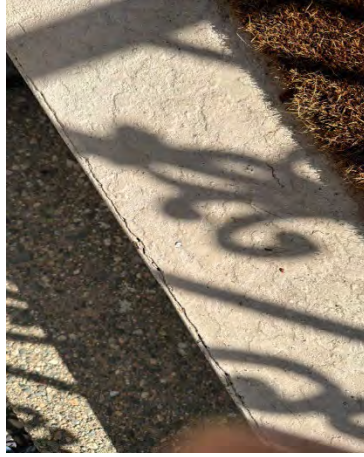
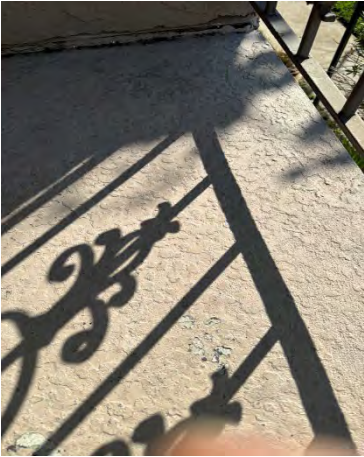
Building Name	5501
Apartment Name	43
Location Name	Entry deck
Visual Report	
Exterior Elements	Decks, Railings, Integrations, Door Threshold, Stucco Interface
Water Proofing Elements	Flashings, Waterproofing, Coatings, Sealants
Visual Review	Good
Any Visual Signs of leaks	No
Further Invasive Review Required	No
Condition Assessment	Pass
Additional Considerations or Concerns	<p>Entry / Balcony / Walking Deck</p> <p>The deck is wood framed with waterproofing over the wood.</p> <p>Handrails are metal and attached to the deck surface and visually in good condition. Maintenance coatings are required for the entry deck waterproofing.</p>
Life Expectancy (EEE)	1-4 Years
Life Expectancy (LBC)	4-7 Years
Life Expectancy (AWE)	1-4 Years
Visual Photos

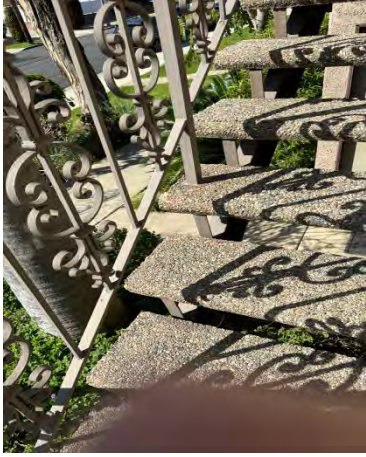
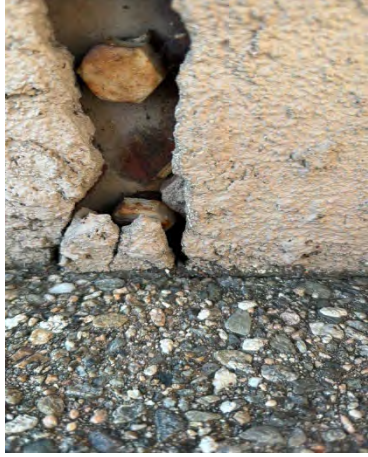
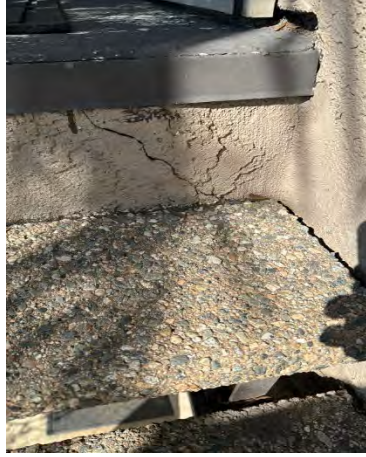
Exterior Elements	Stairs, Stairs Landing, Railings, Integrations
Water Proofing Elements	Flashings, Waterproofing, Coatings, Sealants
Visual Review	Bad
Any Visual Signs of leaks	Yes
Further Invasive Review Required	Yes
Condition Assessment	Fail
Additional Considerations or Concerns	Railing attachments to the front rim Joyce of the deck, appears to be failing lag bolts are pulling out further investigation required
Life Expectancy (EEE)	0-1 Years
Life Expectancy (LBC)	0-1 Years
Life Expectancy (AWE)	0-1 Years

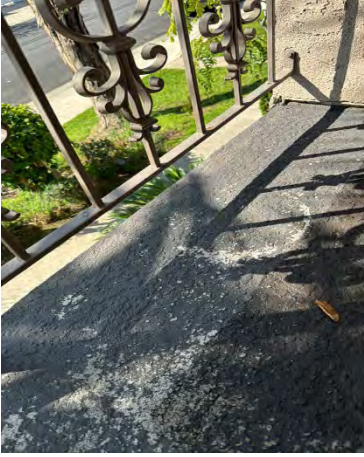
Building Name	5525
Apartment Name	38
Location Name	Entry deck
Visual Report	
Exterior Elements	Decks, Railings, Door Threshold, Integrations, Stucco Interface
Water Proofing Elements	Flashings, Waterproofing, Coatings, Sealants
Visual Review	Fair
Any Visual Signs of leaks	Yes
Further Invasive Review Required	Yes
Condition Assessment	Fail
Additional Considerations or Concerns	<p>This deck is attached to the failed stair system. An invasive investigation needs to occur at the failure. The deck coating is cracked and failing at the leading edge of the rim joist.</p> <p>Replace the deck.</p>
Life Expectancy (EEE)	0-1 Years
Life Expectancy (LBC)	0-1 Years
Life Expectancy (AWE)	0-1 Years

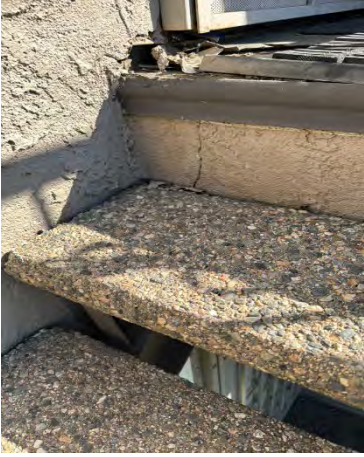
Building Name	5525
Apartment Name	37
Location Name	Stairs
Visual Report	
Exterior Elements	Stairs, Stairs Landing, Railings, Integrations
Water Proofing Elements	Flashings, Waterproofing, Coatings, Sealants
Visual Review	Good
Any Visual Signs of leaks	No
Further Invasive Review Required	No
Condition Assessment	Pass
Additional Considerations or Concerns	<p>Railing at concrete</p> <p>Stairs are steel stringers attached to a wood structure with concrete treads.</p> <p>The handrails are visually in good condition.</p>
Life Expectancy (EEE)	1-4 Years
Life Expectancy (LBC)	1-4 Years
Life Expectancy (AWE)	1-4 Years

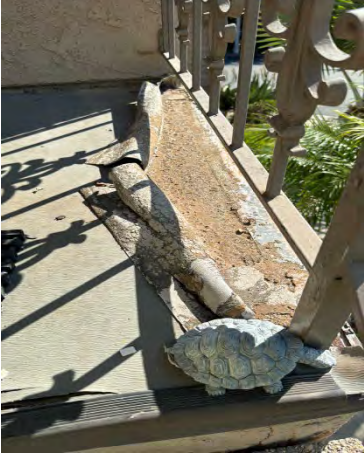
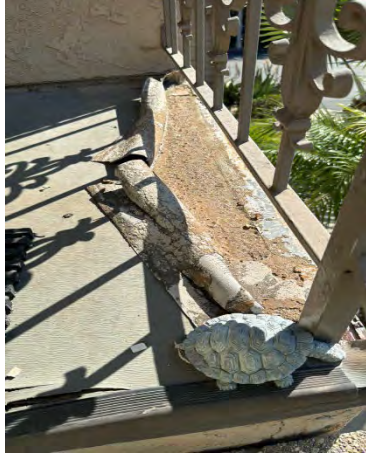
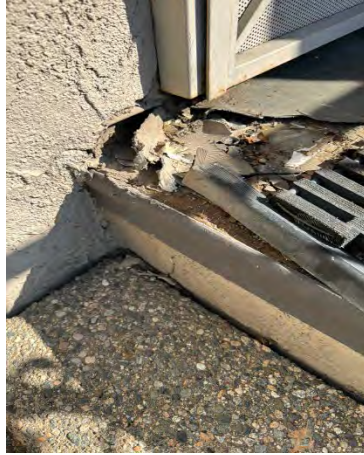
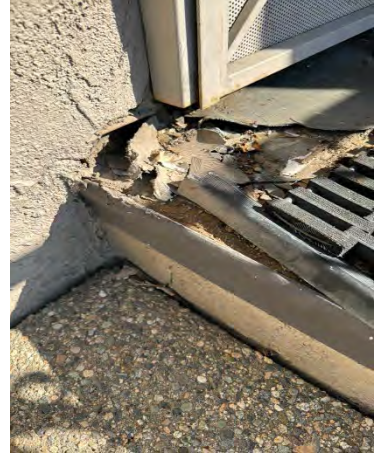
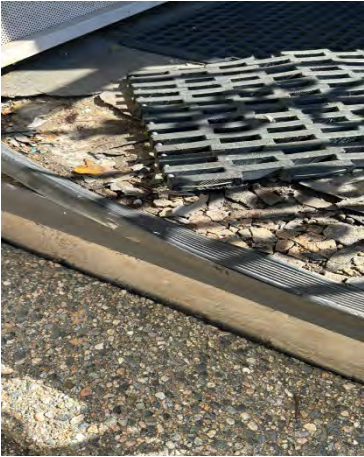
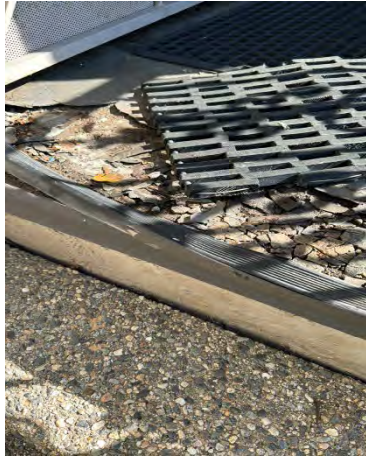
Exterior Elements	Decks, Railings, Integrations, Door Threshold, Stucco Interface
Water Proofing Elements	Flashings, Waterproofing, Coatings, Sealants
Visual Review	Bad
Any Visual Signs of leaks	Yes
Further Invasive Review Required	Yes
Condition Assessment	Fail
Additional Considerations or Concerns	Entry / Balcony / Walking Deck The deck is wood framed with waterproofing over the wood. Handrails are metal and attached to the deck surface and visually in good condition. The waterproofing is severely damaged. Replace or repair the waterproofing, including all damaged wood with new waterproofing and wood structures.
Life Expectancy (EEE)	0-1 Years
Life Expectancy (LBC)	0-1 Years
Life Expectancy (AWE)	0-1 Years

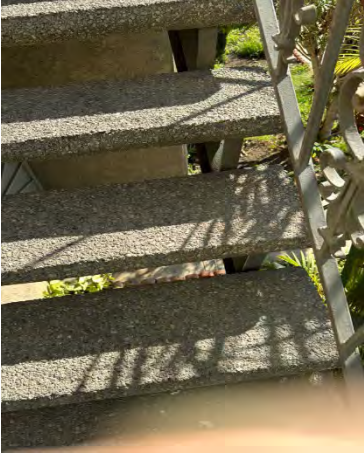
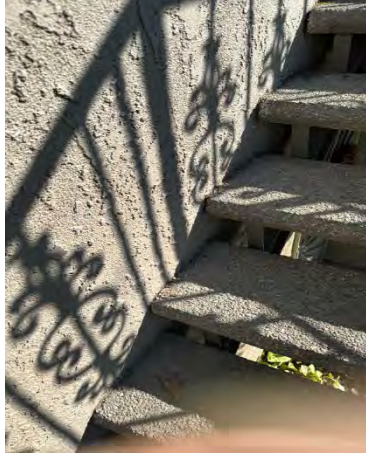
Exterior Elements	Stairs, Stairs Landing, Railings, Integrations
Water Proofing Elements	Flashings, Waterproofing, Coatings, Sealants
Visual Review	Good
Any Visual Signs of leaks	No
Further Invasive Review Required	No
Condition Assessment	Pass
Additional Considerations or Concerns	<p>Railing at concrete</p> <p>Stairs are steel stringers attached to a wood structure with concrete treads.</p> <p>The handrails are visually in good condition</p>
Life Expectancy (EEE)	1-4 Years
Life Expectancy (LBC)	4-7 Years
Life Expectancy (AWE)	1-4 Years

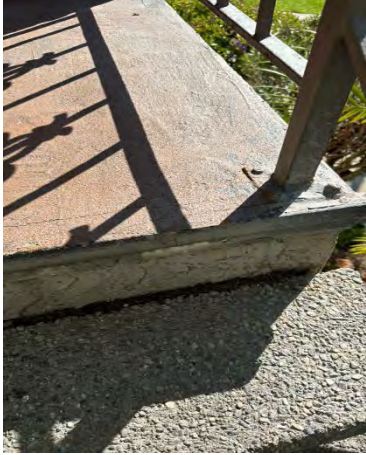
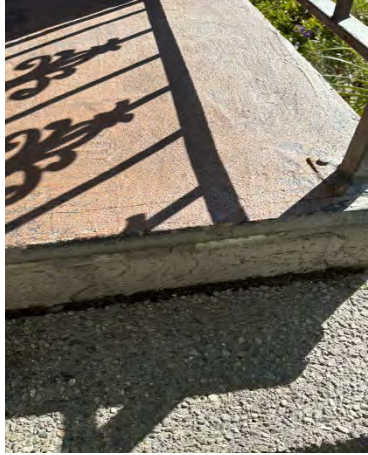
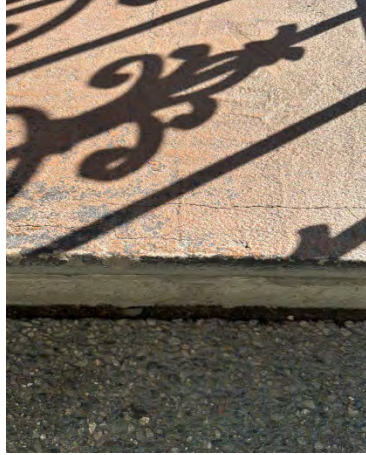
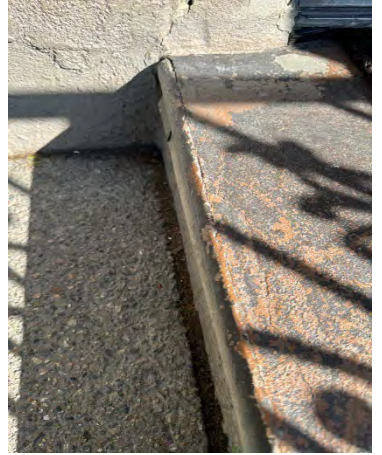
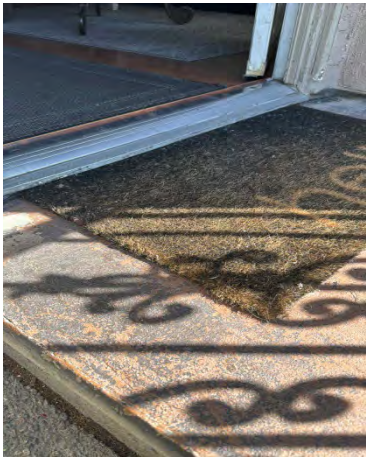
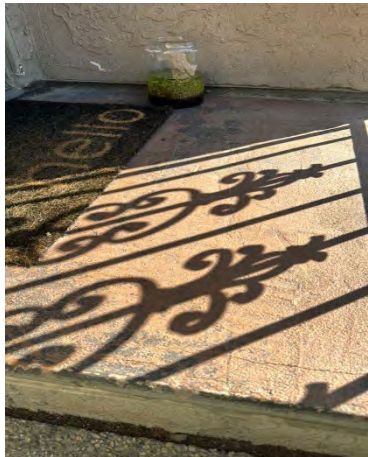
Exterior Elements	Decks, Railings, Integrations, Door Threshold, Stucco Interface
Water Proofing Elements	Flashings, Waterproofing, Coatings, Sealants
Visual Review	Good
Any Visual Signs of leaks	Yes
Further Invasive Review Required	No
Condition Assessment	Fail
Additional Considerations or Concerns	<p>Entry / Balcony / Walking Deck</p> <p>The deck is wood framed with waterproofing over the wood.</p> <p>Handrails are metal and attached to the deck surface and visually in good condition.</p> <p>The waterproofing is severely damaged. Replace or repair the waterproofing, including all damaged wood with new waterproofing and wood structures.</p>
Life Expectancy (EEE)	1-4 Years
Life Expectancy (LBC)	1-4 Years
Life Expectancy (AWE)	0-1 Years

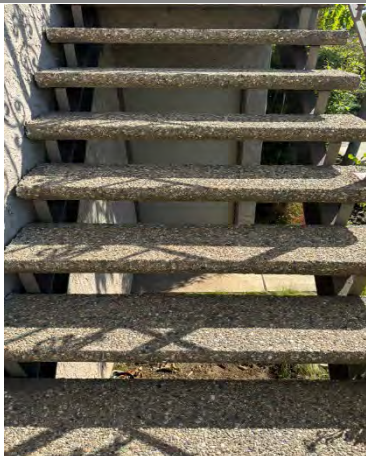
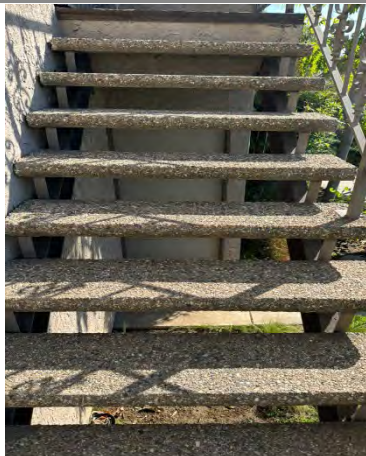
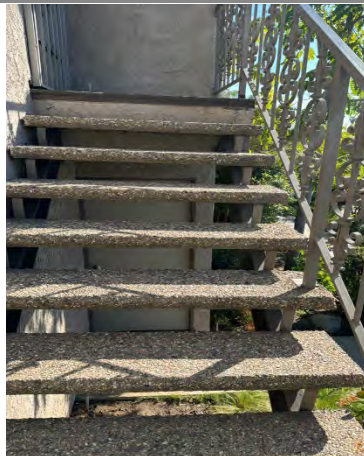
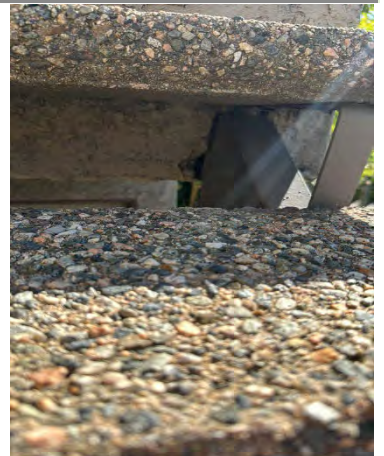
Exterior Elements	Stairs, Stairs Landing, Integrations, Railings
Water Proofing Elements	Flashings, Waterproofing, Coatings, Sealants
Visual Review	Good
Any Visual Signs of leaks	No
Further Invasive Review Required	No
Condition Assessment	Pass
Additional Considerations or Concerns	<p>Railing at concrete</p> <p>Stairs are steel stringers attached to a wood structure with concrete treads.</p> <p>The handrails are visually in good condition.</p>
Life Expectancy (EEE)	1-4 Years
Life Expectancy (LBC)	4-7 Years
Life Expectancy (AWE)	1-4 Years

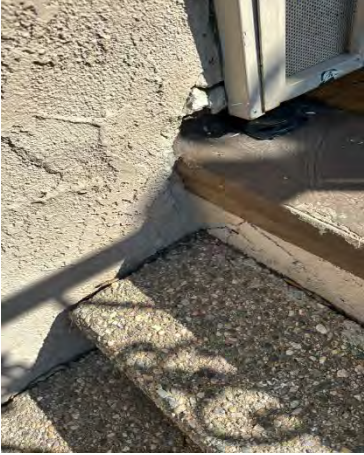
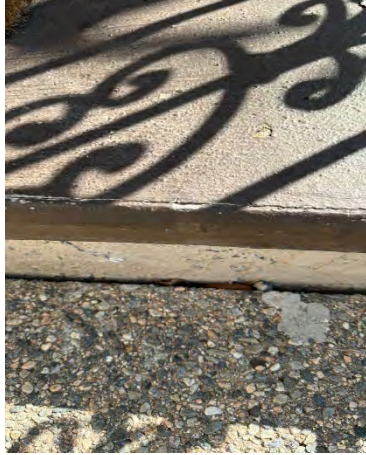
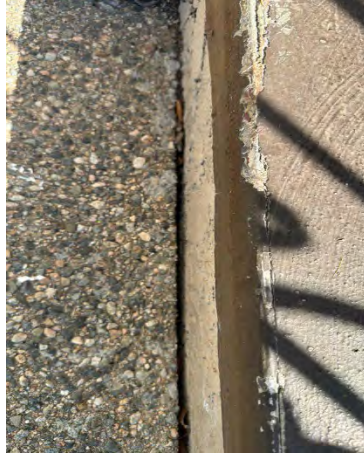
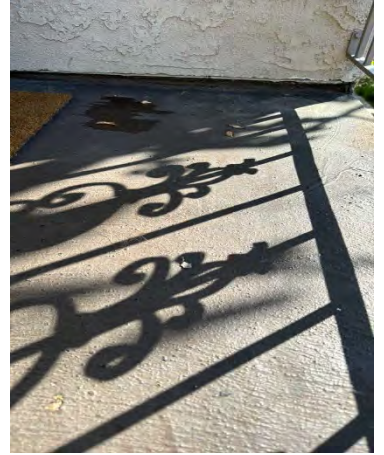
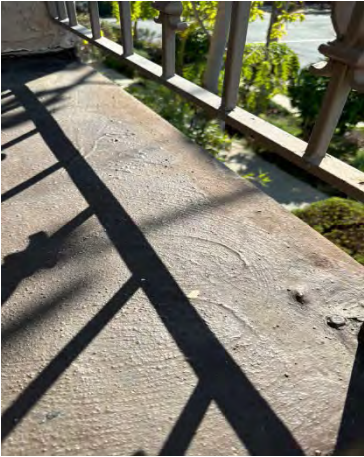
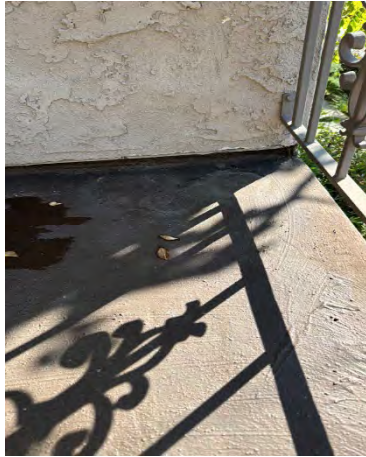
Building Name	5525
Apartment Name	39
Location Name	Entry deck
Visual Report	
Exterior Elements	Decks, Railings, Integrations, Door Threshold, Stucco Interface
Water Proofing Elements	Flashings, Waterproofing, Coatings, Sealants
Visual Review	Fair
Any Visual Signs of leaks	Yes
Further Invasive Review Required	No
Condition Assessment	Fail
Additional Considerations or Concerns	<p>Entry / Balcony / Walking Deck</p> <p>The deck is wood framed with waterproofing over the wood.</p> <p>Handrails are metal and attached to the deck surface and visually in good condition. The deck coating needs repairs at the leading edge of the deck.</p>
Life Expectancy (EEE)	0-1 Years
Life Expectancy (LBC)	1-4 Years
Life Expectancy (AWE)	0-1 Years
Visual Photos

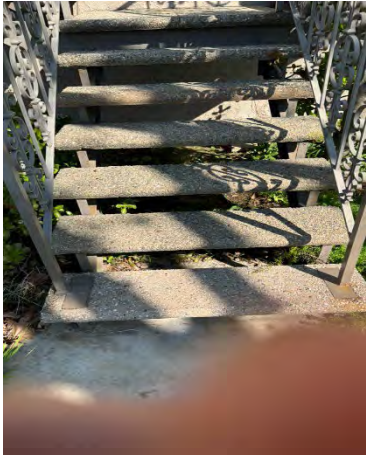
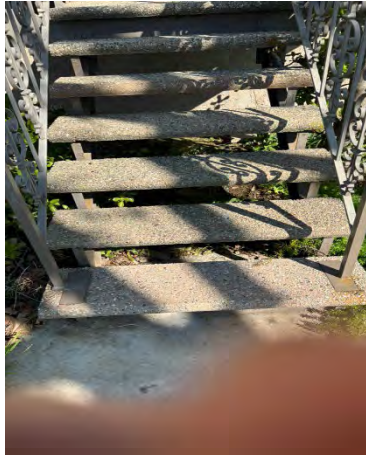
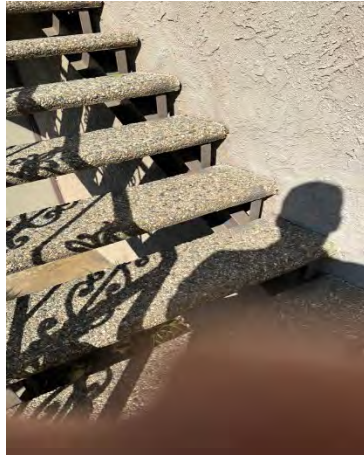
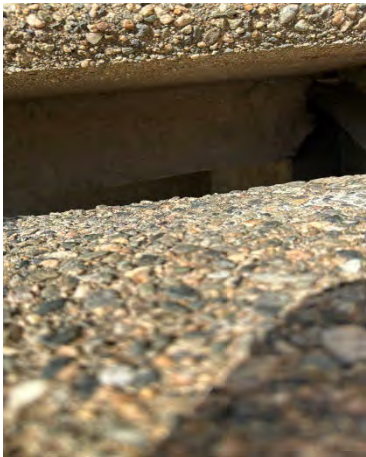
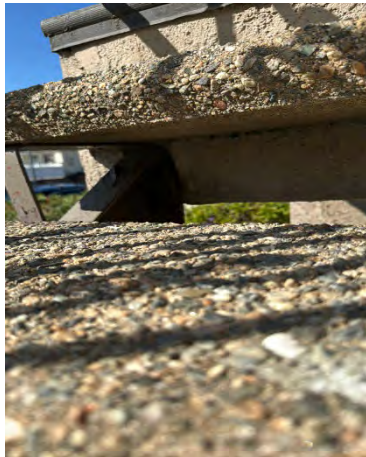
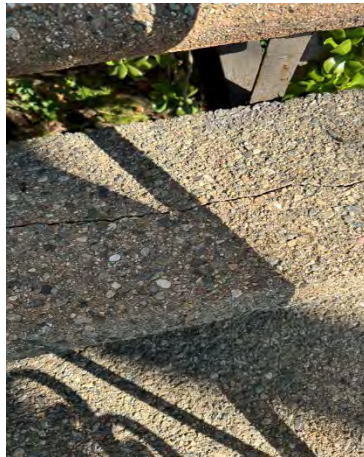
Building Name	5525
Apartment Name	40
Location Name	Stairs
Visual Report	
Exterior Elements	Stairs, Stairs Landing, Railings, Integrations
Water Proofing Elements	Flashings, Waterproofing, Coatings, Sealants
Visual Review	Bad
Any Visual Signs of leaks	No
Further Invasive Review Required	No
Condition Assessment	Fail
Additional Considerations or Concerns	<p>Railing at concrete Stairs are steel stringers attached to a wood structure with concrete treads.</p> <p>The handrails are visually in good condition. Large crack in the third tread on the stairs. Replace the damaged tread.</p>
Life Expectancy (EEE)	0-1 Years
Life Expectancy (LBC)	4-7 Years
Life Expectancy (AWE)	1-4 Years
Visual Photos

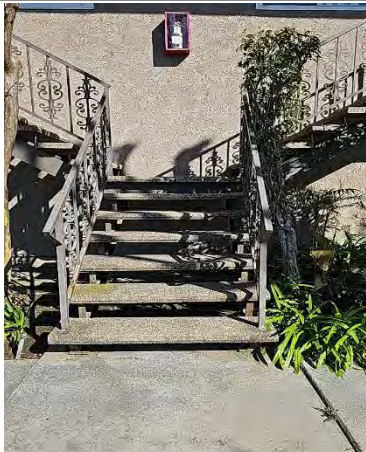
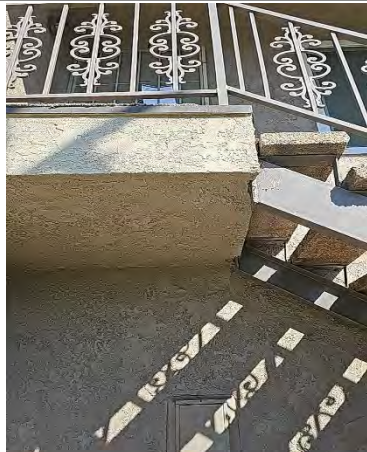
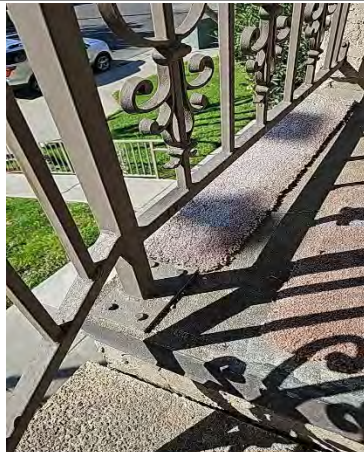
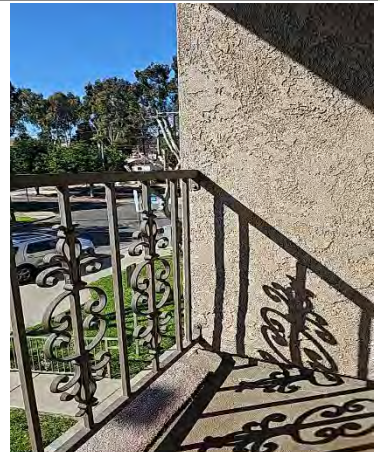
Exterior Elements	Porches/Entry, Decks, Stairs, Stairs Landing, Railings, Integrations, Stucco Interface
Water Proofing Elements	Flashings, Waterproofing, Coatings, Sealants
Visual Review	Good
Any Visual Signs of leaks	No
Further Invasive Review Required	No
Condition Assessment	Pass
Additional Considerations or Concerns	<p>Railing at concrete</p> <p>Stairs are steel stringers attached to a wood structure with concrete treads.</p> <p>The handrails are visually in good condition.</p>
Life Expectancy (EEE)	1-4 Years
Life Expectancy (LBC)	1-4 Years
Life Expectancy (AWE)	1-4 Years

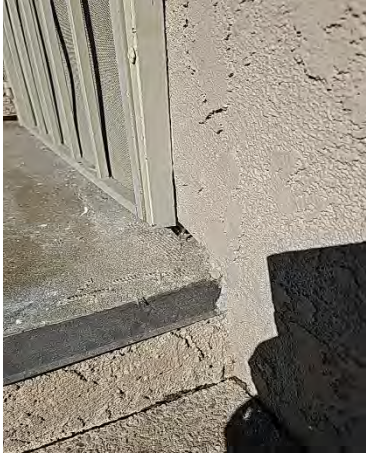
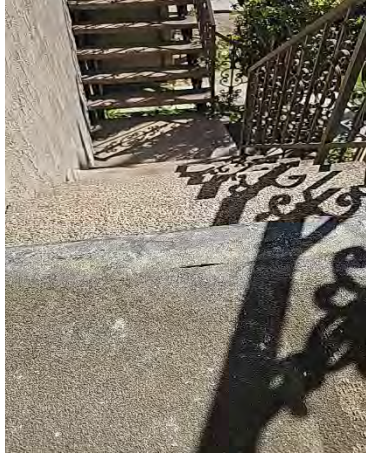
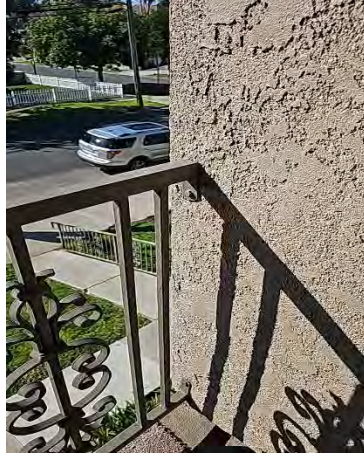
Building Name	5465-1
Apartment Name	114
Location Name	Entry deck
Visual Report	
Exterior Elements	Decks, Porches/Entry, Stairs Landing, Railings, Integrations, Stucco Interface
Water Proofing Elements	Flashings, Waterproofing, Coatings, Sealants
Visual Review	Bad
Any Visual Signs of leaks	Yes
Further Invasive Review Required	No
Condition Assessment	Pass
Additional Considerations or Concerns	<p>Entry / Balcony / Walking Deck</p> <p>The deck is wood framed with waterproofing over the wood.</p> <p>Handrails are metal and attached to the deck surface and visually in good condition.</p> <p>The waterproofing is severely damaged. Replace or repair the waterproofing, including all damaged wood with new waterproofing and wood structures.</p>
Life Expectancy (EEE)	0-1 Years
Life Expectancy (LBC)	0-1 Years
Life Expectancy (AWE)	0-1 Years
