REPORT OF VISUAL INSPECTION

An inspection ("Inspection") of the Exterior Elevated Elements ("EEE") listed in Annex 1 (attached report), their load-bearing components ("LBC"), and associated waterproofing elements ("AWE") was performed at the property and on the date indicated below:

Autumn Pointe HOA/ 55488 Dobbns St.	Los Angeles	CA	
Date of Inspection:	2/22/2024

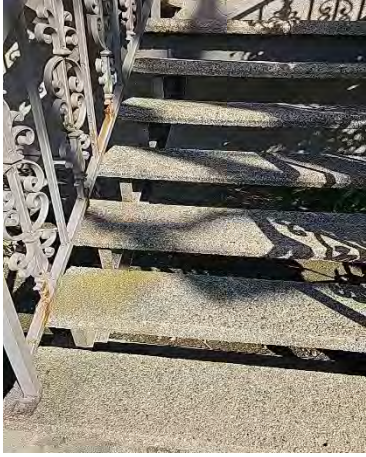
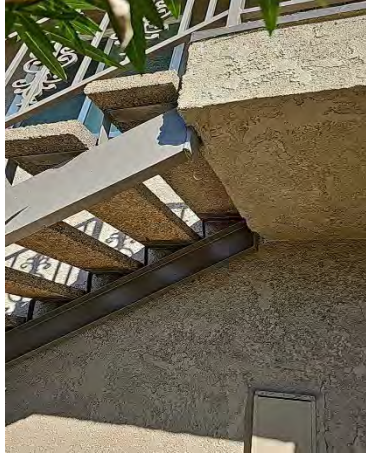
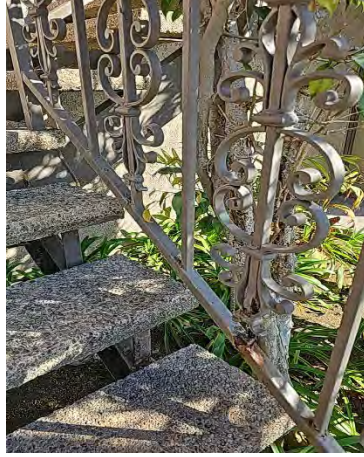
Exterior Elements	Decks, Porches/Entry, Stairs, Stairs Landing, Railings, Integrations, Stucco Interface
Water Proofing Elements	Flashings, Waterproofing, Coatings, Sealants
Visual Review	Fair
Any Visual Signs of leaks	No
Further Invasive Review Required	No
Condition Assessment	Pass
Additional Considerations or Concerns	<p>Railing at concrete Stairs are steel stringers attached to a wood structure with concrete treads.</p> <p>The handrails are visually in good condition.Damaged railing. Repair as necessary</p>
Life Expectancy (EEE)	0-1 Years
Life Expectancy (LBC)	0-1 Years
Life Expectancy (AWE)	0-1 Years

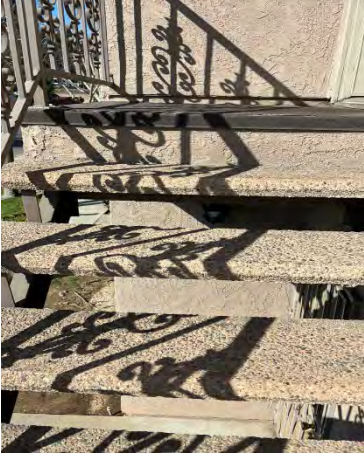
Building Name	5465-2
Apartment Name	111
Location Name	Stairs
Visual Report	
Exterior Elements	Stairs, Stairs Landing, Stucco Interface
Water Proofing Elements	Flashings, Waterproofing, Coatings, Sealants
Visual Review	Good
Any Visual Signs of leaks	No
Further Invasive Review Required	No
Condition Assessment	Pass
Additional Considerations or Concerns	Handrail attachment to the stucco is loose. Secure the attachment.
Life Expectancy (EEE)	1-4 Years
Life Expectancy (LBC)	4-7 Years
Life Expectancy (AWE)	1-4 Years

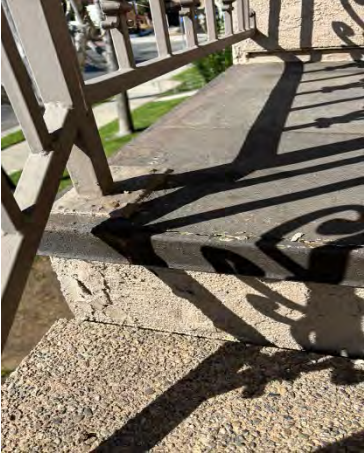
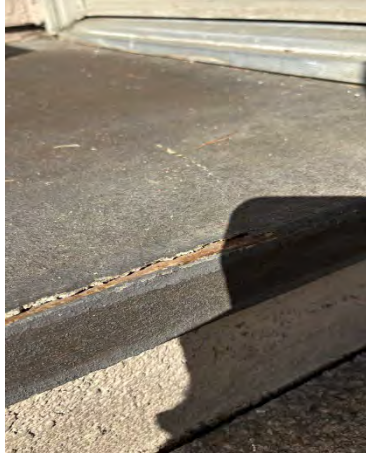
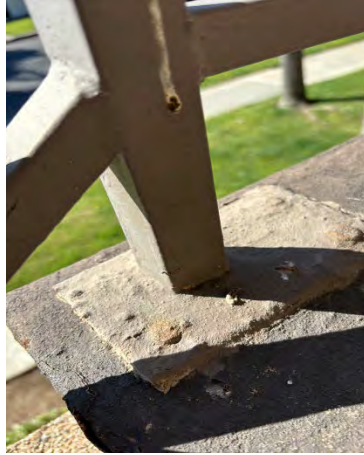
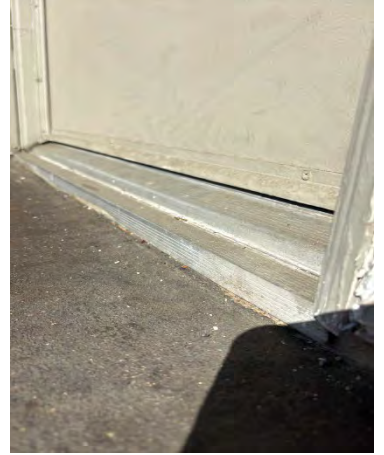
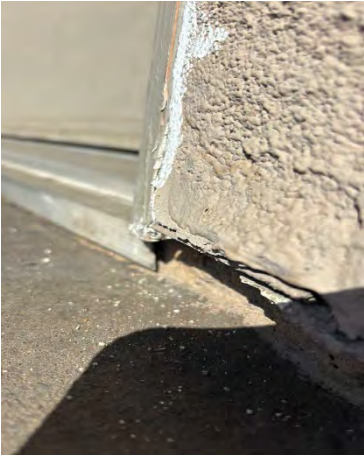
Building Name	5465-2
Apartment Name	111
Location Name	Entry deck
Visual Report	
Exterior Elements	Porches/Entry, Railings, Integrations, Door Threshold, Stucco Interface
Water Proofing Elements	Flashings, Waterproofing, Coatings, Sealants
Visual Review	Bad
Any Visual Signs of leaks	Yes
Further Invasive Review Required	Yes
Condition Assessment	Fail
Additional Considerations or Concerns	<p>Entry / Balcony / Walking Deck</p> <p>The deck is wood framed with waterproofing over the wood.</p> <p>Handrails are metal and attached to the deck surface and visually in good condition.</p> <p>The waterproofing is severely damaged. Replace or repair the waterproofing, including all damaged wood with new waterproofing and wood structures</p>
Life Expectancy (EEE)	1-4 Years
Life Expectancy (LBC)	1-4 Years
Life Expectancy (AWE)	0-1 Years

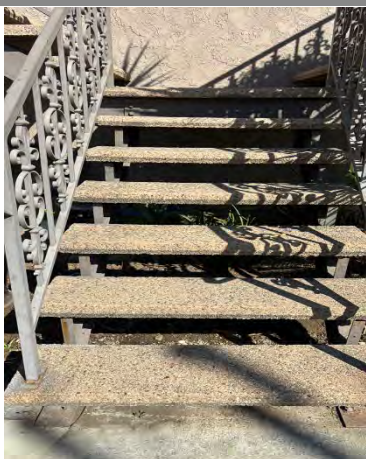
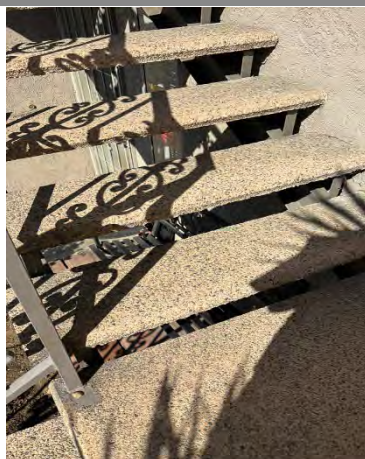
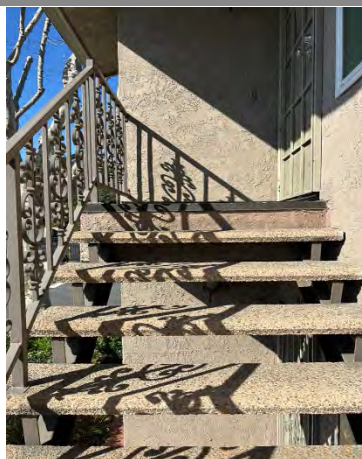
Exterior Elements	Stairs, Stairs Landing, Stucco Interface
Water Proofing Elements	Flashings, Waterproofing, Coatings, Sealants
Visual Review	Fair
Any Visual Signs of leaks	No
Further Invasive Review Required	No
Condition Assessment	Pass
Additional Considerations or Concerns	Stairs are in fair condition.
Life Expectancy (EEE)	1-4 Years
Life Expectancy (LBC)	4-7 Years
Life Expectancy (AWE)	1-4 Years

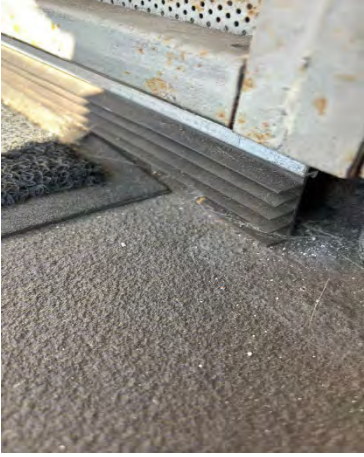
Exterior Elements	Decks, Railings, Integrations, Door Threshold, Stucco Interface
Water Proofing Elements	Flashings, Waterproofing, Coatings, Sealants
Visual Review	Fair
Any Visual Signs of leaks	No
Further Invasive Review Required	No
Condition Assessment	Pass
Additional Considerations or Concerns	Deck is in fair condition however the railing attachment at the deck is loose. Repair as necessary
Life Expectancy (EEE)	1-4 Years
Life Expectancy (LBC)	4-7 Years
Life Expectancy (AWE)	1-4 Years

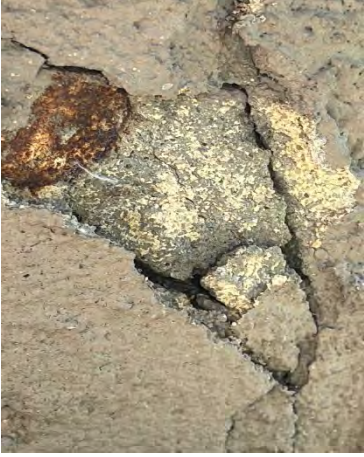
Exterior Elements	Stairs, Stairs Landing
Water Proofing Elements	Flashings, Waterproofing, Coatings, Sealants
Visual Review	Fair
Any Visual Signs of leaks	No
Further Invasive Review Required	No
Condition Assessment	Pass
Additional Considerations or Concerns	The stringer attachment in one location has stucco cracked. No visual signs of structural decay. repair as necessary.
Life Expectancy (EEE)	1-4 Years
Life Expectancy (LBC)	4-7 Years
Life Expectancy (AWE)	1-4 Years

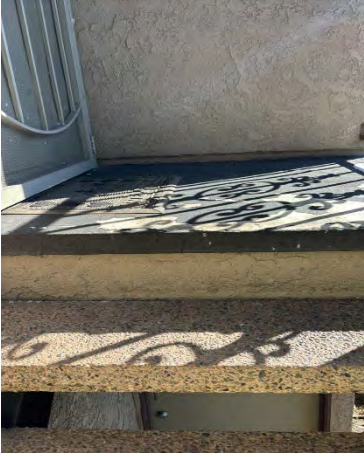
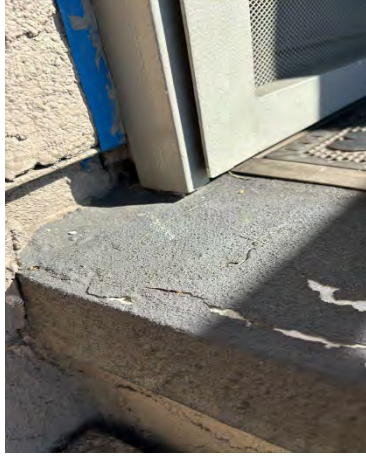
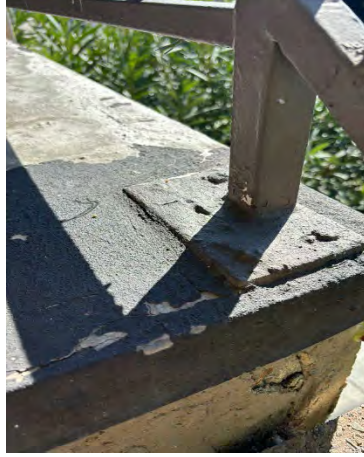
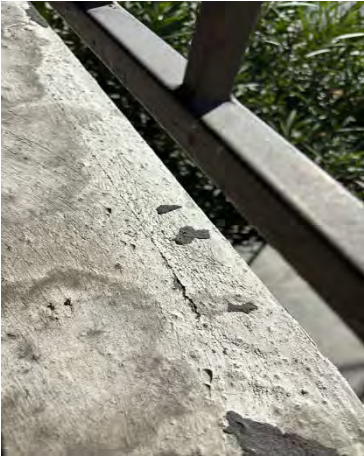
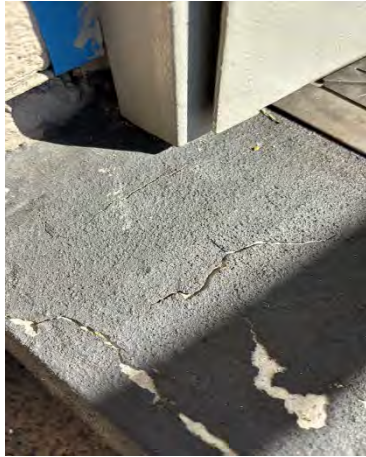
Building Name	5465-2
Apartment Name	115
Location Name	Entry deck
Visual Report	
Exterior Elements	Porches/Entry, Railings, Integrations, Door Threshold, Stucco Interface
Water Proofing Elements	Flashings, Waterproofing, Coatings, Sealants
Visual Review	Bad
Any Visual Signs of leaks	Yes
Further Invasive Review Required	No
Condition Assessment	Fail
Additional Considerations or Concerns	<p>Entry / Balcony / Walking Deck</p> <p>The deck is wood framed with waterproofing over the wood.</p> <p>Handrails are metal and attached to the deck surface and visually in good condition.</p> <p>The waterproofing is severely damaged. Replace or repair the waterproofing, including all damaged wood with new waterproofing and wood structures.</p>
Life Expectancy (EEE)	0-1 Years
Life Expectancy (LBC)	1-4 Years
Life Expectancy (AWE)	0-1 Years
Visual Photos

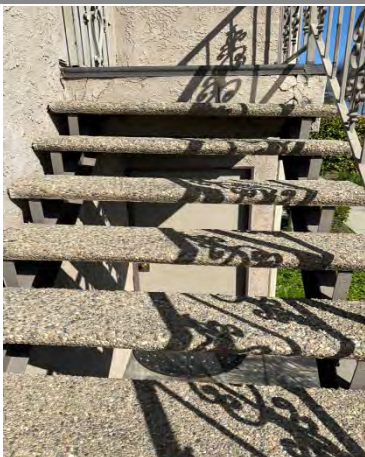
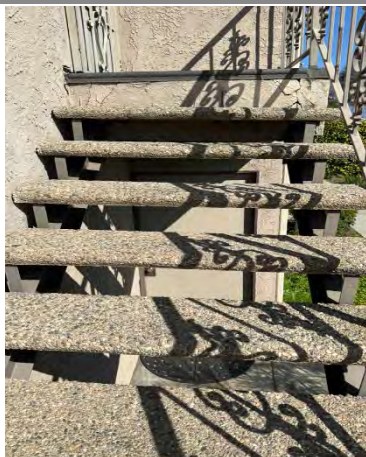
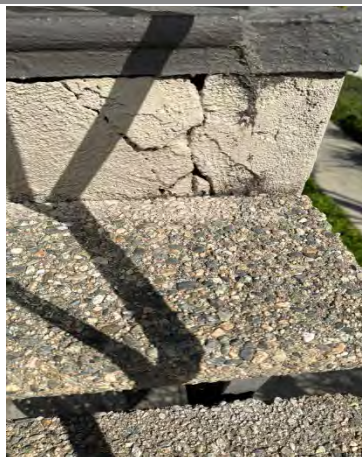
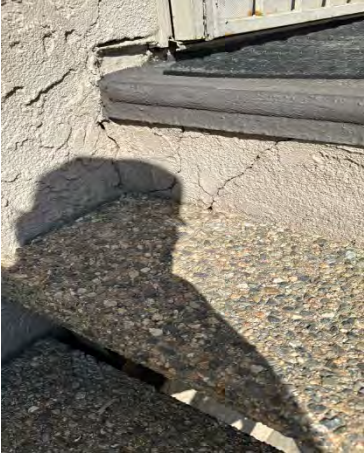
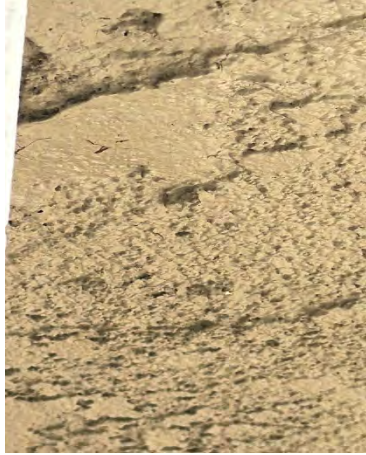
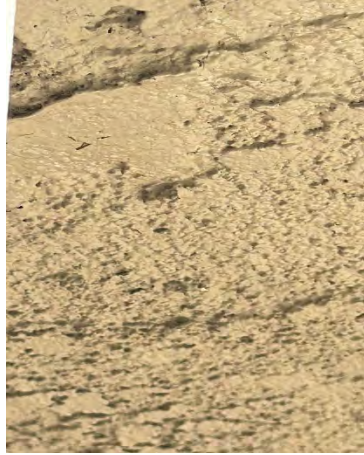
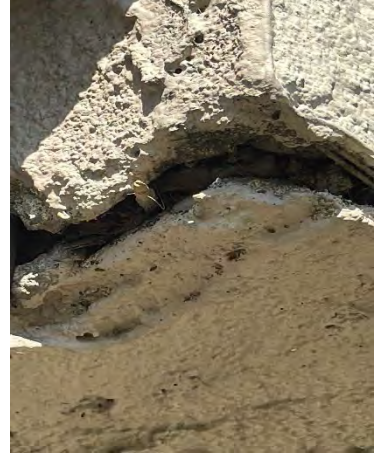
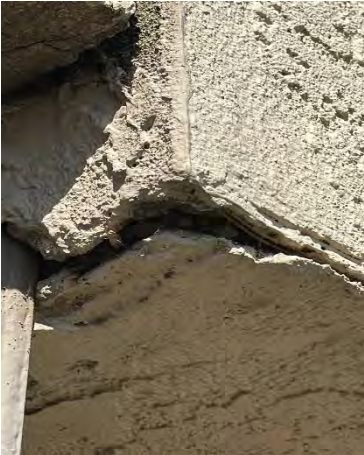
Exterior Elements	Stairs, Stairs Landing, Railings, Integrations
Water Proofing Elements	Flashings, Waterproofing, Coatings, Sealants
Visual Review	Bad
Any Visual Signs of leaks	No
Further Invasive Review Required	Yes
Condition Assessment	Fail
Additional Considerations or Concerns	Attachment of the state steel stringer to the rim, joist appears to be failing.
Life Expectancy (EEE)	0-1 Years
Life Expectancy (LBC)	0-1 Years
Life Expectancy (AWE)	1-4 Years

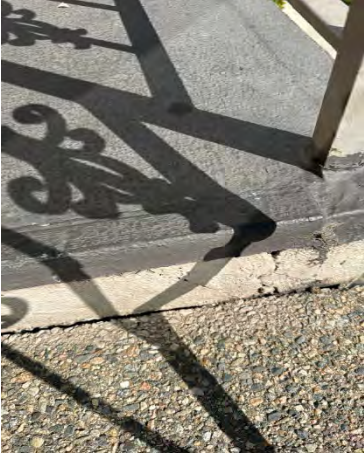
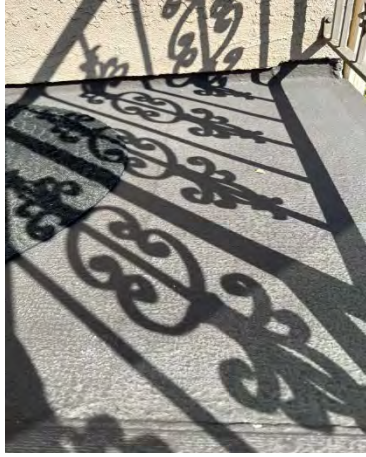
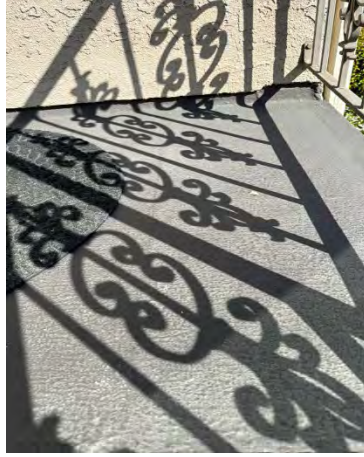
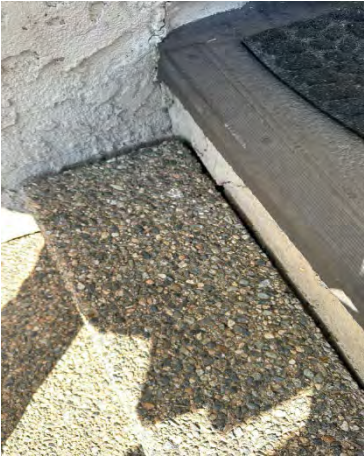
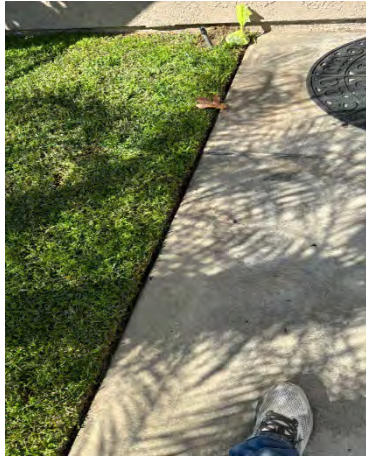
Building Name	2315
Apartment Name	32
Location Name	Entry deck
Visual Report	
Exterior Elements	Decks, Railings, Integrations, Door Threshold, Stucco Interface
Water Proofing Elements	Flashings, Waterproofing, Coatings, Sealants
Visual Review	Good
Any Visual Signs of leaks	No
Further Invasive Review Required	No
Condition Assessment	Pass
Additional Considerations or Concerns	<p>Entry / Balcony / Walking Deck</p> <p>The deck is wood framed with waterproofing over the wood.</p> <p>Handrails are metal and attached to the deck surface and visually in good condition</p>
Life Expectancy (EEE)	1-4 Years
Life Expectancy (LBC)	1-4 Years
Life Expectancy (AWE)	1-4 Years
Visual Photos

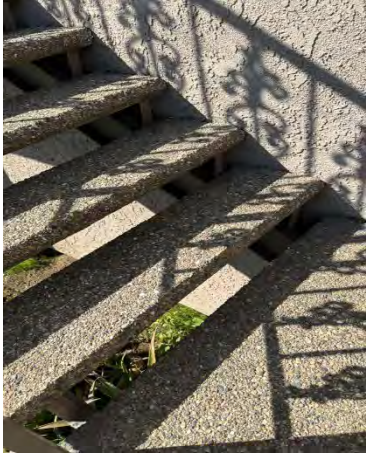
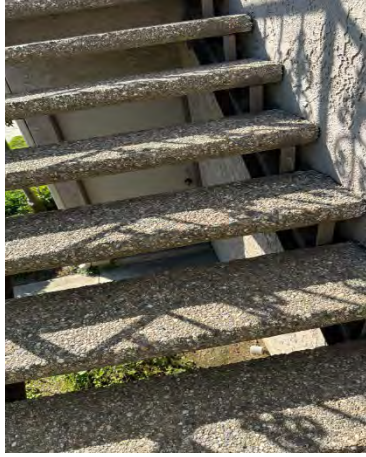
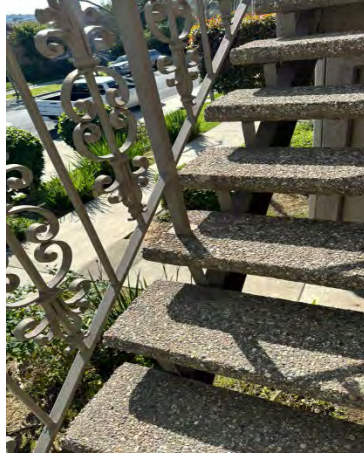
Building Name	2315
Apartment Name	31
Location Name	Stairs
Visual Report	
Exterior Elements	Stairs, Stairs Landing, Railings, Integrations
Water Proofing Elements	Flashings, Waterproofing, Coatings, Sealants
Visual Review	Good
Any Visual Signs of leaks	No
Further Invasive Review Required	No
Condition Assessment	Pass
Additional Considerations or Concerns	<p>Railing at concrete</p> <p>Stairs are steel stringers attached to a wood structure with concrete treads.</p> <p>The handrails are visually in good condition.</p>
Life Expectancy (EEE)	1-4 Years
Life Expectancy (LBC)	4-7 Years
Life Expectancy (AWE)	1-4 Years

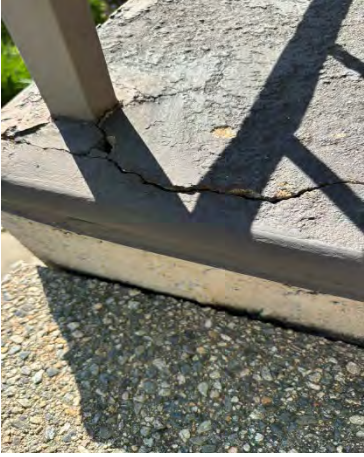
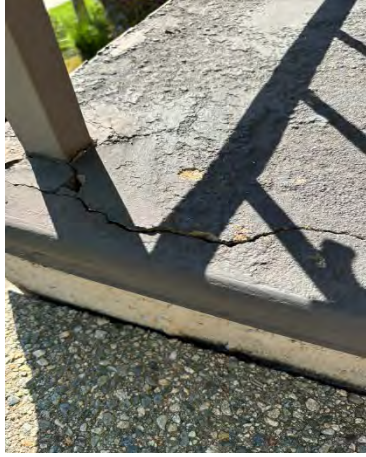
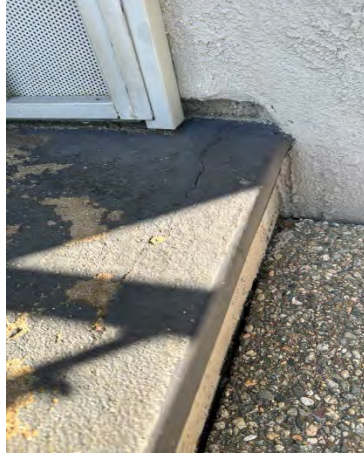
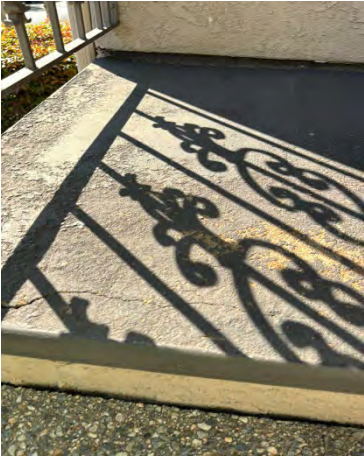
Exterior Elements	Decks, Railings, Integrations, Door Threshold, Stucco Interface
Water Proofing Elements	Flashings, Waterproofing, Coatings, Sealants
Visual Review	Bad
Any Visual Signs of leaks	Yes
Further Invasive Review Required	Yes
Condition Assessment	Fail
Additional Considerations or Concerns	Entry / Balcony / Walking Deck The deck is wood framed with waterproofing over the wood. Handrails are metal and attached to the deck surface and visually in good condition. The waterproofing is severely damaged. Replace or repair the waterproofing, including all damaged wood with new waterproofing and wood structures.
Life Expectancy (EEE)	0-1 Years
Life Expectancy (LBC)	0-1 Years
Life Expectancy (AWE)	0-1 Years

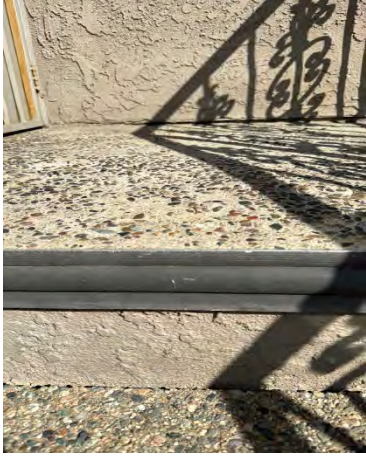
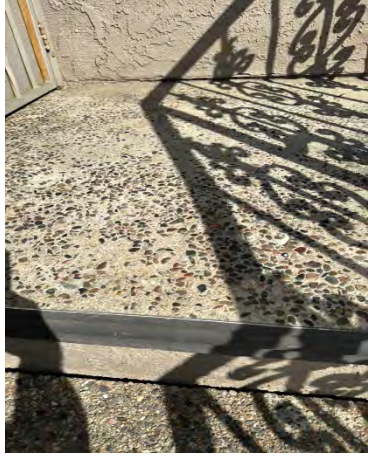
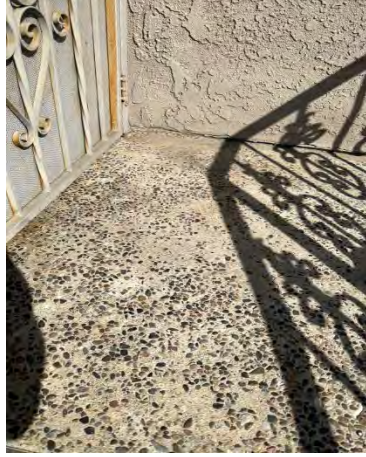
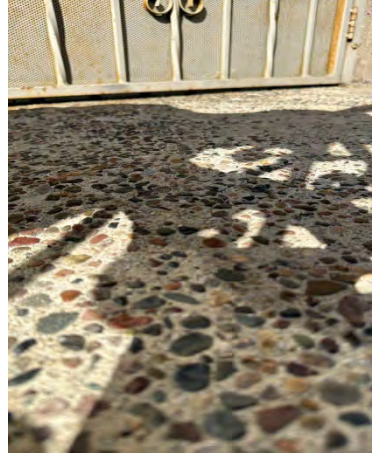
Building Name	2315
Apartment Name	30
Location Name	Entry deck
Visual Report	
Exterior Elements	Decks, Railings, Door Threshold, Stucco Interface, Integrations
Water Proofing Elements	Flashings, Waterproofing, Coatings, Sealants
Visual Review	Bad
Any Visual Signs of leaks	Yes
Further Invasive Review Required	Yes
Condition Assessment	Fail
Additional Considerations or Concerns	<p>Entry / Balcony / Walking DeckThe deck is wood framed with waterproofing over the wood. Handrails are metal and attached to the deck surface and visually in good condition.</p> <p>The waterproofing is severely damaged. Replace or repair the waterproofing, including all damaged wood with new waterproofing and wood structures. Concrete pebble overlay bubbling, causing large rise in the walking area of the deck. Remove and replace.</p>
Life Expectancy (EEE)	0-1 Years
Life Expectancy (LBC)	0-1 Years
Life Expectancy (AWE)	0-1 Years
Visual Photos

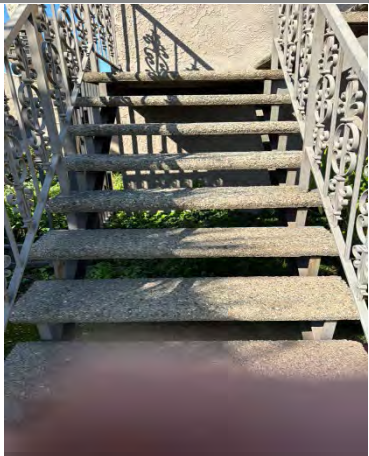
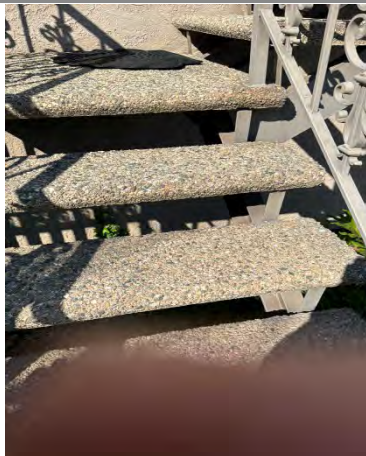
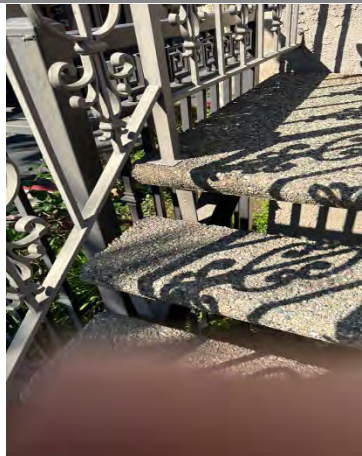
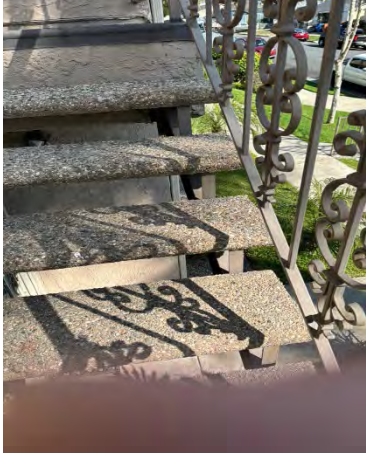
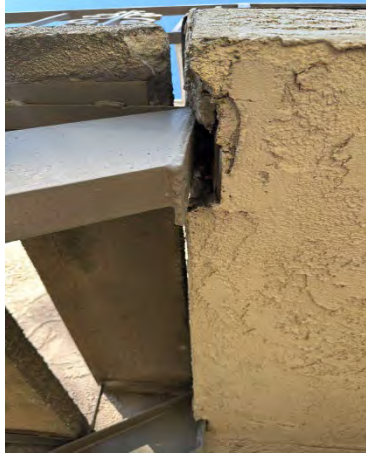
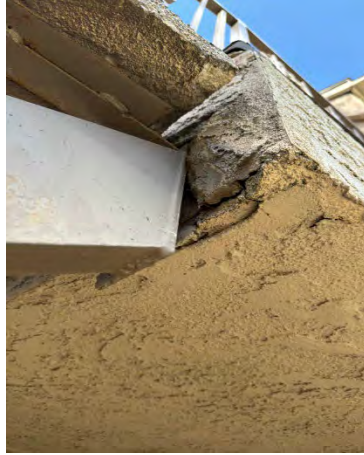
Building Name	2315
Apartment Name	35
Location Name	Stairs
Visual Report	
Exterior Elements	Stairs, Stairs Landing, Railings, Integrations
Water Proofing Elements	Flashings, Waterproofing, Coatings, Sealants
Visual Review	Good
Any Visual Signs of leaks	No
Further Invasive Review Required	No
Condition Assessment	Pass
Additional Considerations or Concerns	<p>Railing at concrete</p> <p>Stairs are steel stringers attached to a wood structure with concrete treads.</p> <p>The handrails are visually in good condition</p>
Life Expectancy (EEE)	1-4 Years
Life Expectancy (LBC)	4-7 Years
Life Expectancy (AWE)	1-4 Years

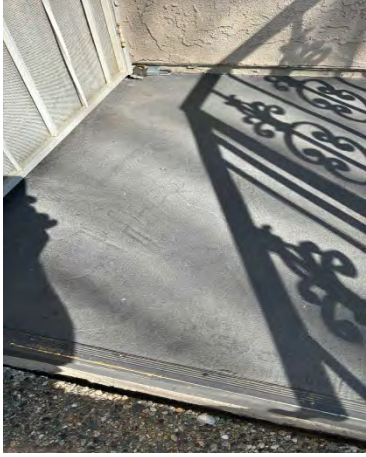
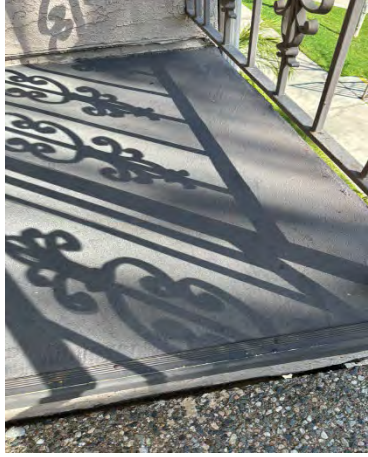
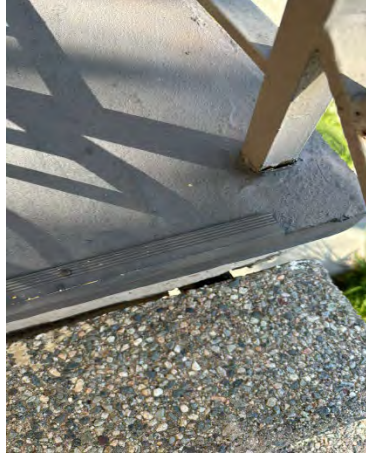
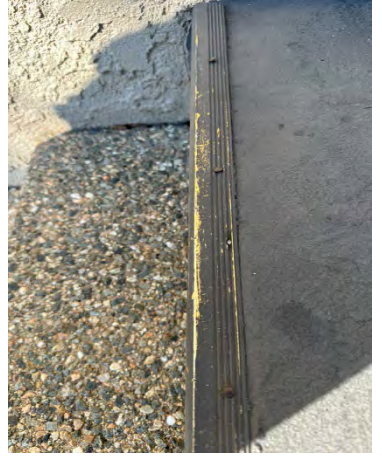
Building Name	2315
Apartment Name	35
Location Name	Entry deck
Visual Report	
Exterior Elements	Decks, Railings, Stucco Interface, Door Threshold, Integrations
Water Proofing Elements	Flashings, Waterproofing, Coatings, Sealants
Visual Review	Good
Any Visual Signs of leaks	No
Further Invasive Review Required	No
Condition Assessment	Pass
Additional Considerations or Concerns	<p>Entry / Balcony / Walking Deck</p> <p>The deck is wood framed with waterproofing over the wood.</p> <p>Handrails are metal and attached to the deck surface and visually in good condition</p>
Life Expectancy (EEE)	1-4 Years
Life Expectancy (LBC)	4-7 Years
Life Expectancy (AWE)	1-4 Years
Visual Photos

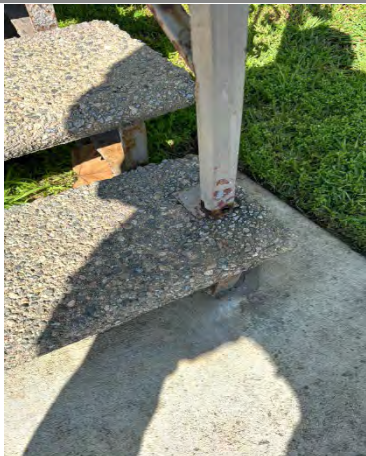
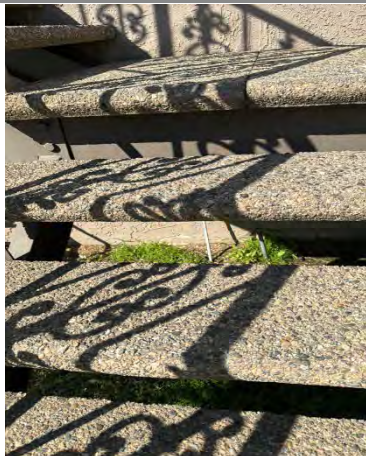
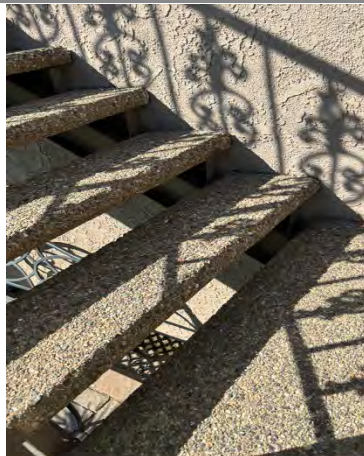
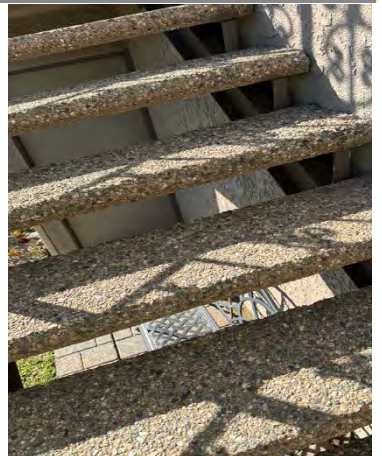
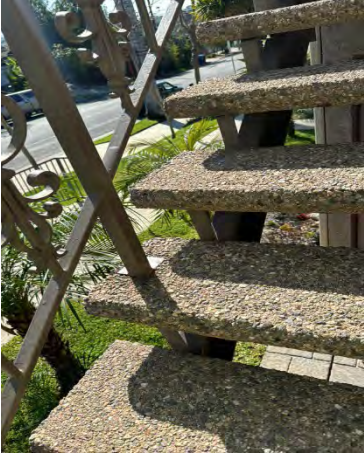
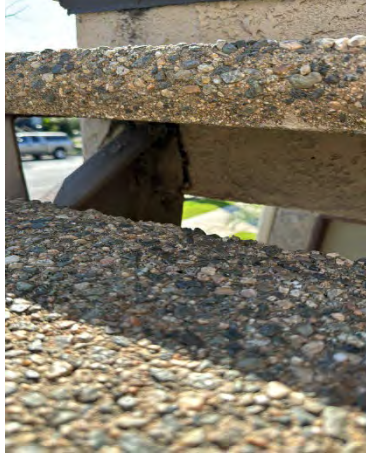
Building Name	2315
Apartment Name	33
Location Name	Stairs
Visual Report	
Exterior Elements	Stairs, Stairs Landing, Railings, Integrations
Water Proofing Elements	Flashings, Waterproofing, Coatings, Sealants
Visual Review	Good
Any Visual Signs of leaks	No
Further Invasive Review Required	No
Condition Assessment	Pass
Additional Considerations or Concerns	<p>Railing at concrete</p> <p>Stairs are steel stringers attached to a wood structure with concrete treads.</p> <p>The handrails are visually in good condition.</p>
Life Expectancy (EEE)	1-4 Years
Life Expectancy (LBC)	4-7 Years
Life Expectancy (AWE)	1-4 Years

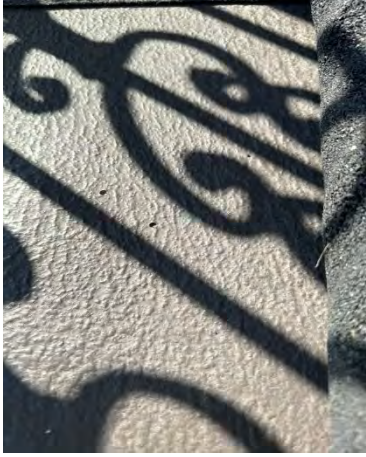
Exterior Elements	Decks, Railings, Integrations, Door Threshold, Stucco Interface
Water Proofing Elements	Flashings, Waterproofing, Coatings, Sealants
Visual Review	Fair
Any Visual Signs of leaks	No
Further Invasive Review Required	No
Condition Assessment	Pass
Additional Considerations or Concerns	A few cracks around the railing, post attachments, and in the center of the deck repair the deck. Repair or replace as necessary
Life Expectancy (EEE)	1-4 Years
Life Expectancy (LBC)	4-7 Years
Life Expectancy (AWE)	0-1 Years

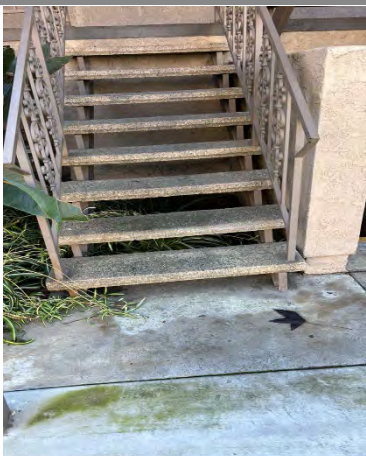
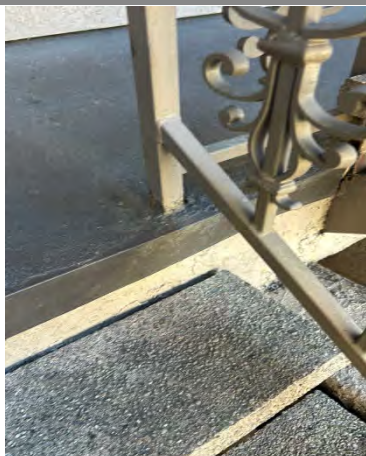
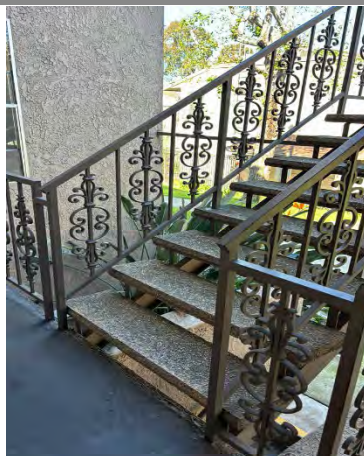
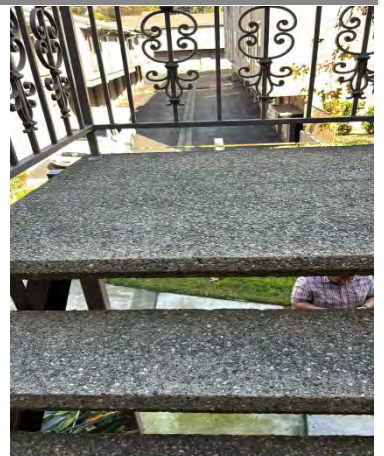
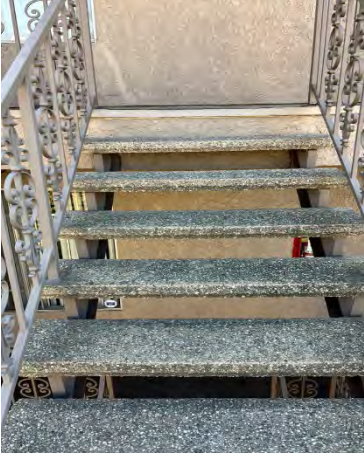
Building Name	2310-1
Apartment Name	125
Location Name	Stairs
Visual Report	
Exterior Elements	Stairs, Stairs Landing
Water Proofing Elements	Flashings, Waterproofing, Coatings, Sealants
Visual Review	Fair
Any Visual Signs of leaks	No
Further Invasive Review Required	No
Condition Assessment	Pass
Additional Considerations or Concerns	<p>Railing at concrete Stairs are steel stringers attached to a wood structure with concrete treads.</p> <p>The handrails are visually in good condition.</p>
Life Expectancy (EEE)	1-4 Years
Life Expectancy (LBC)	4-7 Years
Life Expectancy (AWE)	1-4 Years

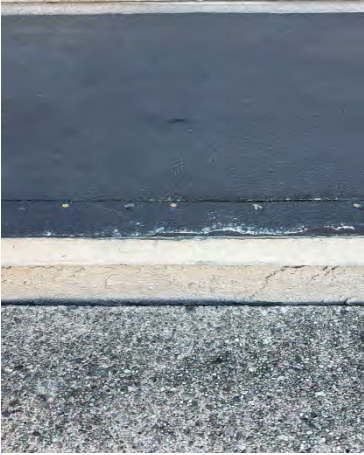
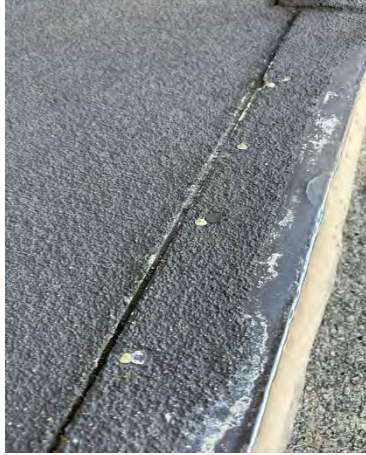
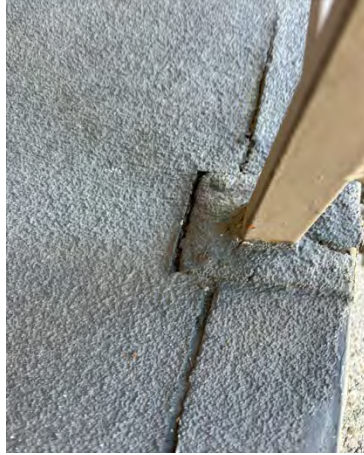
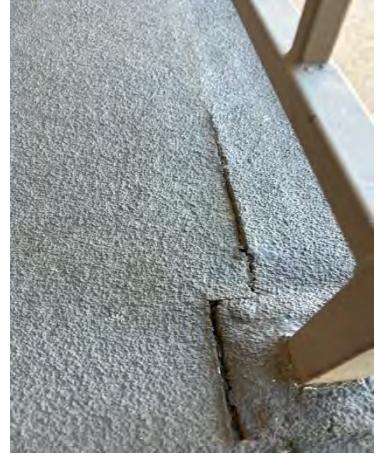
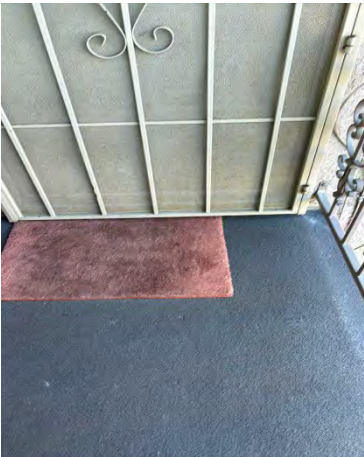
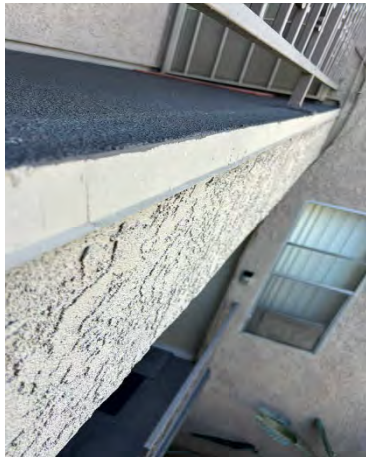
Building Name	2310-1
Apartment Name	125
Location Name	Entry deck
Visual Report	
Exterior Elements	Decks, Railings, Integrations, Door Threshold, Stucco Interface
Water Proofing Elements	Flashings, Waterproofing, Coatings, Sealants
Visual Review	Bad
Any Visual Signs of leaks	Yes
Further Invasive Review Required	Yes
Condition Assessment	Fail
Additional Considerations or Concerns	<p>Entry / Balcony / Walking Deck</p> <p>The deck is wood framed with waterproofing over the wood.</p> <p>Handrails are metal and attached to the deck surface and visually in good condition.</p> <p>The waterproofing is severely damaged. Replace or repair the waterproofing, including all damaged wood with new waterproofing and wood structures</p>
Life Expectancy (EEE)	0-1 Years
Life Expectancy (LBC)	1-4 Years
Life Expectancy (AWE)	0-1 Years

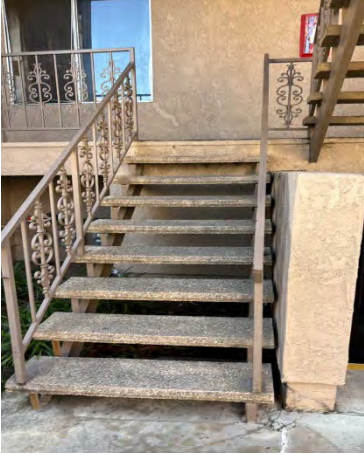
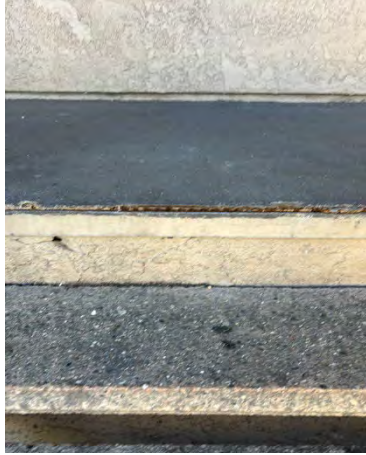
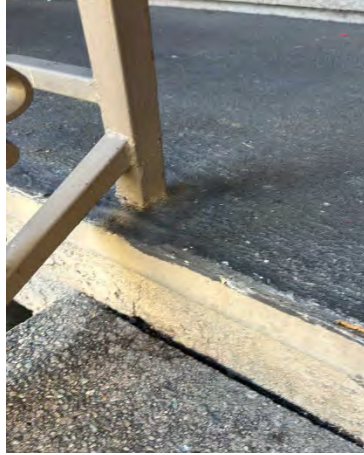
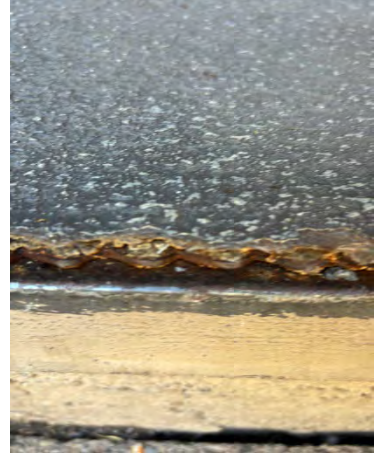
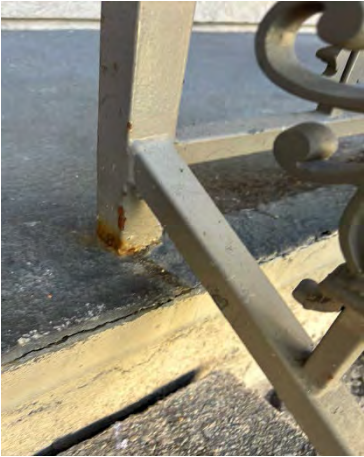
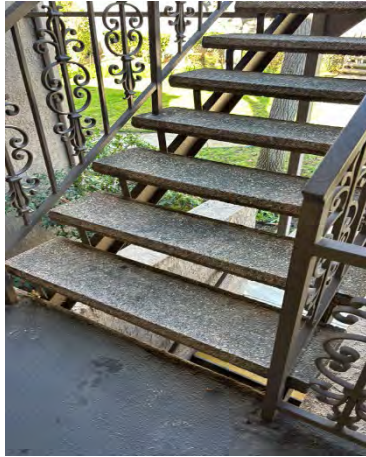
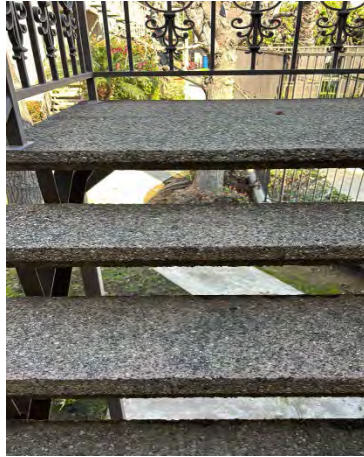
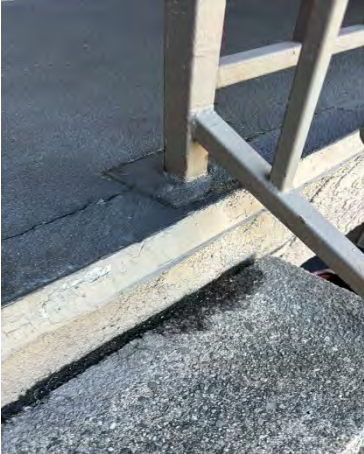
Building Name	2310-1
Apartment Name	121
Location Name	Stairs & Mid Landing
Visual Report	
Exterior Elements	Stairs, Stairs Landing, Railings
Water Proofing Elements	Flashings, Waterproofing, Coatings, Sealants
Visual Review	Bad
Any Visual Signs of leaks	Yes
Further Invasive Review Required	No
Condition Assessment	Fail
Additional Considerations or Concerns	<p>Entry / Balcony / Walking Deck</p> <p>The deck is wood framed with waterproofing over the wood.</p> <p>Mid Landing and Stairs Handrails are metal and attached to the deck surface and visually in good condition.</p> <p>The waterproofing is severely damaged. Replace or repair the waterproofing, including all damaged wood with new waterproofing and wood structures</p>
Life Expectancy (EEE)	0-1 Years
Life Expectancy (LBC)	1-4 Years
Life Expectancy (AWE)	0-1 Years

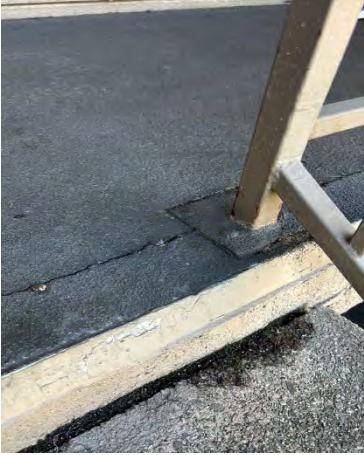
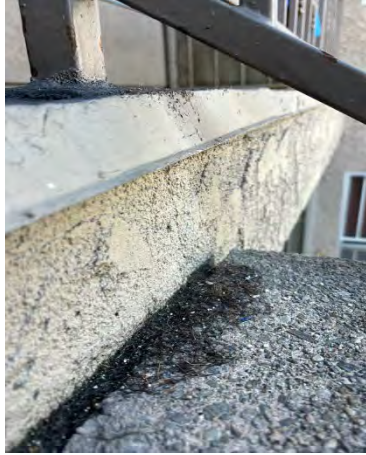
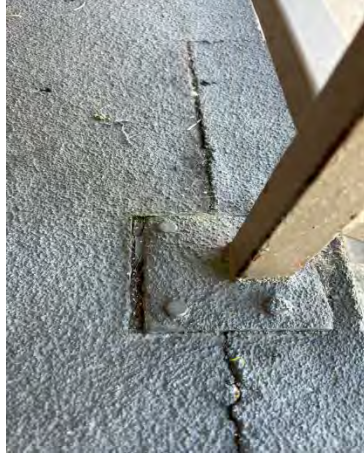
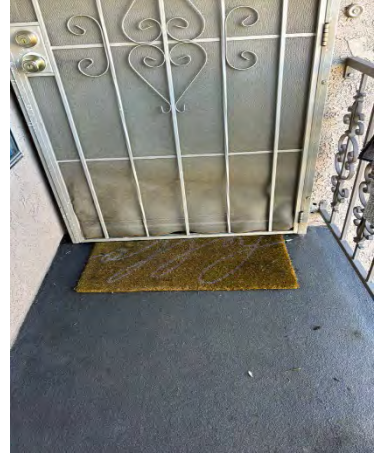
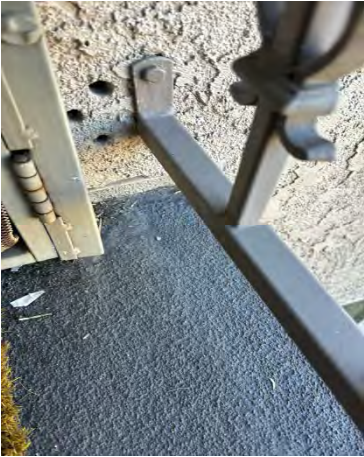
Building Name	2310-1
Apartment Name	121
Location Name	Entry deck
Visual Report	
Exterior Elements	Porches/Entry, Integrations, Door Threshold, Railings, Stucco Interface
Water Proofing Elements	Flashings, Waterproofing, Coatings, Sealants
Visual Review	Bad
Any Visual Signs of leaks	Yes
Further Invasive Review Required	Yes
Condition Assessment	Fail
Additional Considerations or Concerns	<p>Entry / Balcony / Walking Deck</p> <p>The deck is wood framed with waterproofing over the wood.</p> <p>Handrails are metal and attached to the deck surface and visually in good condition.</p> <p>The waterproofing is severely damaged. Replace or repair the waterproofing, including all damaged wood with new waterproofing and wood structures</p>
Life Expectancy (EEE)	0-1 Years
Life Expectancy (LBC)	1-4 Years
Life Expectancy (AWE)	0-1 Years

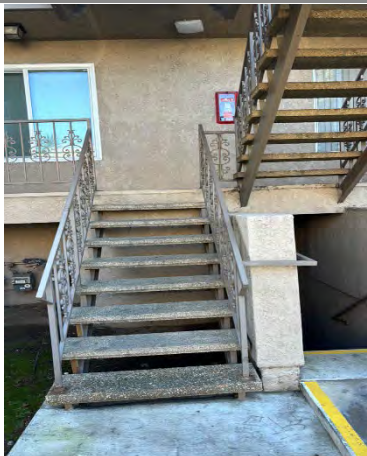
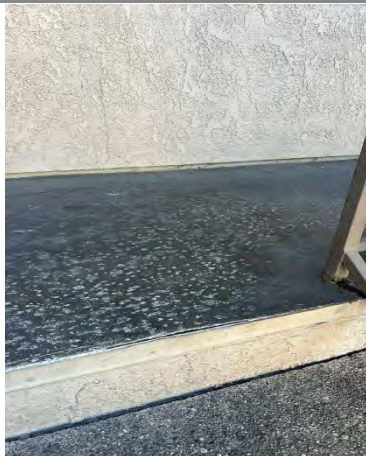
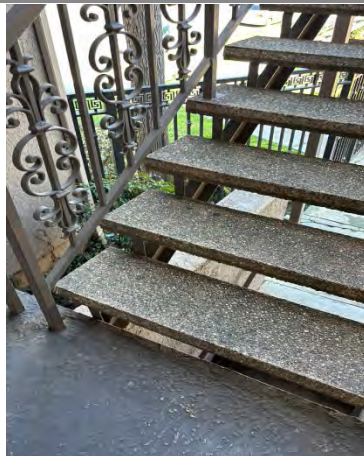
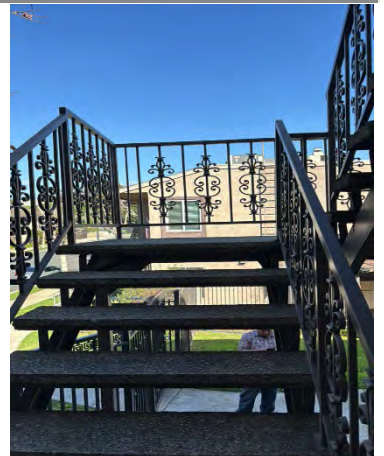
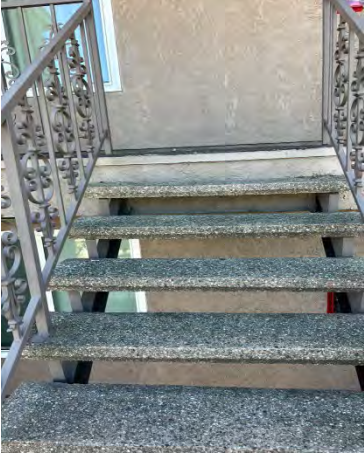
Building Name	2310-1
Apartment Name	129
Location Name	Stairs
Visual Report	
Exterior Elements	Stairs, Stairs Landing, Stucco Interface
Water Proofing Elements	Flashings, Waterproofing, Coatings, Sealants
Visual Review	Good
Any Visual Signs of leaks	No
Further Invasive Review Required	No
Condition Assessment	Fail
Additional Considerations or Concerns	<p>Railing at concrete</p> <p>Stairs are steel stringers attached to a wood structure with concrete treads.</p> <p>The handrails are visually in good condition.</p>
Life Expectancy (EEE)	1-4 Years
Life Expectancy (LBC)	4-7 Years
Life Expectancy (AWE)	1-4 Years

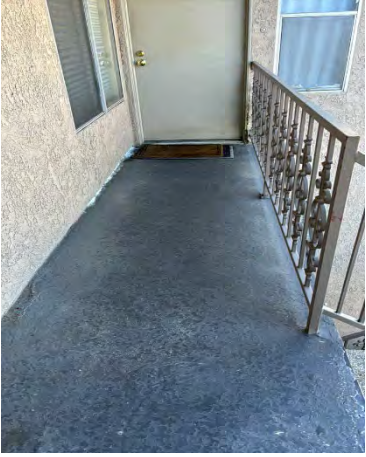
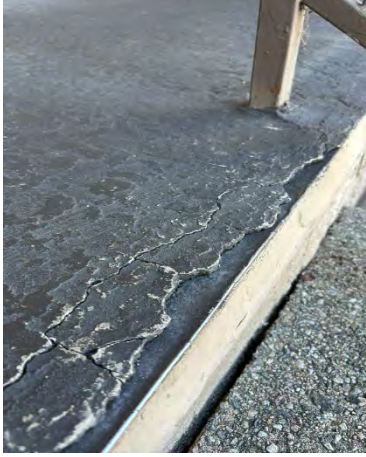
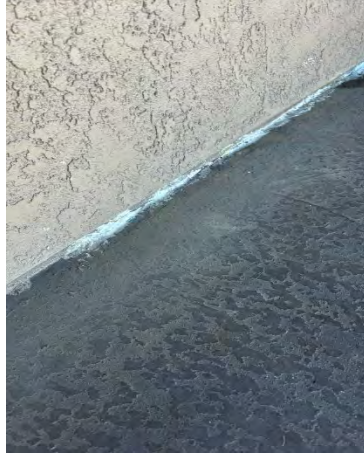
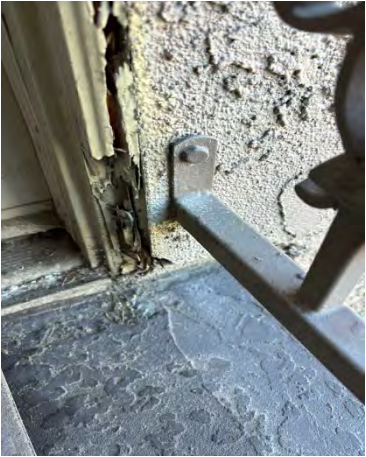
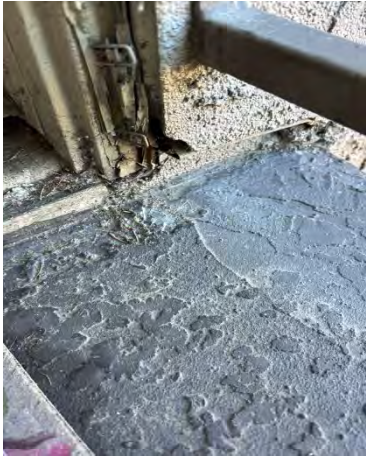
Exterior Elements	Decks, Integrations, Door Threshold, Stucco Interface, Railings
Water Proofing Elements	Flashings, Waterproofing, Coatings, Sealants
Visual Review	Fair
Any Visual Signs of leaks	Yes
Further Invasive Review Required	No
Condition Assessment	Fail
Additional Considerations or Concerns	<p>Entry / Balcony / Walking Deck</p> <p>The deck is wood framed with waterproofing over the wood.</p> <p>Handrails are metal and attached to the deck surface and visually in good condition.</p> <p>The waterproofing is severely damaged. Replace or repair the waterproofing, including all damaged wood with new waterproofing and wood structures.</p>
Life Expectancy (EEE)	0-1 Years
Life Expectancy (LBC)	1-4 Years
Life Expectancy (AWE)	0-1 Years

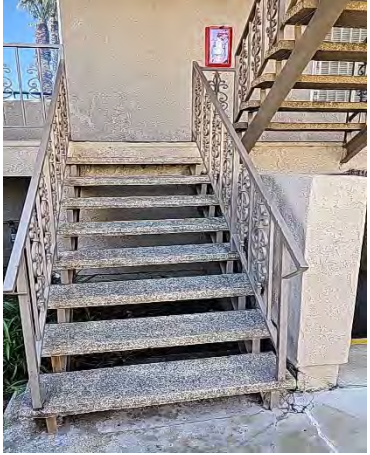
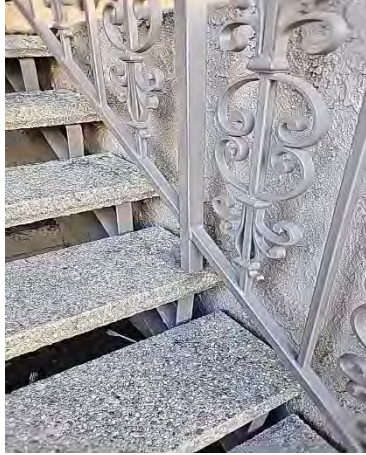
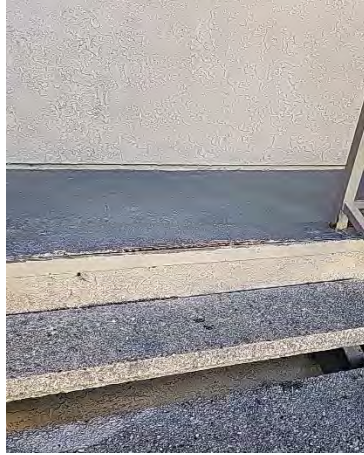
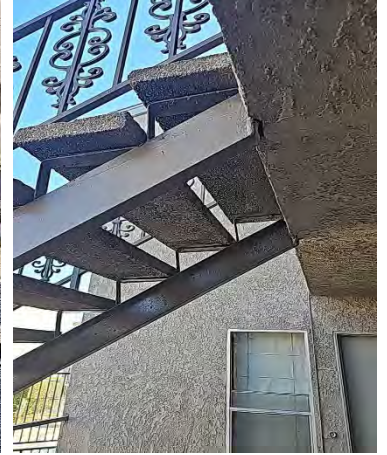
Building Name	2310-2
Apartment Name	119
Location Name	Stairs
Visual Report	
Exterior Elements	Stairs, Railings, Integrations, Stucco Interface
Water Proofing Elements	Flashings, Waterproofing, Coatings, Sealants
Visual Review	Bad
Any Visual Signs of leaks	Yes
Further Invasive Review Required	No
Condition Assessment	Fail
Additional Considerations or Concerns	<p>Mid Landing:</p> <p>The deck is wood framed with waterproofing over the wood.</p> <p>Handrails are metal and attached to the deck surface and visually in good condition.</p> <p>The waterproofing is severely damaged. Replace or repair the waterproofing, including all damaged wood with new waterproofing and wood structure. Railing at concrete Stairs are steel stringers attached to a wood structure with concrete treads. The handrails are visually in good condition.</p>
Life Expectancy (EEE)	0-1 Years
Life Expectancy (LBC)	1-4 Years
Life Expectancy (AWE)	0-1 Years

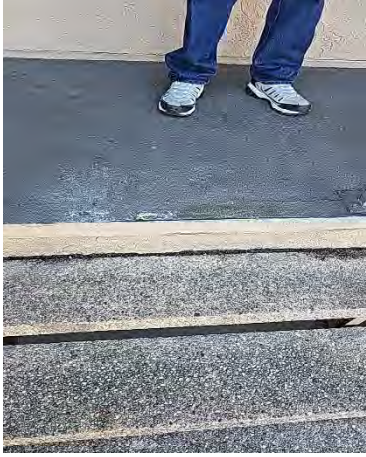
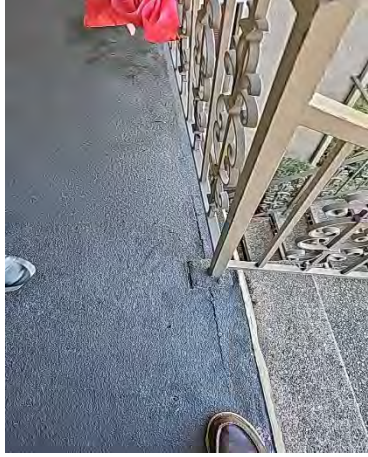
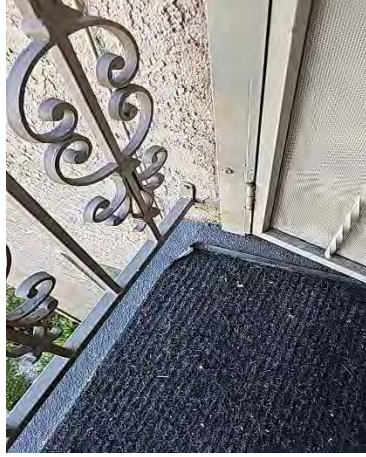
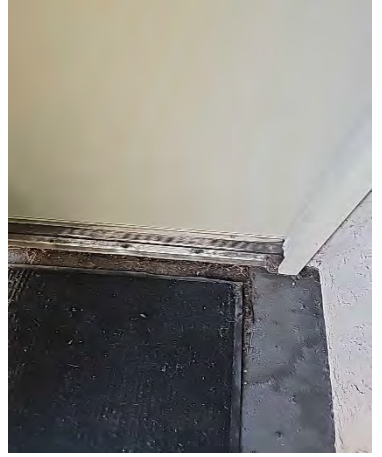
Building Name	2310-2
Apartment Name	119
Location Name	Entry deck
Visual Report	
Exterior Elements	Integrations, Stucco Interface, Porches/Entry, Stairs Landing
Water Proofing Elements	Flashings, Waterproofing, Coatings, Sealants
Visual Review	Bad
Any Visual Signs of leaks	Yes
Further Invasive Review Required	No
Condition Assessment	Fail
Additional Considerations or Concerns	<p>Entry / Balcony / Walking Deck</p> <p>The deck is wood framed with waterproofing over the wood.</p> <p>Handrails are metal and attached to the deck surface and visually in good condition.</p> <p>The waterproofing is severely damaged. Replace or repair the waterproofing, including all damaged wood with new waterproofing and wood structures.</p>
Life Expectancy (EEE)	0-1 Years
Life Expectancy (LBC)	1-4 Years
Life Expectancy (AWE)	0-1 Years
Visual Photos

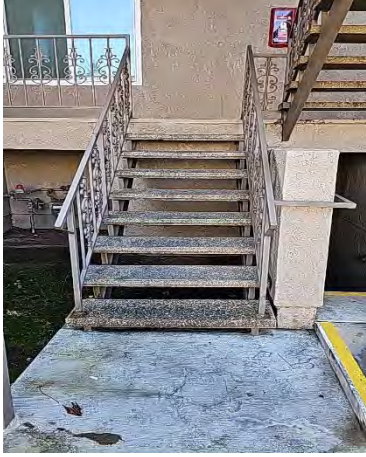
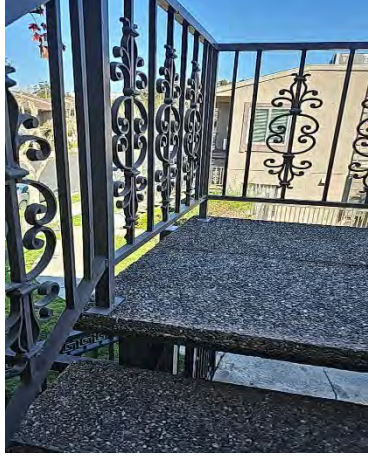
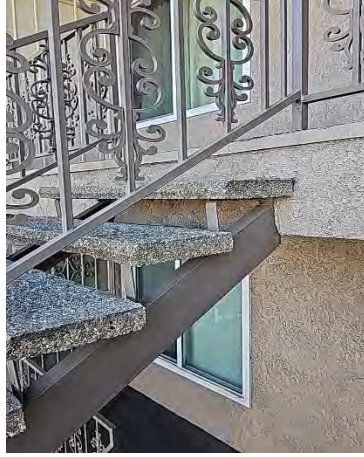
Building Name	2310-2
Apartment Name	127
Location Name	Stairs
Visual Report	
Exterior Elements	Stairs, Railings, Integrations, Stucco Interface, Decks
Water Proofing Elements	Flashings, Waterproofing, Coatings, Sealants
Visual Review	Good
Any Visual Signs of leaks	No
Further Invasive Review Required	No
Condition Assessment	Pass
Additional Considerations or Concerns	<p>Autum Pointe HOA</p> <p>Railing at concrete</p> <p>Stairs are steel stringers attached to a wood structure with concrete treads.</p> <p>The handrails are visually in good condition.</p>
Life Expectancy (EEE)	1-4 Years
Life Expectancy (LBC)	1-4 Years
Life Expectancy (AWE)	1-4 Years
Visual Photos
