REPORT OF VISUAL INSPECTION

An inspection ("Inspection") of the Exterior Elevated Elements ("EEE") listed in Annex 1 (attached report), their load-bearing components ("LBC"), and associated waterproofing elements ("AWE") was performed at the property and on the date indicated below:

Autumn Pointe HOA/ 55488 Dobbns St.	Los Angeles	CA	
Date of Inspection:	2/22/2024

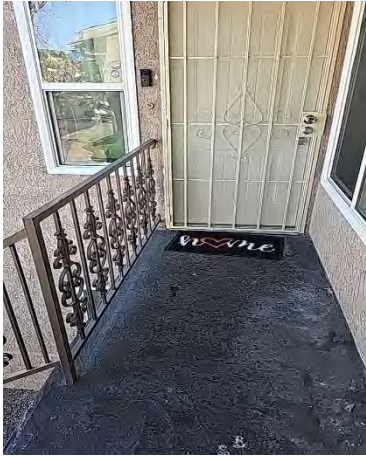
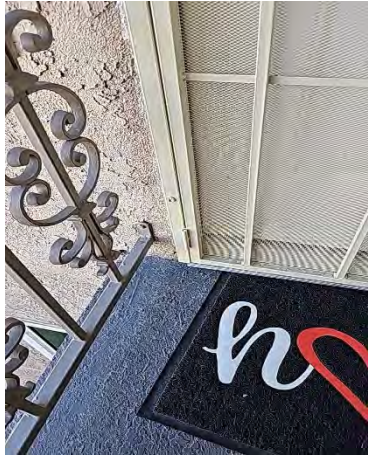
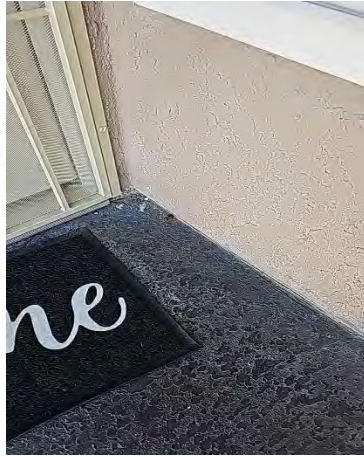
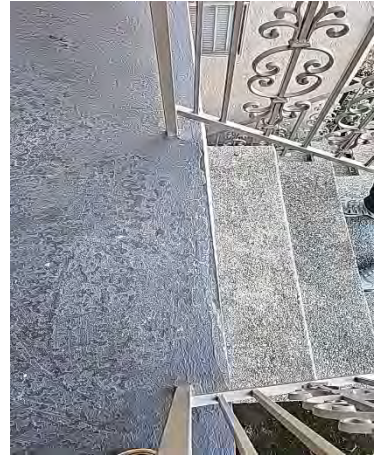
Exterior Elements	Decks, Stairs, Stairs Landing, Railings, Integrations, Stucco Interface
Water Proofing Elements	Flashings, Waterproofing, Coatings, Sealants
Visual Review	Fair
Any Visual Signs of leaks	Yes
Further Invasive Review Required	No
Condition Assessment	Fail
Additional Considerations or Concerns	<p>Entry / Balcony / Walking Deck</p> <p>The deck is wood framed with waterproofing over the wood.</p> <p>Handrails are metal and attached to the deck surface and visually in good condition.</p> <p>The waterproofing is severely damaged. Replace or repair the waterproofing, including all damaged wood with new waterproofing and wood structures.</p>
Life Expectancy (EEE)	0-1 Years
Life Expectancy (LBC)	1-4 Years
Life Expectancy (AWE)	0-1 Years

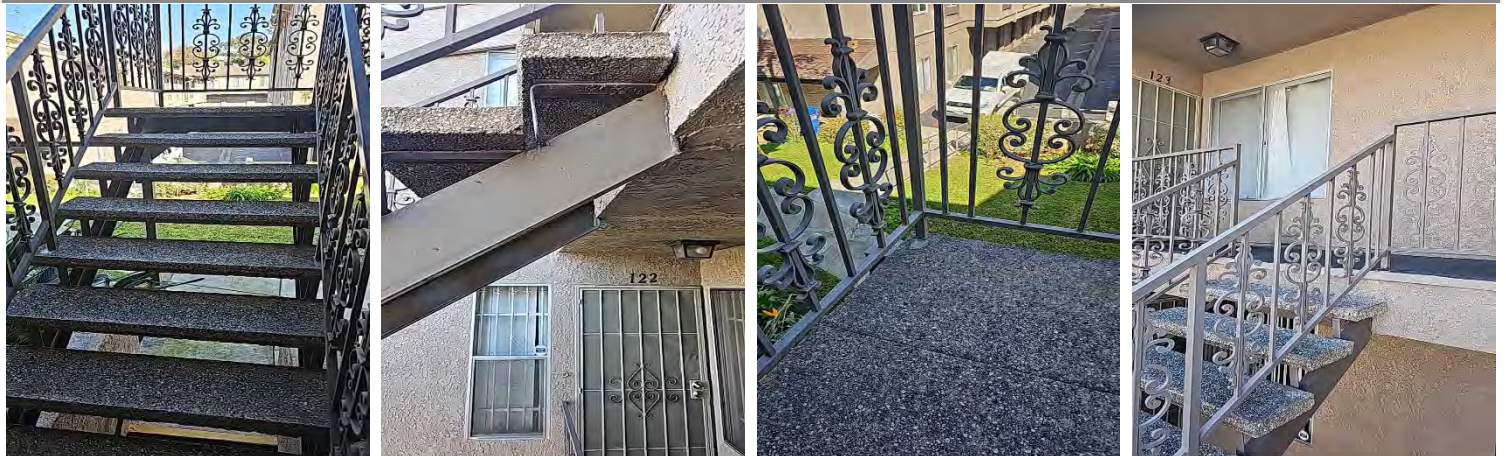
Building Name	2310-2
Apartment Name	123
Location Name	Stairs
Visual Report	
Exterior Elements	Stairs, Railings, Stucco Interface
Water Proofing Elements	Flashings, Waterproofing, Coatings, Sealants
Visual Review	Good
Any Visual Signs of leaks	No
Further Invasive Review Required	No
Condition Assessment	Pass
Additional Considerations or Concerns	<p>Railing at concrete</p> <p>Stairs are steel stringers attached to a wood structure with concrete treads.</p> <p>The handrails are visually in good condition.</p>
Life Expectancy (EEE)	1-4 Years
Life Expectancy (LBC)	1-4 Years
Life Expectancy (AWE)	1-4 Years

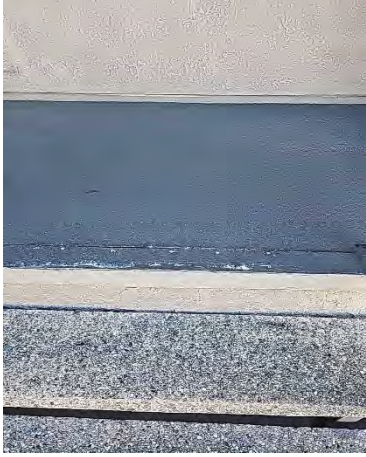
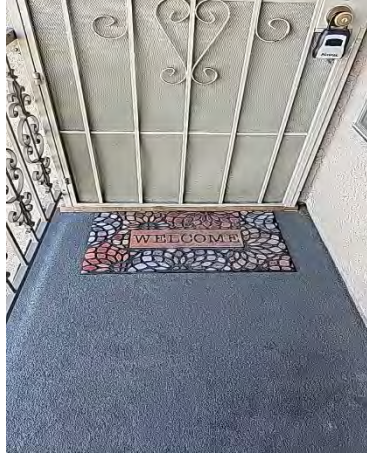
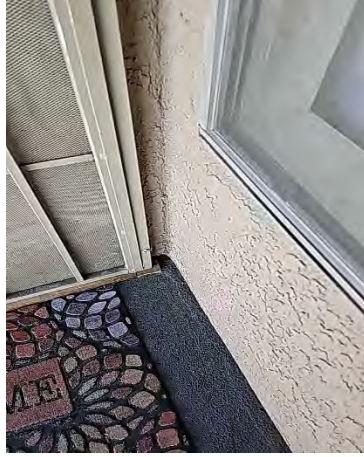
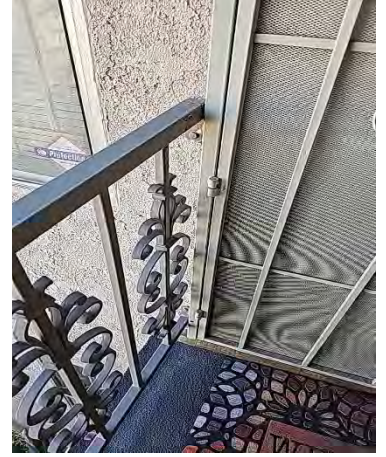
Exterior Elements	Decks, Railings, Stucco Interface, Integrations
Water Proofing Elements	Flashings, Waterproofing, Coatings, Sealants
Visual Review	Bad
Any Visual Signs of leaks	Yes
Further Invasive Review Required	No
Condition Assessment	Fail
Additional Considerations or Concerns	Entry / Balcony / Walking Deck The deck is wood framed with waterproofing over the wood. Handrails are metal and attached to the deck surface and visually in good condition. The waterproofing is severely damaged. Replace or repair the waterproofing, including all damaged wood with new waterproofing and wood structures.
Life Expectancy (EEE)	0-1 Years
Life Expectancy (LBC)	1-4 Years
Life Expectancy (AWE)	0-1 Years

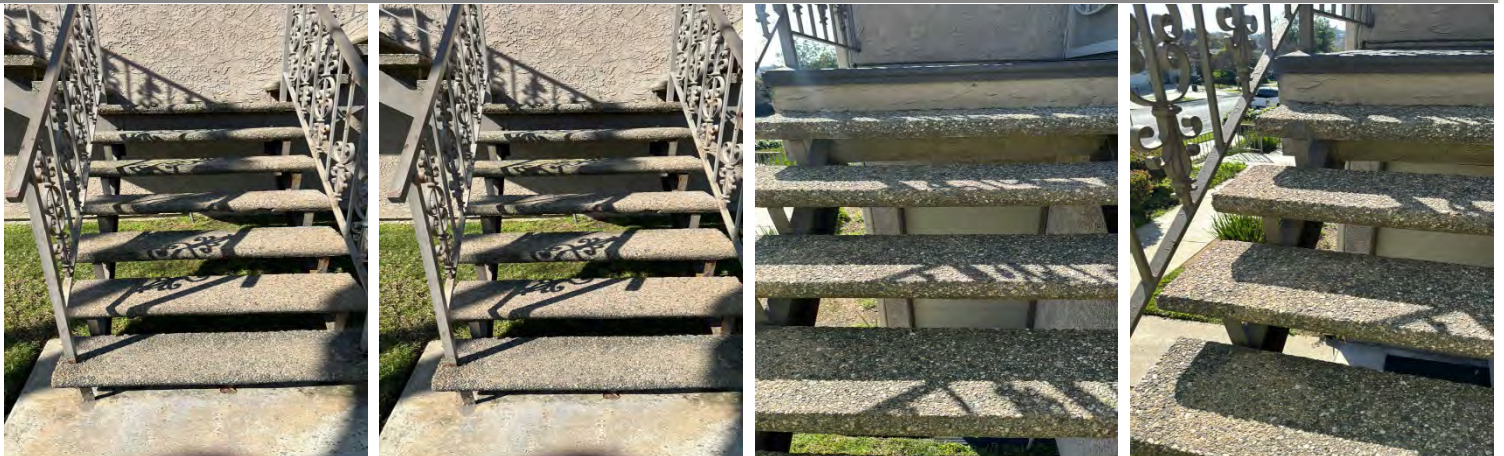
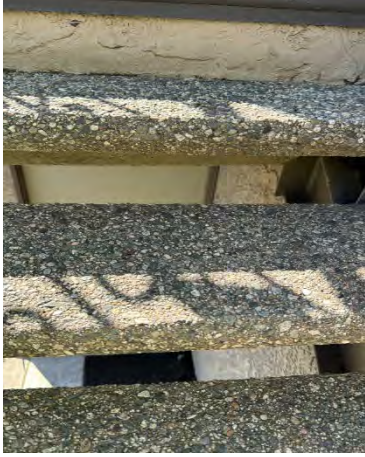
Exterior Elements	Stairs, Stairs Landing, Railings, Integrations
Water Proofing Elements	Flashings, Waterproofing, Coatings, Sealants
Visual Review	Good
Any Visual Signs of leaks	No
Further Invasive Review Required	No
Condition Assessment	Pass
Additional Considerations or Concerns	<p>Railing at concrete</p> <p>Stairs are steel stringers attached to a wood structure with concrete treads.</p> <p>The handrails are visually in good condition</p>
Life Expectancy (EEE)	1-4 Years
Life Expectancy (LBC)	4-7 Years
Life Expectancy (AWE)	1-4 Years

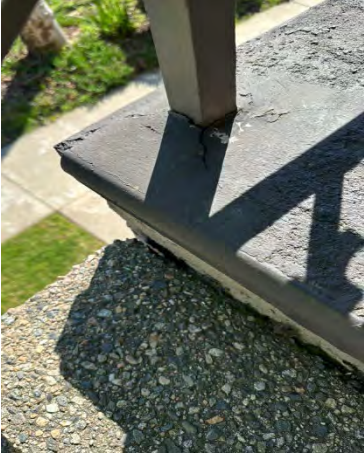
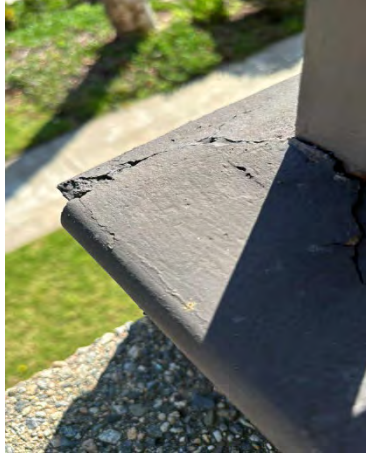
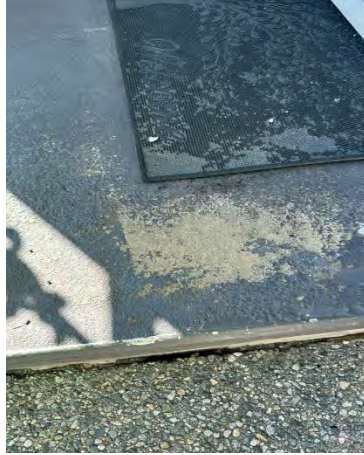
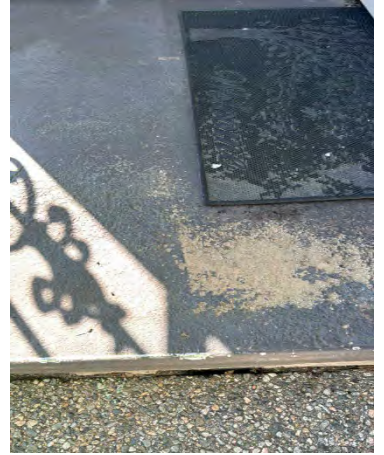
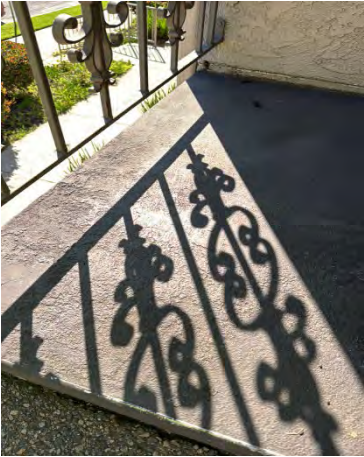
Exterior Elements	Decks, Stucco Interface, Door Threshold, Integrations, Railings
Water Proofing Elements	Flashings, Waterproofing, Coatings, Sealants
Visual Review	Bad
Any Visual Signs of leaks	Yes
Further Invasive Review Required	No
Condition Assessment	Fail
Additional Considerations or Concerns	Entry / Balcony / Walking Deck The deck is wood framed with waterproofing over the wood. Handrails are metal and attached to the deck surface and visually in good condition. The waterproofing is severely damaged. Replace or repair the waterproofing, including all damaged wood with new waterproofing and wood structures.
Life Expectancy (EEE)	1-4 Years
Life Expectancy (LBC)	1-4 Years
Life Expectancy (AWE)	0-1 Years

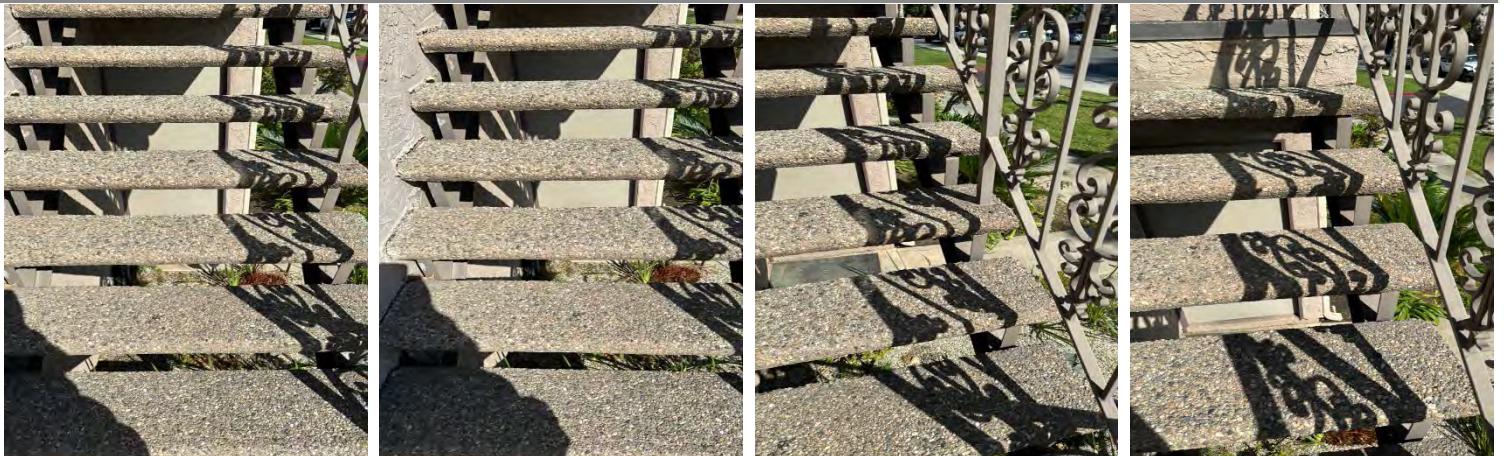
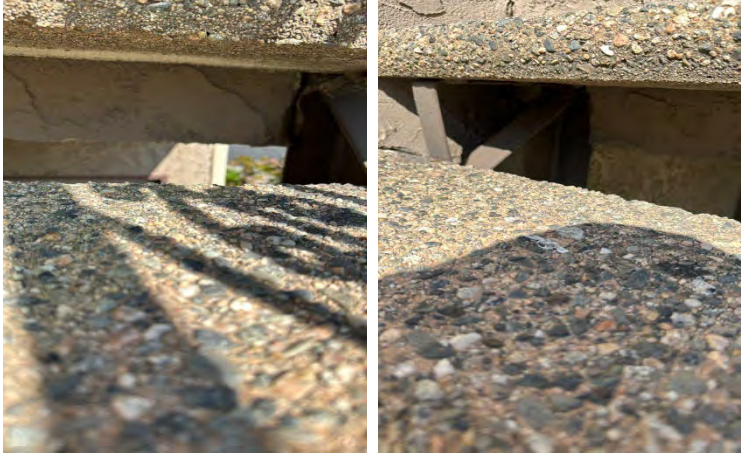
Exterior Elements	Porches/Entry, Stairs, Stairs Landing, Railings
Water Proofing Elements	Flashings, Waterproofing, Coatings, Sealants
Visual Review	Good
Any Visual Signs of leaks	No
Further Invasive Review Required	No
Condition Assessment	Pass
Additional Considerations or Concerns	<p>Railing at concrete</p> <p>Stairs are steel stringers attached to a wood structure with concrete treads.</p> <p>The handrails are visually in good condition.</p>
Life Expectancy (EEE)	1-4 Years
Life Expectancy (LBC)	4-7 Years
Life Expectancy (AWE)	1-4 Years

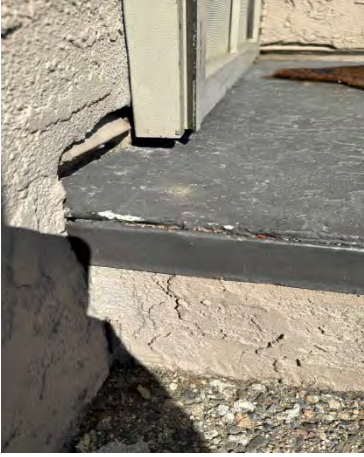
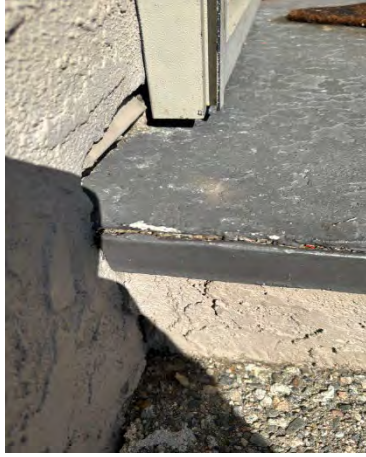
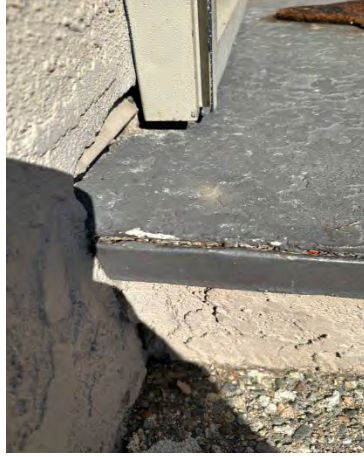
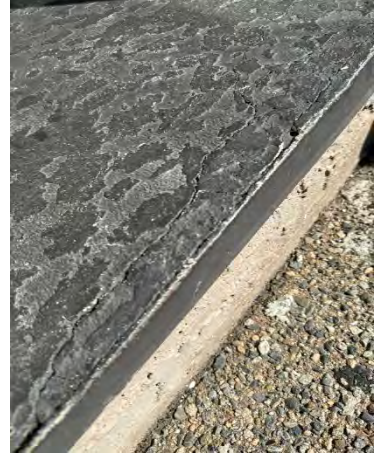
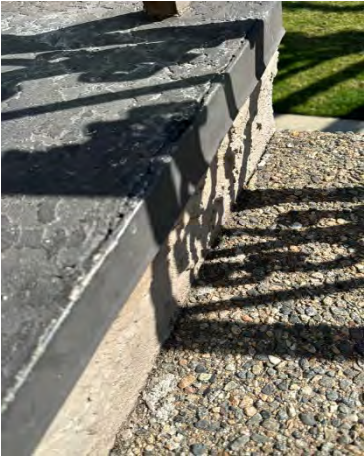
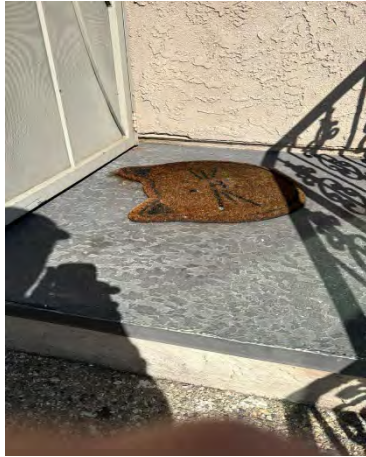
Exterior Elements	Decks, Railings, Integrations, Door Threshold, Stucco Interface
Water Proofing Elements	Flashings, Waterproofing, Coatings, Sealants
Visual Review	Bad
Any Visual Signs of leaks	Yes
Further Invasive Review Required	No
Condition Assessment	Fail
Additional Considerations or Concerns	Entry / Balcony / Walking Deck The deck is wood framed with waterproofing over the wood. Handrails are metal and attached to the deck surface and visually in good condition. The waterproofing is severely damaged. Replace or repair the waterproofing, including all damaged wood with new waterproofing and wood structures.
Life Expectancy (EEE)	1-4 Years
Life Expectancy (LBC)	1-4 Years
Life Expectancy (AWE)	0-1 Years

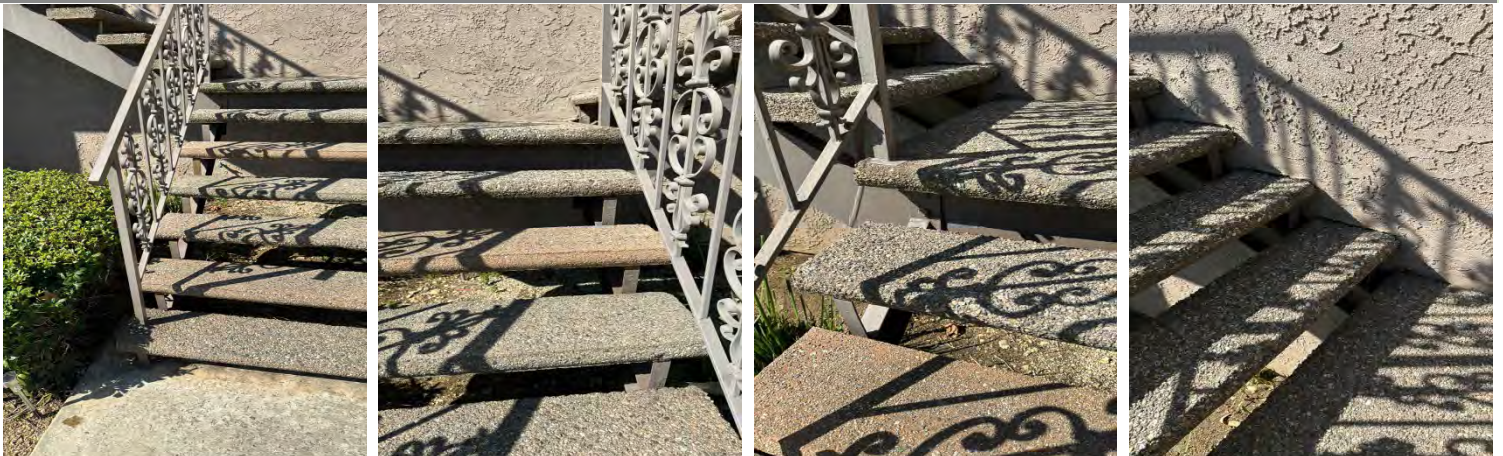
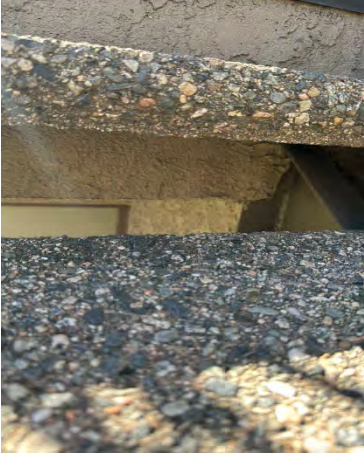
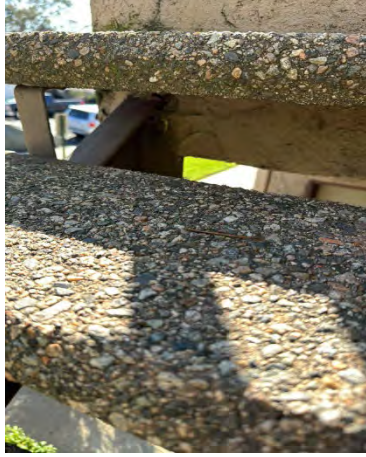
Building Name	2331
Apartment Name	26
Location Name	Stairs
Visual Report	
Exterior Elements	Stairs, Stairs Landing, Railings, Integrations
Water Proofing Elements	Flashings, Waterproofing, Coatings, Sealants
Visual Review	Good
Any Visual Signs of leaks	No
Further Invasive Review Required	No
Condition Assessment	Pass
Additional Considerations or Concerns	<p>Railing at concrete</p> <p>Stairs are steel stringers attached to a wood structure with concrete treads.</p> <p>The handrails are visually in good condition.</p>
Life Expectancy (EEE)	1-4 Years
Life Expectancy (LBC)	4-7 Years
Life Expectancy (AWE)	1-4 Years

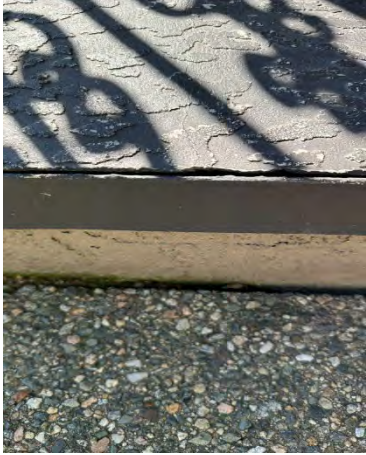
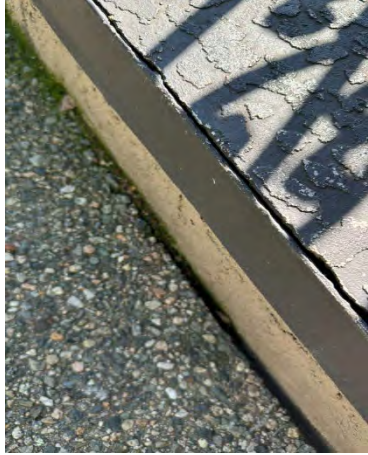
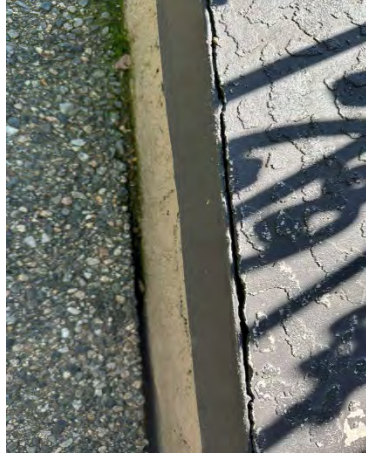
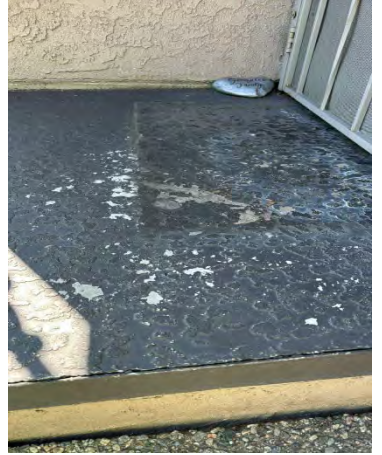
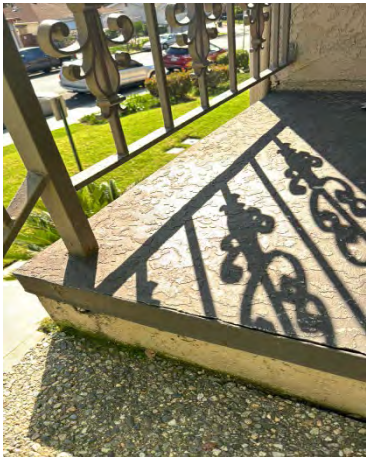
Building Name	2331
Apartment Name	26
Location Name	Entry deck
Visual Report	
Exterior Elements	Decks, Railings, Integrations, Door Threshold, Stucco Interface
Water Proofing Elements	Flashings, Waterproofing, Coatings, Sealants
Visual Review	Bad
Any Visual Signs of leaks	Yes
Further Invasive Review Required	No
Condition Assessment	Fail
Additional Considerations or Concerns	<p>Entry / Balcony / Walking Deck</p> <p>The deck is wood framed with waterproofing over the wood.</p> <p>Handrails are metal and attached to the deck surface and visually in good condition.</p> <p>The waterproofing is severely damaged. Replace or repair the waterproofing, including all damaged wood with new waterproofing and wood structures</p>
Life Expectancy (EEE)	1-4 Years
Life Expectancy (LBC)	1-4 Years
Life Expectancy (AWE)	0-1 Years

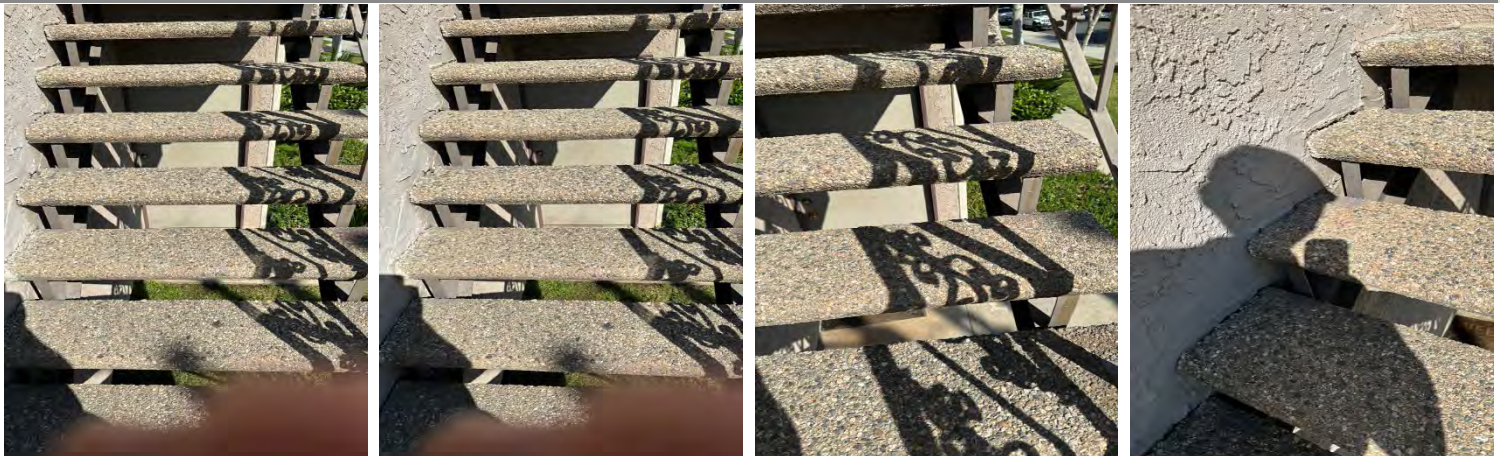
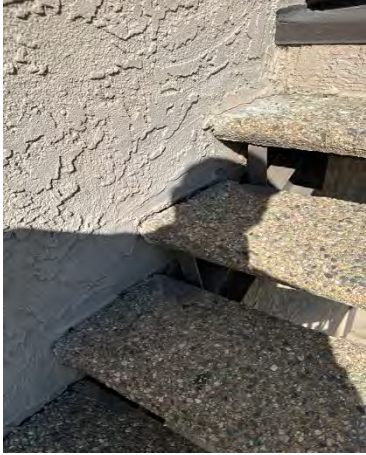
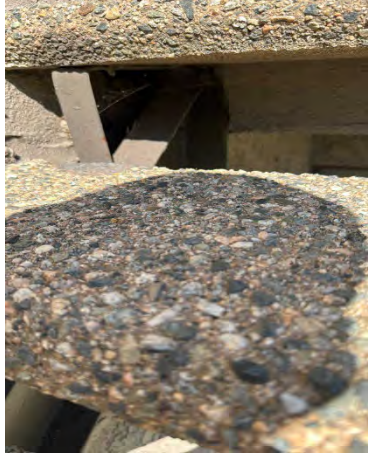
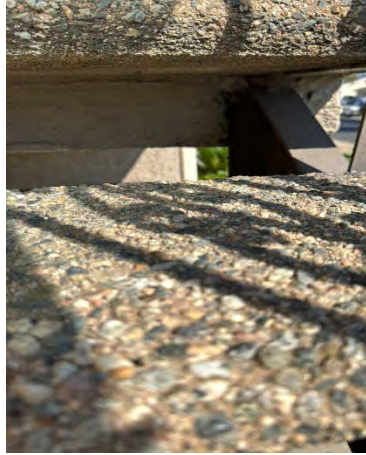
Building Name	2331
Apartment Name	27
Location Name	Stairs
Visual Report	
Exterior Elements	Stairs, Stairs Landing, Railings, Integrations
Water Proofing Elements	Flashings, Waterproofing, Coatings, Sealants
Visual Review	Good
Any Visual Signs of leaks	No
Further Invasive Review Required	No
Condition Assessment	Pass
Additional Considerations or Concerns	<p>Railing at concrete</p> <p>Stairs are steel stringers attached to a wood structure with concrete treads.</p> <p>The handrails are visually in good condition.</p>
Life Expectancy (EEE)	1-4 Years
Life Expectancy (LBC)	4-7 Years
Life Expectancy (AWE)	1-4 Years

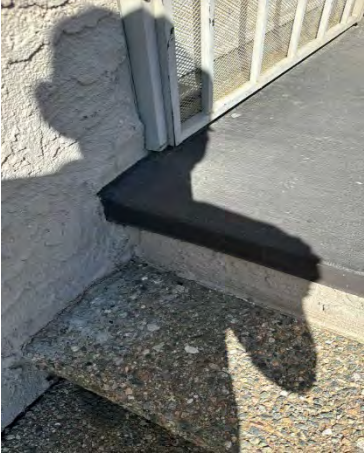
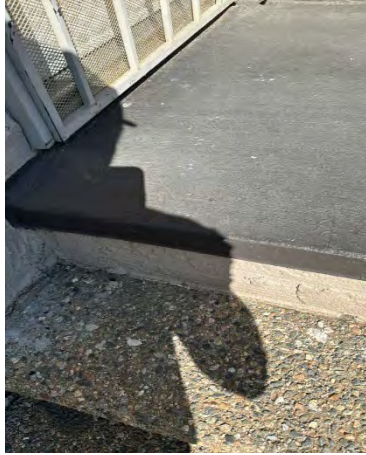
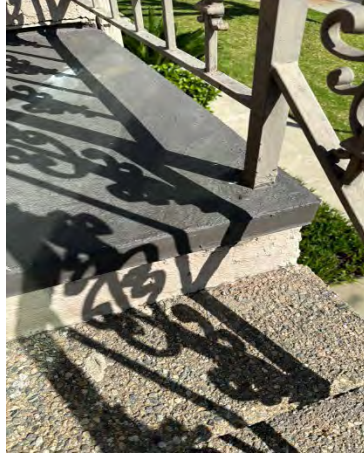
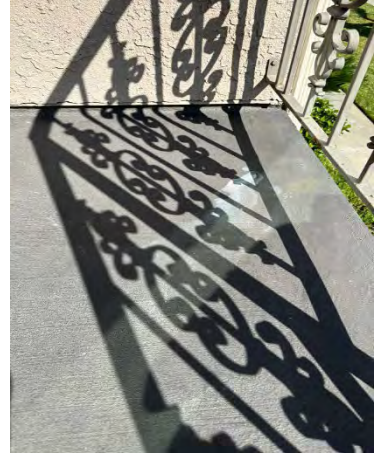
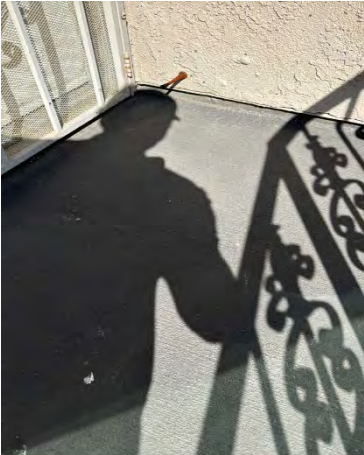
Building Name	2331
Apartment Name	27
Location Name	Entry deck
Visual Report	
Exterior Elements	Decks, Railings, Integrations, Door Threshold, Stucco Interface
Water Proofing Elements	Flashings, Waterproofing, Coatings, Sealants
Visual Review	Good
Any Visual Signs of leaks	No
Further Invasive Review Required	No
Condition Assessment	Pass
Additional Considerations or Concerns	<p>Entry / Balcony / Walking Deck</p> <p>The deck is wood framed with waterproofing over the wood.</p> <p>Handrails are metal and attached to the deck surface and visually in good condition.</p>
Life Expectancy (EEE)	1-4 Years
Life Expectancy (LBC)	1-4 Years
Life Expectancy (AWE)	1-4 Years
Visual Photos

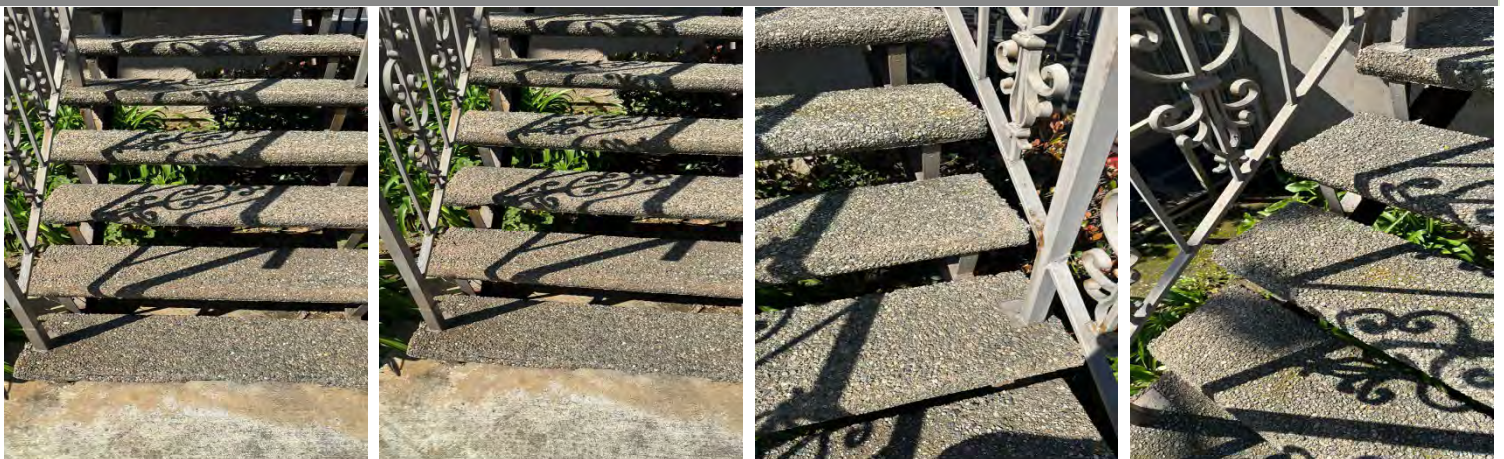
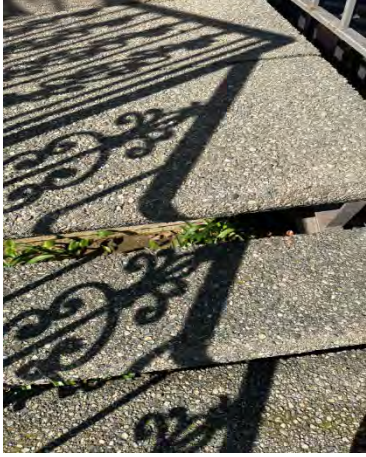
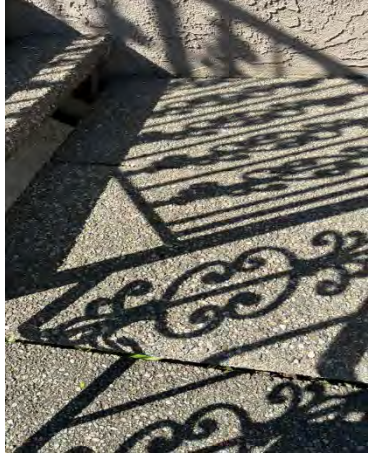
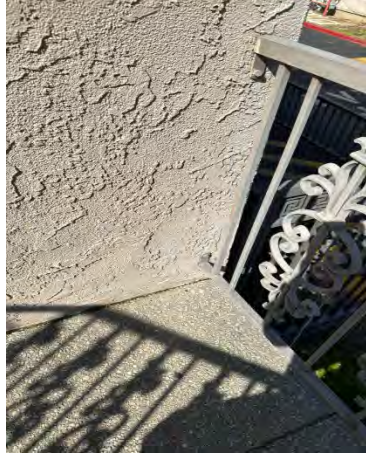
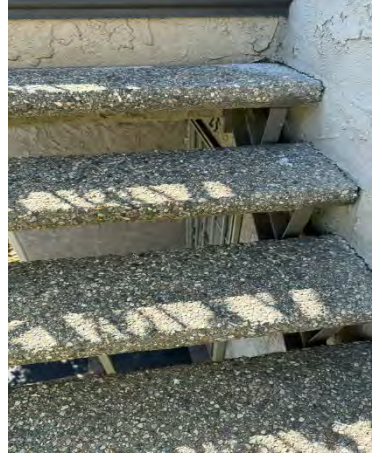
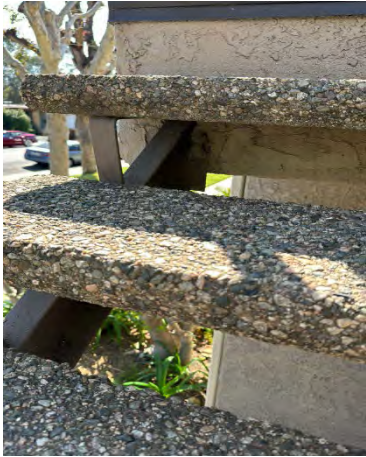
Building Name	2331
Apartment Name	24
Location Name	Stairs
Visual Report	
Exterior Elements	Stairs, Stairs Landing, Railings, Integrations
Water Proofing Elements	Flashings, Waterproofing, Coatings, Sealants
Visual Review	Good
Any Visual Signs of leaks	No
Further Invasive Review Required	No
Condition Assessment	Pass
Additional Considerations or Concerns	
Life Expectancy (EEE)	1-4 Years
Life Expectancy (LBC)	4-7 Years
Life Expectancy (AWE)	1-4 Years

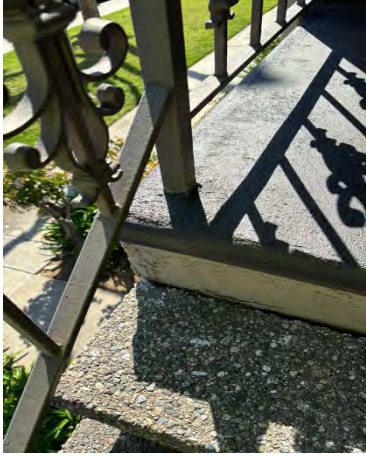
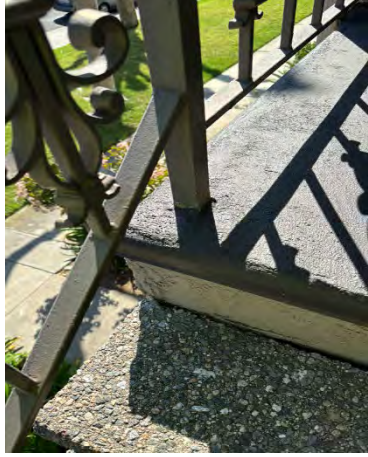
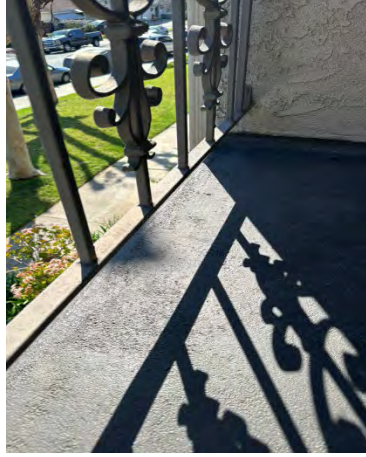
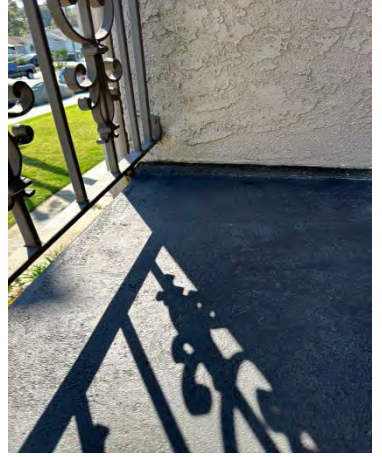
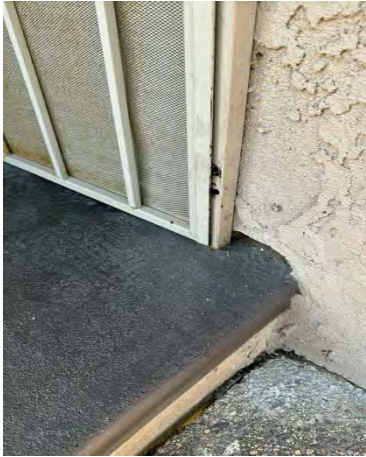
Building Name	2331
Apartment Name	24
Location Name	Entry deck
Visual Report	
Exterior Elements	Decks, Railings, Integrations, Door Threshold, Stucco Interface
Water Proofing Elements	Flashings, Waterproofing, Coatings, Sealants
Visual Review	Good
Any Visual Signs of leaks	No
Further Invasive Review Required	No
Condition Assessment	Pass
Additional Considerations or Concerns	<p>Entry / Balcony / Walking Deck</p> <p>The deck is wood framed with waterproofing over the wood.</p> <p>Handrails are metal and attached to the deck surface and visually in good condition.</p>
Life Expectancy (EEE)	1-4 Years
Life Expectancy (LBC)	4-7 Years
Life Expectancy (AWE)	1-4 Years
Visual Photos

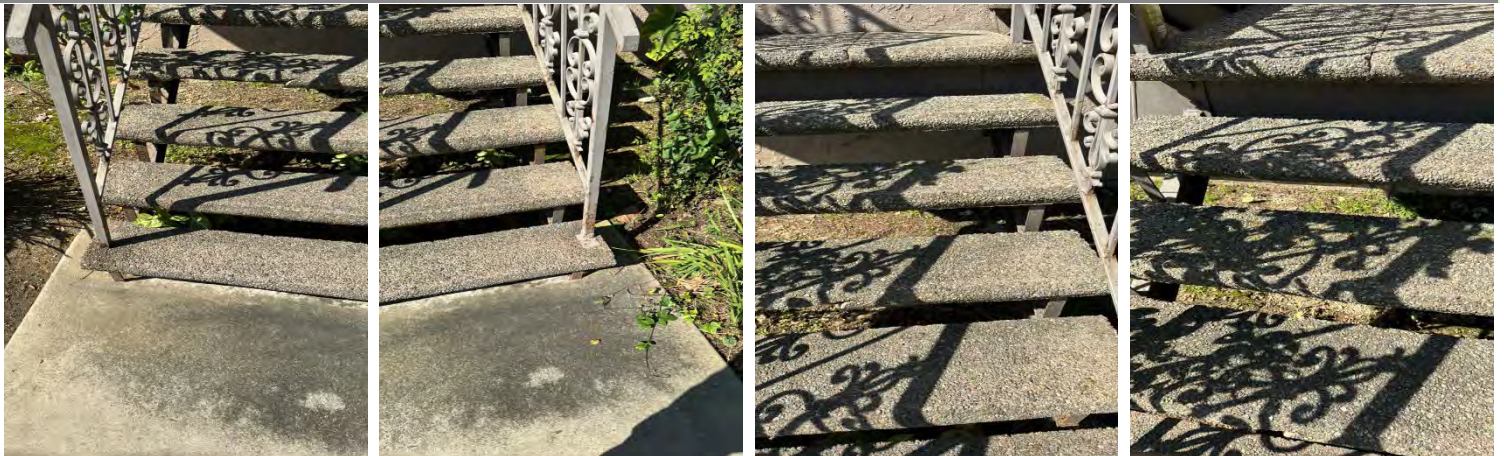
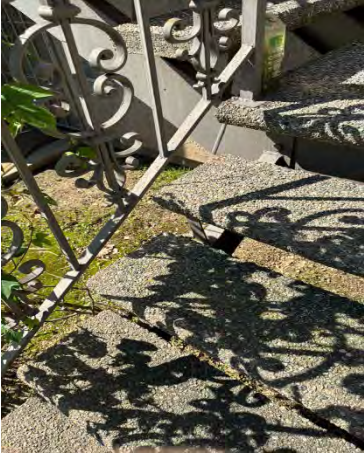
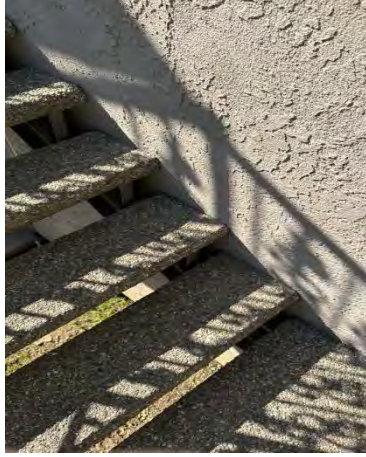
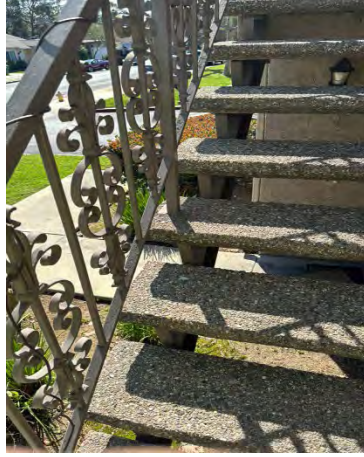
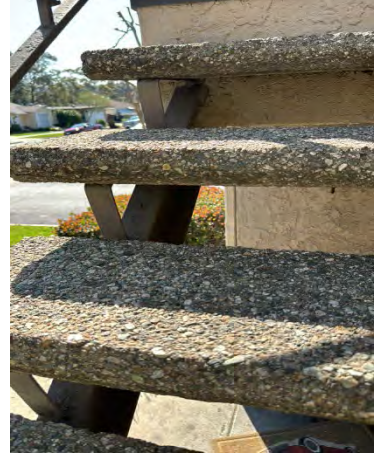
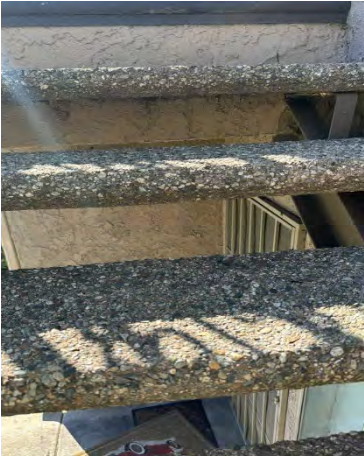
Exterior Elements	Stairs, Stairs Landing, Railings, Integrations
Water Proofing Elements	Flashings, Waterproofing, Coatings, Sealants
Visual Review	Good
Any Visual Signs of leaks	No
Further Invasive Review Required	No
Condition Assessment	Pass
Additional Considerations or Concerns	<p>Railing at concrete</p> <p>Stairs are steel stringers attached to a wood structure with concrete treads.</p> <p>The handrails are visually in good condition.</p>
Life Expectancy (EEE)	1-4 Years
Life Expectancy (LBC)	4-7 Years
Life Expectancy (AWE)	1-4 Years

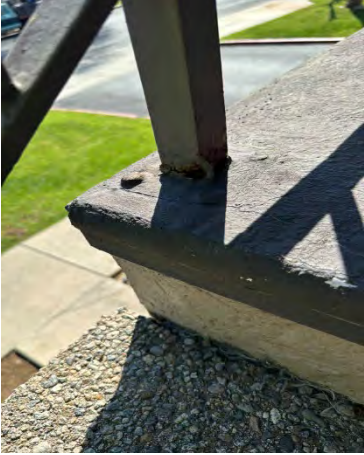
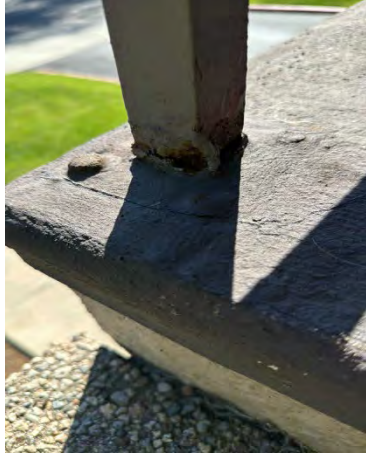
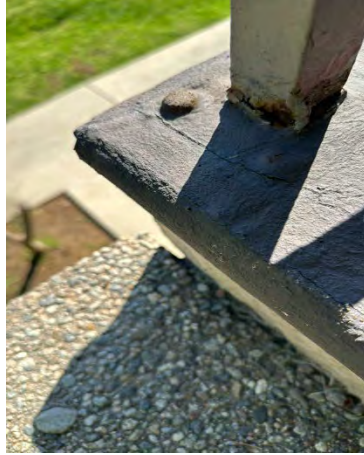
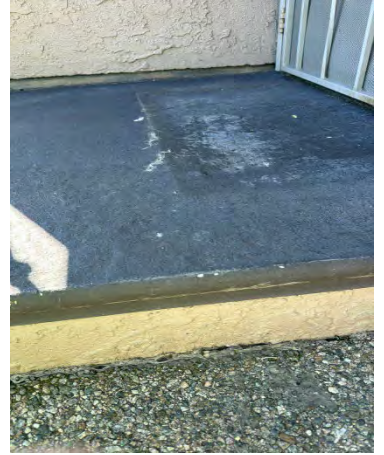
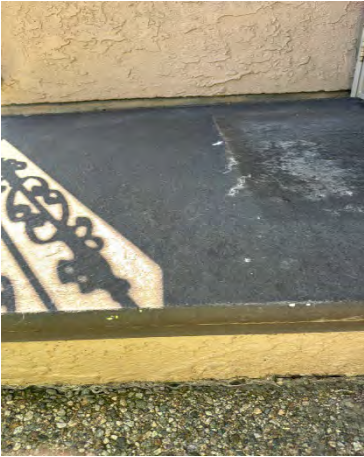
Building Name	2345-1
Apartment Name	22
Location Name	Entry deck
Visual Report	
Exterior Elements	Decks, Railings, Integrations, Door Threshold, Stucco Interface
Water Proofing Elements	Flashings, Waterproofing, Coatings, Sealants
Visual Review	Fair
Any Visual Signs of leaks	Yes
Further Invasive Review Required	No
Condition Assessment	Pass
Additional Considerations or Concerns	<p>Entry / Balcony / Walking Deck</p> <p>The deck is wood framed with waterproofing over the wood.</p> <p>Handrails are metal and attached to the deck surface and visually in good condition. Railing attachment needs to be repaired.</p>
Life Expectancy (EEE)	1-4 Years
Life Expectancy (LBC)	4-7 Years
Life Expectancy (AWE)	0-1 Years
Visual Photos

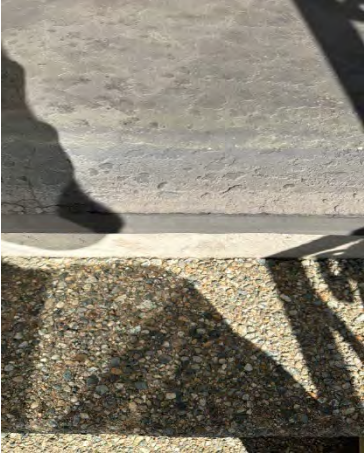
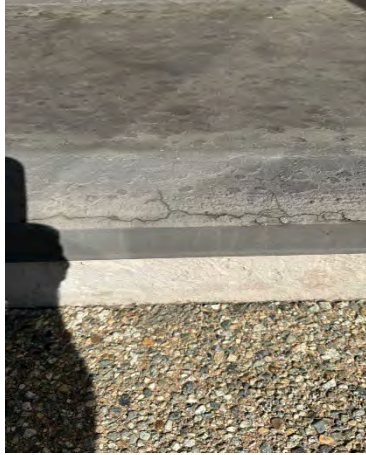
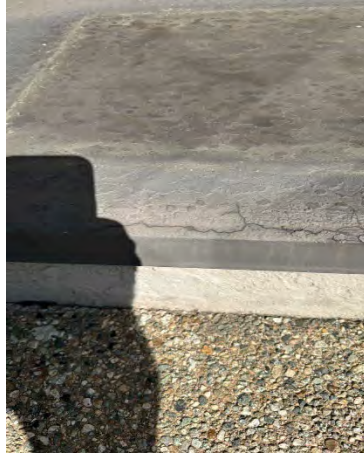
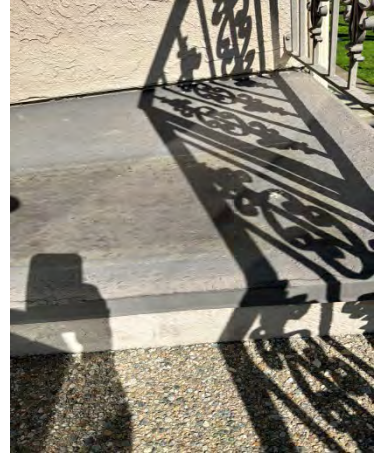
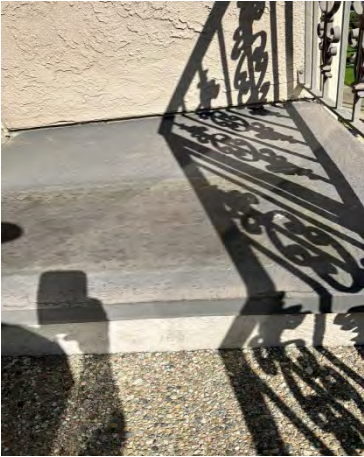
Exterior Elements	Decks, Railings, Integrations, Door Threshold, Stucco Interface
Water Proofing Elements	Flashings, Waterproofing, Coatings, Sealants
Visual Review	Bad
Any Visual Signs of leaks	Yes
Further Invasive Review Required	No
Condition Assessment	Fail
Additional Considerations or Concerns	Entry / Balcony / Walking Deck The deck is wood framed with waterproofing over the wood. Handrails are metal and attached to the deck surface and visually in good condition. The waterproofing is severely damaged. Replace or repair the waterproofing, including all damaged wood with new waterproofing and wood structures.
Life Expectancy (EEE)	1-4 Years
Life Expectancy (LBC)	4-7 Years
Life Expectancy (AWE)	0-1 Years

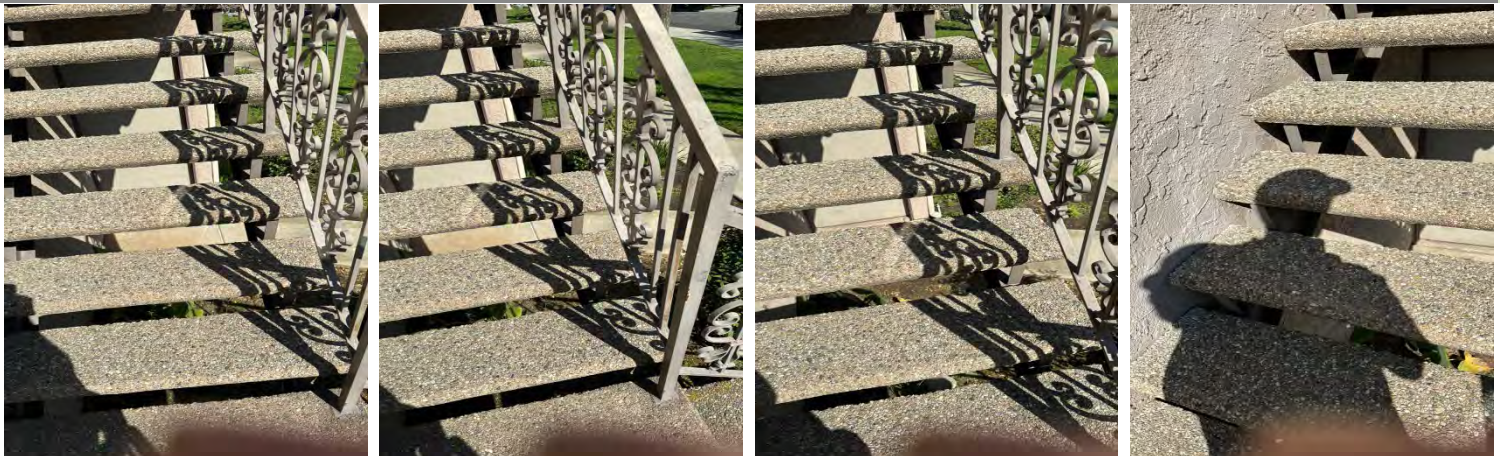
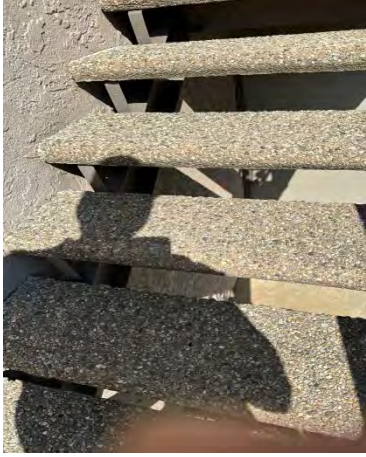
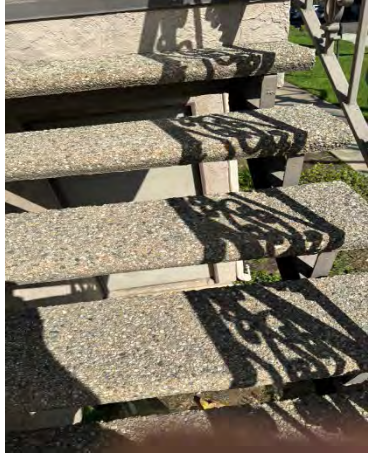
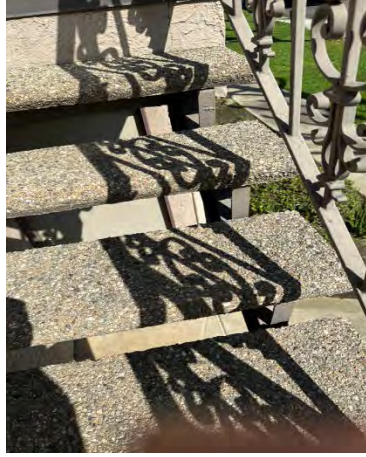
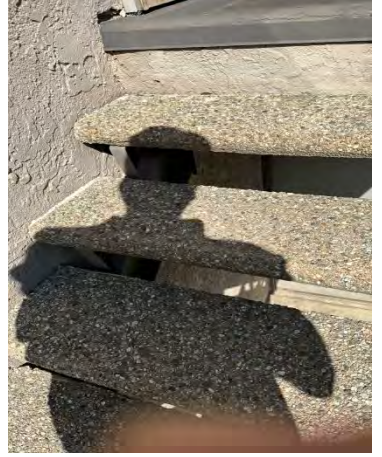
Building Name	2345-1
Apartment Name	20
Location Name	Stairs
Visual Report	
Exterior Elements	Railings, Porches/Entry, Stairs, Integrations
Water Proofing Elements	Flashings, Waterproofing, Coatings, Sealants
Visual Review	Good
Any Visual Signs of leaks	No
Further Invasive Review Required	No
Condition Assessment	Pass
Additional Considerations or Concerns	<p>Railing at concrete</p> <p>Stairs are steel stringers attached to a wood structure with concrete treads.</p> <p>The handrails are visually in good condition.</p>
Life Expectancy (EEE)	1-4 Years
Life Expectancy (LBC)	4-7 Years
Life Expectancy (AWE)	1-4 Years

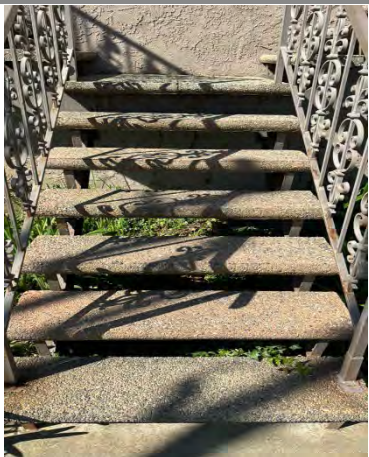
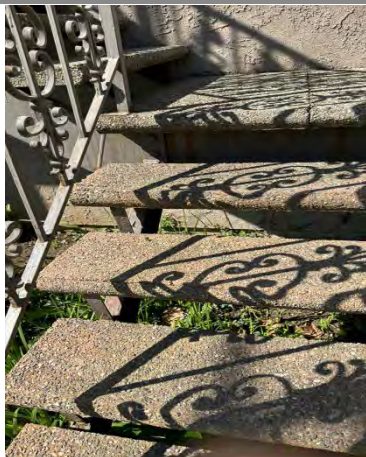
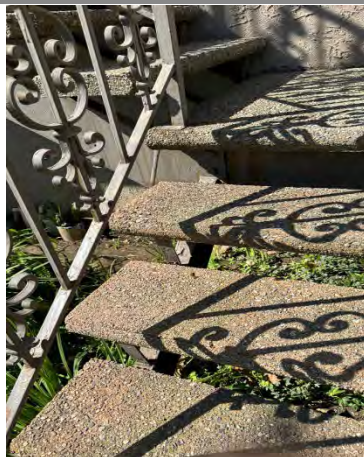
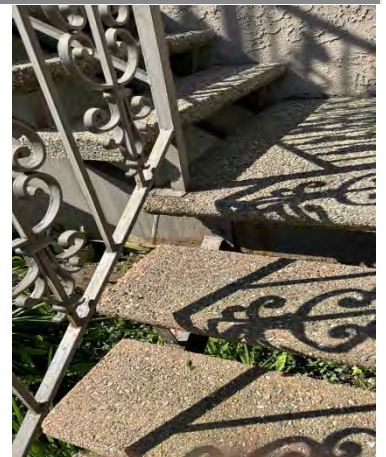
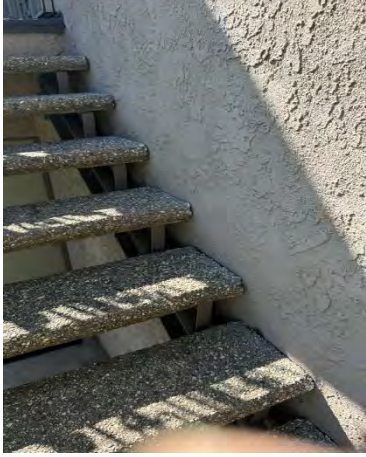
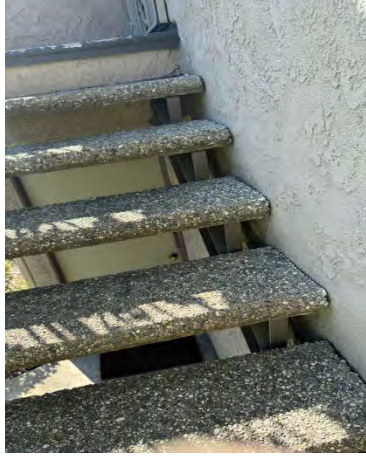
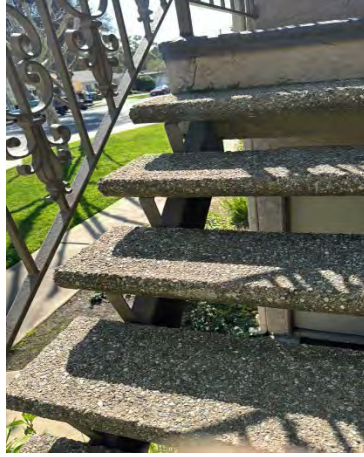
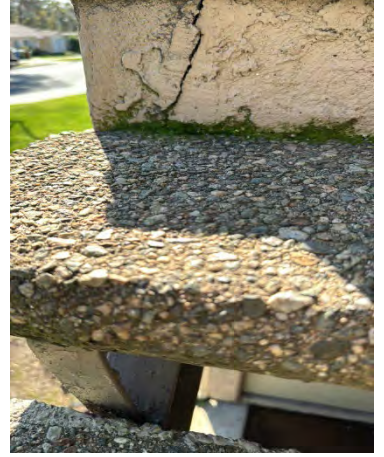
Building Name	2345-1
Apartment Name	19
Location Name	Stairs
Visual Report	
Exterior Elements	Stairs, Stairs Landing, Railings, Integrations
Water Proofing Elements	Flashings, Waterproofing, Coatings, Sealants
Visual Review	Good
Any Visual Signs of leaks	No
Further Invasive Review Required	No
Condition Assessment	Pass
Additional Considerations or Concerns	
Life Expectancy (EEE)	1-4 Years
Life Expectancy (LBC)	4-7 Years
Life Expectancy (AWE)	1-4 Years

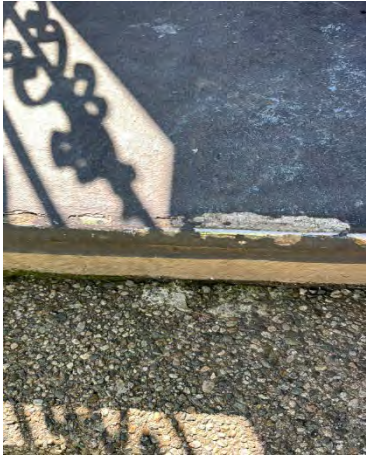
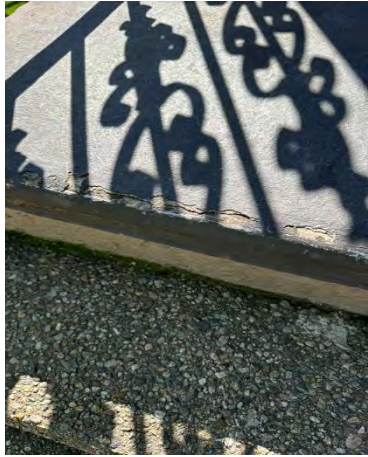
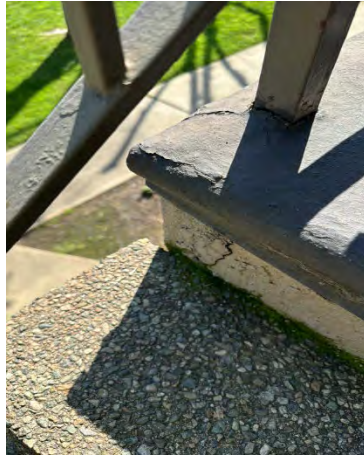
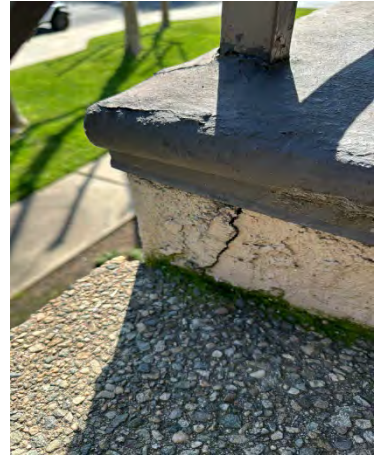
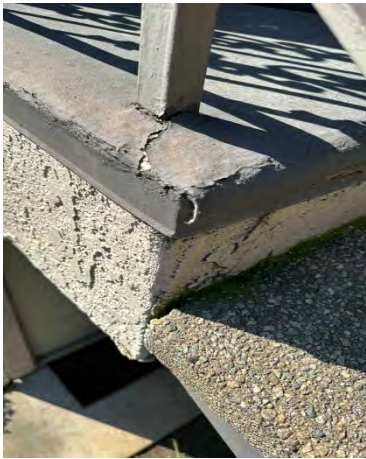
Exterior Elements	Decks, Railings, Integrations, Door Threshold, Stucco Interface
Water Proofing Elements	Flashings, Waterproofing, Coatings, Sealants
Visual Review	Bad
Any Visual Signs of leaks	Yes
Further Invasive Review Required	Yes
Condition Assessment	Fail
Additional Considerations or Concerns	<p>Cracks at the railing attachment to the rim joist. Entry / Balcony / Walking DeckThe deck is wood framed with waterproofing over the wood. Handrails are metal and attached to the deck surface and visually in good condition.</p> <p>The waterproofing is severely damaged. Replace or repair the waterproofing, including all damaged wood with new waterproofing and wood structures. Further investigation required.</p>
Life Expectancy (EEE)	0-1 Years
Life Expectancy (LBC)	0-1 Years
Life Expectancy (AWE)	0-1 Years
