REPORT OF VISUAL INSPECTION

An inspection ("Inspection") of the Exterior Elevated Elements ("EEE") listed in Annex 1 (attached report), their load-bearing components ("LBC"), and associated waterproofing elements ("AWE") was performed at the property and on the date indicated below:

Autumn Pointe HOA/ 55488 Dobbns St.	Los Angeles	CA	
Date of Inspection:	2/22/2024

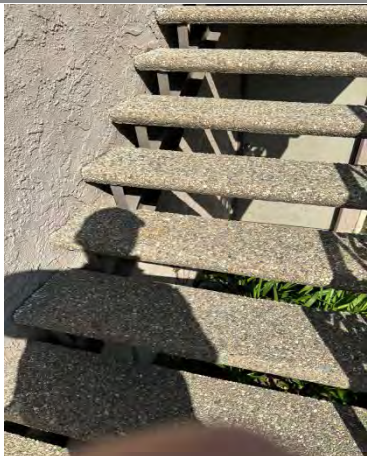
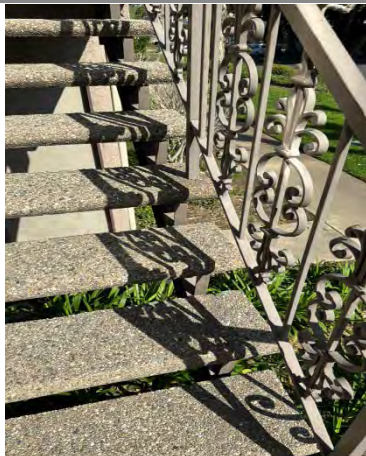
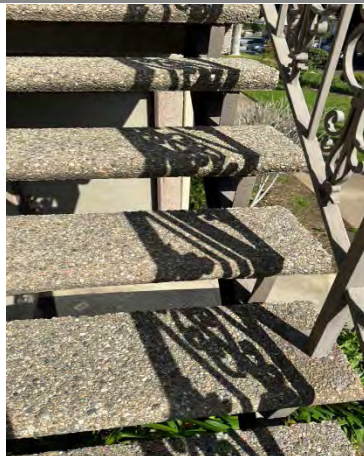
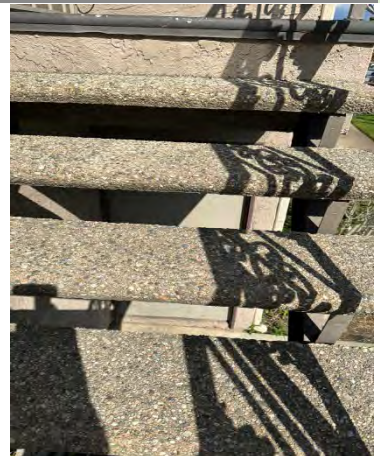
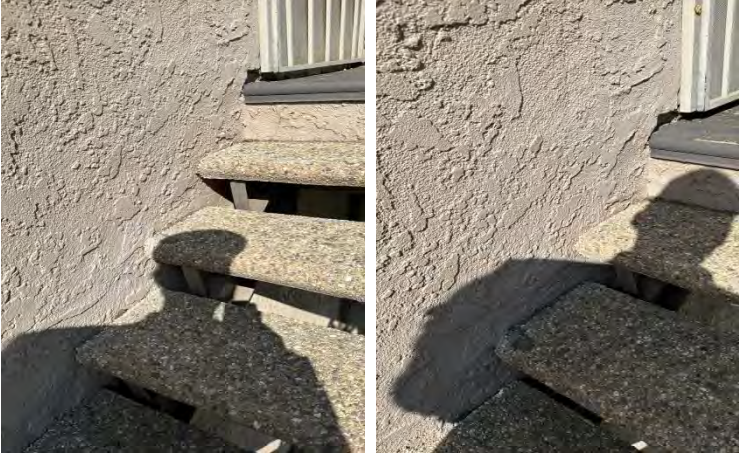
Exterior Elements	Stairs, Stairs Landing, Railings, Integrations
Water Proofing Elements	Flashings, Waterproofing, Coatings, Sealants
Visual Review	Good
Any Visual Signs of leaks	No
Further Invasive Review Required	No
Condition Assessment	Pass
Additional Considerations or Concerns	<p>Railing at concrete</p> <p>Stairs are steel stringers attached to a wood structure with concrete treads.</p> <p>The handrails are visually in good condition.</p>
Life Expectancy (EEE)	1-4 Years
Life Expectancy (LBC)	4-7 Years
Life Expectancy (AWE)	1-4 Years

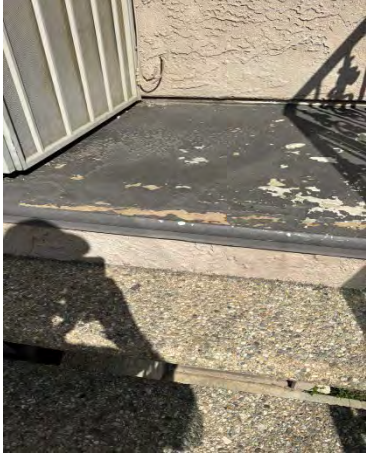
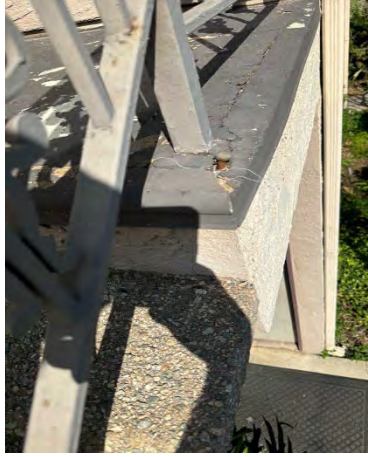
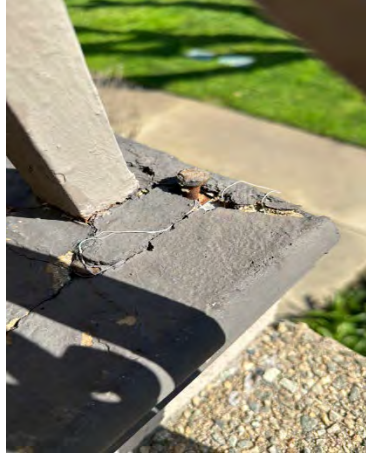
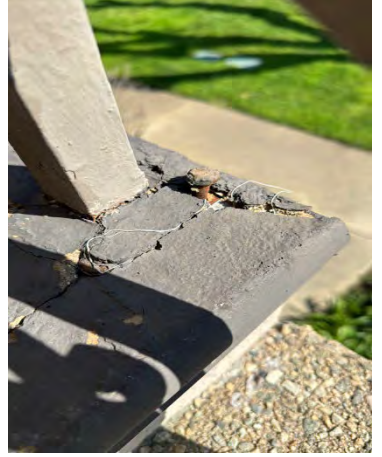
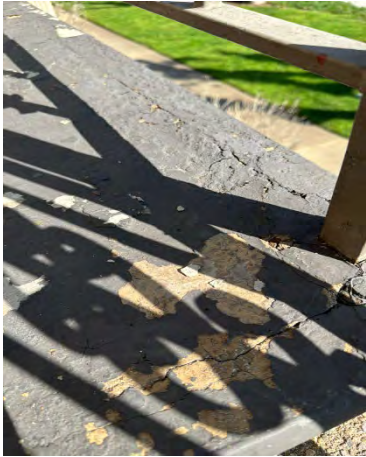
Exterior Elements	Decks, Railings, Door Threshold, Integrations, Stucco Interface
Water Proofing Elements	Flashings, Waterproofing, Coatings, Sealants
Visual Review	Bad
Any Visual Signs of leaks	Yes
Further Invasive Review Required	Yes
Condition Assessment	Fail
Additional Considerations or Concerns	Entry / Balcony / Walking Deck The deck is wood framed with waterproofing over the wood. Handrails are metal and attached to the deck surface and visually in poor condition. Plate fasteners backed out. Secure the plate attachment. The waterproofing is severely damaged. Replace or repair the waterproofing, including all damaged wood with new waterproofing and wood structures
Life Expectancy (EEE)	0-1 Years
Life Expectancy (LBC)	0-1 Years
Life Expectancy (AWE)	0-1 Years

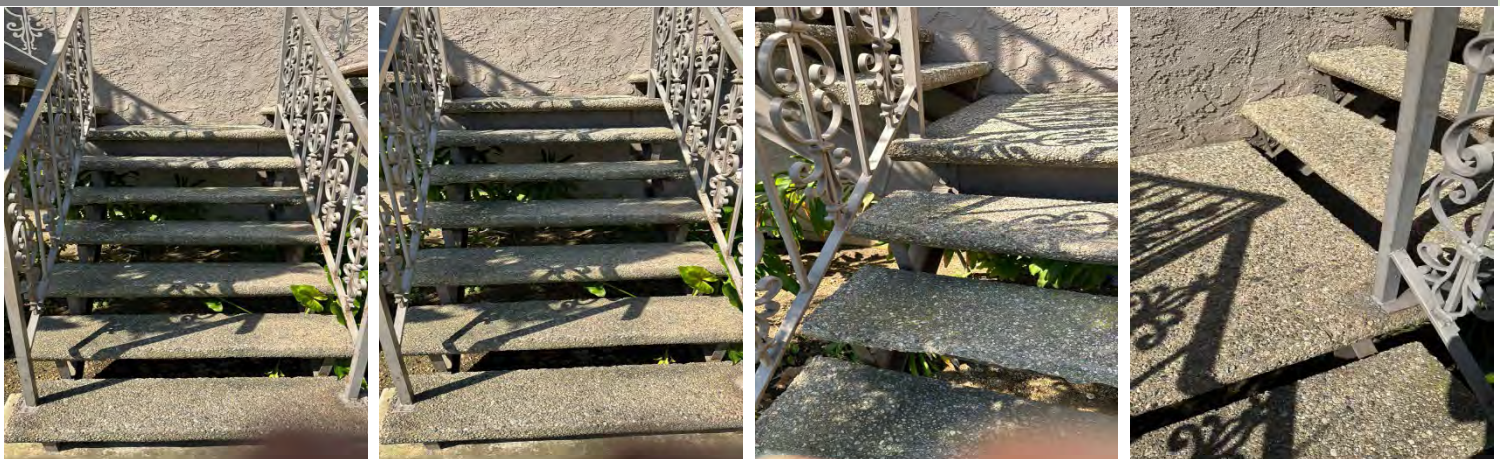
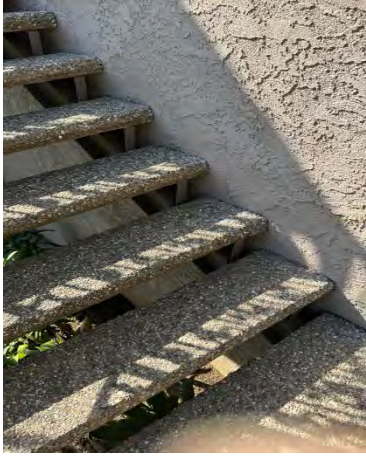
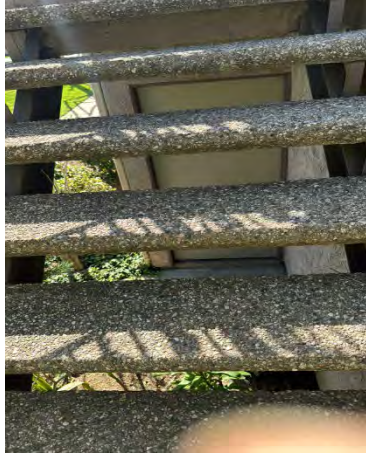
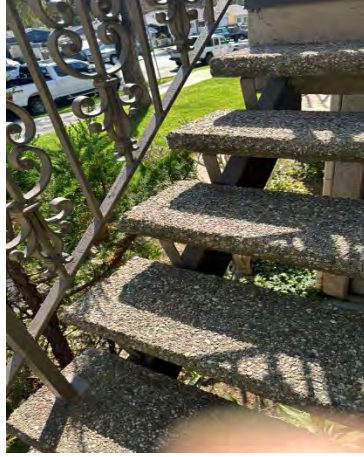
Exterior Elements	Decks, Stairs Landing, Railings, Integrations, Stairs
Water Proofing Elements	Flashings, Waterproofing, Coatings, Sealants
Visual Review	Good
Any Visual Signs of leaks	No
Further Invasive Review Required	No
Condition Assessment	Pass
Additional Considerations or Concerns	None
Life Expectancy (EEE)	1-4 Years
Life Expectancy (LBC)	4-7 Years
Life Expectancy (AWE)	1-4 Years

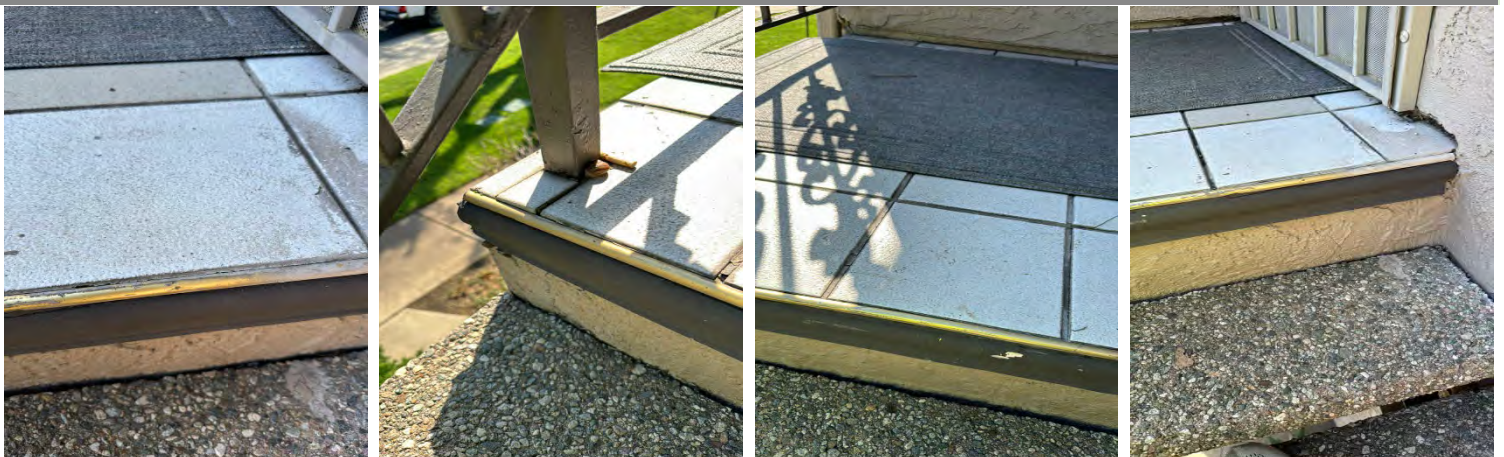
Exterior Elements	Decks, Railings, Integrations, Door Threshold, Stucco Interface
Water Proofing Elements	Flashings, Waterproofing, Coatings, Sealants
Visual Review	Bad
Any Visual Signs of leaks	Yes
Further Invasive Review Required	Yes
Condition Assessment	Fail
Additional Considerations or Concerns	<p>Deck has tile overlay which appears to be failing. Tile is loose. Waterproofing is failed.</p> <p>Remove tile, replace with waterproof deck coating. Further investigation required.</p>
Life Expectancy (EEE)	0-1 Years
Life Expectancy (LBC)	0-1 Years
Life Expectancy (AWE)	0-1 Years

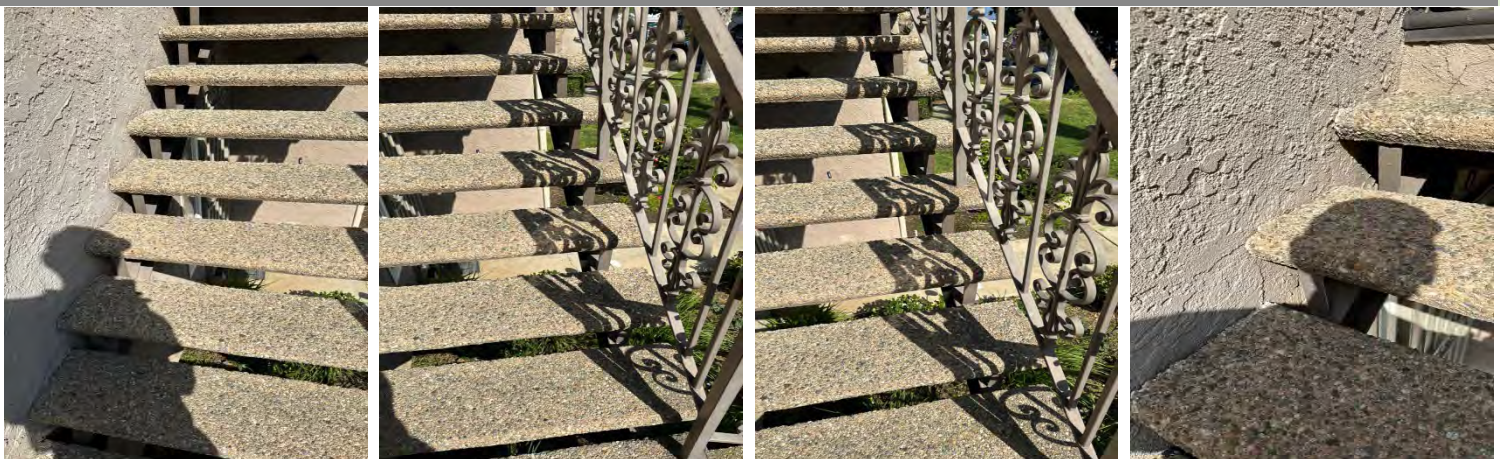
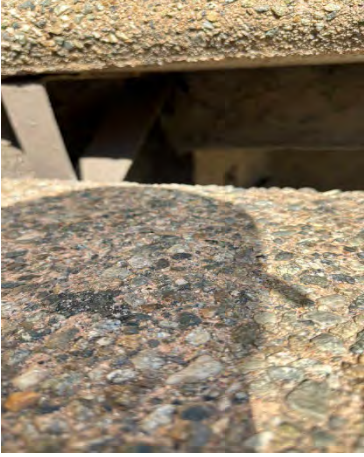
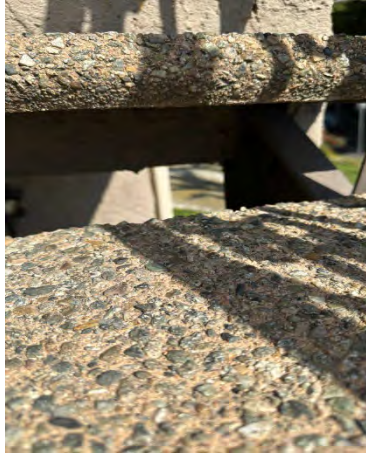
Exterior Elements	Stairs, Stairs Landing, Railings, Integrations
Water Proofing Elements	Flashings, Waterproofing, Coatings, Sealants
Visual Review	Good
Any Visual Signs of leaks	No
Further Invasive Review Required	No
Condition Assessment	Pass
Additional Considerations or Concerns	
Life Expectancy (EEE)	1-4 Years
Life Expectancy (LBC)	4-7 Years
Life Expectancy (AWE)	1-4 Years

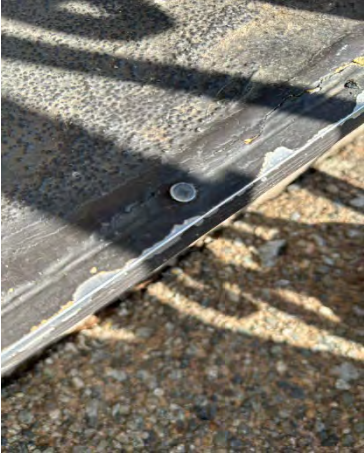
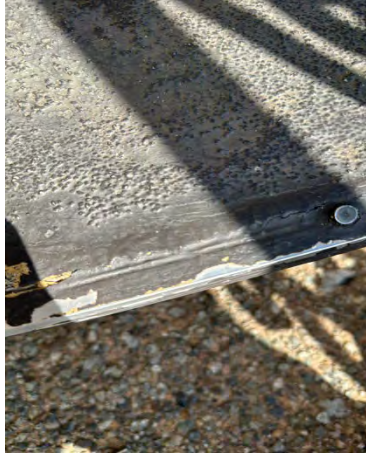
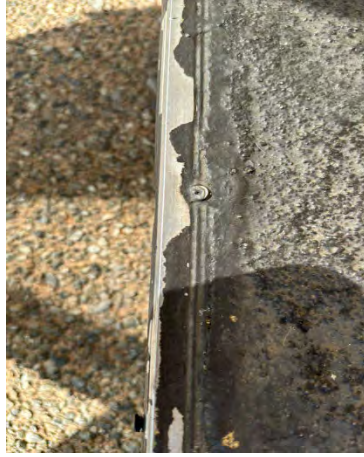
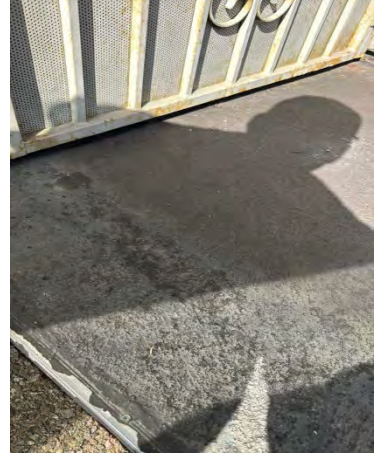
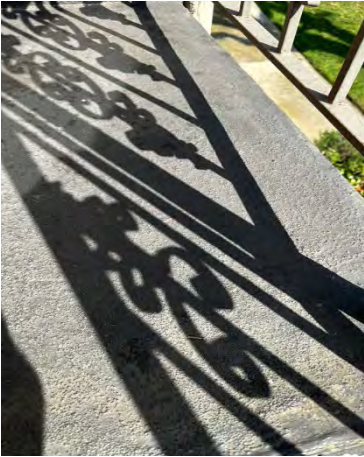
Building Name	2345-1
Apartment Name	16
Location Name	Entry deck
Visual Report	
Exterior Elements	Decks, Stucco Interface, Door Threshold, Integrations
Water Proofing Elements	Flashings, Waterproofing, Coatings, Sealants
Visual Review	Bad
Any Visual Signs of leaks	Yes
Further Invasive Review Required	No
Condition Assessment	Fail
Additional Considerations or Concerns	<p>Entry / Balcony / Walking Deck</p> <p>The deck is wood framed with waterproofing over the wood.</p> <p>Handrails are metal and attached to the deck surface and visually in good condition.</p> <p>The waterproofing is severely damaged. Replace or repair the waterproofing, including all damaged wood with new waterproofing and wood structures.</p>
Life Expectancy (EEE)	1-4 Years
Life Expectancy (LBC)	4-7 Years
Life Expectancy (AWE)	0-1 Years

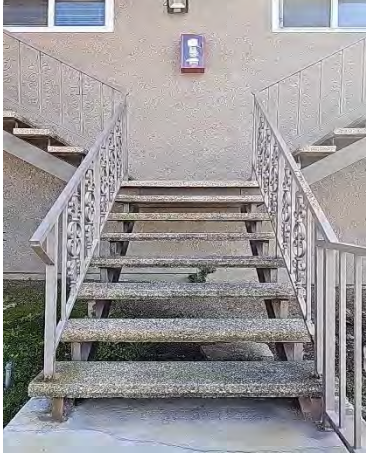
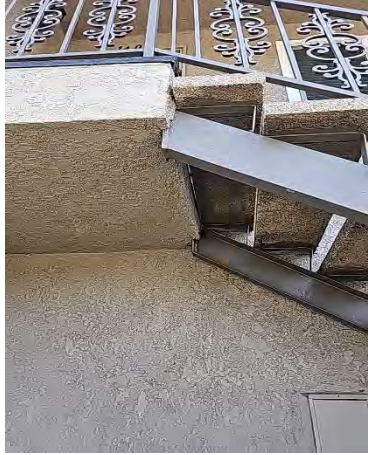
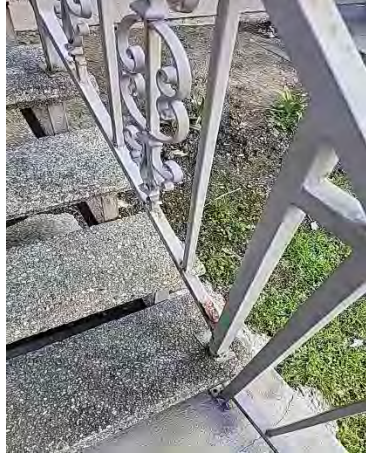
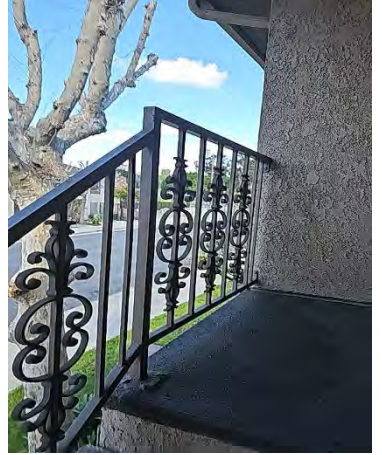
Building Name	2324-2
Building Common Name	140
Location Name	Stairs
Visual Report	
Exterior Elements	Stairs, Railings, Integrations, Stucco Interface
Water Proofing Elements	Flashings, Waterproofing, Coatings, Sealants
Visual Review	Good
Any Visual Signs of leaks	No
Further Invasive Review Required	No
Condition Assessment	Pass
Additional Considerations or Concerns	<p>Railing at concrete</p> <p>Stairs are steel stringers attached to a wood structure with concrete treads.</p> <p>The handrails are visually in good condition.</p> <p>The railing attachment to the concrete structure is rusted. Repair as necessary to ensure a solid rust-free attachment.</p>
Life Expectancy (EEE)	0-1 Years
Life Expectancy (LBC)	1-4 Years
Life Expectancy (AWE)	1-4 Years
Visual Photos

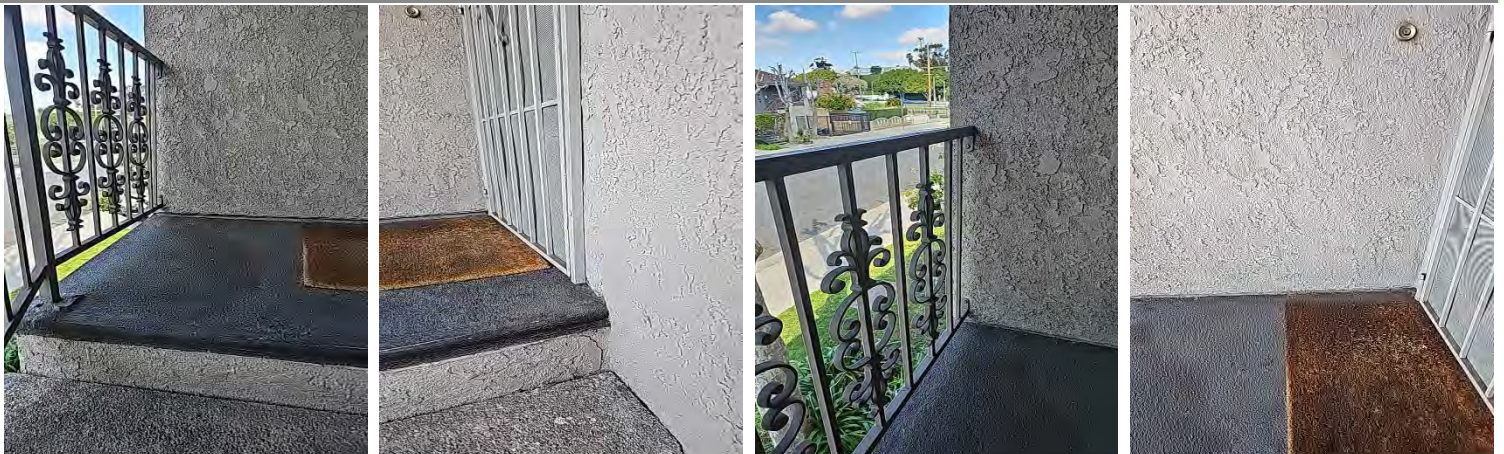
Exterior Elements	Railings, Integrations, Stucco Interface, Decks
Water Proofing Elements	Flashings, Waterproofing, Coatings, Sealants
Visual Review	Fair
Any Visual Signs of leaks	No
Further Invasive Review Required	No
Condition Assessment	Pass
Additional Considerations or Concerns	<p>Entry / Balcony / Walking Deck</p> <p>The deck is wood framed with waterproofing over the wood.</p> <p>Handrails are metal and attached to the deck surface and visually in good condition.</p>
Life Expectancy (EEE)	1-4 Years
Life Expectancy (LBC)	1-4 Years
Life Expectancy (AWE)	1-4 Years

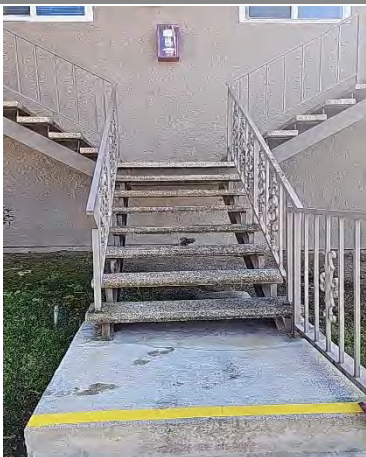
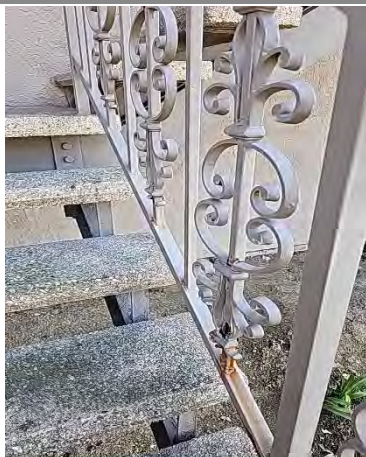
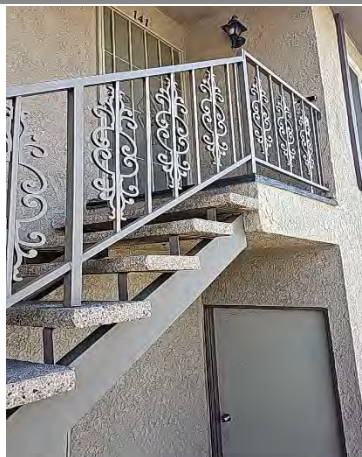
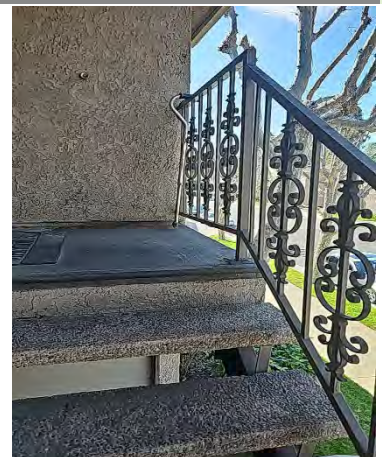
Exterior Elements	Stairs, Stairs Landing, Railings, Integrations, Stucco Interface
Water Proofing Elements	Flashings, Waterproofing, Coatings, Sealants
Visual Review	Good
Any Visual Signs of leaks	No
Further Invasive Review Required	No
Condition Assessment	Pass
Additional Considerations or Concerns	Surface rust on handrails.
Life Expectancy (EEE)	1-4 Years
Life Expectancy (LBC)	1-4 Years
Life Expectancy (AWE)	1-4 Years

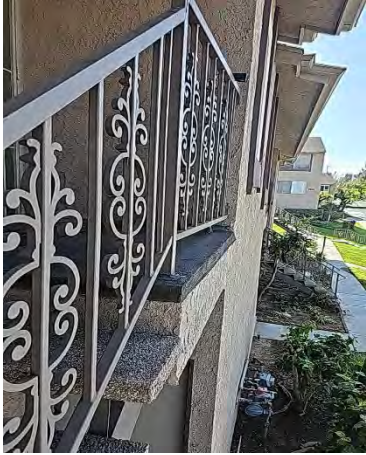
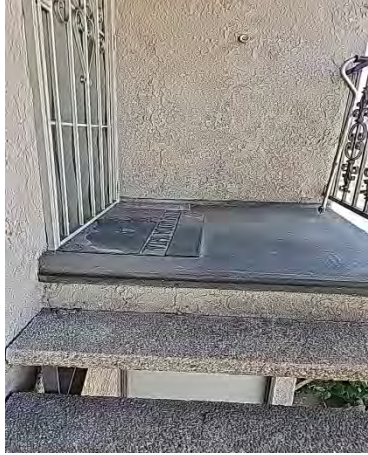
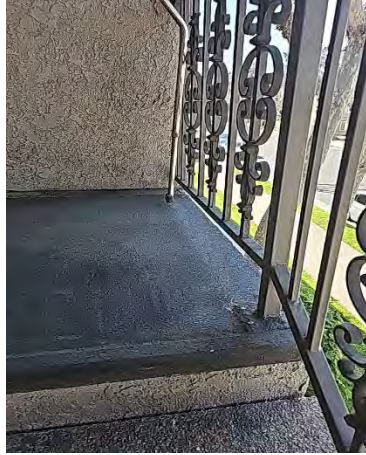
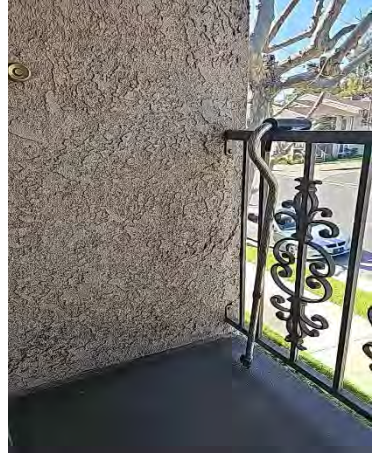
Building Name	2324-2
Building Common Name	141
Location Name	Entry deck
Visual Report	
Exterior Elements	Decks, Porches/Entry, Railings, Integrations, Stucco Interface
Water Proofing Elements	Flashings, Waterproofing, Coatings, Sealants
Visual Review	Fair
Any Visual Signs of leaks	No
Further Invasive Review Required	No
Condition Assessment	Pass
Additional Considerations or Concerns	<p>Entry / Balcony / Walking Deck</p> <p>The deck is wood framed with waterproofing over the wood.</p> <p>Handrails are metal and attached to the deck surface and visually in good condition.</p>
Life Expectancy (EEE)	1-4 Years
Life Expectancy (LBC)	1-4 Years
Life Expectancy (AWE)	1-4 Years
Visual Photos

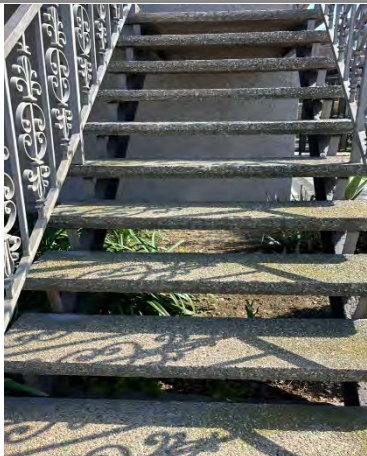
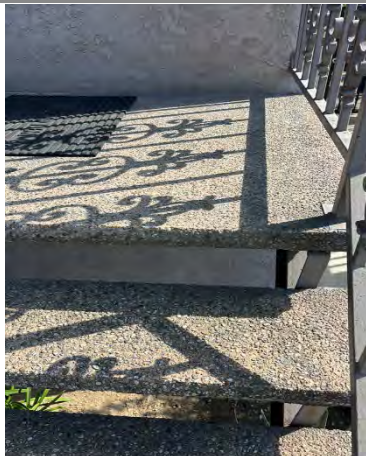
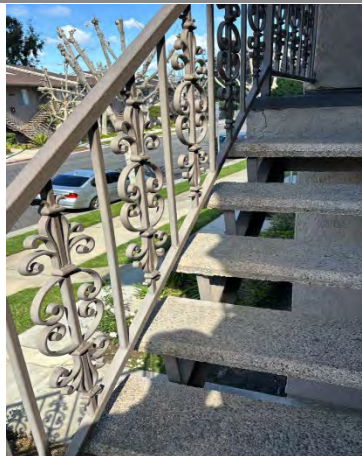
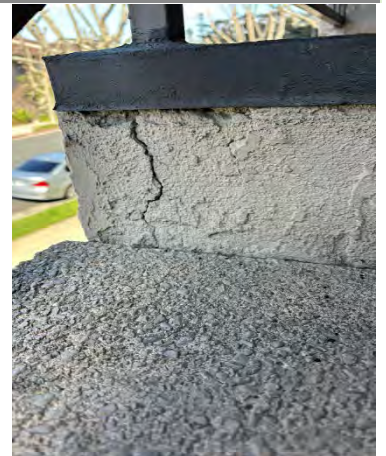
Building Name	2324
Apartment Name	145
Location Name	Stairs
Visual Report	
Exterior Elements	Stairs, Stairs Landing
Water Proofing Elements	Flashings, Waterproofing, Coatings, Sealants
Visual Review	Good
Any Visual Signs of leaks	No
Further Invasive Review Required	No
Condition Assessment	Pass
Additional Considerations or Concerns	<p>Railing at concrete</p> <p>Stairs are steel stringers attached to a wood structure with concrete treads.</p> <p>The handrails are visually in good condition.</p>
Life Expectancy (EEE)	1-4 Years
Life Expectancy (LBC)	4-7 Years
Life Expectancy (AWE)	1-4 Years

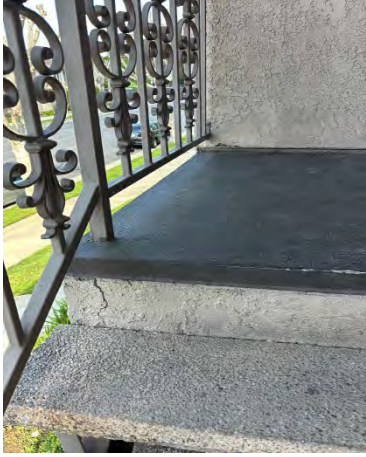
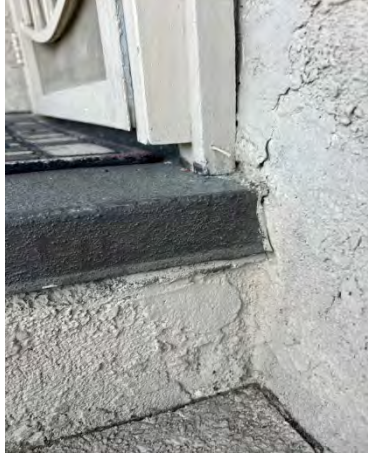
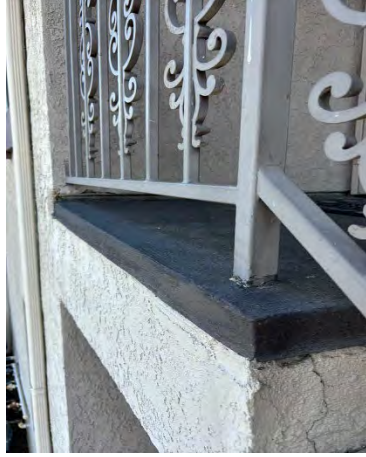
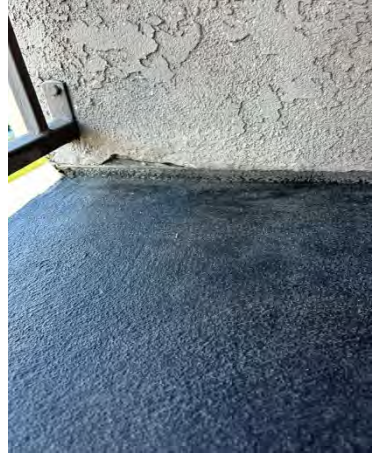
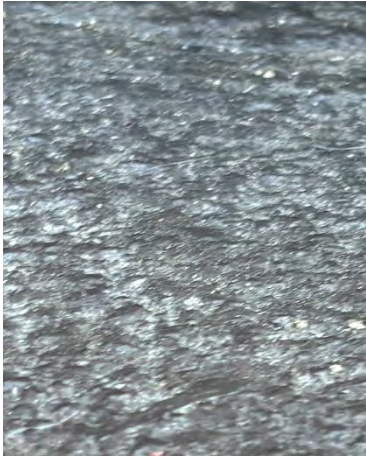
Building Name	2324
Apartment Name	145
Location Name	Entry deck
Visual Report	
Exterior Elements	Porches/Entry, Railings, Integrations, Door Threshold, Stucco Interface
Water Proofing Elements	Flashings, Waterproofing, Coatings, Sealants
Visual Review	Fair
Any Visual Signs of leaks	No
Further Invasive Review Required	No
Condition Assessment	Pass
Additional Considerations or Concerns	<p>Entry / Balcony / Walking Deck</p> <p>The deck is wood framed with waterproofing over the wood.</p> <p>Handrails are metal and attached to the deck surface and visually in good condition</p>
Life Expectancy (EEE)	1-4 Years
Life Expectancy (LBC)	4-7 Years
Life Expectancy (AWE)	1-4 Years
Visual Photos

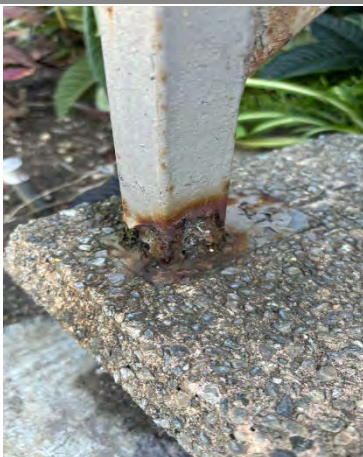
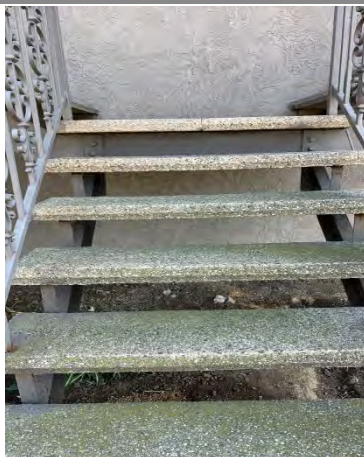
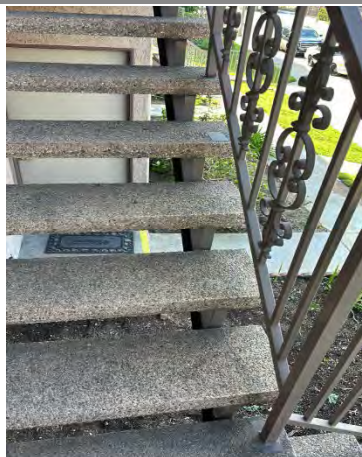
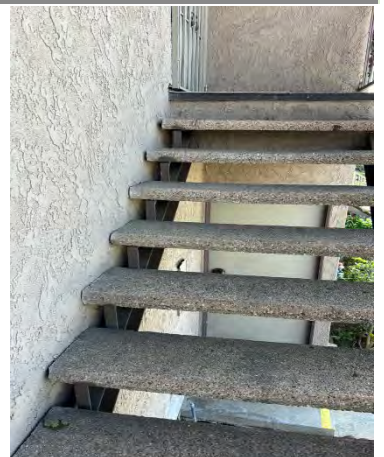
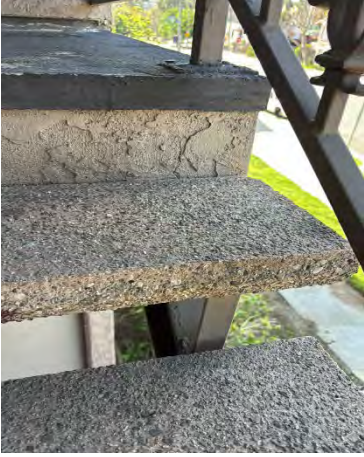
Exterior Elements	Stairs, Stairs Landing, Stucco Interface
Water Proofing Elements	Flashings, Waterproofing, Coatings, Sealants
Visual Review	Fair
Any Visual Signs of leaks	No
Further Invasive Review Required	No
Condition Assessment	Pass
Additional Considerations or Concerns	Handrail attachments at the bottom are severely corroded. Recommend repair.
Life Expectancy (EEE)	0-1 Years
Life Expectancy (LBC)	1-4 Years
Life Expectancy (AWE)	1-4 Years

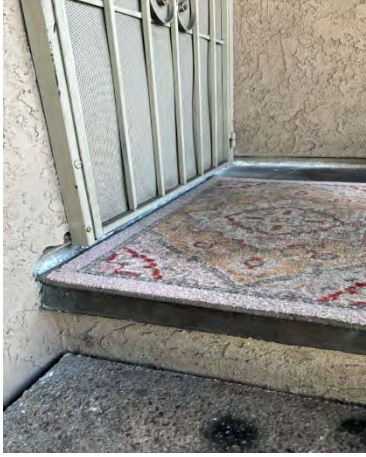
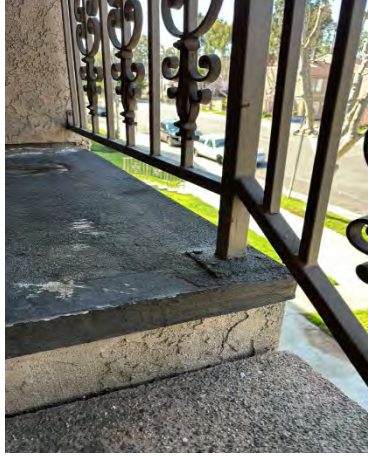
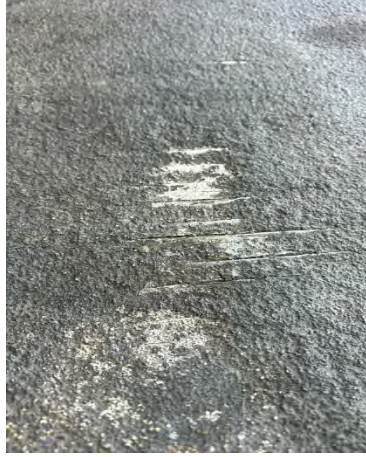
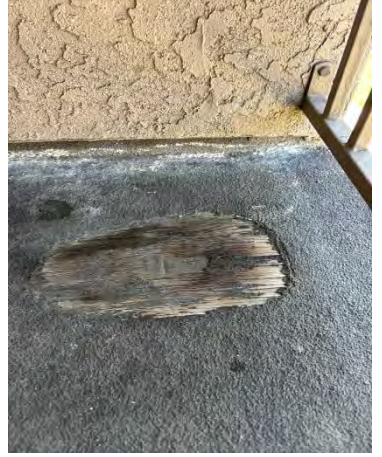
Building Name	2324
Apartment Name	143
Location Name	entry deck
Visual Report	
Exterior Elements	Decks, Integrations, Door Threshold, Stucco Interface
Water Proofing Elements	Flashings, Waterproofing, Coatings, Sealants
Visual Review	Bad
Any Visual Signs of leaks	Yes
Further Invasive Review Required	Yes
Condition Assessment	Future Inspection
Additional Considerations or Concerns	<p>Entry / Balcony / Walking Deck</p> <p>The deck is wood framed with waterproofing over the wood.</p> <p>Handrails are metal and attached to the deck surface and visually in good condition.</p> <p>The waterproofing is severely damaged. Replace or repair the waterproofing, including all damaged wood with new waterproofing and wood structures.</p>
Life Expectancy (EEE)	0-1 Years
Life Expectancy (LBC)	0-1 Years
Life Expectancy (AWE)	0-1 Years

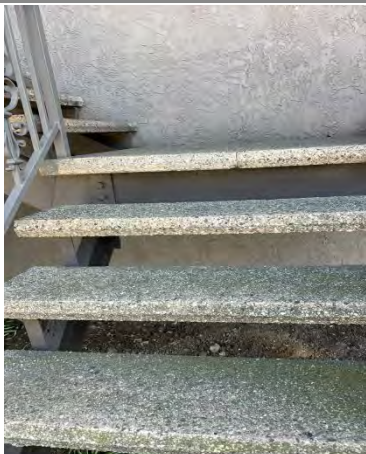
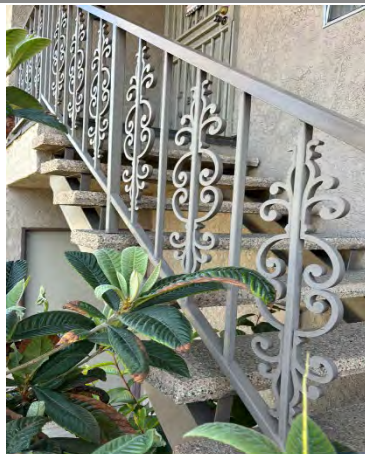
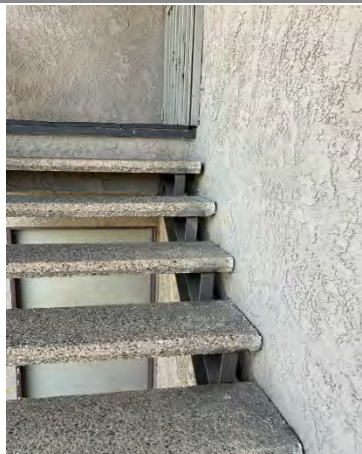
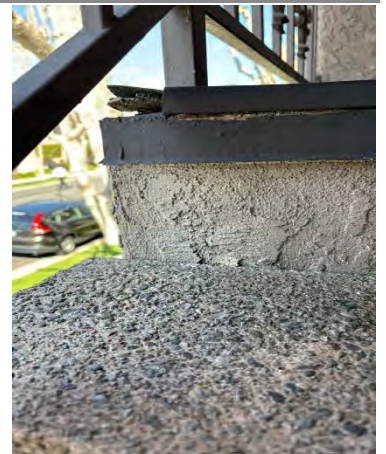
Exterior Elements	Stairs, Stairs Landing, Integrations, Railings, Stucco Interface
Water Proofing Elements	Flashings, Waterproofing, Coatings, Sealants
Visual Review	Good
Any Visual Signs of leaks	No
Further Invasive Review Required	No
Condition Assessment	Pass
Additional Considerations or Concerns	<p>Railing at concrete</p> <p>Stairs are steel stringers attached to a wood structure with concrete treads.</p> <p>The handrails are visually in good condition.</p>
Life Expectancy (EEE)	1-4 Years
Life Expectancy (LBC)	4-7 Years
Life Expectancy (AWE)	1-4 Years

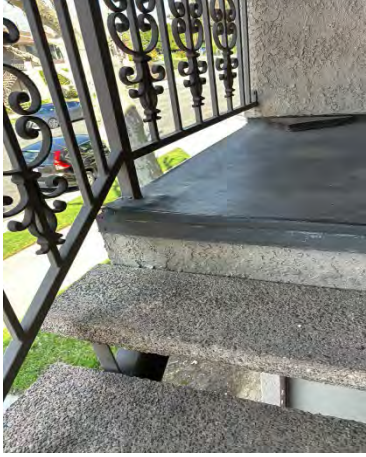
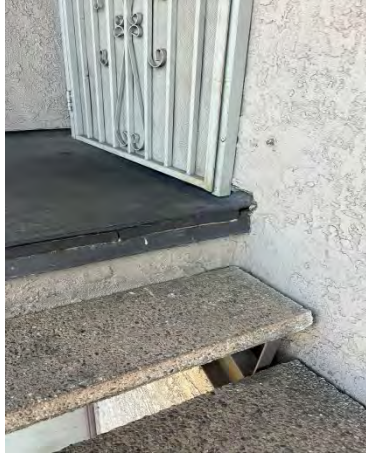
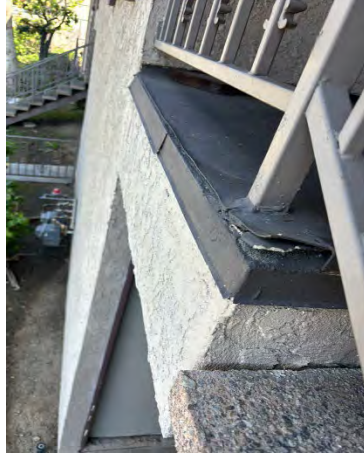
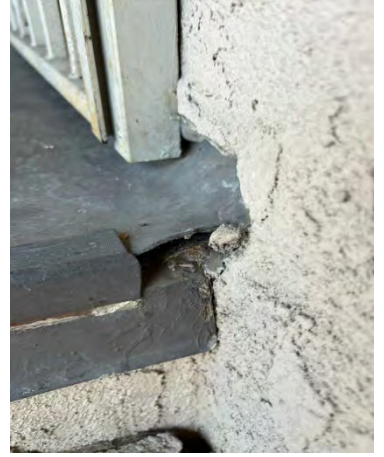
Exterior Elements	Porches/Entry, Railings, Integrations, Door Threshold, Stucco Interface
Water Proofing Elements	Flashings, Waterproofing, Coatings, Sealants
Visual Review	Bad
Any Visual Signs of leaks	No
Further Invasive Review Required	Yes
Condition Assessment	Fail
Additional Considerations or Concerns	Entry / Balcony / Walking Deck The deck is wood framed with waterproofing over the wood. Handrails are metal and attached to the deck surface and visually in good condition. Further investigation required. The waterproofing is severely damaged. Replace or repair the waterproofing, including all damaged wood with new waterproofing and wood structures.
Life Expectancy (EEE)	0-1 Years
Life Expectancy (LBC)	1-4 Years
Life Expectancy (AWE)	0-1 Years

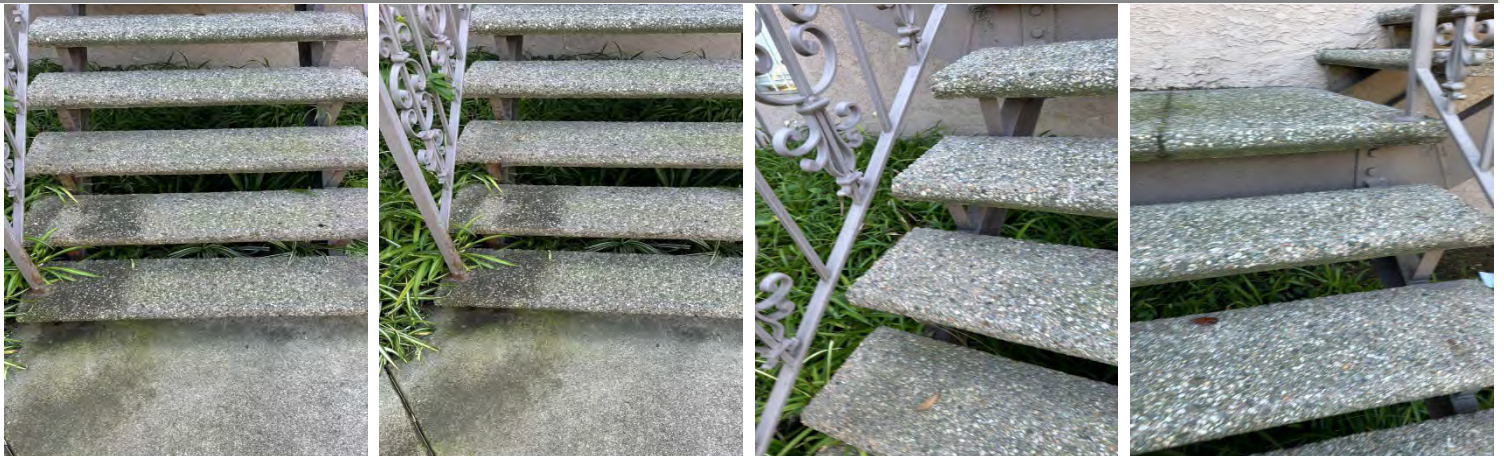
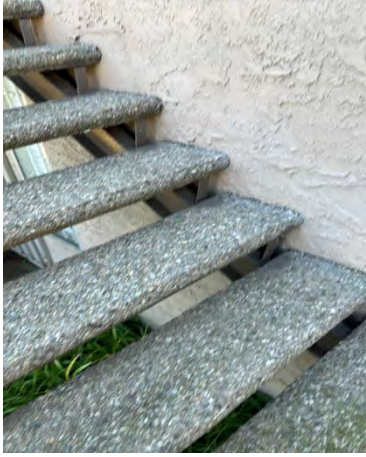
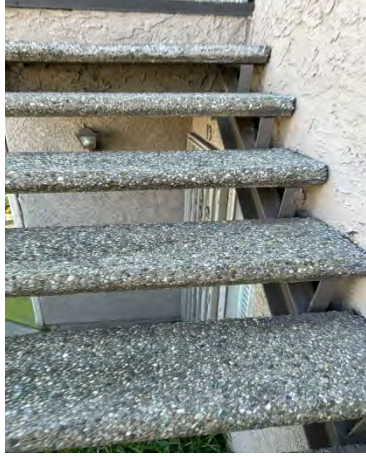
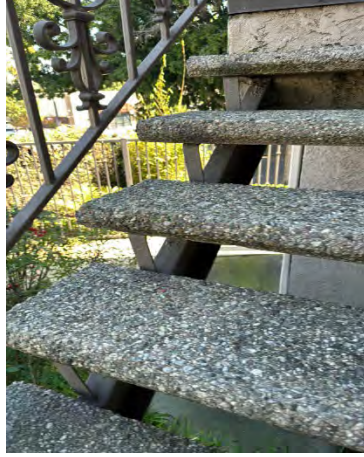
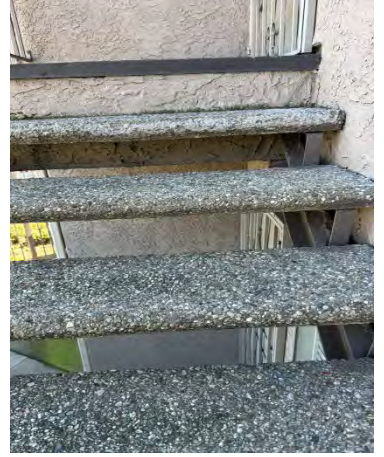
Building Name	5518
Apartment Name	14
Location Name	Stairs
Visual Report	
Exterior Elements	Stairs, Stairs Landing, Railings, Integrations
Water Proofing Elements	Flashings, Waterproofing, Coatings, Sealants
Visual Review	Good
Any Visual Signs of leaks	No
Further Invasive Review Required	No
Condition Assessment	Pass
Additional Considerations or Concerns	<p>Railing at concrete</p> <p>Stairs are steel stringers attached to a wood structure with concrete treads.</p> <p>The handrails are visually in good condition</p>
Life Expectancy (EEE)	1-4 Years
Life Expectancy (LBC)	4-7 Years
Life Expectancy (AWE)	1-4 Years

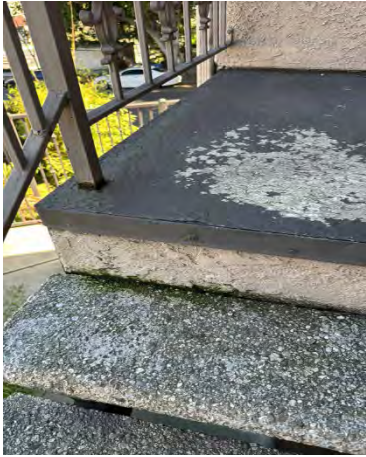
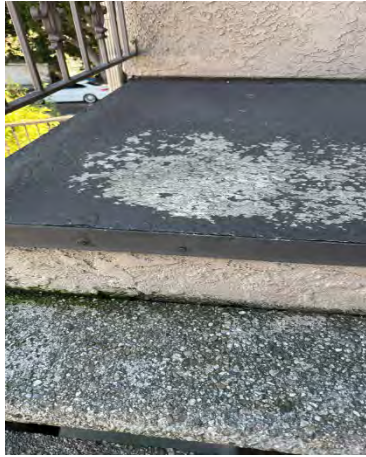
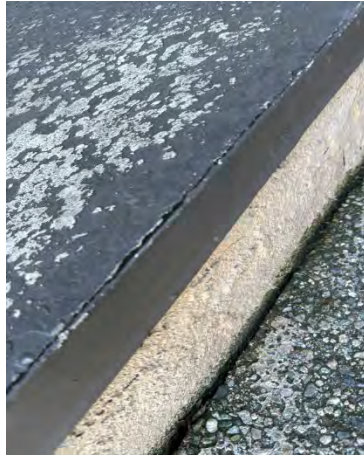
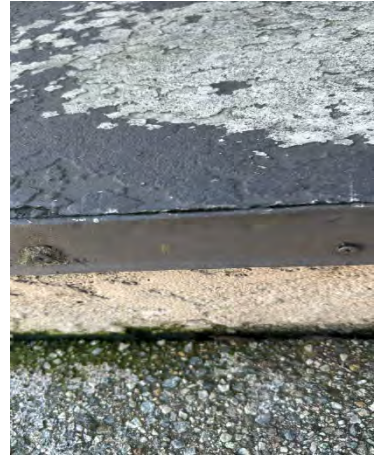
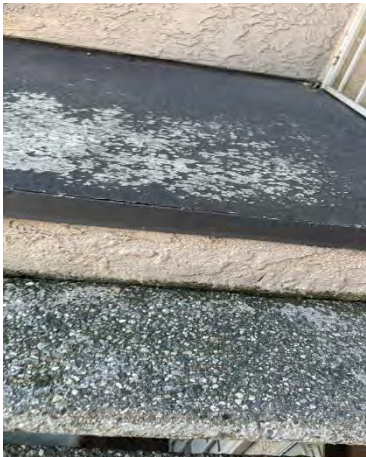
Exterior Elements	Decks, Railings, Integrations, Door Threshold, Stucco Interface
Water Proofing Elements	Flashings, Waterproofing, Coatings, Sealants
Visual Review	Fair
Any Visual Signs of leaks	Yes
Further Invasive Review Required	No
Condition Assessment	Fail
Additional Considerations or Concerns	<p>Entry / Balcony / Walking Deck</p> <p>The deck is wood framed with waterproofing over the wood.</p> <p>Handrails are metal and attached to the deck surface and visually in good condition.</p> <p>The waterproofing is severely damaged. Replace or repair the waterproofing, including all damaged wood with new waterproofing and wood structures.</p>
Life Expectancy (EEE)	1-4 Years
Life Expectancy (LBC)	4-7 Years
Life Expectancy (AWE)	0-1 Years

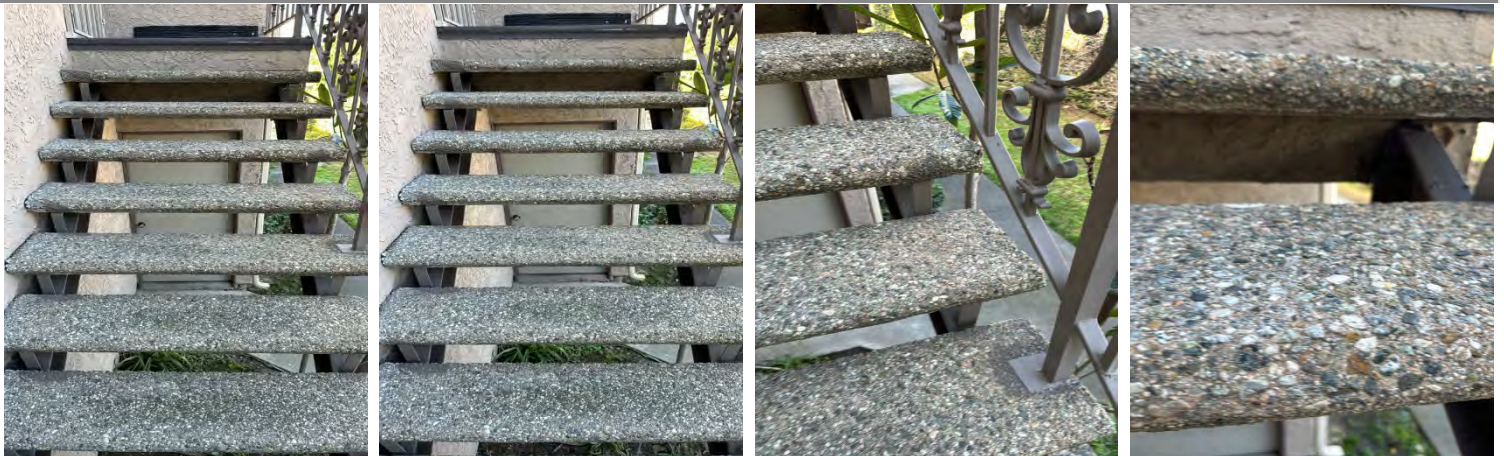
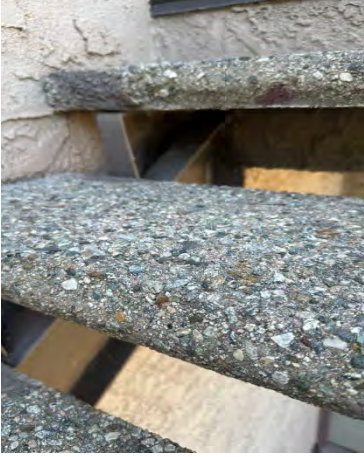
Exterior Elements	Stairs, Stairs Landing, Railings, Integrations
Water Proofing Elements	Flashings, Waterproofing, Coatings, Sealants
Visual Review	Good
Any Visual Signs of leaks	No
Further Invasive Review Required	No
Condition Assessment	Pass
Additional Considerations or Concerns	<p>Railing at concrete</p> <p>Stairs are steel stringers attached to a wood structure with concrete treads.</p> <p>The handrails are visually in good condition.</p>
Life Expectancy (EEE)	1-4 Years
Life Expectancy (LBC)	4-7 Years
Life Expectancy (AWE)	1-4 Years

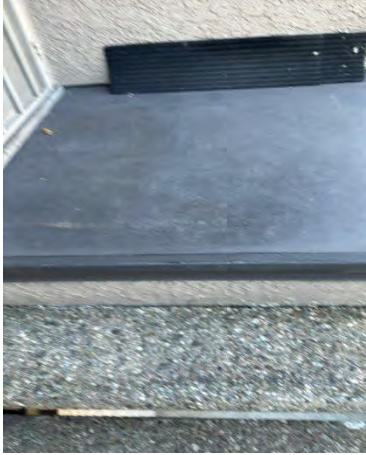
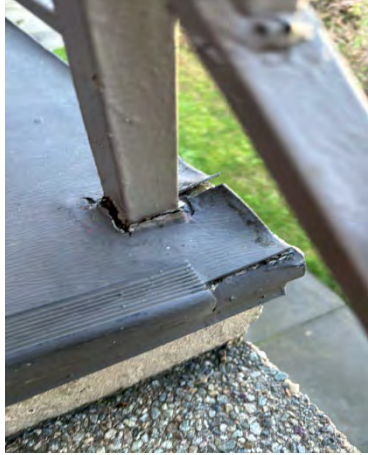
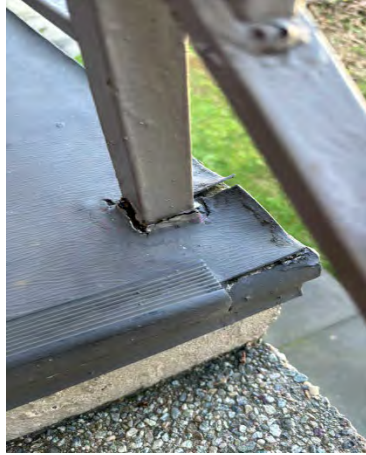
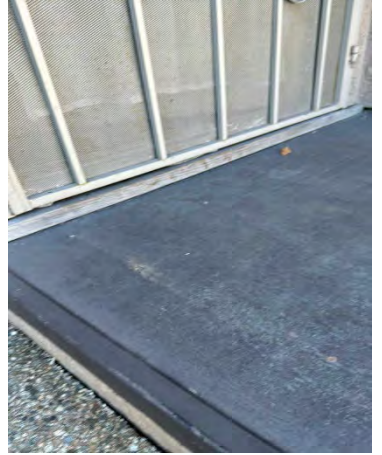
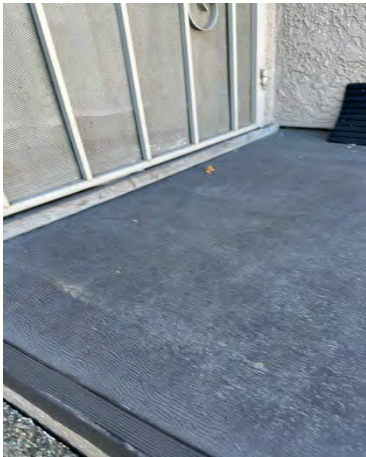
Exterior Elements	Decks, Railings, Integrations, Door Threshold, Stucco Interface
Water Proofing Elements	Flashings, Waterproofing, Coatings, Sealants
Visual Review	Bad
Any Visual Signs of leaks	Yes
Further Invasive Review Required	No
Condition Assessment	Fail
Additional Considerations or Concerns	Entry / Balcony / Walking Deck The deck is wood framed with waterproofing over the wood. Handrails are metal and attached to the deck surface and visually in good condition. The waterproofing is severely damaged. Replace or repair the waterproofing, including all damaged wood with new waterproofing and wood structures.
Life Expectancy (EEE)	1-4 Years
Life Expectancy (LBC)	4-7 Years
Life Expectancy (AWE)	0-1 Years

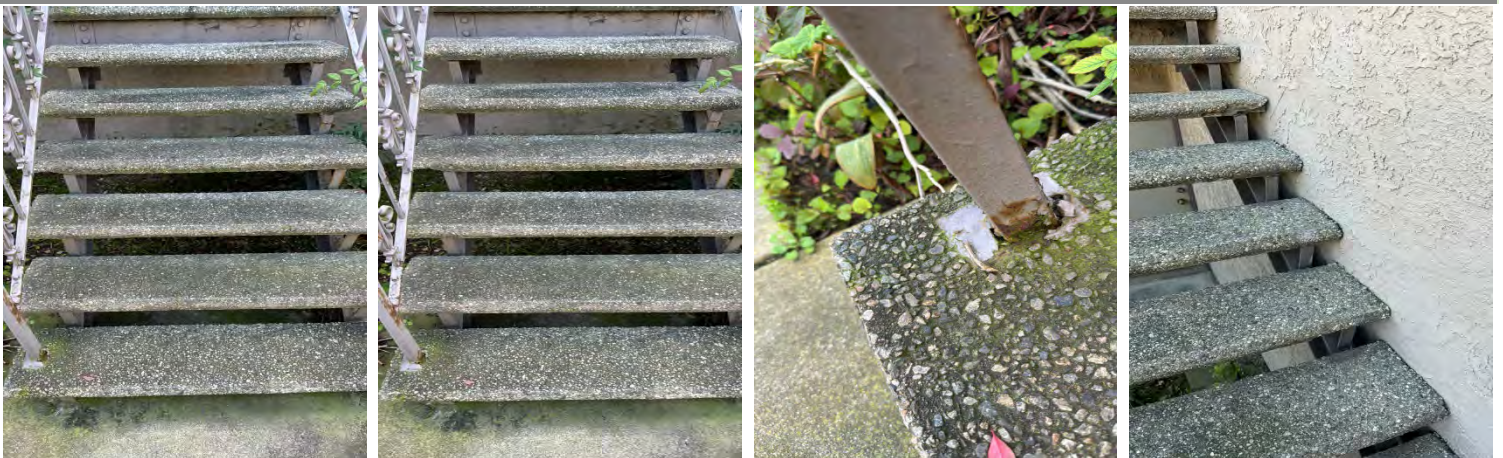
Exterior Elements	Stairs, Stairs Landing, Railings, Integrations
Water Proofing Elements	Flashings, Waterproofing, Coatings, Sealants
Visual Review	Good
Any Visual Signs of leaks	No
Further Invasive Review Required	No
Condition Assessment	Pass
Additional Considerations or Concerns	Railing attachments at the bottom portion of the stairs are severely corroded. Replace the corroded components.
Life Expectancy (EEE)	1-4 Years
Life Expectancy (LBC)	4-7 Years
Life Expectancy (AWE)	1-4 Years

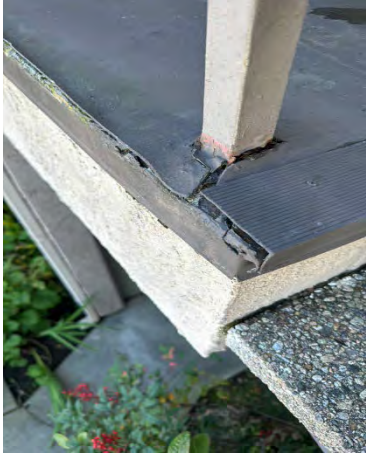
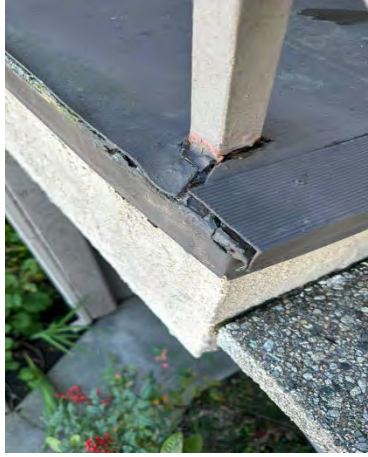
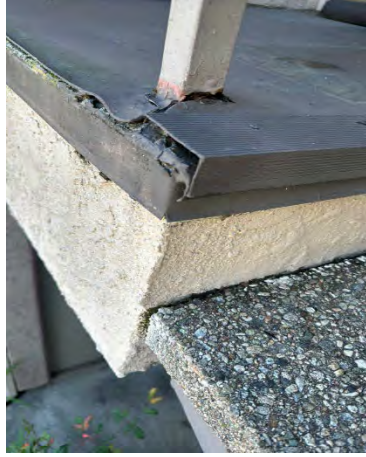
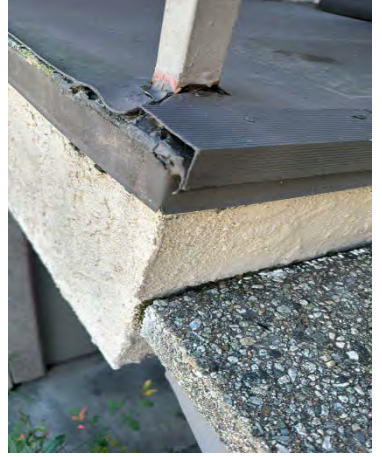
Exterior Elements	Decks, Railings, Integrations, Door Threshold, Stucco Interface
Water Proofing Elements	Flashings, Waterproofing, Coatings, Sealants
Visual Review	Bad
Any Visual Signs of leaks	Yes
Further Invasive Review Required	Yes
Condition Assessment	Fail
Additional Considerations or Concerns	Entry / Balcony / Walking Deck The deck is wood framed with waterproofing over the wood. Handrails are metal and attached to the deck surface and visually in good condition. The waterproofing is severely damaged. Replace or repair the waterproofing, including all damaged wood with new waterproofing and wood structures.
Life Expectancy (EEE)	0-1 Years
Life Expectancy (LBC)	1-4 Years
Life Expectancy (AWE)	0-1 Years

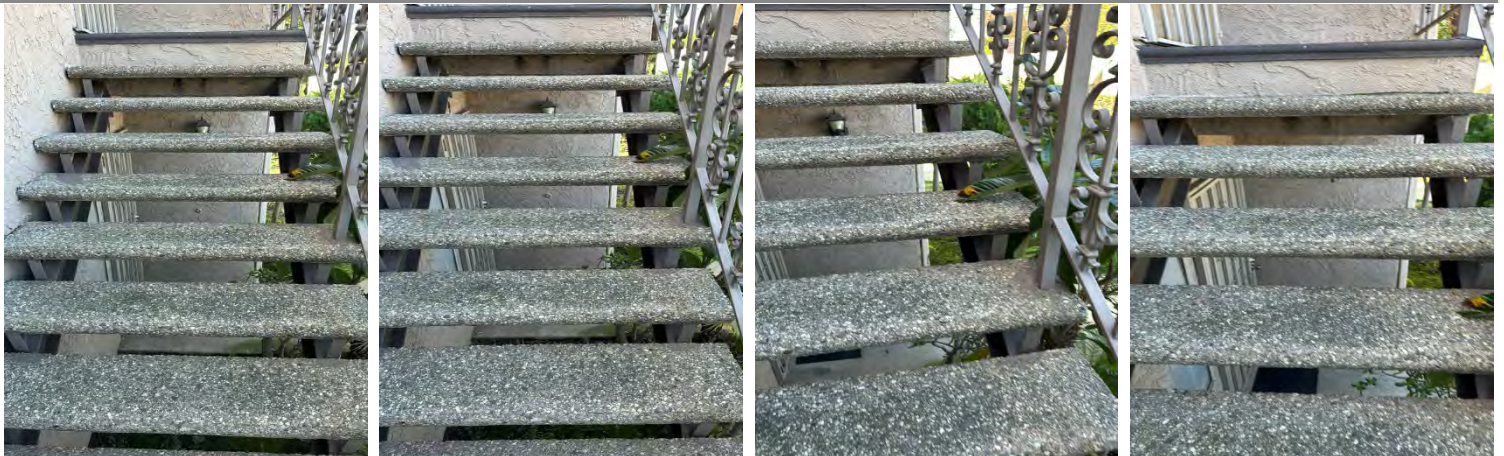
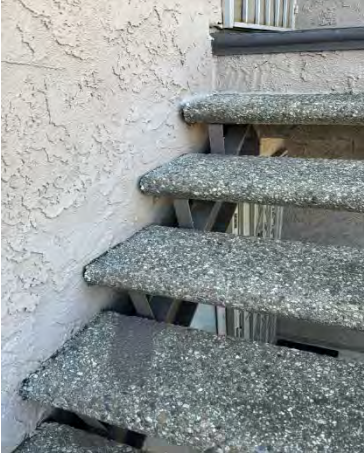
Exterior Elements	Stairs, Stairs Landing, Railings, Integrations
Water Proofing Elements	Flashings, Waterproofing, Coatings, Sealants
Visual Review	Good
Any Visual Signs of leaks	No
Further Invasive Review Required	No
Condition Assessment	Pass
Additional Considerations or Concerns	<p>Railing at concrete</p> <p>Stairs are steel stringers attached to a wood structure with concrete treads.</p> <p>The handrails are visually in good condition.</p>
Life Expectancy (EEE)	1-4 Years
Life Expectancy (LBC)	4-7 Years
Life Expectancy (AWE)	1-4 Years
