REPORT OF VISUAL INSPECTION

An inspection ("Inspection") of the Exterior Elevated Elements ("EEE") listed in Annex 1 (attached report), their load-bearing components ("LBC"), and associated waterproofing elements ("AWE") was performed at the property and on the date indicated below:

Autumn Pointe HOA/ 55488 Dobbns St.	Los Angeles	CA	
Date of Inspection:	2/22/2024

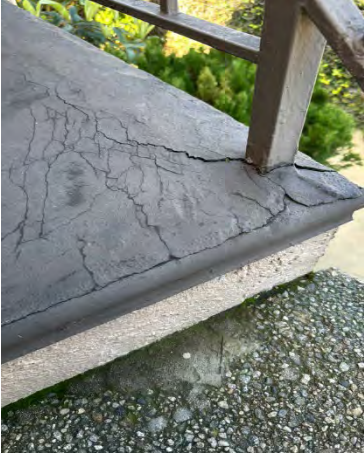
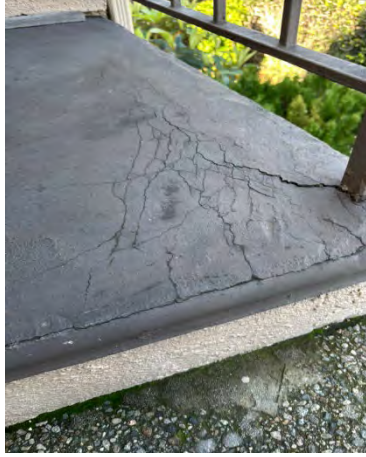
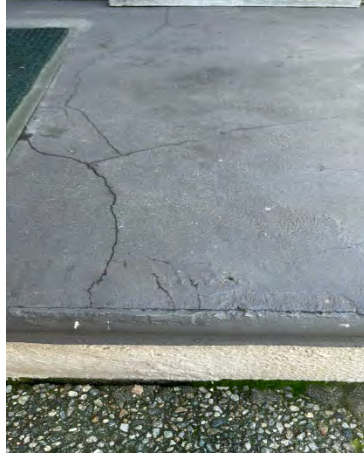
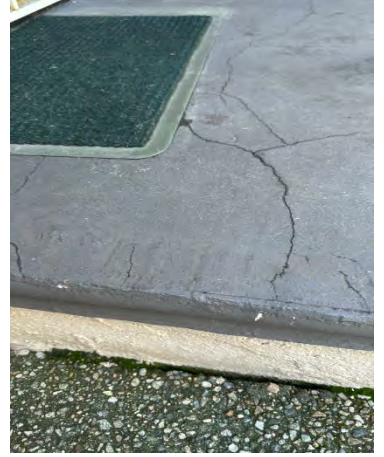
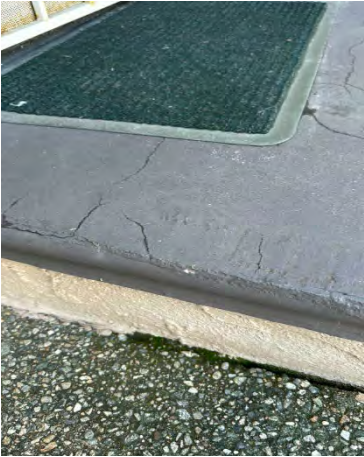
Exterior Elements	Decks, Railings, Integrations, Door Threshold, Stucco Interface
Water Proofing Elements	Flashings, Waterproofing, Coatings, Sealants
Visual Review	Bad
Any Visual Signs of leaks	Yes
Further Invasive Review Required	Yes
Condition Assessment	Fail
Additional Considerations or Concerns	Entry / Balcony / Walking Deck The deck is wood framed with waterproofing over the wood. Handrails are metal and attached to the deck surface and visually in good condition. The waterproofing is severely damaged. Replace or repair the waterproofing, including all damaged wood with new waterproofing and wood structures.
Life Expectancy (EEE)	1-4 Years
Life Expectancy (LBC)	1-4 Years
Life Expectancy (AWE)	0-1 Years

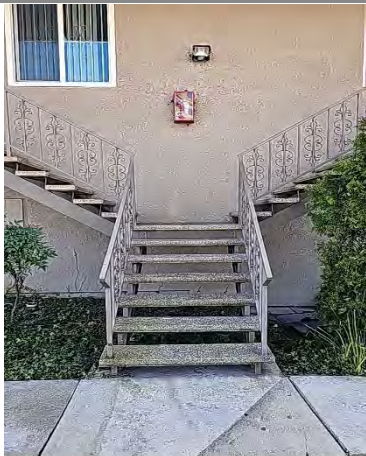
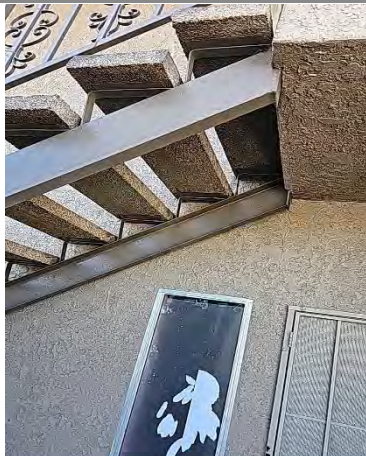
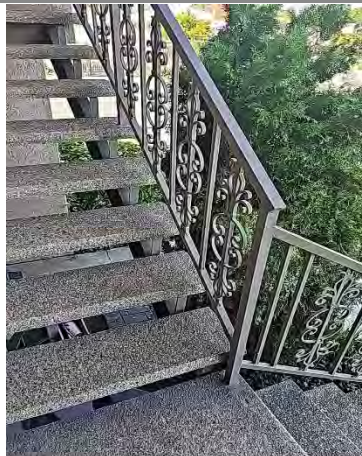
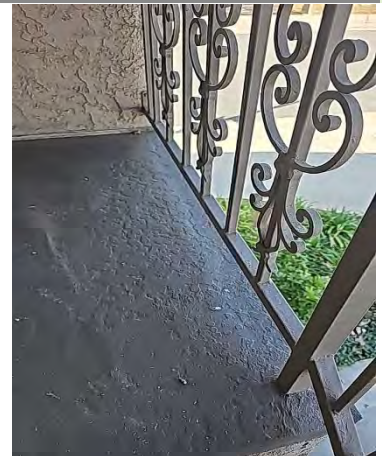
Exterior Elements	Stairs, Railings, Integrations, Stucco Interface
Water Proofing Elements	Flashings, Waterproofing, Coatings, Sealants
Visual Review	Good
Any Visual Signs of leaks	No
Further Invasive Review Required	No
Condition Assessment	Pass
Additional Considerations or Concerns	<p>Railing at concrete</p> <p>Stairs are steel stringers attached to a wood structure with concrete treads.</p> <p>The handrails are visually in good condition.</p>
Life Expectancy (EEE)	1-4 Years
Life Expectancy (LBC)	1-4 Years
Life Expectancy (AWE)	1-4 Years

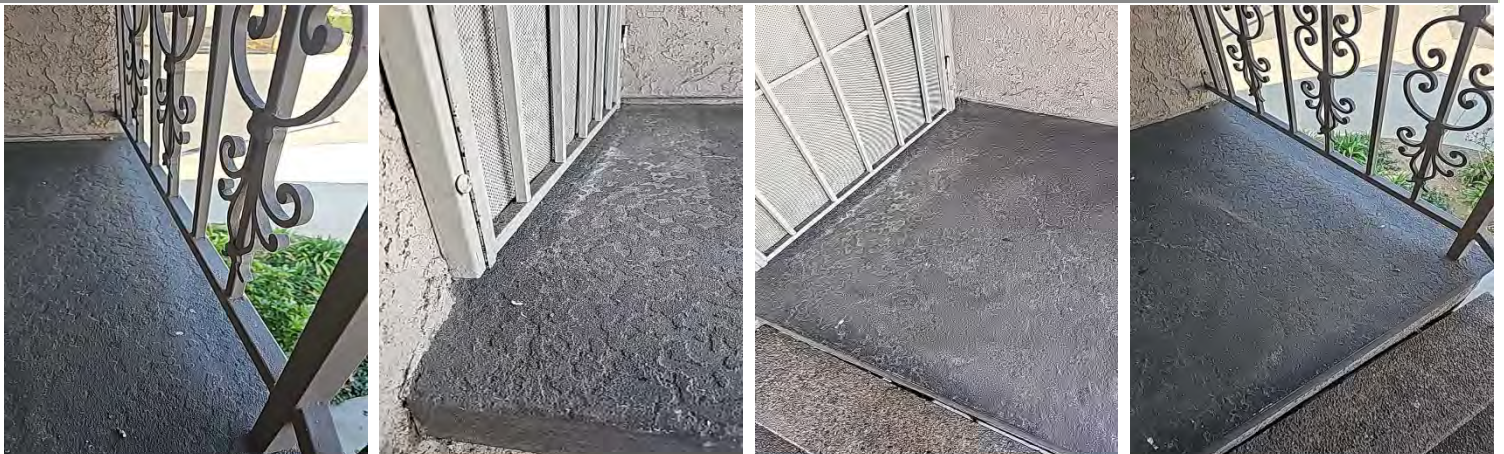
Exterior Elements	Decks, Railings, Integrations, Stucco Interface
Water Proofing Elements	Flashings, Waterproofing, Coatings, Sealants
Visual Review	Fair
Any Visual Signs of leaks	No
Further Invasive Review Required	No
Condition Assessment	Pass
Additional Considerations or Concerns	<p>Entry / Balcony / Walking Deck</p> <p>The deck is wood framed with waterproofing over the wood.</p> <p>Handrails are metal and attached to the deck surface and visually in good condition.</p>
Life Expectancy (EEE)	1-4 Years
Life Expectancy (LBC)	1-4 Years
Life Expectancy (AWE)	1-4 Years

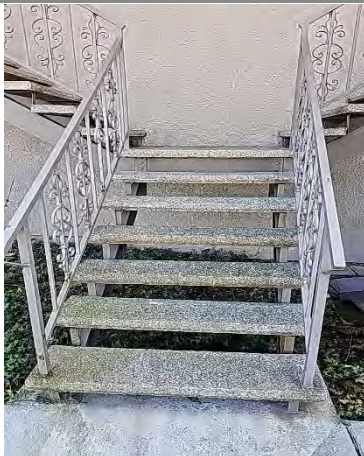
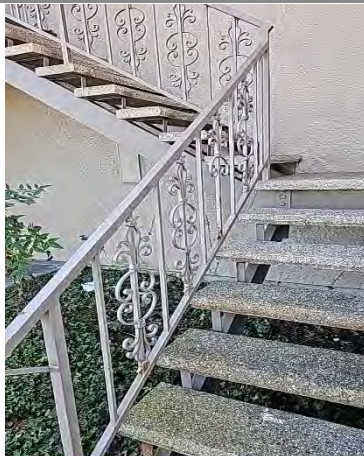
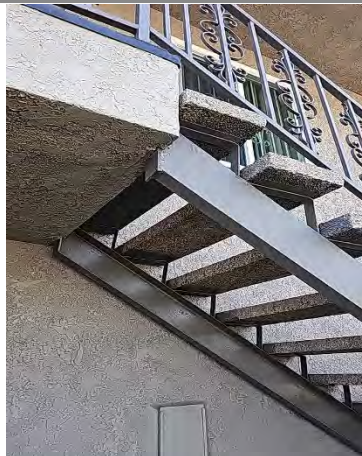
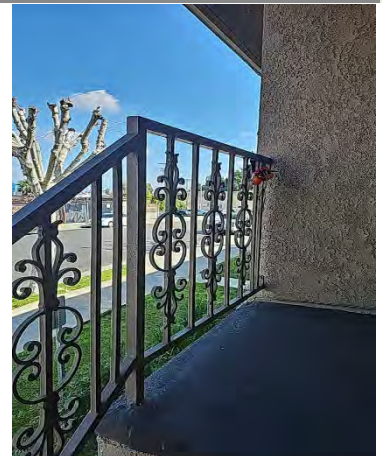
Building Name	5460-1
Apartment Name	87
Location Name	Stairs
Visual Report	
Exterior Elements	Stairs, Railings, Integrations, Stucco Interface
Water Proofing Elements	Flashings, Waterproofing, Coatings, Sealants
Visual Review	Fair
Any Visual Signs of leaks	No
Further Invasive Review Required	No
Condition Assessment	Pass
Additional Considerations or Concerns	<p>Railing at concrete</p> <p>Stairs are steel stringers attached to a wood structure with concrete treads.</p> <p>The handrails are visually in good condition</p>
Life Expectancy (EEE)	1-4 Years
Life Expectancy (LBC)	1-4 Years
Life Expectancy (AWE)	1-4 Years

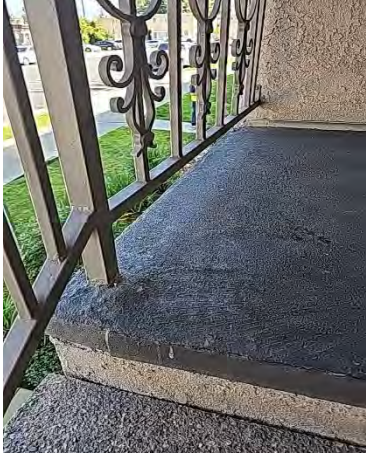
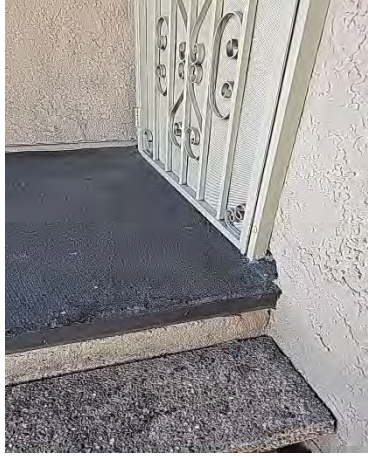
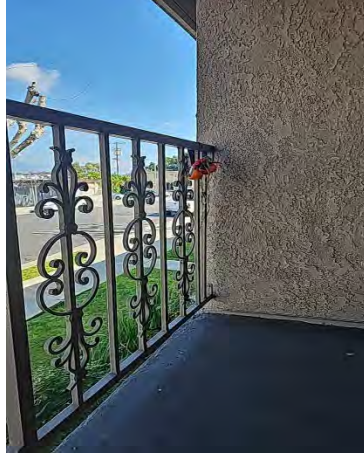
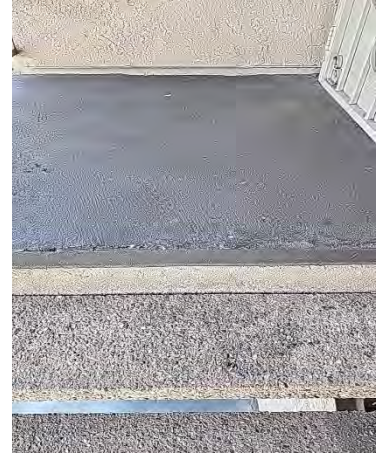
Building Name	5460-1
Apartment Name	87
Location Name	Entry deck
Visual Report	
Exterior Elements	Decks, Integrations, Stucco Interface, Porches/Entry
Water Proofing Elements	Flashings, Waterproofing, Coatings, Sealants
Visual Review	Bad
Any Visual Signs of leaks	No
Further Invasive Review Required	No
Condition Assessment	Fail
Additional Considerations or Concerns	<p>Entry / Balcony / Walking Deck</p> <p>The deck is wood framed with waterproofing over the wood.</p> <p>Handrails are metal and attached to the deck surface and visually in good condition.</p> <p>The waterproofing is severely damaged. Replace or repair the waterproofing, including all damaged wood with new waterproofing and wood structures.</p>
Life Expectancy (EEE)	0-1 Years
Life Expectancy (LBC)	1-4 Years
Life Expectancy (AWE)	0-1 Years

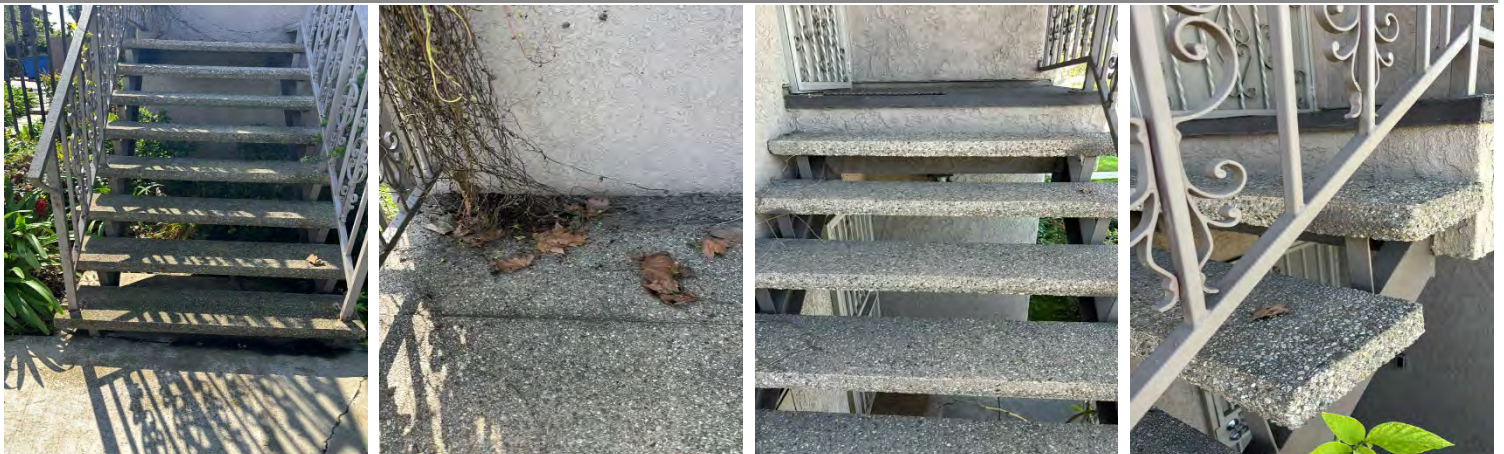
Exterior Elements	Stairs, Railings, Integrations, Stairs Landing, Stucco Interface
Water Proofing Elements	Flashings, Waterproofing, Coatings, Sealants
Visual Review	Good
Any Visual Signs of leaks	No
Further Invasive Review Required	No
Condition Assessment	Pass
Additional Considerations or Concerns	<p>Railing at concrete</p> <p>Stairs are steel stringers attached to a wood structure with concrete treads.</p> <p>The handrails are visually in good condition.</p>
Life Expectancy (EEE)	1-4 Years
Life Expectancy (LBC)	4-7 Years
Life Expectancy (AWE)	1-4 Years

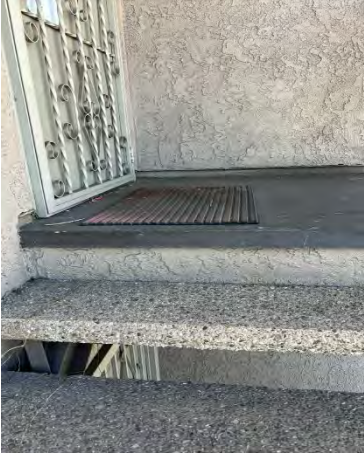
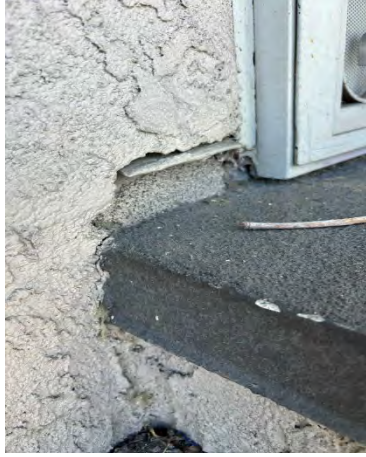
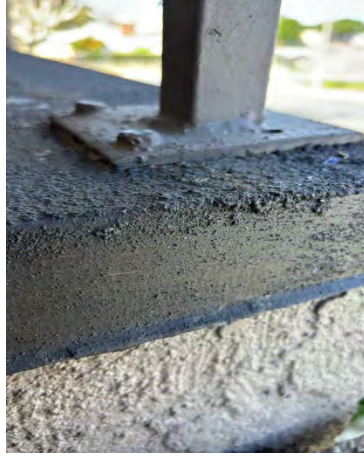
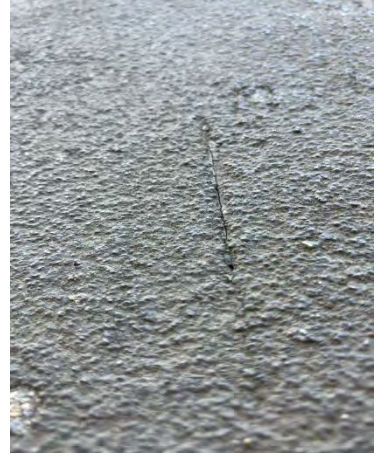
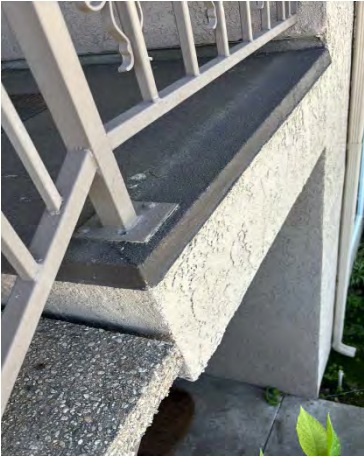
Building Name	5460-2
Apartment Name	91
Location Name	Entry deck
Visual Report	
Exterior Elements	Decks, Railings, Integrations, Door Threshold, Stucco Interface
Water Proofing Elements	Flashings, Waterproofing, Coatings, Sealants
Visual Review	Bad
Any Visual Signs of leaks	Yes
Further Invasive Review Required	No
Condition Assessment	Fail
Additional Considerations or Concerns	<p>Entry / Balcony / Walking Deck</p> <p>The deck is wood framed with waterproofing over the wood.</p> <p>Handrails are metal and attached to the deck surface and visually in good condition.</p> <p>The waterproofing is severely damaged. Replace or repair the waterproofing, including all damaged wood with new waterproofing and wood structures</p>
Life Expectancy (EEE)	0-1 Years
Life Expectancy (LBC)	1-4 Years
Life Expectancy (AWE)	0-1 Years

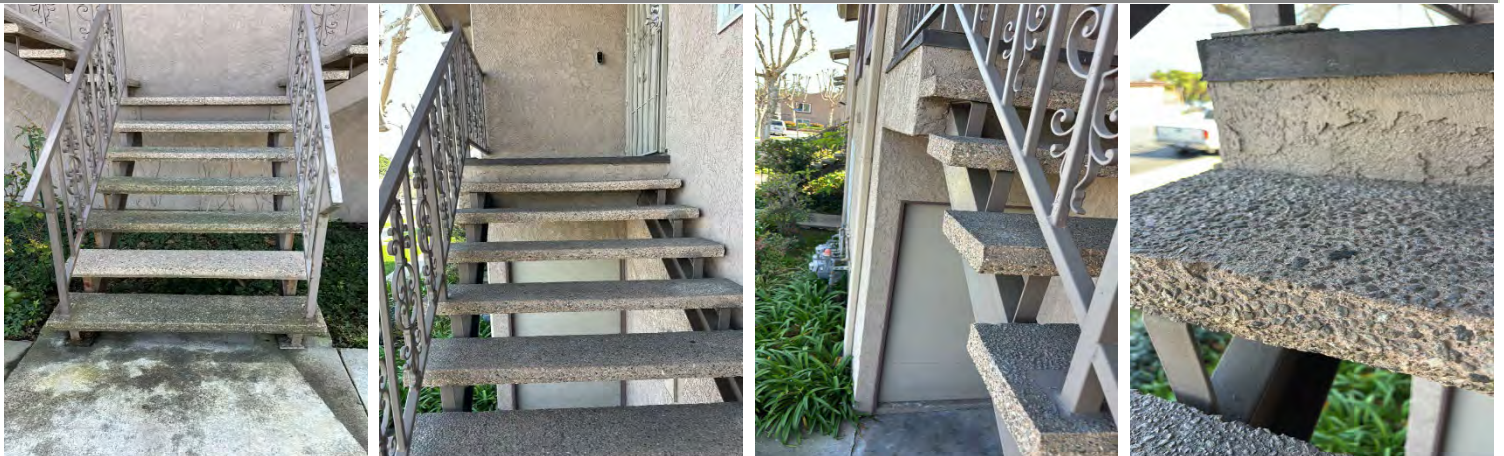
Exterior Elements	Stairs, Stairs Landing, Stucco Interface
Water Proofing Elements	Flashings, Waterproofing, Coatings, Sealants
Visual Review	Fair
Any Visual Signs of leaks	No
Further Invasive Review Required	No
Condition Assessment	Pass
Additional Considerations or Concerns	<p>Railing at concrete</p> <p>Stairs are steel stringers attached to a wood structure with concrete treads.</p> <p>The handrails are visually in good condition</p>
Life Expectancy (EEE)	1-4 Years
Life Expectancy (LBC)	4-7 Years
Life Expectancy (AWE)	1-4 Years

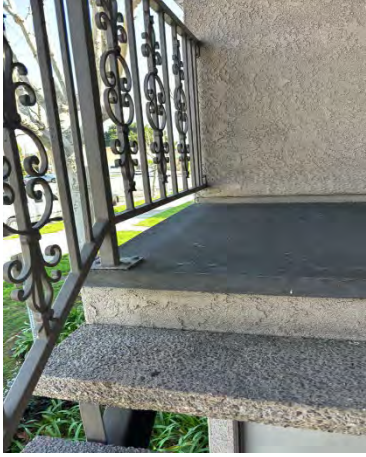
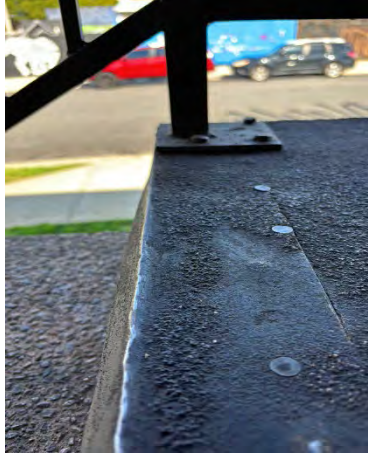
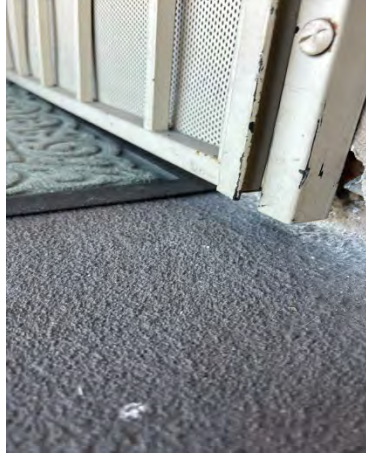
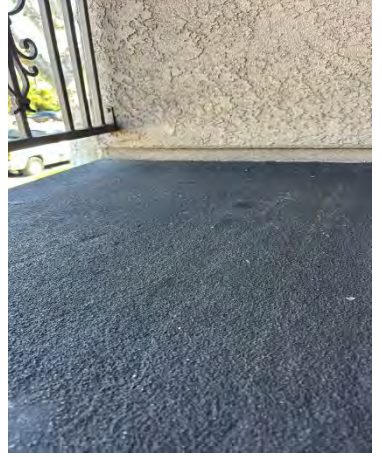
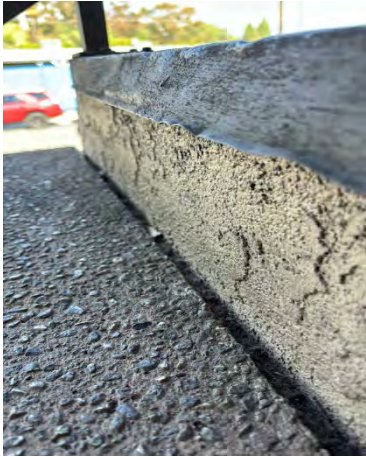
Exterior Elements	Porches/Entry, Railings, Integrations, Door Threshold, Stucco Interface
Water Proofing Elements	Flashings, Waterproofing, Coatings, Sealants
Visual Review	Bad
Any Visual Signs of leaks	No
Further Invasive Review Required	No
Condition Assessment	Fail
Additional Considerations or Concerns	Entry / Balcony / Walking Deck The deck is wood framed with waterproofing over the wood. Handrails are metal and attached to the deck surface and visually in good condition. The waterproofing is severely damaged. Replace or repair the waterproofing, including all damaged wood with new waterproofing and wood structures.
Life Expectancy (EEE)	0-1 Years
Life Expectancy (LBC)	1-4 Years
Life Expectancy (AWE)	0-1 Years

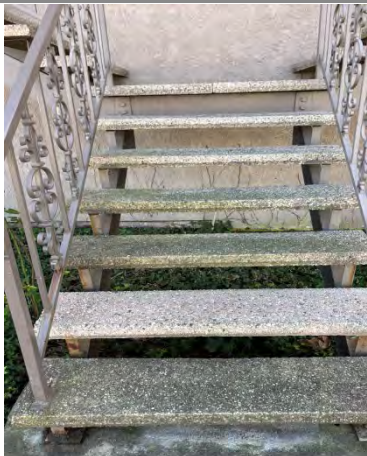
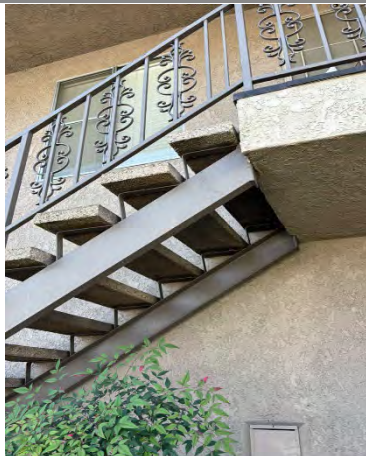
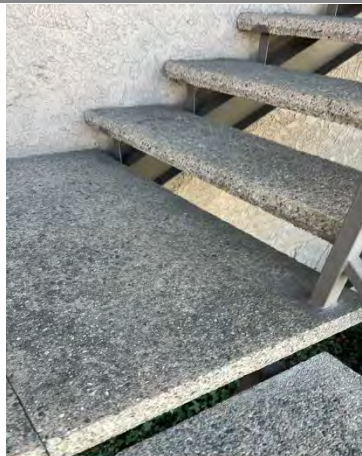
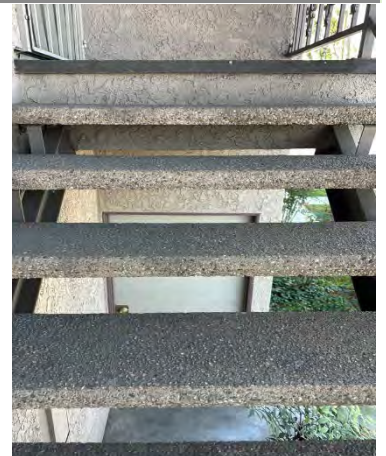
Exterior Elements	Stairs, Stairs Landing, Stucco Interface
Water Proofing Elements	Flashings, Waterproofing, Coatings, Sealants
Visual Review	Good
Any Visual Signs of leaks	No
Further Invasive Review Required	No
Condition Assessment	Pass
Additional Considerations or Concerns	<p>Railing at concrete</p> <p>Stairs are steel stringers attached to a wood structure with concrete treads.</p> <p>The handrails are visually in good condition.</p>
Life Expectancy (EEE)	1-4 Years
Life Expectancy (LBC)	4-7 Years
Life Expectancy (AWE)	1-4 Years

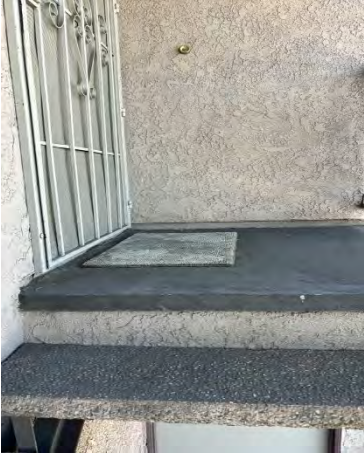
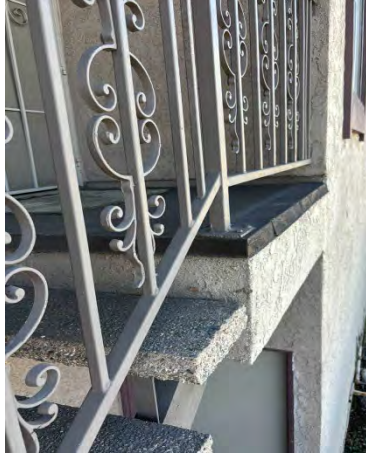
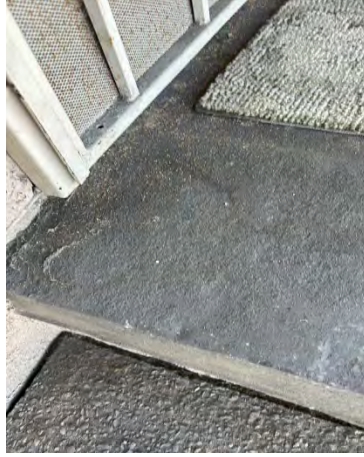
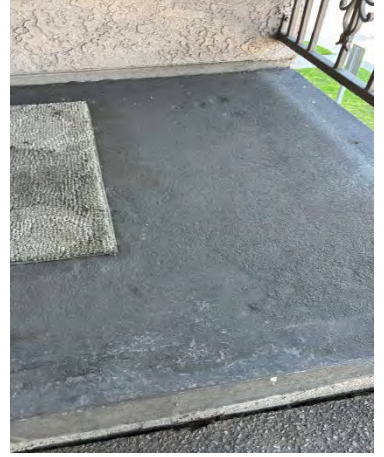
Exterior Elements	Porches/Entry, Railings, Integrations, Door Threshold, Stucco Interface
Water Proofing Elements	Flashings, Waterproofing, Coatings, Sealants
Visual Review	Bad
Any Visual Signs of leaks	Yes
Further Invasive Review Required	No
Condition Assessment	Fail
Additional Considerations or Concerns	<p>Entry / Balcony / Walking Deck</p> <p>The deck is wood framed with waterproofing over the wood.</p> <p>Handrails are metal and attached to the deck surface and visually in good condition.</p> <p>The waterproofing is severely damaged. Replace or repair the waterproofing, including all damaged wood with new waterproofing and wood structures.</p>
Life Expectancy (EEE)	0-1 Years
Life Expectancy (LBC)	1-4 Years
Life Expectancy (AWE)	0-1 Years

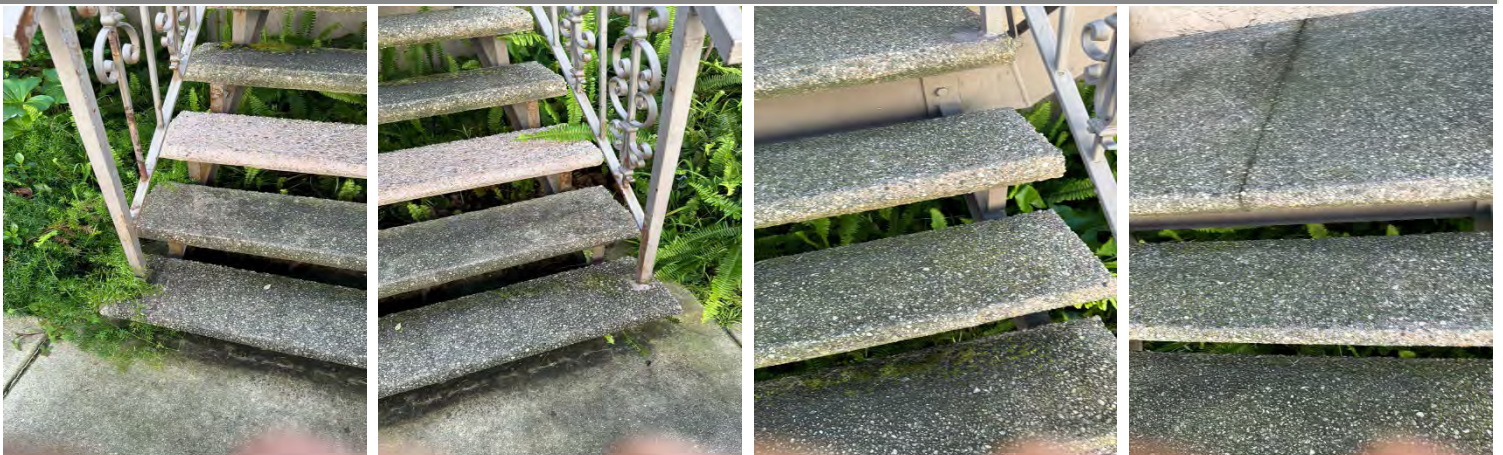
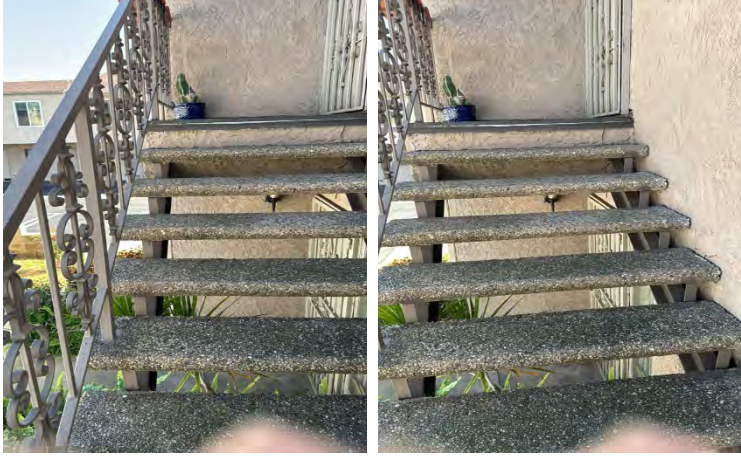
Exterior Elements	Stairs, Stairs Landing, Railings, Integrations
Water Proofing Elements	Flashings, Waterproofing, Coatings, Sealants
Visual Review	Good
Any Visual Signs of leaks	No
Further Invasive Review Required	No
Condition Assessment	Pass
Additional Considerations or Concerns	<p>Railing at concrete</p> <p>Stairs are steel stringers attached to a wood structure with concrete treads.</p> <p>The handrails are visually in good condition.</p>
Life Expectancy (EEE)	1-4 Years
Life Expectancy (LBC)	4-7 Years
Life Expectancy (AWE)	1-4 Years
