## DECK INSPECTORS INC.

#### Part 2 of Visual Inspection:

Autumn Pointe HOA

55488 Dobbs St.

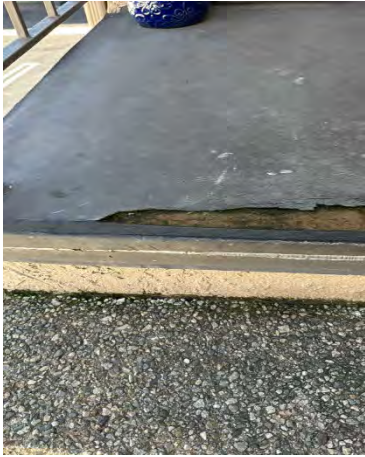
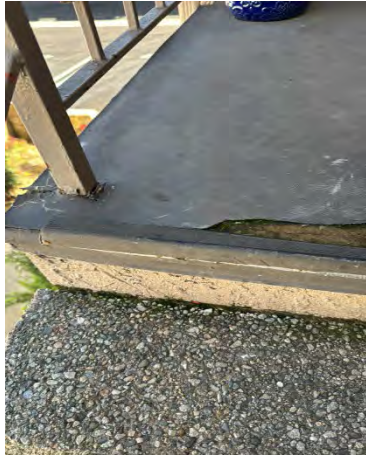
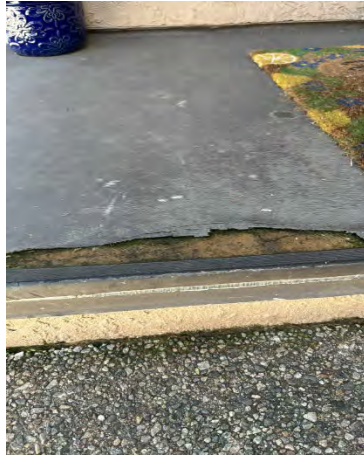
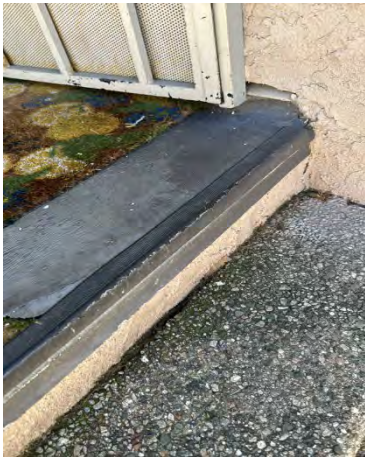
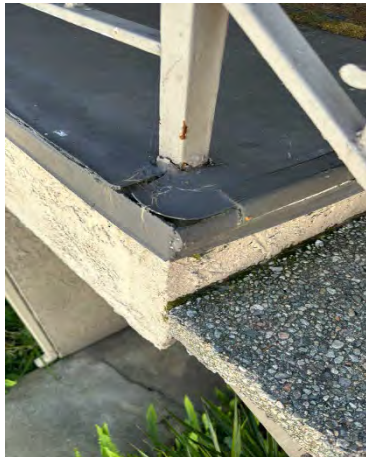
Building Name	5500
Apartment Name	8
Location Name	Entry deck

Exterior Elements	Decks, Stucco Interface, Door Threshold, Integrations, Railings
Water Proofing Elements	Flashings, Waterproofing, Coatings, Sealants
Visual Review	<b>Bad</b>
Any Visual Signs of leaks	<b>Yes</b>
Further Invasive Review Required	<b>Yes</b>
Condition Assessment	<b>Fail</b>
Additional Considerations or Concerns	<b>Entry / Balcony / Walking Deck</b>  <b>The deck is wood framed with waterproofing over the wood.</b>  <b>Handrails are metal and attached to the deck surface and visually in good condition.</b>  <b>The waterproofing is severely damaged. Replace or repair the waterproofing, including all damaged wood with new waterproofing and wood structures.</b>
Life Expectancy (EEE)	<b>1-4 Years</b>
Life Expectancy (LBC)	<b>1-4 Years</b>
Life Expectancy (AWE)	<b>0-1 Years</b>

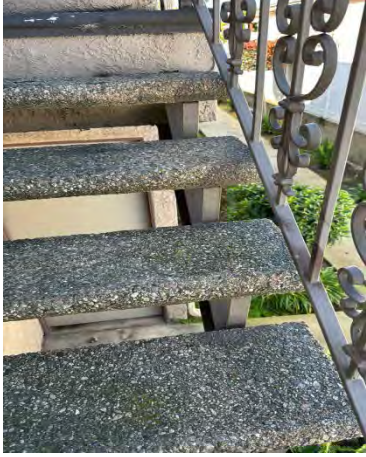
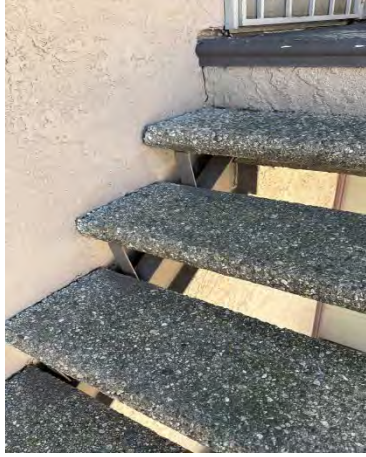
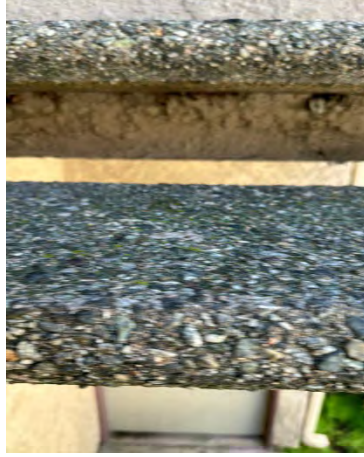
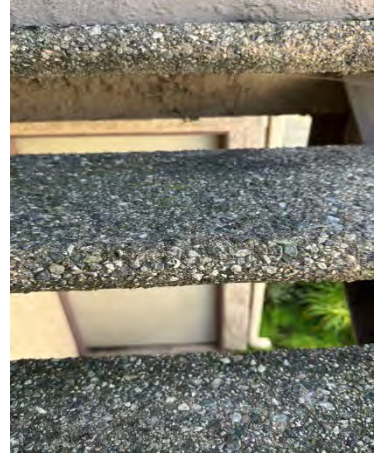
Building Name	5500
Apartment Name	6
Location Name	Stairs

Exterior Elements	Stairs, Stairs Landing, Railings
Water Proofing Elements	Flashings, Waterproofing, Coatings, Sealants
Visual Review	Good
Any Visual Signs of leaks	No
Further Invasive Review Required	No
Condition Assessment	Pass
Additional Considerations or Concerns	<p><b>Railing at concrete</b></p> <p><b>Stairs are steel stringers attached to a wood structure with concrete treads.</b></p> <p><b>The handrails are visually in good condition.</b></p>
Life Expectancy (EEE)	1-4 Years
Life Expectancy (LBC)	4-7 Years
Life Expectancy (AWE)	1-4 Years

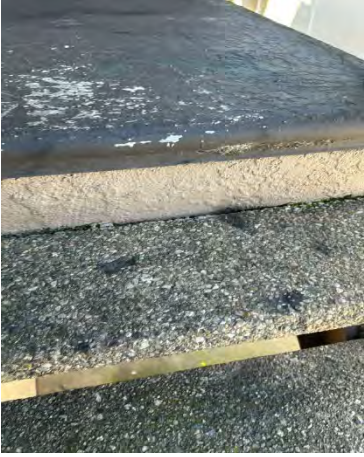
Building Name	5500
Apartment Name	6
Location Name	Entry deck

Exterior Elements	Decks, Railings, Integrations, Door Threshold, Stucco Interface
Water Proofing Elements	Flashings, Waterproofing, Coatings, Sealants
Visual Review	Fair
Any Visual Signs of leaks	No
Further Invasive Review Required	No
Condition Assessment	Pass
Additional Considerations or Concerns	Deck top coat deteriorated, however no signs of waterproofing leak. Refinish the deck waterproofing.
Life Expectancy (EEE)	1-4 Years
Life Expectancy (LBC)	4-7 Years
Life Expectancy (AWE)	0-1 Years

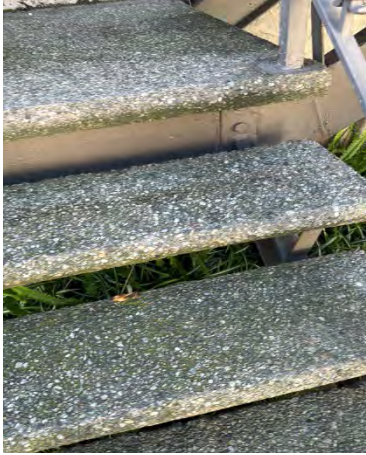
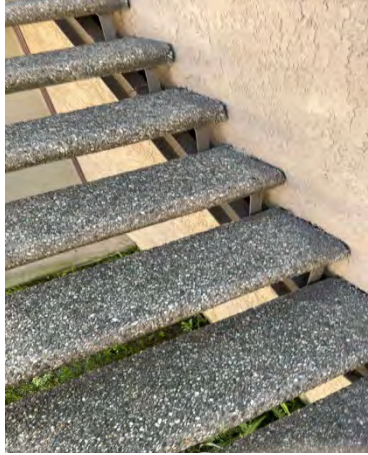
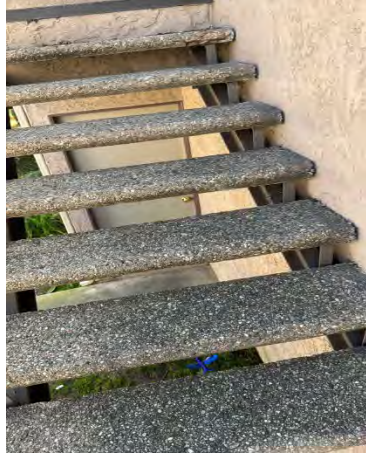
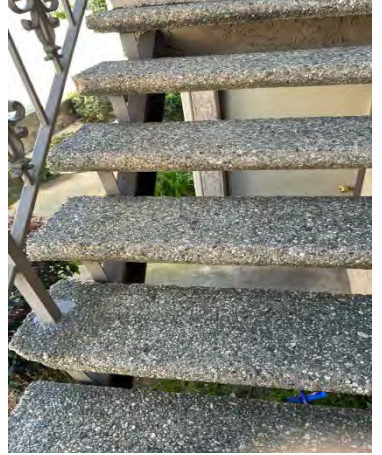
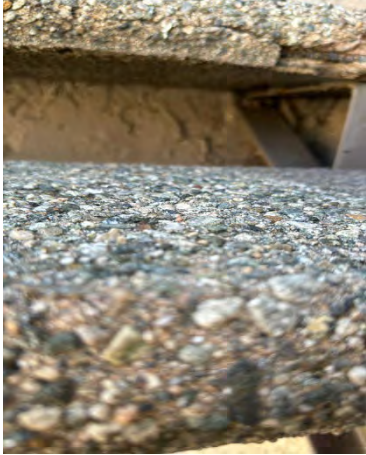
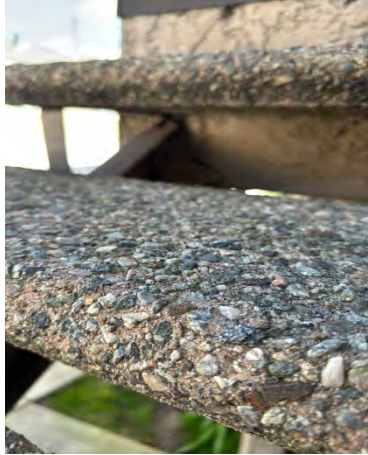
Exterior Elements	Stairs, Stairs Landing, Railings, Integrations
Water Proofing Elements	Flashings, Waterproofing, Coatings, Sealants
Visual Review	Good
Any Visual Signs of leaks	No
Further Invasive Review Required	No
Condition Assessment	Pass
Additional Considerations or Concerns	<p><b>Railing at concrete</b></p> <p><b>Stairs are steel stringers attached to a wood structure with concrete treads.</b></p> <p><b>The handrails are visually in good condition.</b></p>
Life Expectancy (EEE)	1-4 Years
Life Expectancy (LBC)	4-7 Years
Life Expectancy (AWE)	1-4 Years

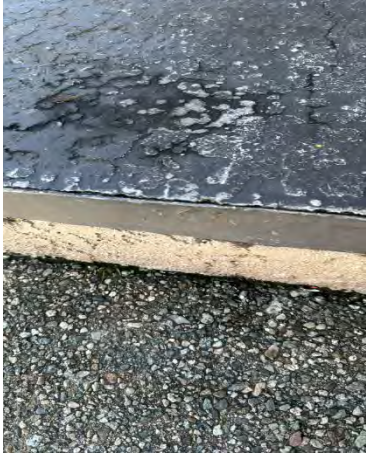
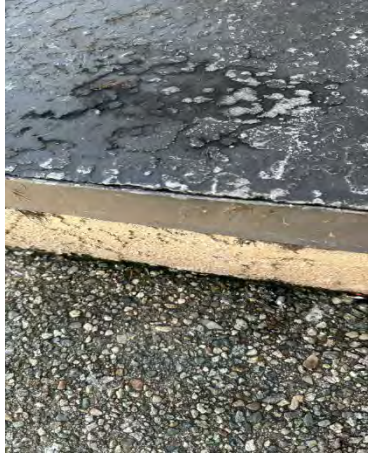
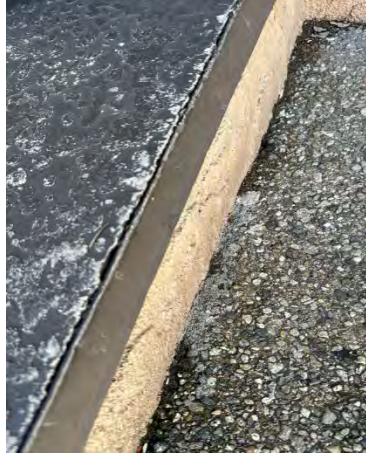
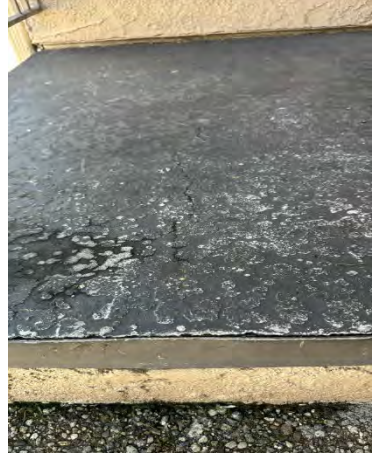
Exterior Elements	Decks, Railings, Integrations, Door Threshold, Stucco Interface
Water Proofing Elements	Flashings, Waterproofing, Coatings, Sealants
Visual Review	<b>Bad</b>
Any Visual Signs of leaks	<b>No</b>
Further Invasive Review Required	<b>Yes</b>
Condition Assessment	<b>Fail</b>
Additional Considerations or Concerns	<b>Entry / Balcony / Walking Deck</b>  <b>The deck is wood framed with waterproofing over the wood.</b>  <b>Handrails are metal and attached to the deck surface and visually in good condition.</b>  <b>The waterproofing is severely damaged. Replace or repair the waterproofing, including all damaged wood with new waterproofing and wood structures.</b>
Life Expectancy (EEE)	<b>1-4 Years</b>
Life Expectancy (LBC)	<b>4-7 Years</b>
Life Expectancy (AWE)	<b>0-1 Years</b>

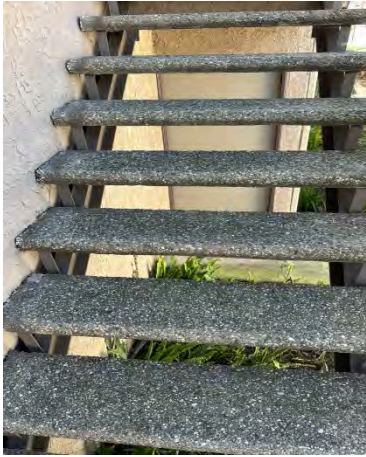
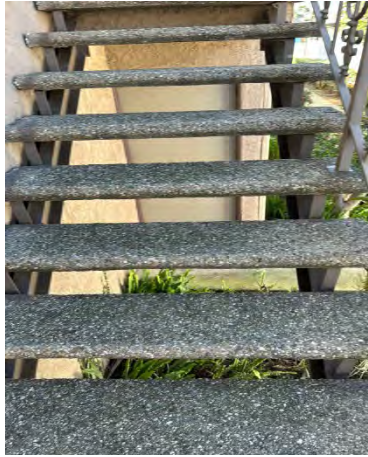
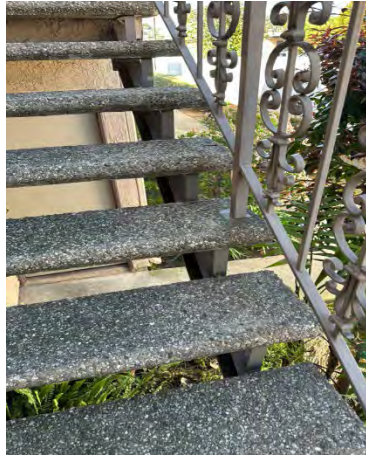
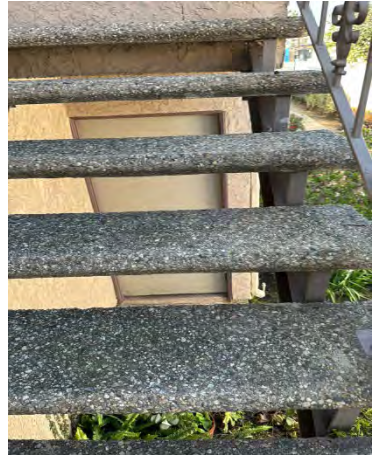
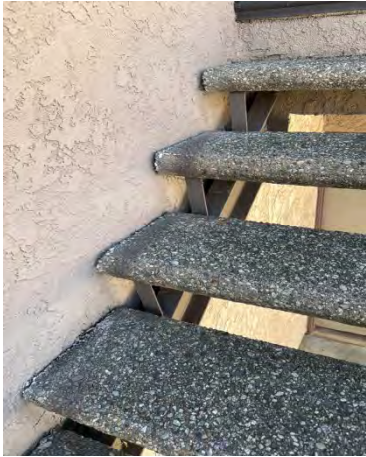
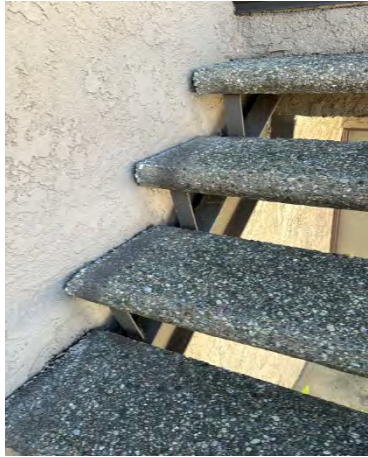
Building Name	5500
Apartment Name	4
Location Name	Stairs
Visual Report	
Exterior Elements	Porches/Entry, Stairs, Stairs Landing, Railings
Water Proofing Elements	Flashings, Waterproofing, Coatings, Sealants
Visual Review	Good
Any Visual Signs of leaks	No
Further Invasive Review Required	No
Condition Assessment	Pass
Additional Considerations or Concerns	<p>Railing at concrete</p> <p>Stairs are steel stringers attached to a wood structure with concrete treads.</p> <p>The handrails are visually in good condition.</p>
Life Expectancy (EEE)	1-4 Years
Life Expectancy (LBC)	4-7 Years
Life Expectancy (AWE)	1-4 Years
Visual Photos

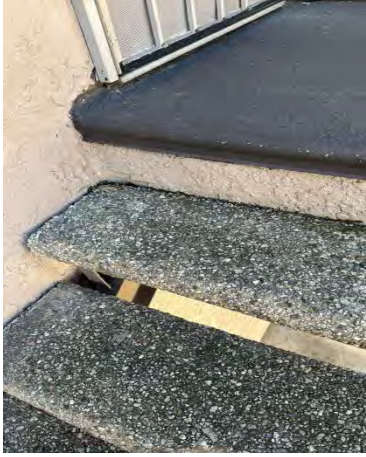
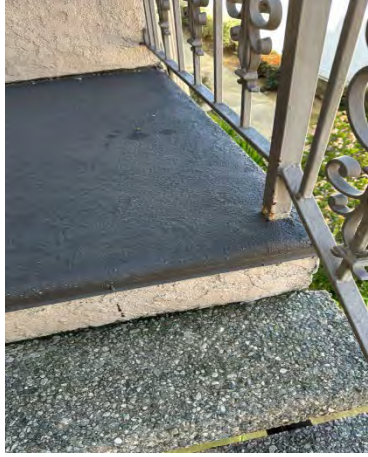
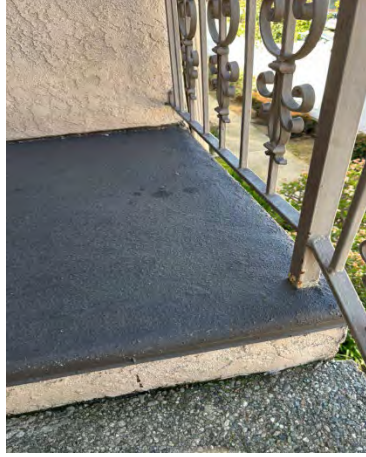
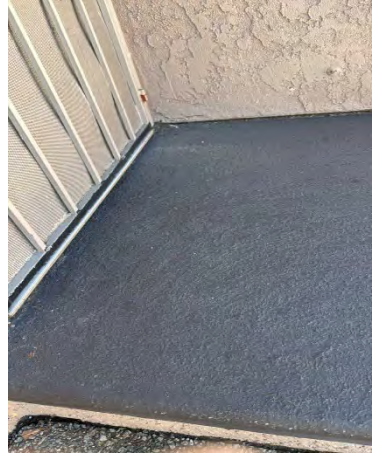
Building Name	5500
Apartment Name	4
Location Name	Entry deck
Visual Report	
Exterior Elements	Decks, Integrations, Door Threshold, Stucco Interface, Railings
Water Proofing Elements	Flashings, Waterproofing, Coatings, Sealants
Visual Review	Good
Any Visual Signs of leaks	No
Further Invasive Review Required	No
Condition Assessment	Pass
Additional Considerations or Concerns	<p>Entry / Balcony / Walking Deck</p> <p>The deck is wood framed with waterproofing over the wood.</p> <p>Handrails are metal and attached to the deck surface and visually in good condition.</p>
Life Expectancy (EEE)	1-4 Years
Life Expectancy (LBC)	4-7 Years
Life Expectancy (AWE)	1-4 Years
Visual Photos

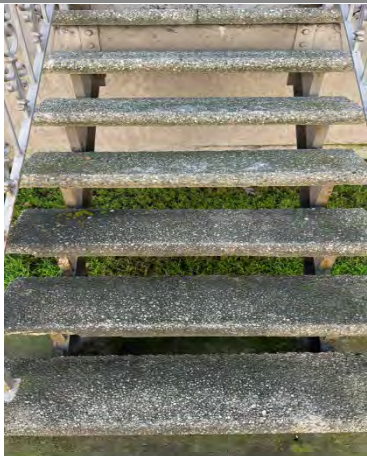
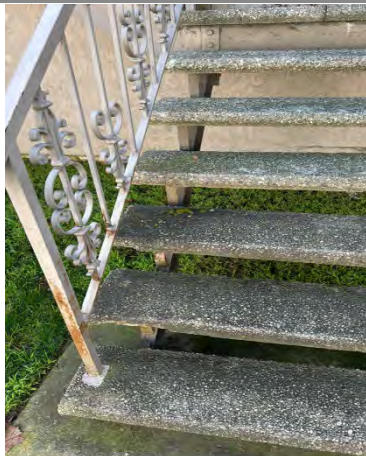
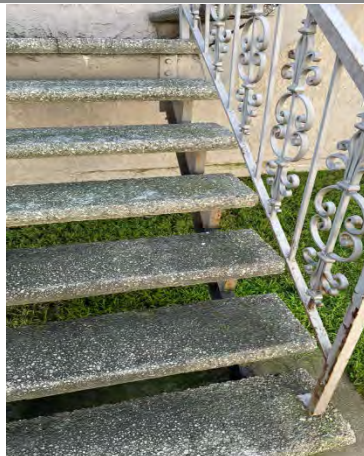
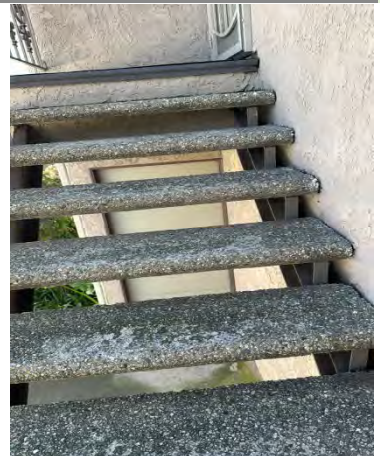
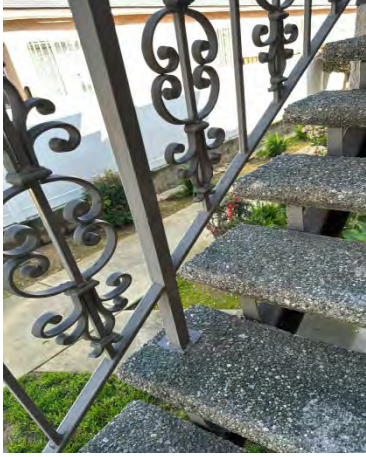
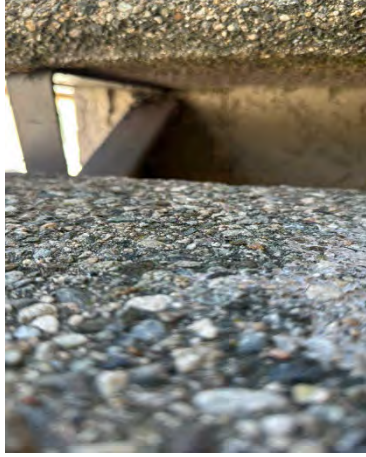
Exterior Elements	Stairs, Stairs Landing, Railings, Integrations
Water Proofing Elements	Flashings, Waterproofing, Coatings, Sealants
Visual Review	Good
Any Visual Signs of leaks	No
Further Invasive Review Required	No
Condition Assessment	Pass
Additional Considerations or Concerns	<p><b>Railing at concrete</b></p> <p><b>Stairs are steel stringers attached to a wood structure with concrete treads.</b></p> <p><b>The handrails are visually in good condition.</b></p>
Life Expectancy (EEE)	1-4 Years
Life Expectancy (LBC)	4-7 Years
Life Expectancy (AWE)	1-4 Years

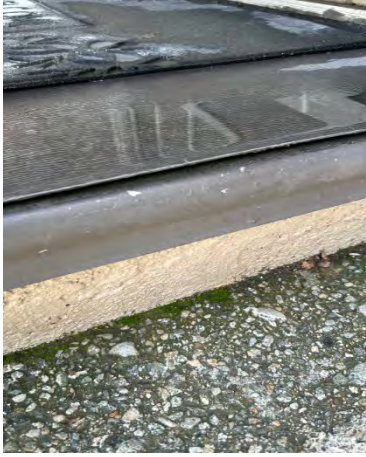
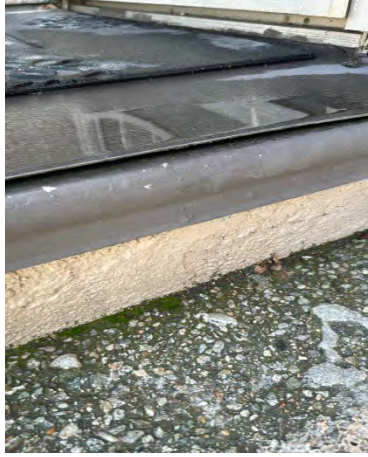
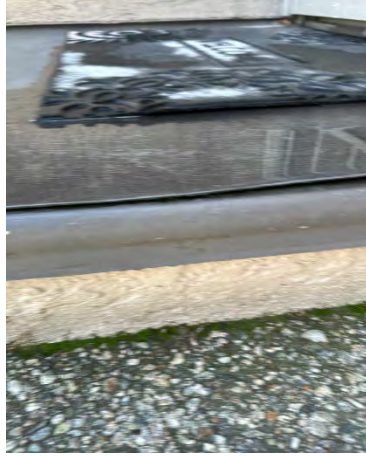
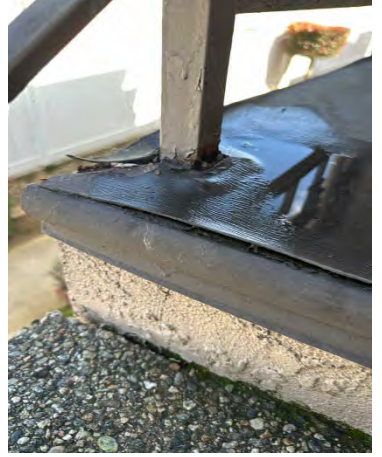
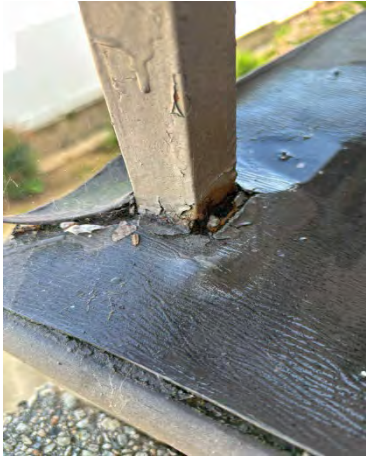
Building Name	5500
Apartment Name	3
Location Name	Entry deck
Visual Report	
Exterior Elements	Decks, Integrations, Door Threshold, Stucco Interface, Railings
Water Proofing Elements	Flashings, Waterproofing, Coatings, Sealants
Visual Review	Bad
Any Visual Signs of leaks	Yes
Further Invasive Review Required	No
Condition Assessment	Fail
Additional Considerations or Concerns	<p>Entry / Balcony / Walking Deck</p> <p>The deck is wood framed with waterproofing over the wood.</p> <p>Handrails are metal and attached to the deck surface and visually in good condition.</p> <p>The waterproofing is severely damaged. Replace or repair the waterproofing, including all damaged wood with new waterproofing and wood structures.</p>
Life Expectancy (EEE)	1-4 Years
Life Expectancy (LBC)	4-7 Years
Life Expectancy (AWE)	0-1 Years

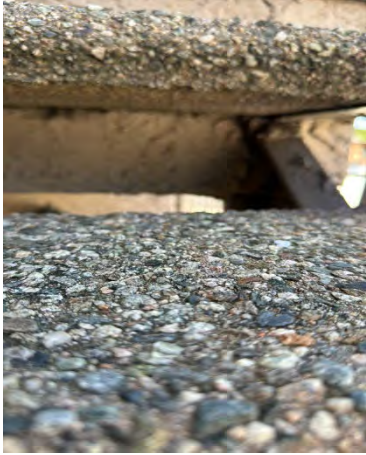
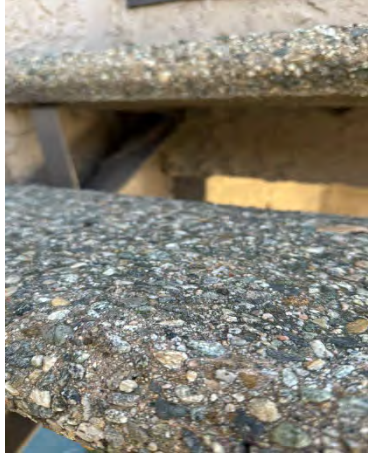
Exterior Elements	Stairs, Stairs Landing, Railings, Integrations
Water Proofing Elements	Flashings, Waterproofing, Coatings, Sealants
Visual Review	Good
Any Visual Signs of leaks	No
Further Invasive Review Required	No
Condition Assessment	Pass
Additional Considerations or Concerns	<p>Railing at concrete</p> <p>Stairs are steel stringers attached to a wood structure with concrete treads.</p> <p>The handrails are visually in good condition.</p>
Life Expectancy (EEE)	1-4 Years
Life Expectancy (LBC)	4-7 Years
Life Expectancy (AWE)	1-4 Years

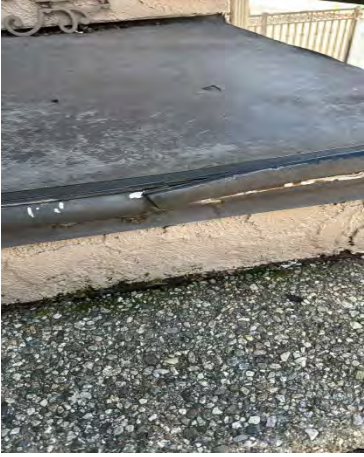
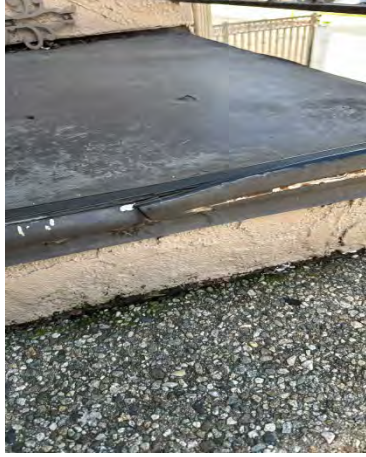
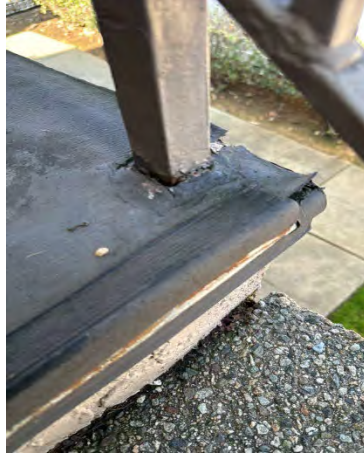
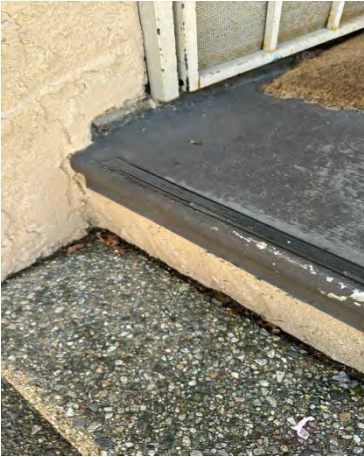
Exterior Elements	Decks, Railings, Integrations, Door Threshold, Stucco Interface
Water Proofing Elements	Flashings, Waterproofing, Coatings, Sealants
Visual Review	<b>Bad</b>
Any Visual Signs of leaks	<b>Yes</b>
Further Invasive Review Required	<b>No</b>
Condition Assessment	<b>Fail</b>
Additional Considerations or Concerns	<b>Entry / Balcony / Walking Deck</b>  <b>The deck is wood framed with waterproofing over the wood.</b>  <b>Handrails are metal and attached to the deck surface and visually in good condition.</b>  <b>The waterproofing is severely damaged. Replace or repair the waterproofing, including all damaged wood with new waterproofing and wood structures.</b>
Life Expectancy (EEE)	<b>1-4 Years</b>
Life Expectancy (LBC)	<b>1-4 Years</b>
Life Expectancy (AWE)	<b>0-1 Years</b>

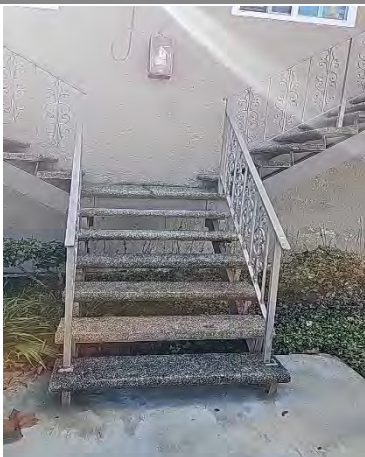
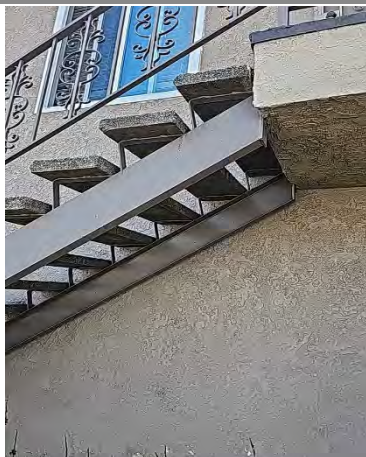
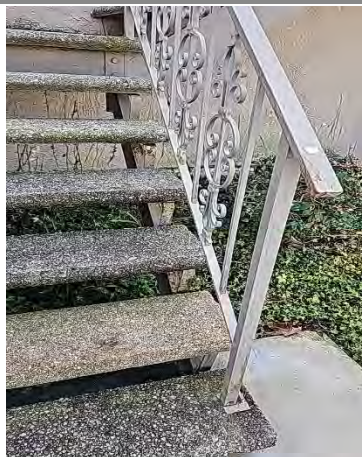
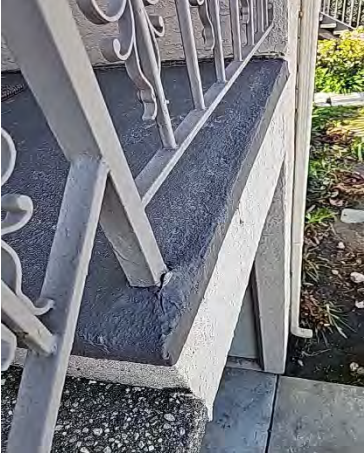
Exterior Elements	Stairs Landing, Railings, Stucco Interface, Integrations
Water Proofing Elements	Flashings, Waterproofing, Coatings, Sealants
Visual Review	Fair
Any Visual Signs of leaks	No
Further Invasive Review Required	No
Condition Assessment	Pass
Additional Considerations or Concerns	Surface rust on railings. Loose railing at first tread plate. Secure loose railing.
Life Expectancy (EEE)	0-1 Years
Life Expectancy (LBC)	1-4 Years
Life Expectancy (AWE)	0-1 Years

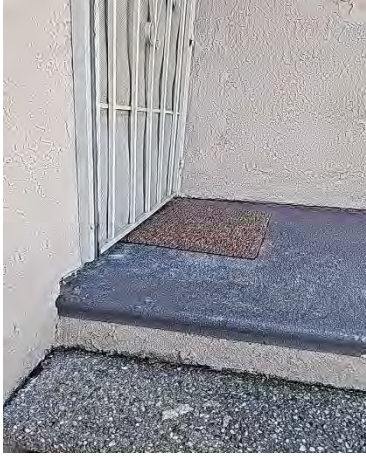
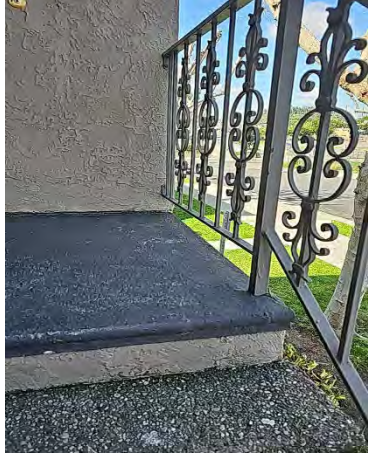
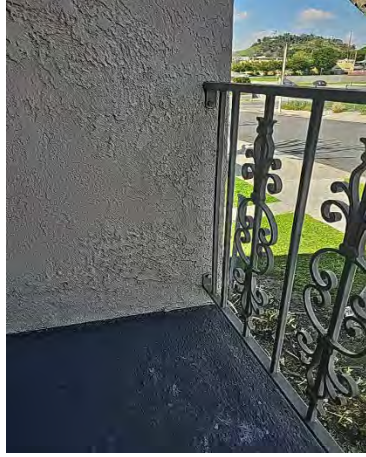
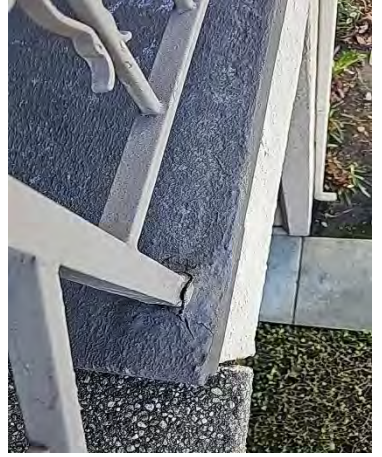
Exterior Elements	Decks, Walkways, Railings, Integrations, Stucco Interface
Water Proofing Elements	Flashings, Waterproofing, Coatings, Sealants
Visual Review	<b>Bad</b>
Any Visual Signs of leaks	<b>Yes</b>
Further Invasive Review Required	<b>No</b>
Condition Assessment	<b>Fail</b>
Additional Considerations or Concerns	<b>Entry / Balcony / Walking Deck</b>  <b>The deck is wood framed with waterproofing over the wood.</b>  <b>Handrails are metal and attached to the deck surface and visually in good condition.</b>  <b>The waterproofing is severely damaged. Replace or repair the waterproofing, including all damaged wood with new waterproofing and wood structures.</b>
Life Expectancy (EEE)	<b>0-1 Years</b>
Life Expectancy (LBC)	<b>1-4 Years</b>
Life Expectancy (AWE)	<b>0-1 Years</b>

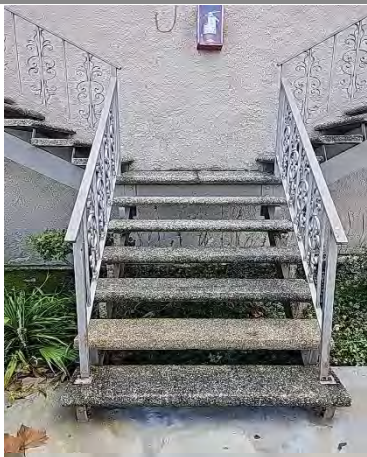
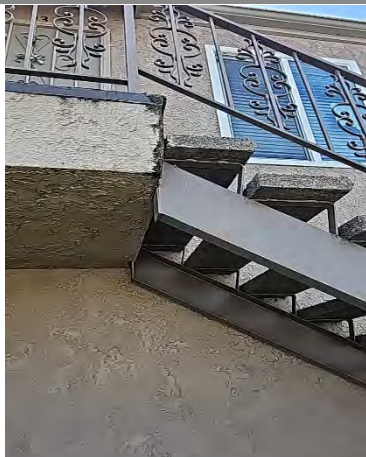
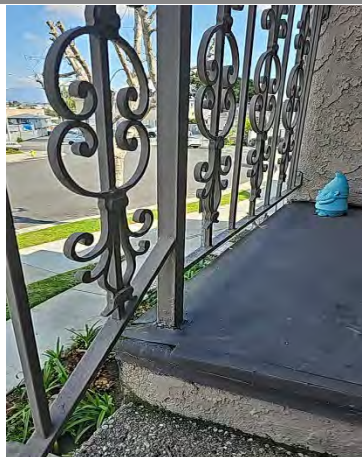
Exterior Elements	Stairs, Railings, Integrations, Stucco Interface
Water Proofing Elements	Flashings, Waterproofing, Coatings, Sealants
Visual Review	Fair
Any Visual Signs of leaks	No
Further Invasive Review Required	No
Condition Assessment	Pass
Additional Considerations or Concerns	Surface rust on railings.
Life Expectancy (EEE)	1-4 Years
Life Expectancy (LBC)	1-4 Years
Life Expectancy (AWE)	1-4 Years

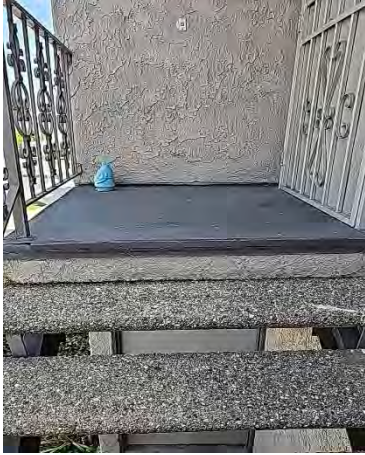
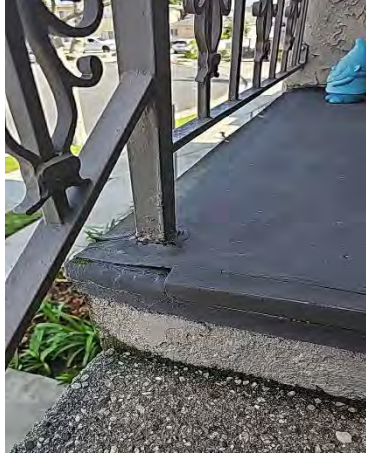
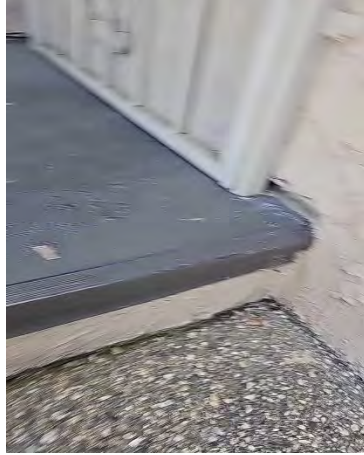
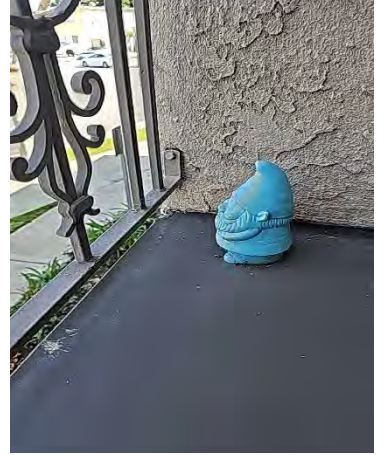
Building Name	5476-1
Apartment Name	93
Location Name	Entry deck
Visual Report	
Exterior Elements	Decks, Railings, Integrations, Stucco Interface
Water Proofing Elements	Flashings, Waterproofing, Coatings, Sealants
Visual Review	Bad
Any Visual Signs of leaks	Yes
Further Invasive Review Required	No
Condition Assessment	Fail
Additional Considerations or Concerns	<p>Entry / Balcony / Walking Deck</p> <p>The deck is wood framed with waterproofing over the wood.</p> <p>Handrails are metal and attached to the deck surface and visually in good condition.</p> <p>The waterproofing is severely damaged. Replace or repair the waterproofing, including all damaged wood with new waterproofing and wood structures.</p>
Life Expectancy (EEE)	0-1 Years
Life Expectancy (LBC)	1-4 Years
Life Expectancy (AWE)	0-1 Years

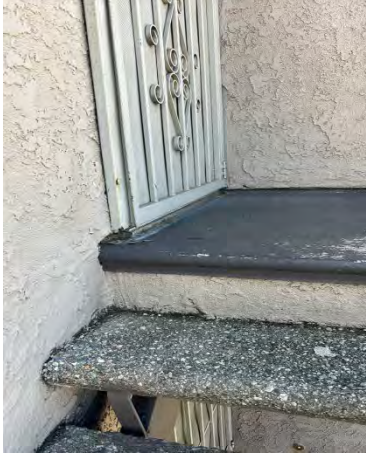
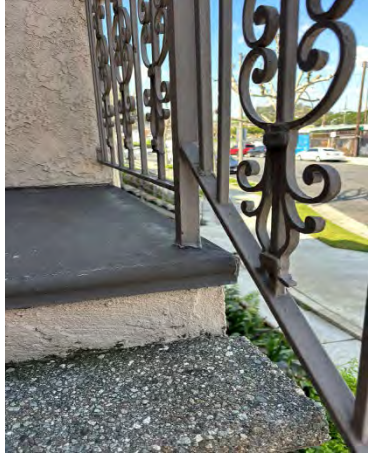
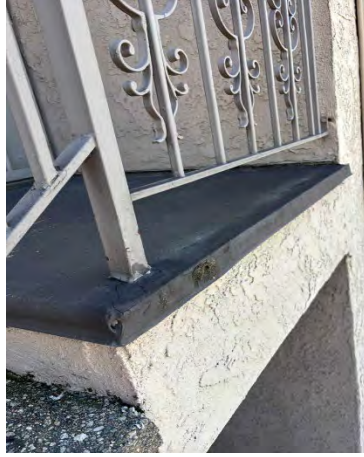
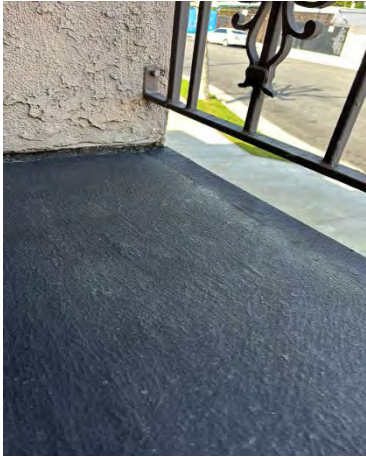
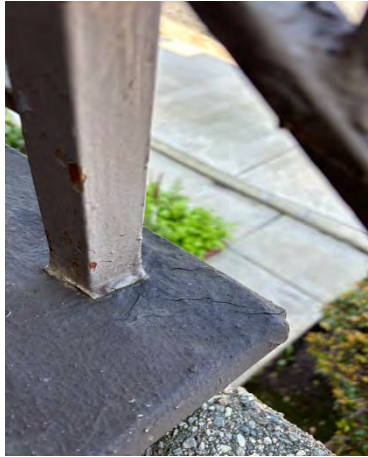
Building Name	5476-2
Apartment Name	97
Location Name	Entry deck
Visual Report	
Exterior Elements	Porches/Entry, Railings, Integrations, Door Threshold, Stucco Interface
Water Proofing Elements	Flashings, Waterproofing, Coatings, Sealants
Visual Review	Fair
Any Visual Signs of leaks	No
Further Invasive Review Required	No
Condition Assessment	Pass
Additional Considerations or Concerns	<p>Entry / Balcony / Walking Deck</p> <p>The deck is wood framed with waterproofing over the wood.</p> <p>Handrails are metal and attached to the deck surface and visually in good condition.</p>
Life Expectancy (EEE)	1-4 Years
Life Expectancy (LBC)	1-4 Years
Life Expectancy (AWE)	1-4 Years
Visual Photos

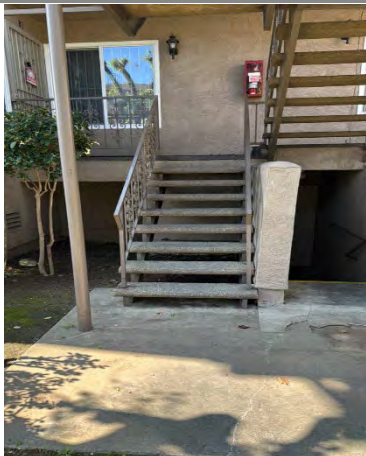
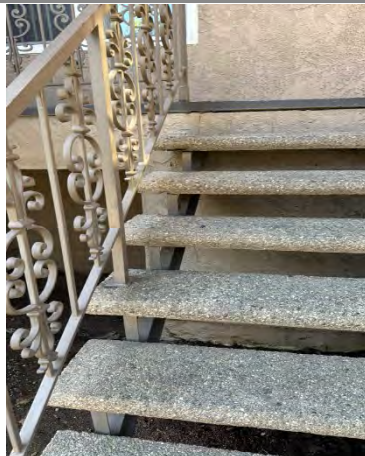
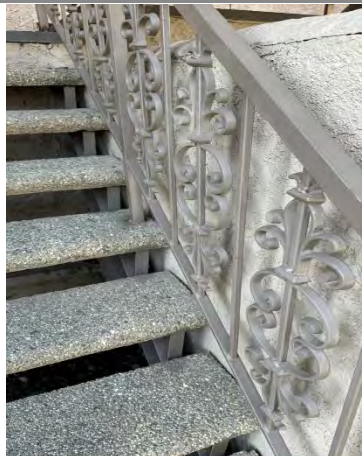
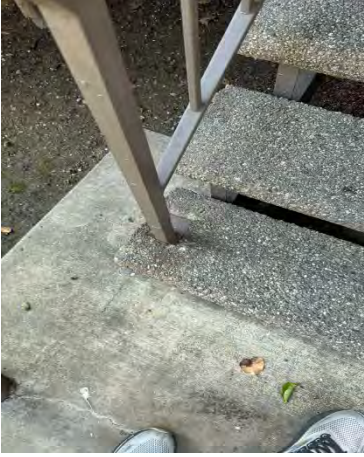
Exterior Elements	Stairs, Stairs Landing, Railings
Water Proofing Elements	Flashings, Waterproofing, Coatings, Sealants
Visual Review	Good
Any Visual Signs of leaks	No
Further Invasive Review Required	No
Condition Assessment	Pass
Additional Considerations or Concerns	<p><b>Railing at concrete</b></p> <p><b>Stairs are steel stringers attached to a wood structure with concrete treads.</b></p> <p><b>The handrails are visually in good condition.</b></p>
Life Expectancy (EEE)	1-4 Years
Life Expectancy (LBC)	4-7 Years
Life Expectancy (AWE)	1-4 Years

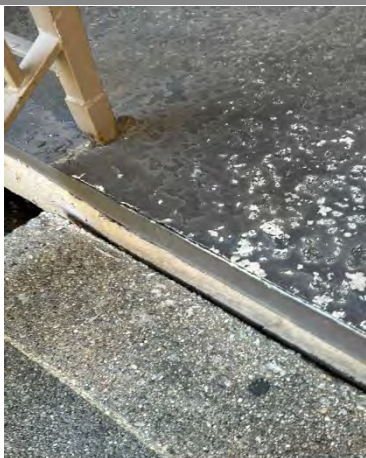
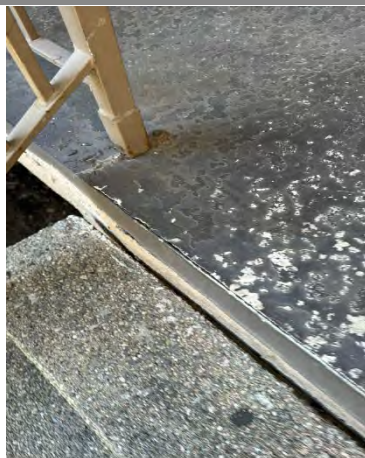
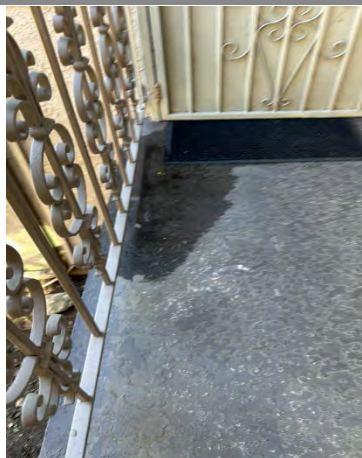
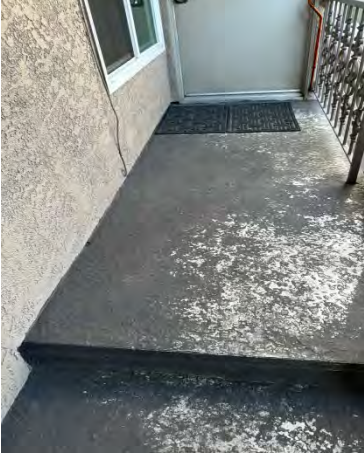
Exterior Elements	Decks, Stairs Landing, Railings, Integrations, Door Threshold, Stucco Interface
Water Proofing Elements	Flashings, Waterproofing, Coatings, Sealants
Visual Review	Fair
Any Visual Signs of leaks	No
Further Invasive Review Required	No
Condition Assessment	Pass
Additional Considerations or Concerns	The waterproofing is severely damaged. Replace or repair the waterproofing, including all damaged wood with new waterproofing and wood structures
Life Expectancy (EEE)	1-4 Years
Life Expectancy (LBC)	4-7 Years
Life Expectancy (AWE)	0-1 Years

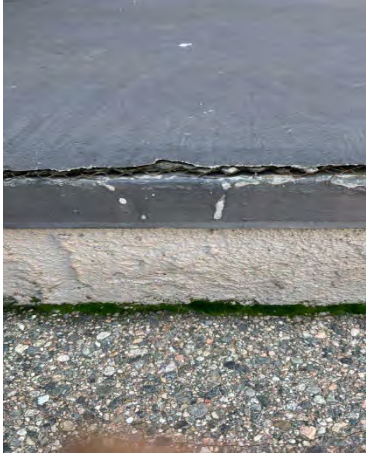
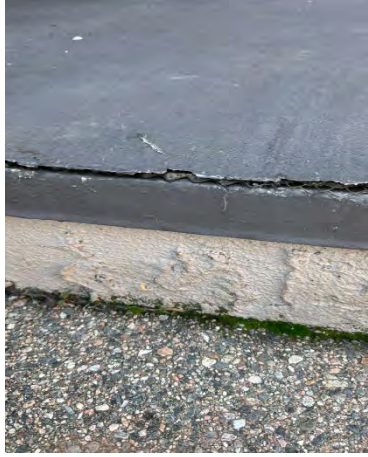
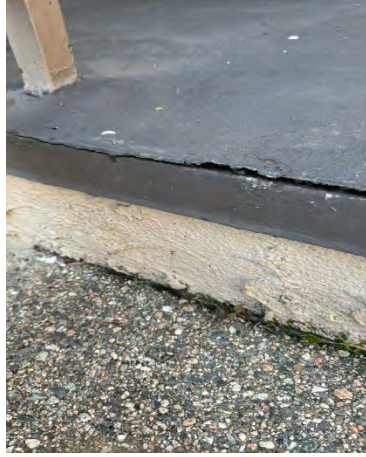
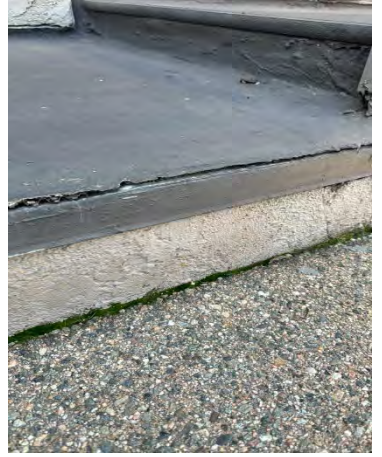
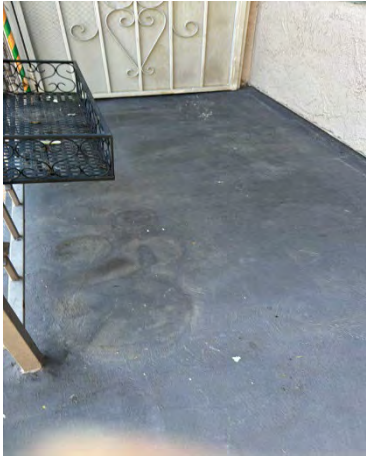
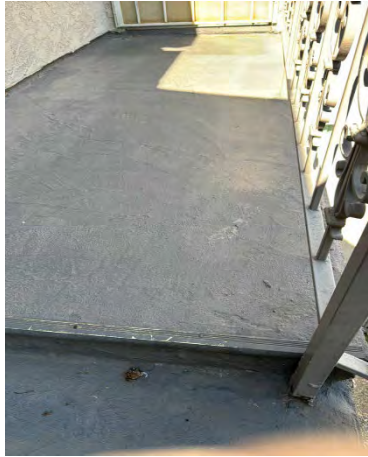
Exterior Elements	Decks, Door Threshold, Stucco Interface, Integrations, Railings
Water Proofing Elements	Flashings, Waterproofing, Coatings, Sealants
Visual Review	<b>Bad</b>
Any Visual Signs of leaks	<b>Yes</b>
Further Invasive Review Required	<b>No</b>
Condition Assessment	<b>Fail</b>
Additional Considerations or Concerns	<b>Entry / Balcony / Walking Deck</b>  <b>The deck is wood framed with waterproofing over the wood.</b>  <b>Handrails are metal and attached to the deck surface and visually in good condition.</b>  <b>The waterproofing is severely damaged. Replace or repair the waterproofing, including all damaged wood with new waterproofing and wood structures.</b>
Life Expectancy (EEE)	<b>1-4 Years</b>
Life Expectancy (LBC)	<b>4-7 Years</b>
Life Expectancy (AWE)	<b>0-1 Years</b>

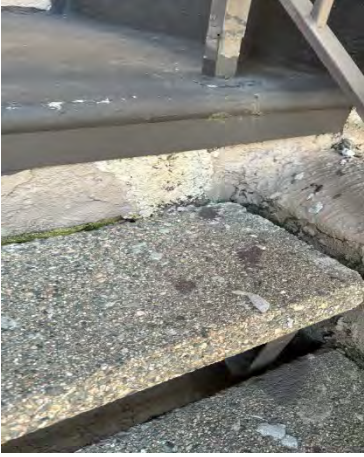
Building Name	5504
Apartment Name	77-79
Location Name	Stairs
Visual Report	
Exterior Elements	Stairs, Stairs Landing, Railings, Integrations
Water Proofing Elements	Flashings, Waterproofing, Coatings, Sealants
Visual Review	Good
Any Visual Signs of leaks	No
Further Invasive Review Required	No
Condition Assessment	Pass
Additional Considerations or Concerns	<p><b>Railing at concrete</b></p> <p><b>Stairs are steel stringers attached to a wood structure with concrete treads.</b></p> <p><b>The handrails are visually in good condition.</b></p>
Life Expectancy (EEE)	1-4 Years
Life Expectancy (LBC)	4-7 Years
Life Expectancy (AWE)	1-4 Years

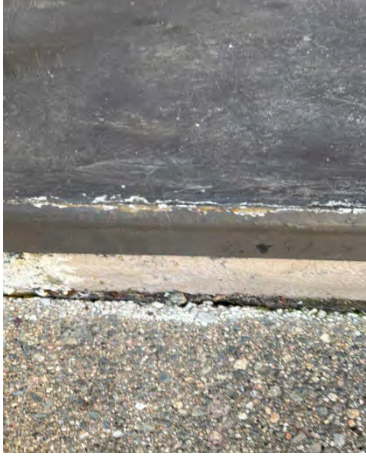
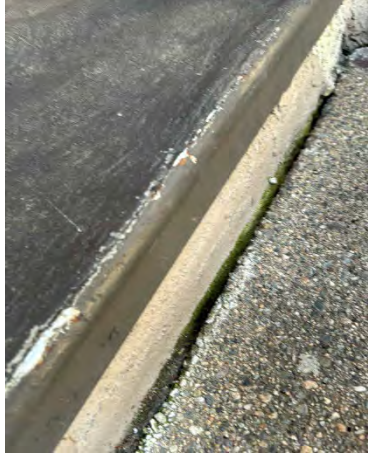
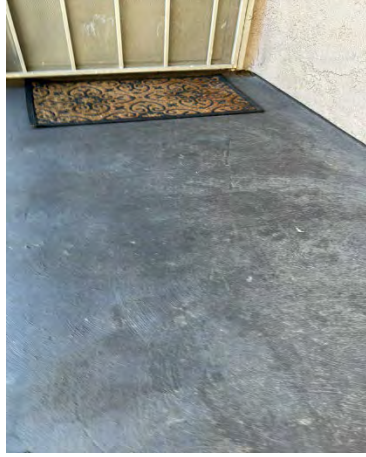
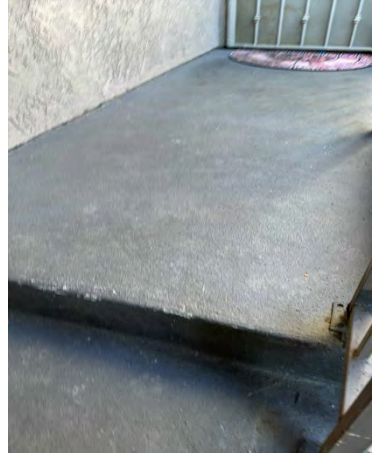
Exterior Elements	Decks, Railings, Integrations, Door Threshold, Stucco Interface
Water Proofing Elements	Flashings, Waterproofing, Coatings, Sealants
Visual Review	<b>Bad</b>
Any Visual Signs of leaks	<b>Yes</b>
Further Invasive Review Required	<b>No</b>
Condition Assessment	<b>Fail</b>
Additional Considerations or Concerns	<p><b>Entry / Balcony / Walking Deck</b></p> <p><b>The deck is wood framed with waterproofing over the wood.</b></p> <p><b>Handrails are metal and attached to the deck surface and visually in good condition.</b></p> <p><b>The waterproofing is severely damaged. Replace or repair the waterproofing, including all damaged wood with new waterproofing and wood structures</b></p>
Life Expectancy (EEE)	<b>1-4 Years</b>
Life Expectancy (LBC)	<b>4-7 Years</b>
Life Expectancy (AWE)	<b>0-1 Years</b>

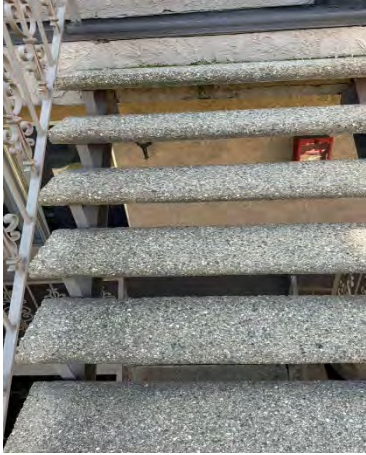
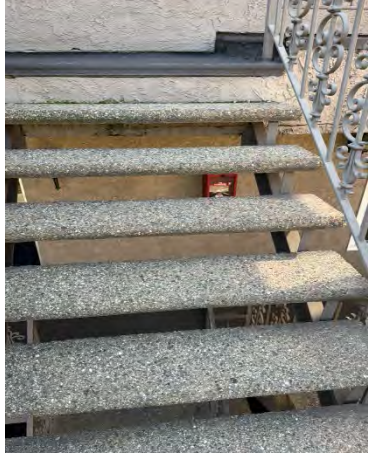
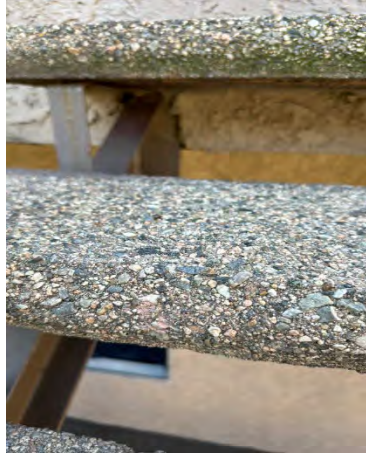
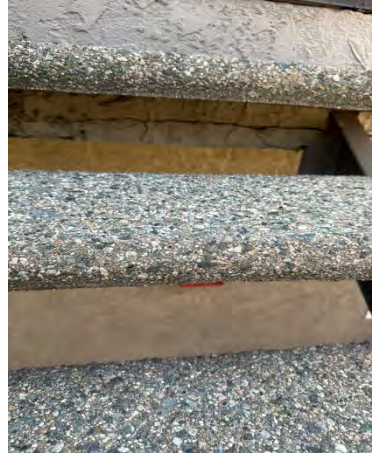
Exterior Elements	Stairs, Stairs Landing, Railings, Integrations
Water Proofing Elements	Flashings, Waterproofing, Coatings, Sealants
Visual Review	Good
Any Visual Signs of leaks	No
Further Invasive Review Required	No
Condition Assessment	Pass
Additional Considerations or Concerns	<p><b>Railing at concrete</b></p> <p><b>Stairs are steel stringers attached to a wood structure with concrete treads.</b></p> <p><b>The handrails are visually in good condition.</b></p>
Life Expectancy (EEE)	1-4 Years
Life Expectancy (LBC)	4-7 Years
Life Expectancy (AWE)	1-4 Years

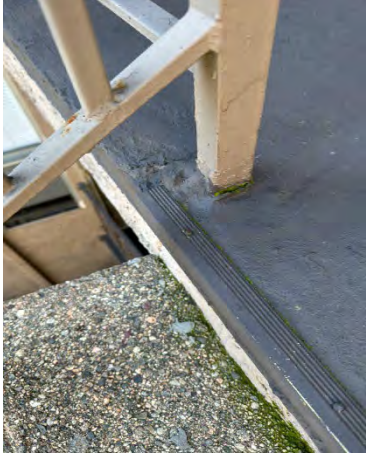
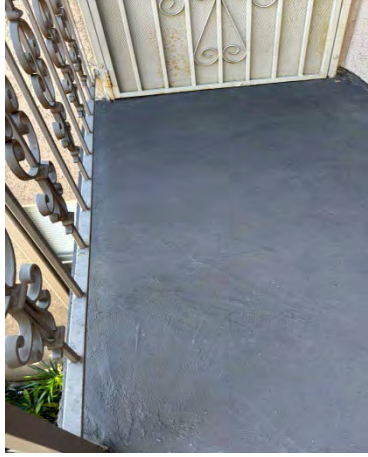
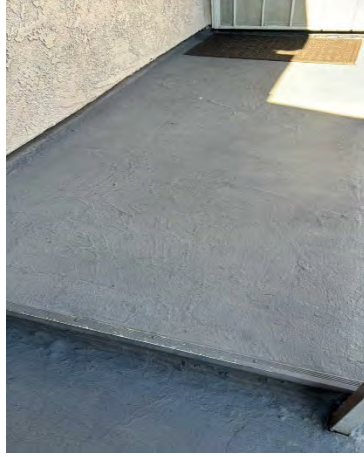
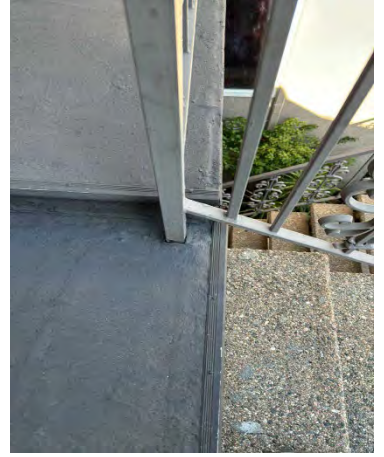
Building Name	5504
Apartment Name	78-80
Location Name	Entry deck
Visual Report	
Exterior Elements	Decks, Integrations, Door Threshold, Stucco Interface, Railings
Water Proofing Elements	Flashings, Waterproofing, Coatings, Sealants
Visual Review	Good
Any Visual Signs of leaks	No
Further Invasive Review Required	No
Condition Assessment	Pass
Additional Considerations or Concerns	<p>Entry / Balcony / Walking Deck</p> <p>The deck is wood framed with waterproofing over the wood.</p> <p>Handrails are metal and attached to the deck surface and visually in good condition.</p>
Life Expectancy (EEE)	1-4 Years
Life Expectancy (LBC)	4-7 Years
Life Expectancy (AWE)	1-4 Years
Visual Photos

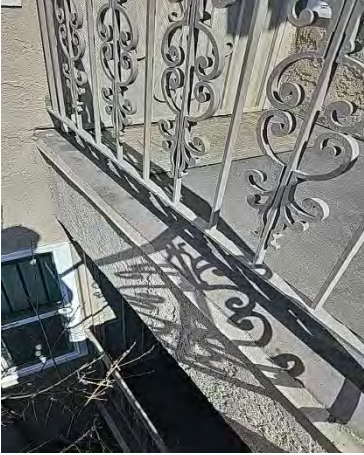
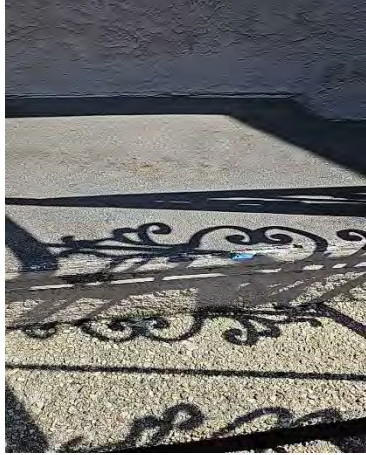
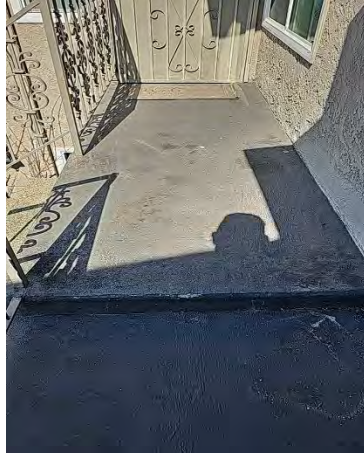
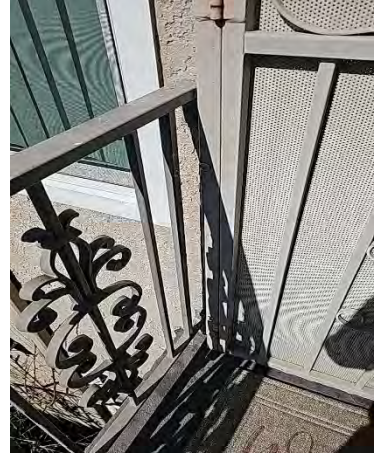
Building Name	5488-1
Apartment Name	103
Location Name	Entry deck
Visual Report	
Exterior Elements	Decks, Railings, Integrations, Stucco Interface
Water Proofing Elements	Flashings, Waterproofing, Coatings, Sealants
Visual Review	Bad
Any Visual Signs of leaks	Yes
Further Invasive Review Required	No
Condition Assessment	Fail
Additional Considerations or Concerns	<p>Entry / Balcony / Walking Deck</p> <p>The deck is wood framed with waterproofing over the wood.</p> <p>Handrails are metal and attached to the deck surface and visually in good condition.</p> <p>The waterproofing is severely damaged. Replace or repair the waterproofing, including all damaged wood with new waterproofing and wood structures.</p>
Life Expectancy (EEE)	0-1 Years
Life Expectancy (LBC)	1-4 Years
Life Expectancy (AWE)	0-1 Years

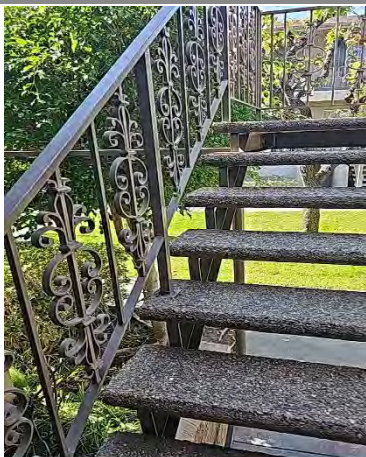
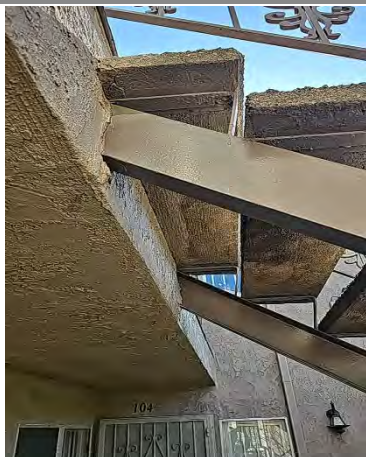
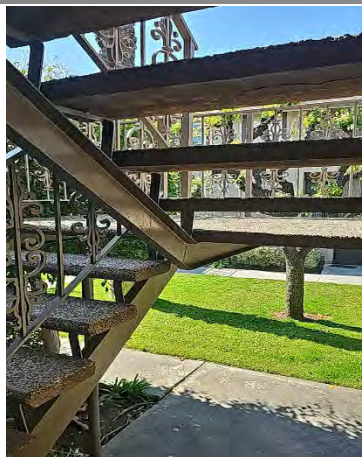
Exterior Elements	Stairs, Railings, Integrations, Stucco Interface
Water Proofing Elements	Flashings, Waterproofing, Coatings, Sealants
Visual Review	Fair
Any Visual Signs of leaks	No
Further Invasive Review Required	No
Condition Assessment	Pass
Additional Considerations or Concerns	Signs of rust at the hand rail attachments. Repair as necessary. Surface rust on handrail
Life Expectancy (EEE)	1-4 Years
Life Expectancy (LBC)	1-4 Years
Life Expectancy (AWE)	1-4 Years

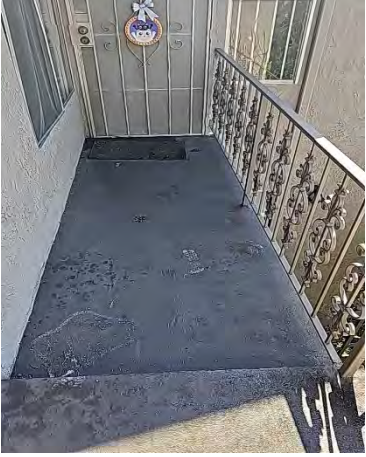
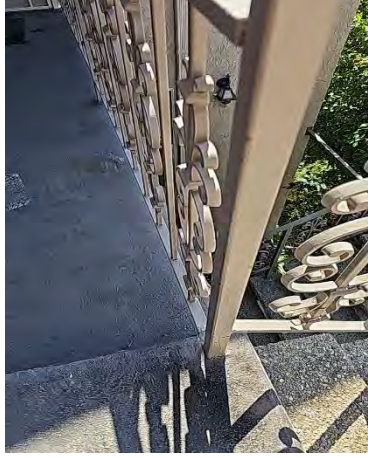
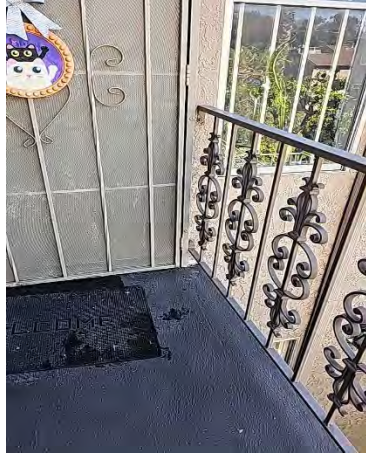
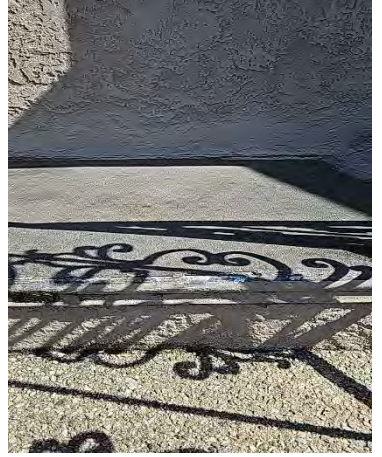
Building Name	5488-1
Apartment Name	105
Location Name	Entry decks
Visual Report	
Exterior Elements	Decks, Railings, Integrations, Stucco Interface
Water Proofing Elements	Flashings, Waterproofing, Coatings, Sealants
Visual Review	Bad
Any Visual Signs of leaks	No
Further Invasive Review Required	No
Condition Assessment	Fail
Additional Considerations or Concerns	<p>Entry / Balcony / Walking Deck</p> <p>The deck is wood framed with waterproofing over the wood.</p> <p>Handrails are metal and attached to the deck surface and visually in good condition.</p> <p>The waterproofing is severely damaged. Replace or repair the waterproofing, including all damaged wood with new waterproofing and wood structures.</p>
Life Expectancy (EEE)	0-1 Years
Life Expectancy (LBC)	1-4 Years
Life Expectancy (AWE)	0-1 Years
