## DECK INSPECTORS INC.

#### Part 2 of Visual Inspection:

Autumn Pointe HOA

55488 Dobbs St.

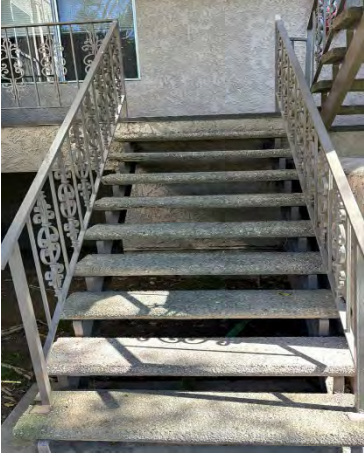
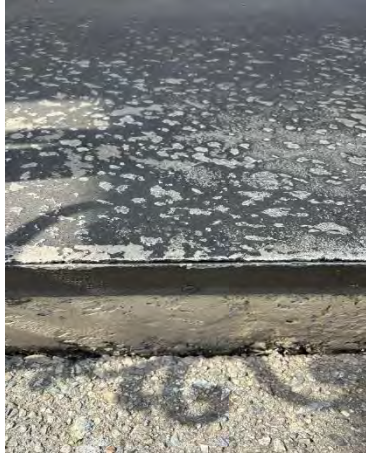
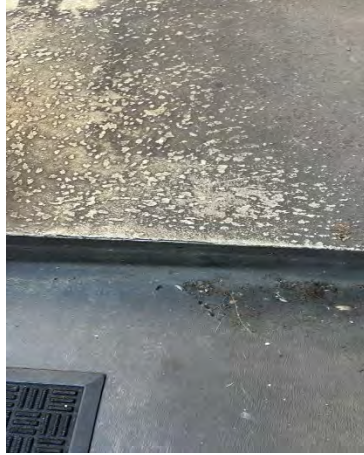
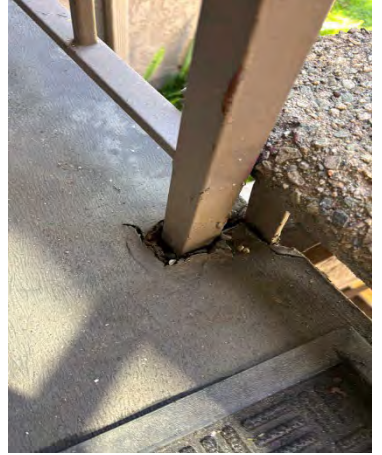
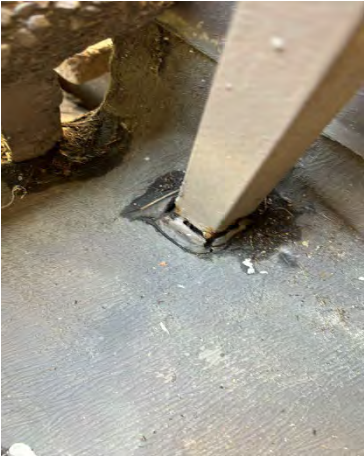
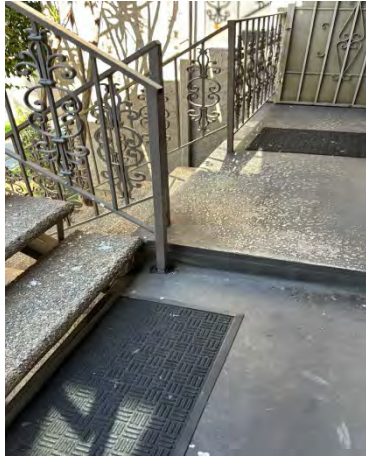
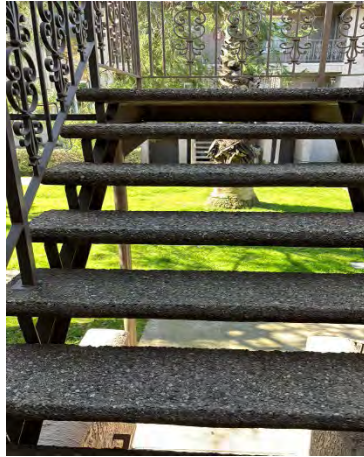
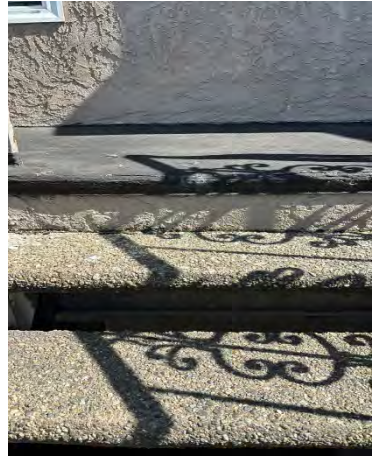
Exterior Elements	Stairs Landing, Railings, Integrations
Water Proofing Elements	Flashings, Waterproofing, Coatings, Sealants
Visual Review	<b>Bad</b>
Any Visual Signs of leaks	<b>Yes</b>
Further Invasive Review Required	<b>No</b>
Condition Assessment	<b>Fail</b>

**Handrails are metal and attached to the deck surface and visually in good condition.**

**The waterproofing is severely damaged.  
Replace or repair the waterproofing, including all damaged wood with new waterproofing and wood structures.**

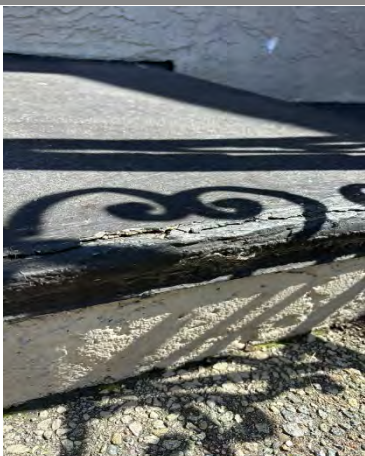
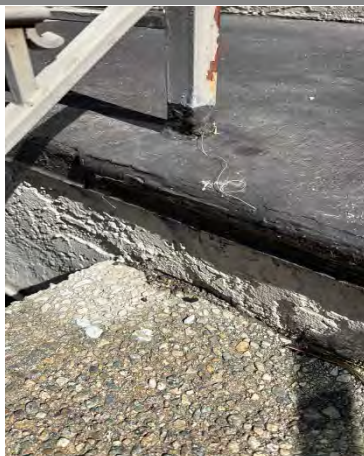
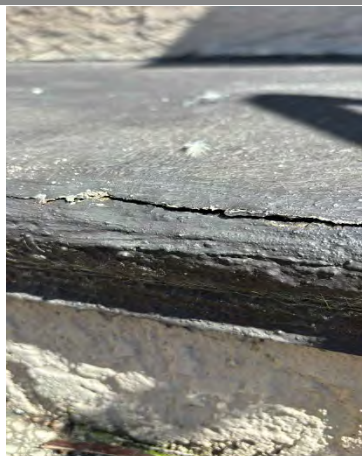
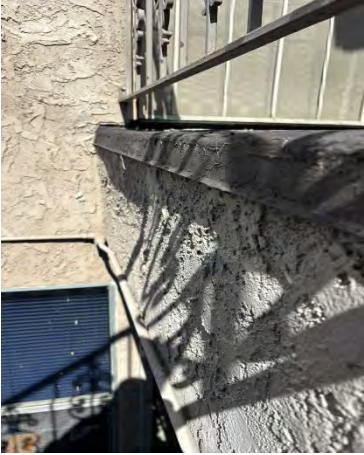
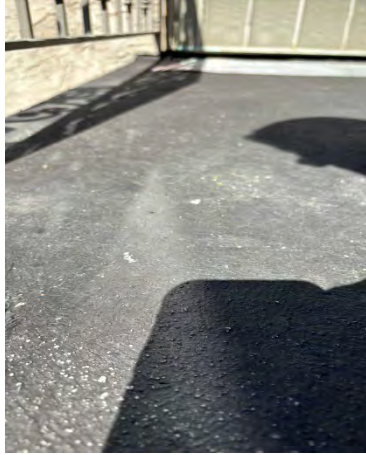
Exterior Elements	Porches/Entry, Railings, Integrations, Door Threshold, Stucco Interface
Water Proofing Elements	Flashings, Waterproofing, Coatings, Sealants
Visual Review	<b>Bad</b>
Any Visual Signs of leaks	<b>Yes</b>
Further Invasive Review Required	<b>Yes</b>
Condition Assessment	<b>Fail</b>
Additional Considerations or Concerns	<b>Deck has significant humps and bulges in the deck coating. Recommend further investigation at this locations.</b>
Life Expectancy (EEE)	<b>0-1 Years</b>
Life Expectancy (LBC)	<b>0-1 Years</b>
Life Expectancy (AWE)	<b>0-1 Years</b>

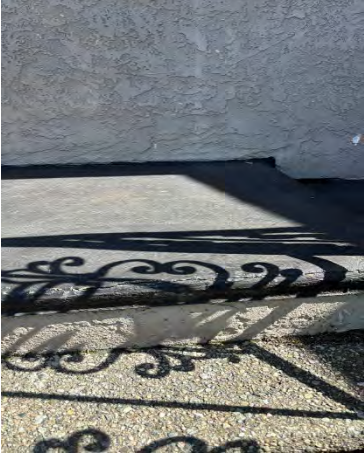
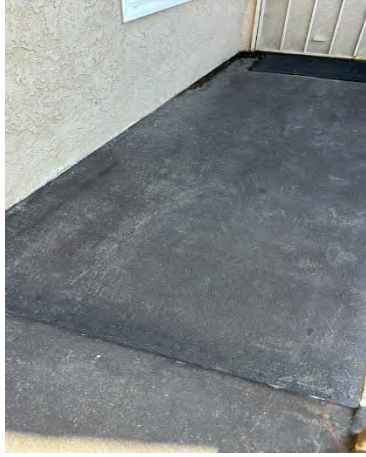
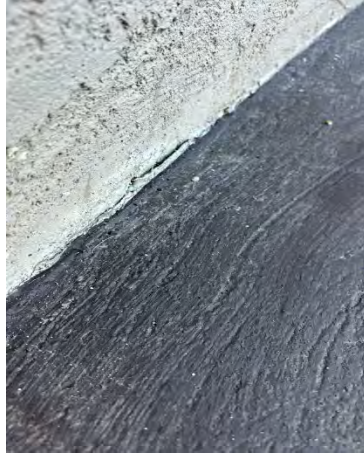
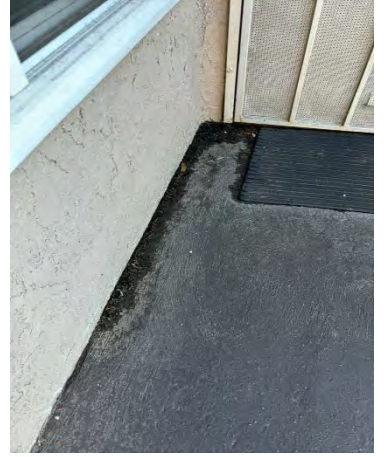
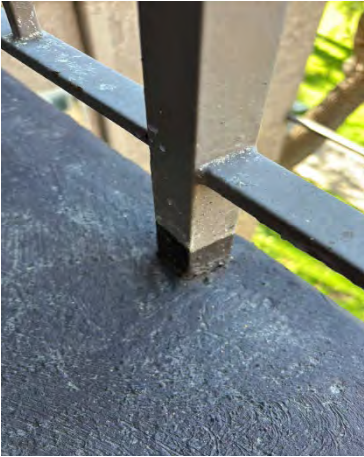
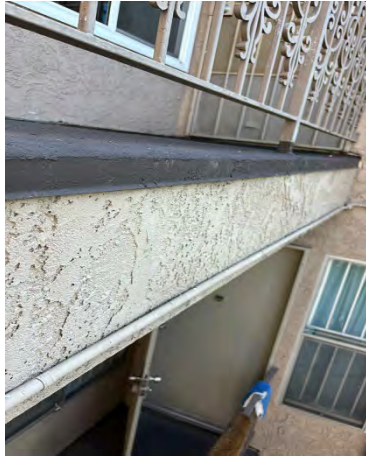
Building Name	5488-2
Apartment Name	101
Location Name	Entry deck
Visual Report	
Exterior Elements	Porches/Entry, Railings, Integrations, Door Threshold, Stucco Interface
Water Proofing Elements	Flashings, Waterproofing, Coatings, Sealants
Visual Review	Fair
Any Visual Signs of leaks	No
Further Invasive Review Required	No
Condition Assessment	Pass
Additional Considerations or Concerns	<p>Entry / Balcony / Walking Deck</p> <p>The deck is wood framed with waterproofing over the wood.</p> <p>Handrails are metal and attached to the deck surface and visually in good condition.</p>
Life Expectancy (EEE)	1-4 Years
Life Expectancy (LBC)	1-4 Years
Life Expectancy (AWE)	1-4 Years
Visual Photos

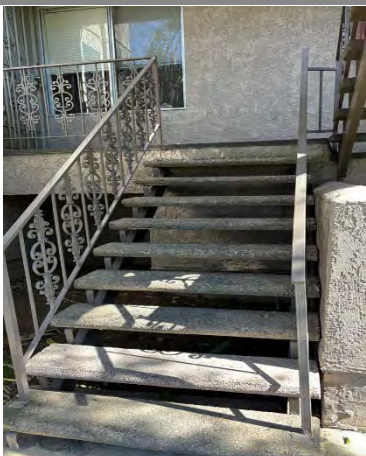
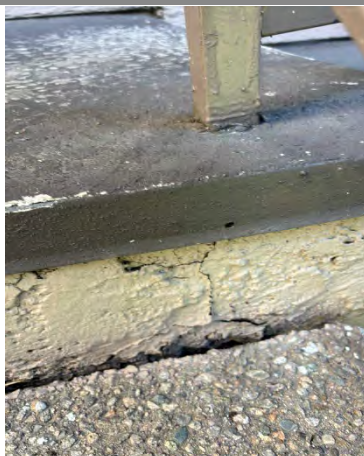
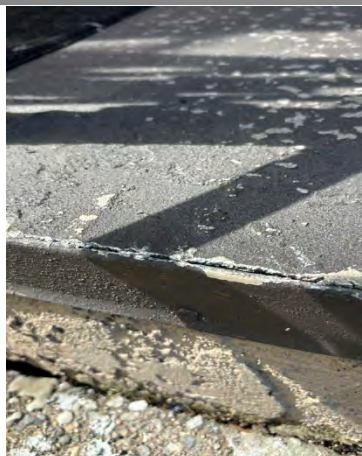
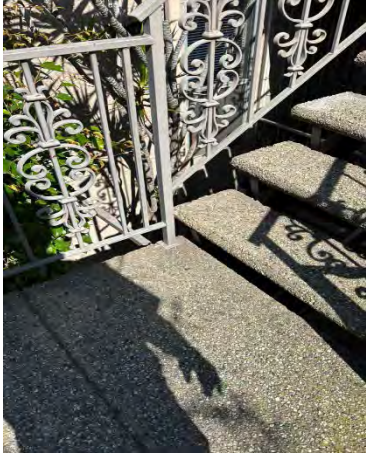
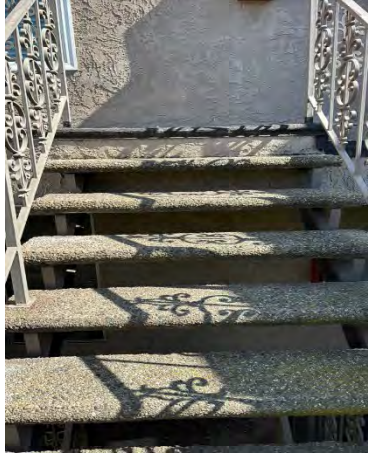
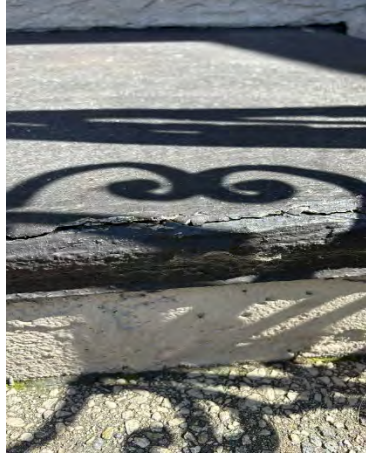
Building Name	5488-2
Apartment Name	101
Location Name	Stairs

Exterior Elements	Stairs, Stairs Landing, Stucco Interface, Integrations, Railings
Water Proofing Elements	Flashings, Waterproofing, Coatings, Sealants
Visual Review	<b>Bad</b>
Any Visual Signs of leaks	<b>No</b>
Further Invasive Review Required	<b>Yes</b>
Condition Assessment	<b>Fail</b>
Additional Considerations or Concerns	<b>Delamination of the stucco around the bottom landing stringer attachment. Further investigation recommended.</b>
Life Expectancy (EEE)	<b>0-1 Years</b>
Life Expectancy (LBC)	<b>4-7 Years</b>
Life Expectancy (AWE)	<b>0-1 Years</b>

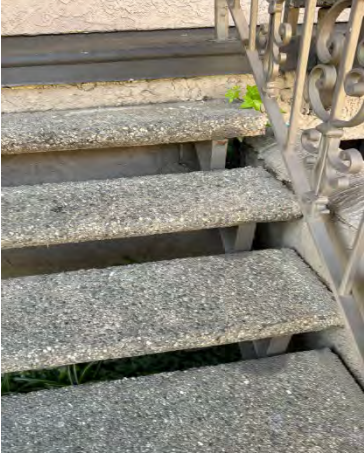
Exterior Elements	Stairs, Stairs Landing, Railings, Integrations
Water Proofing Elements	Flashings, Waterproofing, Coatings, Sealants
Visual Review	Good
Any Visual Signs of leaks	No
Further Invasive Review Required	No
Condition Assessment	Pass
Additional Considerations or Concerns	<p><b>Railing at concrete</b></p> <p><b>Stairs are steel stringers attached to a wood structure with concrete treads.</b></p> <p><b>The handrails are visually in good condition</b></p>
Life Expectancy (EEE)	1-4 Years
Life Expectancy (LBC)	4-7 Years
Life Expectancy (AWE)	1-4 Years

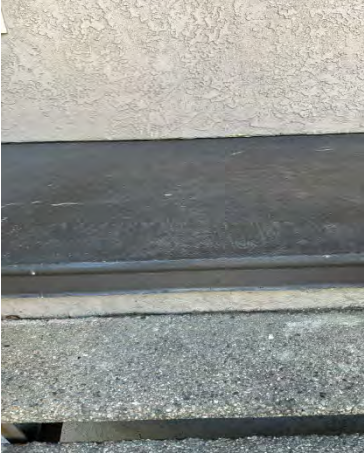
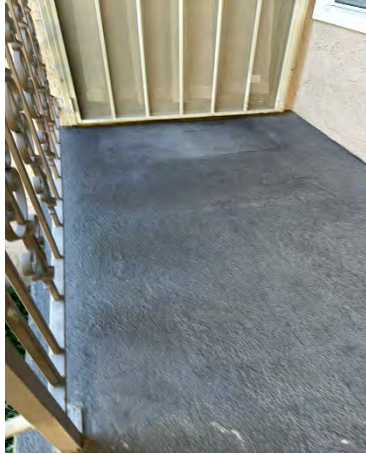
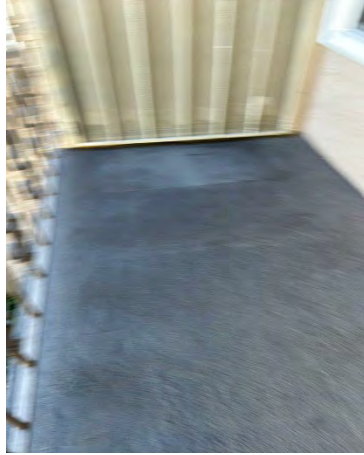
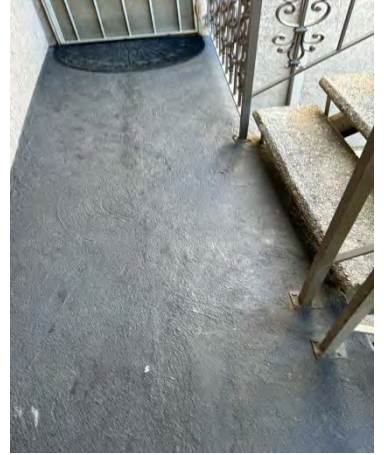
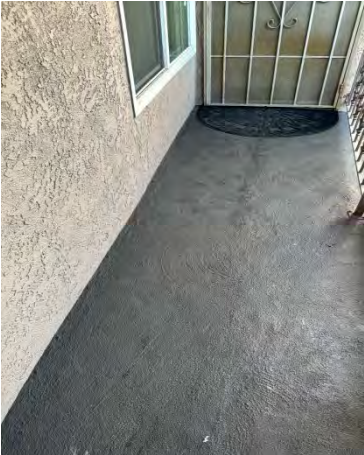
Building Name	5502
Apartment Name	73-75
Location Name	Entry deck
Visual Report	
Exterior Elements	Decks, Stucco Interface, Door Threshold, Integrations, Railings
Water Proofing Elements	Flashings, Waterproofing, Coatings, Sealants
Visual Review	Good
Any Visual Signs of leaks	No
Further Invasive Review Required	No
Condition Assessment	Pass
Additional Considerations or Concerns	<p>Entry / Balcony / Walking Deck</p> <p>The deck is wood framed with waterproofing over the wood.</p> <p>Handrails are metal and attached to the deck surface and visually in good condition.</p>
Life Expectancy (EEE)	1-4 Years
Life Expectancy (LBC)	4-7 Years
Life Expectancy (AWE)	1-4 Years
Visual Photos

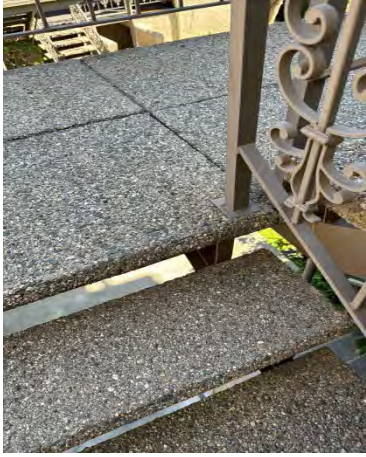
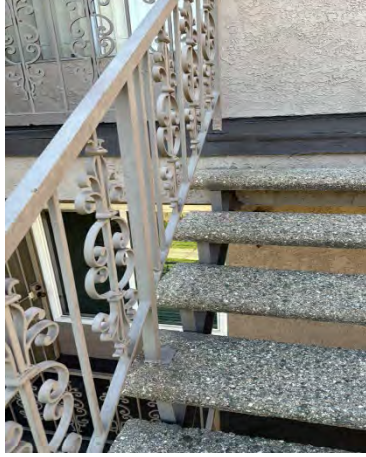
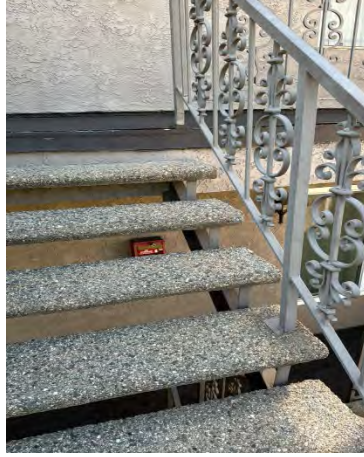
Exterior Elements	Stairs, Stairs Landing, Railings, Integrations
Water Proofing Elements	Flashings, Waterproofing, Coatings, Sealants
Visual Review	Good
Any Visual Signs of leaks	No
Further Invasive Review Required	No
Condition Assessment	Pass
Additional Considerations or Concerns	Railing at concrete Stairs are steel stringers attached to a wood structure with concrete treads. The handrails are visually in good condition
Life Expectancy (EEE)	1-4 Years
Life Expectancy (LBC)	4-7 Years
Life Expectancy (AWE)	1-4 Years

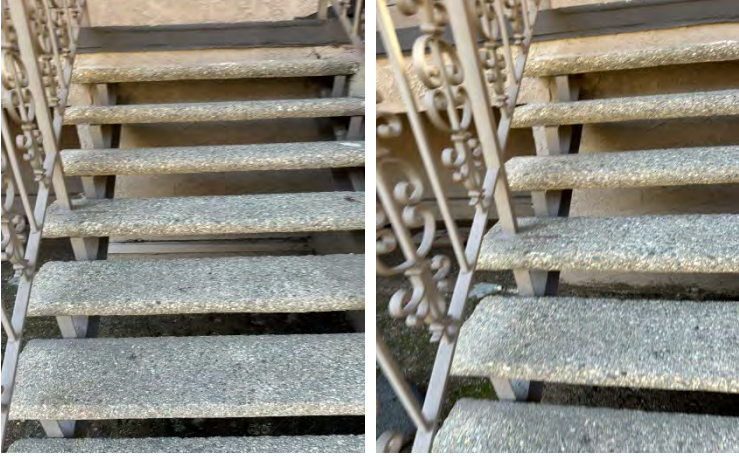
Exterior Elements	Stairs, Stairs Landing, Railings, Integrations
Water Proofing Elements	Flashings, Waterproofing, Coatings, Sealants
Visual Review	Good
Any Visual Signs of leaks	No
Further Invasive Review Required	No
Condition Assessment	Pass
Additional Considerations or Concerns	<p><b>Railing at concrete</b></p> <p><b>Stairs are steel stringers attached to a wood structure with concrete treads.</b></p> <p><b>The handrails are visually in good condition.</b></p>
Life Expectancy (EEE)	1-4 Years
Life Expectancy (LBC)	4-7 Years
Life Expectancy (AWE)	1-4 Years

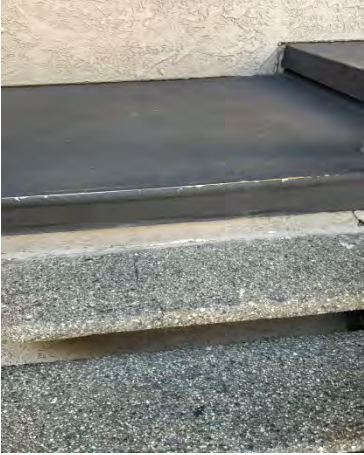
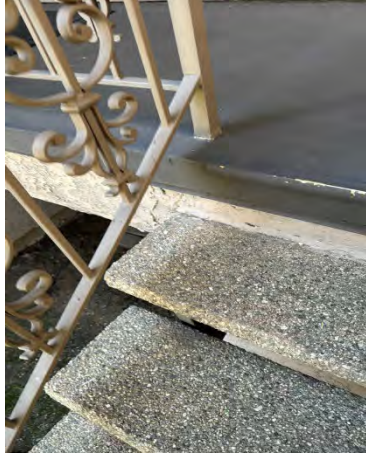
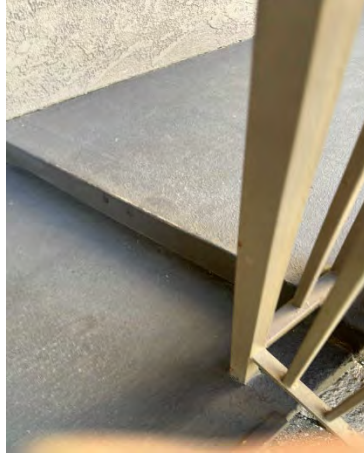
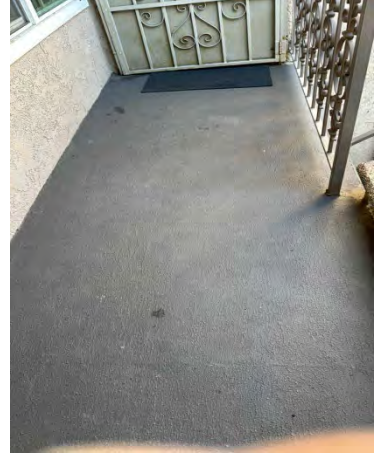
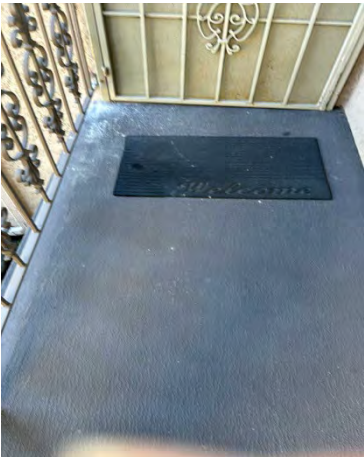
Building Name	5502
Apartment Name	69-71
Location Name	Entry deck
Visual Report	
Exterior Elements	Decks, Railings, Integrations, Door Threshold, Stucco Interface
Water Proofing Elements	Flashings, Waterproofing, Coatings, Sealants
Visual Review	Good
Any Visual Signs of leaks	No
Further Invasive Review Required	No
Condition Assessment	Pass
Additional Considerations or Concerns	<p>Entry / Balcony / Walking Deck</p> <p>The deck is wood framed with waterproofing over the wood.</p> <p>Handrails are metal and attached to the deck surface and visually in good condition.</p>
Life Expectancy (EEE)	1-4 Years
Life Expectancy (LBC)	4-7 Years
Life Expectancy (AWE)	1-4 Years
Visual Photos

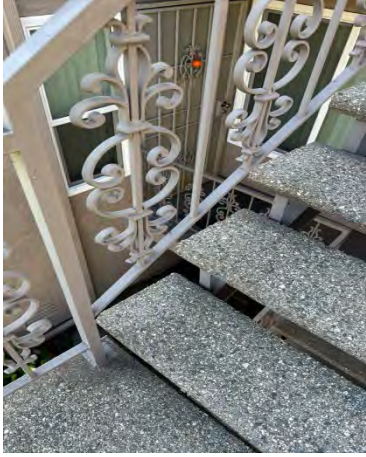
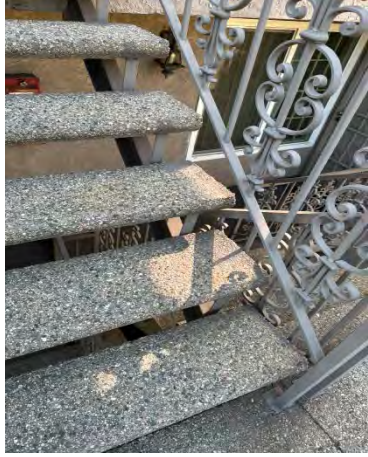
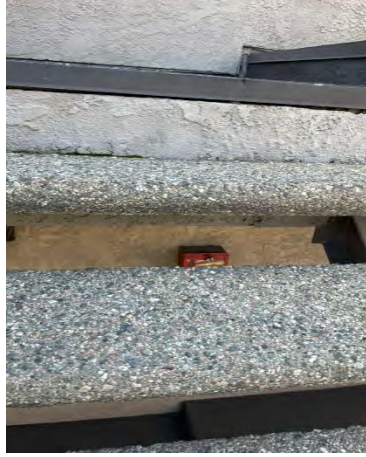
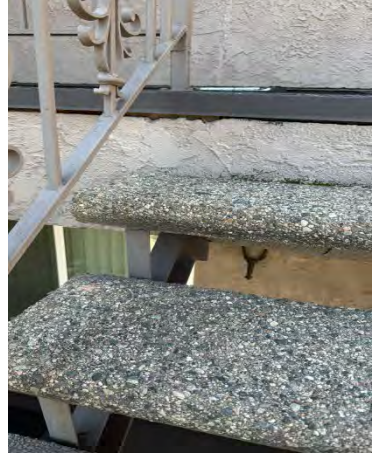
Building Name	5502
Apartment Name	70-72
Location Name	Stairs
Visual Report	
Exterior Elements	Porches/Entry, Stairs, Stairs Landing, Railings
Water Proofing Elements	Flashings, Waterproofing, Coatings, Sealants
Visual Review	Good
Any Visual Signs of leaks	No
Further Invasive Review Required	No
Condition Assessment	Pass
Additional Considerations or Concerns	<p><b>Railing at concrete</b></p> <p><b>Stairs are steel stringers attached to a wood structure with concrete treads.</b></p> <p><b>The handrails are visually in good condition.</b></p>
Life Expectancy (EEE)	1-4 Years
Life Expectancy (LBC)	4-7 Years
Life Expectancy (AWE)	1-4 Years

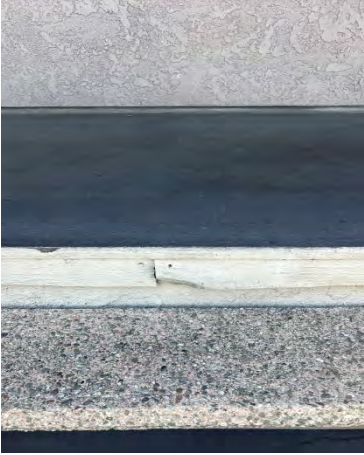
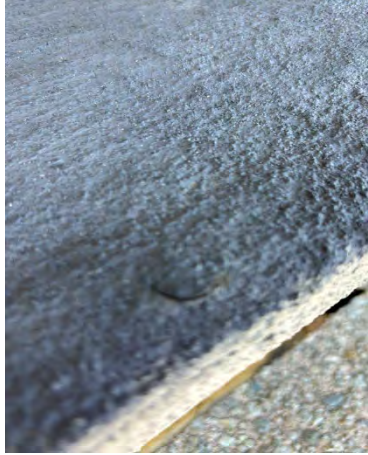
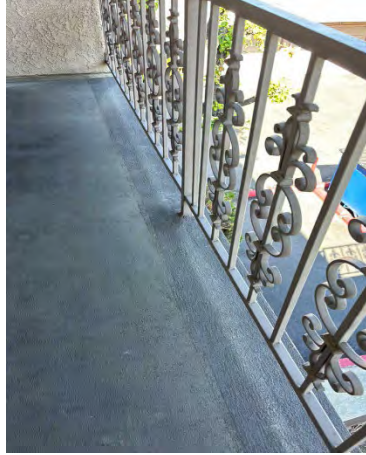
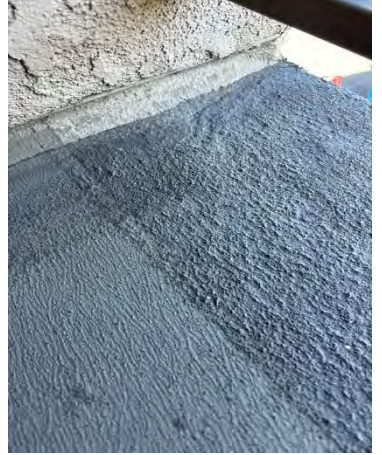
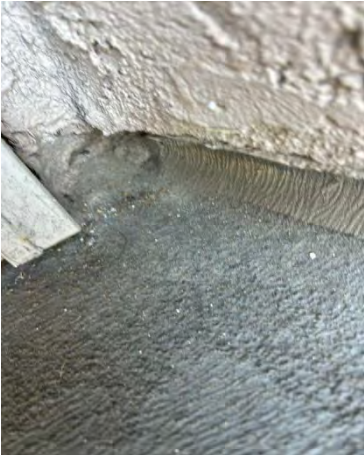
Exterior Elements	Porches/Entry, Railings, Integrations, Stucco Interface
Water Proofing Elements	Flashings, Waterproofing, Coatings, Sealants
Visual Review	Fair
Any Visual Signs of leaks	No
Further Invasive Review Required	No
Condition Assessment	Fail

Handrails are metal and attached to the deck surface and visually in good condition.

The waterproofing is severely damaged.  
Replace or repair the waterproofing, including all damaged wood with new waterproofing and wood structures.

Life Expectancy (EEE)	0-1 Years
Life Expectancy (LBC)	1-4 Years
Life Expectancy (AWE)	0-1 Years

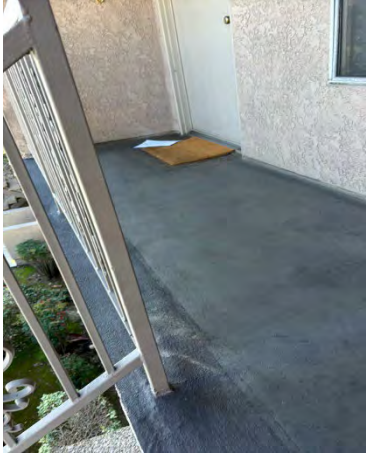
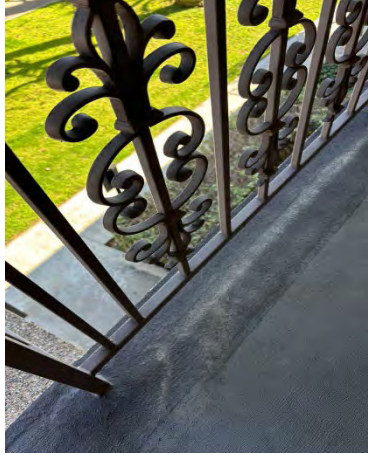
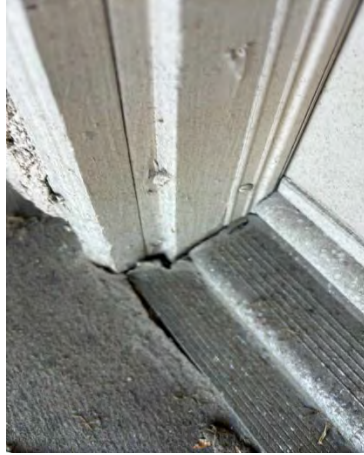
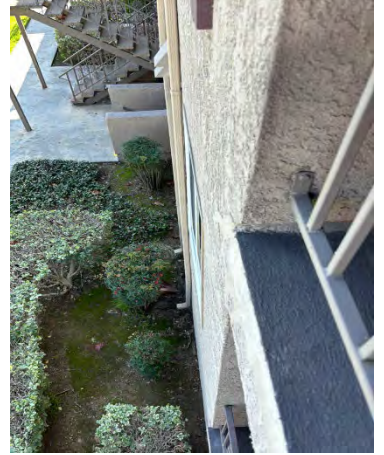
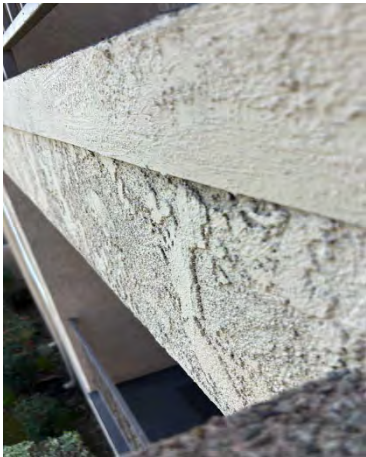
Exterior Elements	Porches/Entry, Railings, Integrations, Door Threshold, Stucco Interface
Water Proofing Elements	Flashings, Waterproofing, Coatings, Sealants
Visual Review	<b>Bad</b>
Any Visual Signs of leaks	<b>No</b>
Further Invasive Review Required	<b>No</b>
Condition Assessment	<b>Fail</b>
Additional Considerations or Concerns	<b>Entry / Balcony / Walking Deck</b>  <b>The deck is wood framed with waterproofing over the wood.</b>  <b>Handrails are metal and attached to the deck surface and visually in good condition.</b>  <b>The waterproofing is severely damaged. Replace or repair the waterproofing, including all damaged wood with new waterproofing and wood structures.</b>
Life Expectancy (EEE)	<b>0-1 Years</b>
Life Expectancy (LBC)	<b>1-4 Years</b>
Life Expectancy (AWE)	<b>0-1 Years</b>

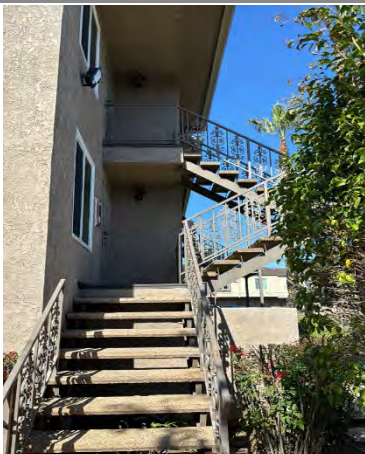
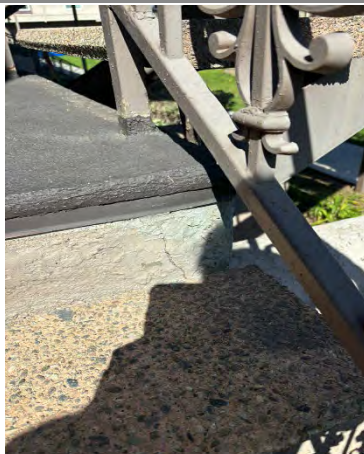
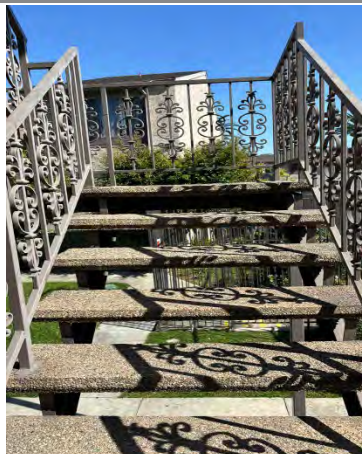
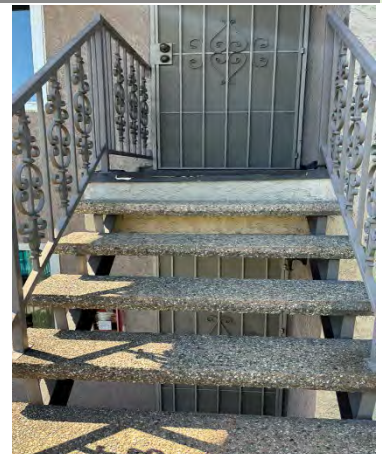
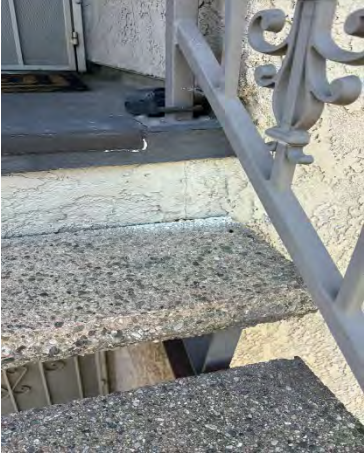
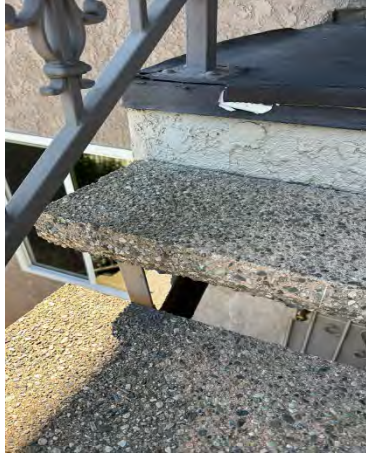
Exterior Elements	Stairs, Stairs Landing, Stucco Interface
Water Proofing Elements	Flashings, Waterproofing, Coatings, Sealants
Visual Review	Fair
Any Visual Signs of leaks	No
Further Invasive Review Required	No
Condition Assessment	Pass
Additional Considerations or Concerns	<p><b>Railing at concrete</b></p> <p><b>Stairs are steel stringers attached to a wood structure with concrete treads.</b></p> <p><b>The handrails are visually in good condition.</b></p>
Life Expectancy (EEE)	1-4 Years
Life Expectancy (LBC)	1-4 Years
Life Expectancy (AWE)	1-4 Years

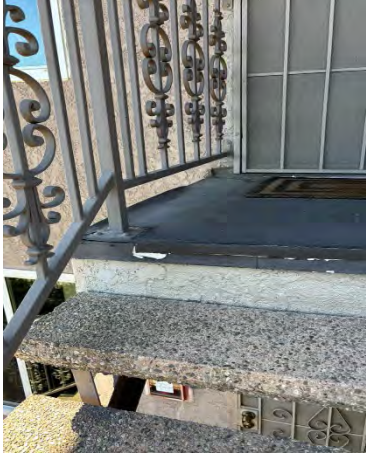
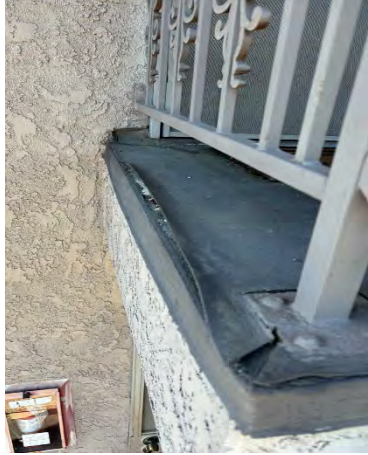
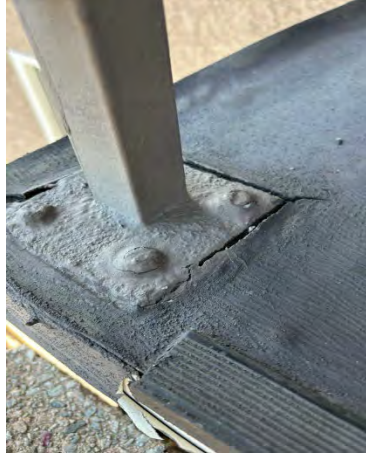
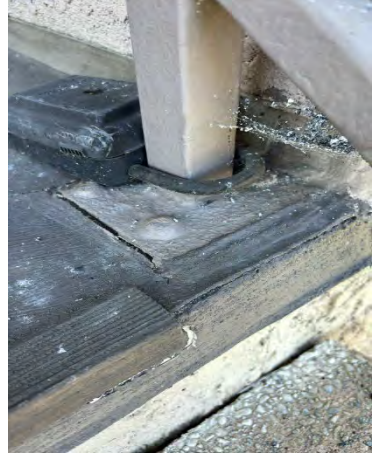
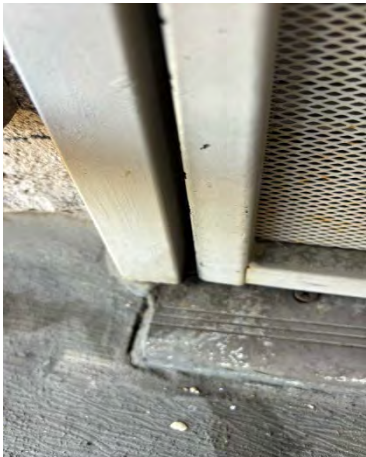
Exterior Elements	Porches/Entry, Railings, Integrations, Door Threshold, Stucco Interface
Water Proofing Elements	Flashings, Waterproofing, Coatings, Sealants
Visual Review	<b>Bad</b>
Any Visual Signs of leaks	<b>Yes</b>
Further Invasive Review Required	<b>Yes</b>
Condition Assessment	<b>Fail</b>
Additional Considerations or Concerns	<b>Entry / Balcony / Walking Deck</b>  <b>The deck is wood framed with waterproofing over the wood.</b>  <b>Handrails are metal and attached to the deck surface and visually in good condition.</b>  <b>The waterproofing is severely damaged. Replace or repair the waterproofing, including all damaged wood with new waterproofing and wood structures.</b>
Life Expectancy (EEE)	<b>0-1 Years</b>
Life Expectancy (LBC)	<b>0-1 Years</b>
Life Expectancy (AWE)	<b>0-1 Years</b>

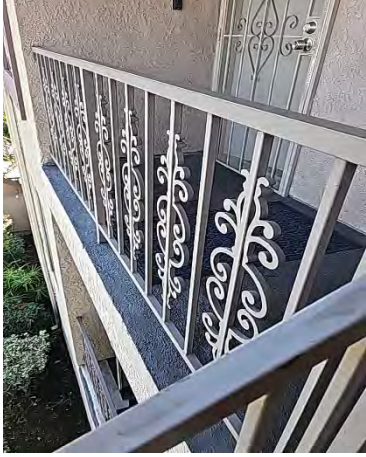
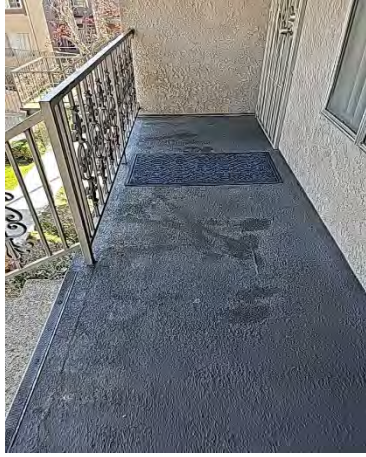
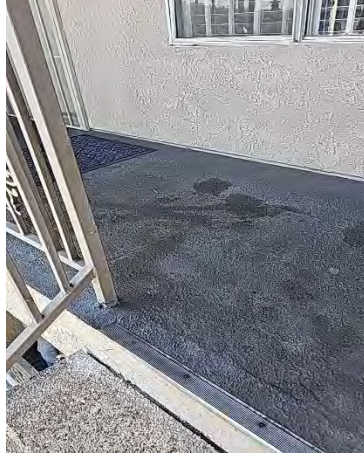
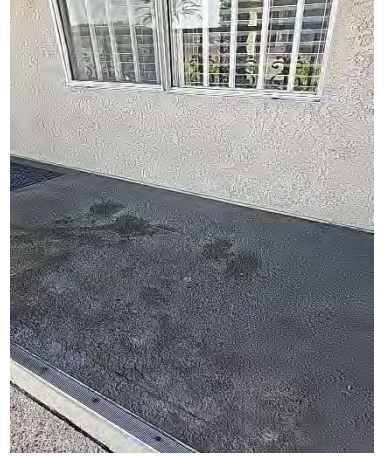
Building Name	5484-2
Apartment Name	133
Location Name	Entry deck
Visual Report	
Exterior Elements	Decks, Railings, Integrations, Stucco Interface
Water Proofing Elements	Flashings, Waterproofing, Coatings, Sealants
Visual Review	Fair
Any Visual Signs of leaks	No
Further Invasive Review Required	No
Condition Assessment	Pass
Additional Considerations or Concerns	<p>Entry / Balcony / Walking Deck</p> <p>The deck is wood framed with waterproofing over the wood.</p> <p>Handrails are metal and attached to the deck surface and visually in good condition</p>
Life Expectancy (EEE)	1-4 Years
Life Expectancy (LBC)	1-4 Years
Life Expectancy (AWE)	1-4 Years
Visual Photos

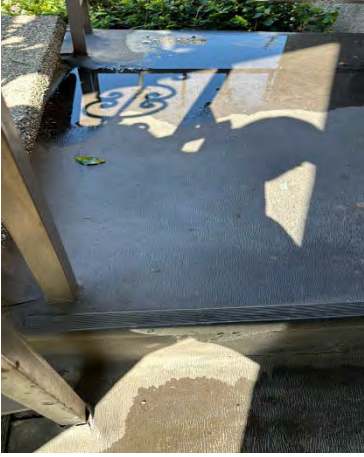
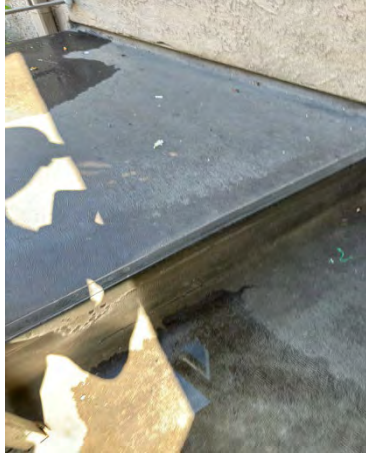
Exterior Elements	Decks, Railings, Integrations, Door Threshold, Stucco Interface
Water Proofing Elements	Flashings, Waterproofing, Coatings, Sealants
Visual Review	<b>Bad</b>
Any Visual Signs of leaks	<b>Yes</b>
Further Invasive Review Required	<b>No</b>
Condition Assessment	<b>Fail</b>
Additional Considerations or Concerns	<b>The waterproofing is severely damaged. Replace or repair the waterproofing, including all damaged wood with new waterproofing and wood structures</b>
Life Expectancy (EEE)	<b>1-4 Years</b>
Life Expectancy (LBC)	<b>4-7 Years</b>
Life Expectancy (AWE)	<b>0-1 Years</b>

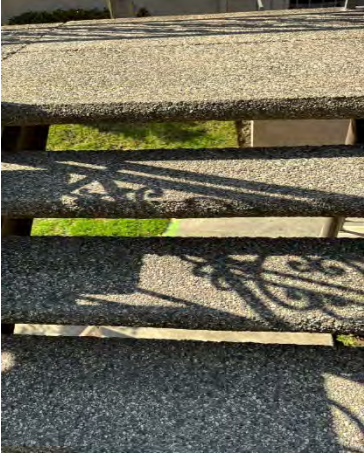
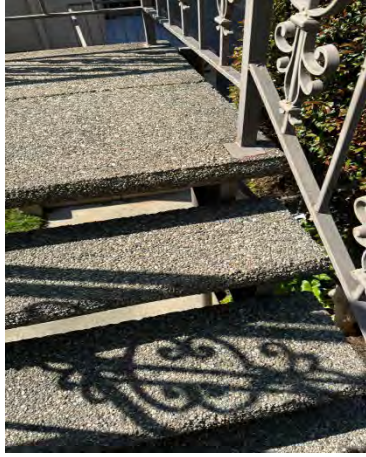
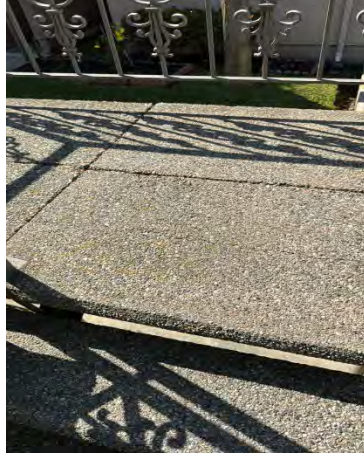
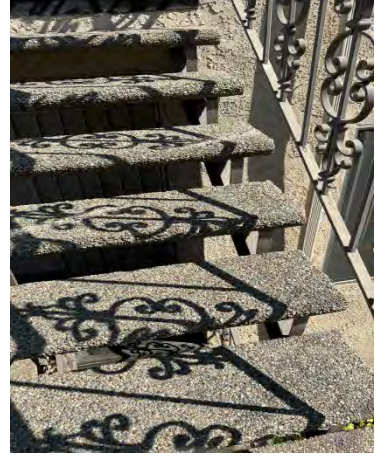
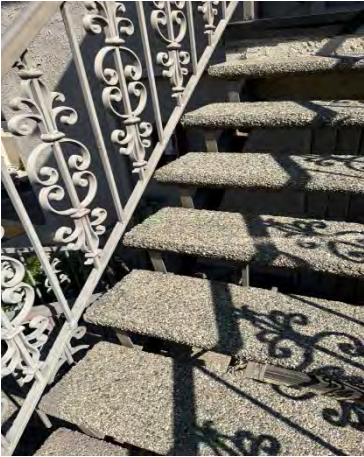
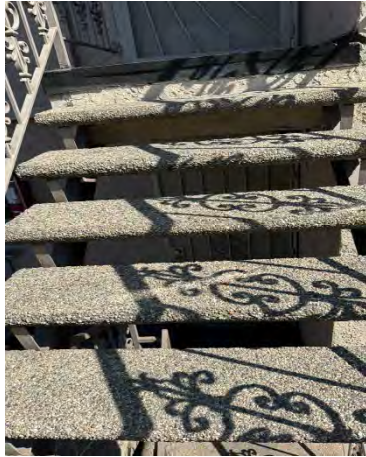
Exterior Elements	Stairs, Stairs Landing, Railings, Integrations
Water Proofing Elements	Flashings, Waterproofing, Coatings, Sealants
Visual Review	Good
Any Visual Signs of leaks	No
Further Invasive Review Required	No
Condition Assessment	Pass
Additional Considerations or Concerns	<p><b>Railing at concrete</b></p> <p><b>Stairs are steel stringers attached to a wood structure with concrete treads.</b></p> <p><b>The handrails are visually in good condition.</b></p>
Life Expectancy (EEE)	1-4 Years
Life Expectancy (LBC)	4-7 Years
Life Expectancy (AWE)	1-4 Years

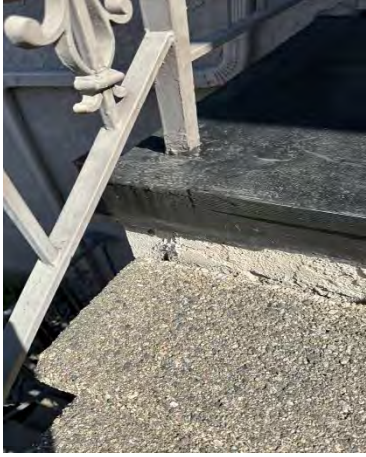
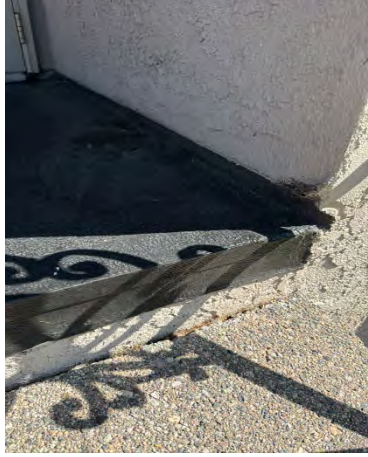
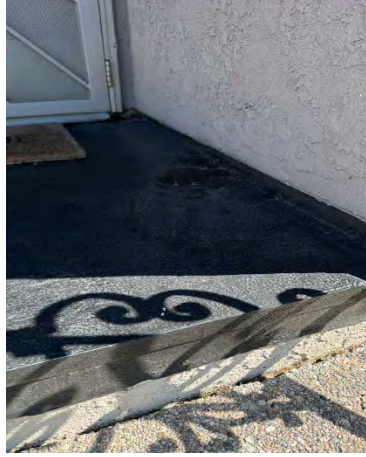
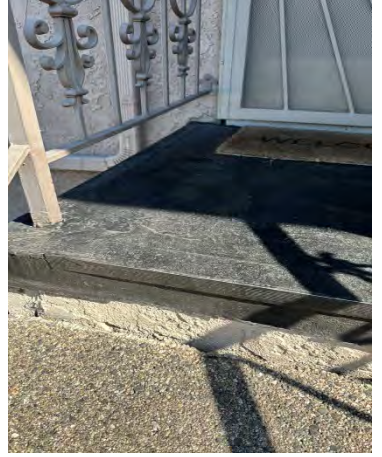
Building Name	2325
Apartment Name	68
Location Name	Entry deck
Visual Report	
Exterior Elements	Decks, Railings, Integrations, Door Threshold, Stucco Interface
Water Proofing Elements	Flashings, Waterproofing, Coatings, Sealants
Visual Review	Good
Any Visual Signs of leaks	No
Further Invasive Review Required	No
Condition Assessment	Pass
Additional Considerations or Concerns	<p>Entry / Balcony / Walking Deck</p> <p>The deck is wood framed with waterproofing over the wood.</p> <p>Handrails are metal and attached to the deck surface and visually in good condition.</p>
Life Expectancy (EEE)	1-4 Years
Life Expectancy (LBC)	4-7 Years
Life Expectancy (AWE)	1-4 Years
Visual Photos

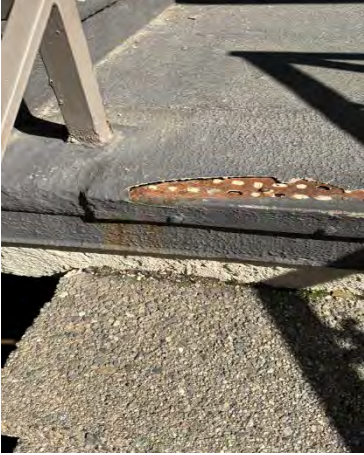
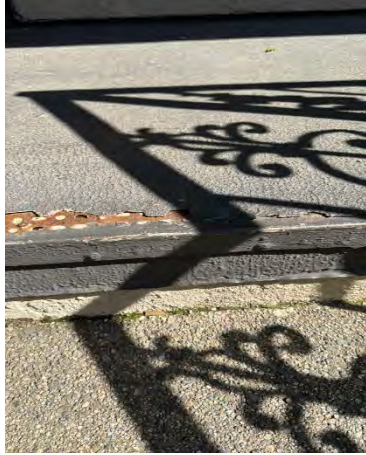
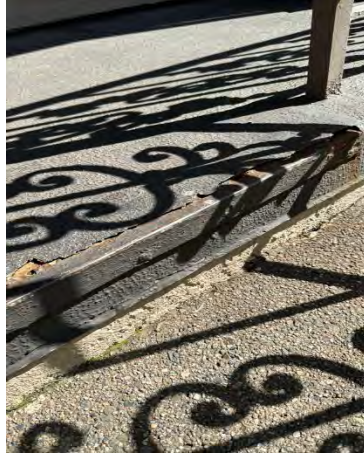
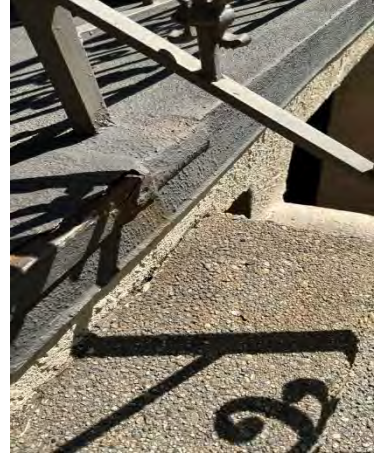
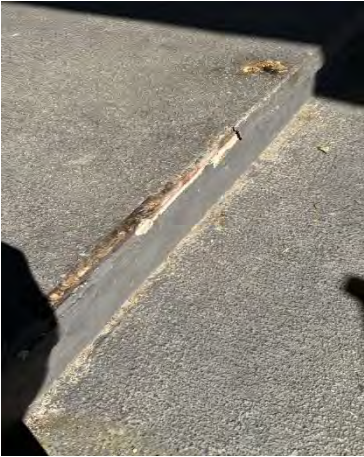
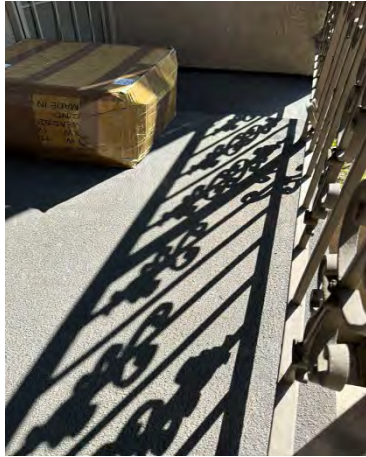
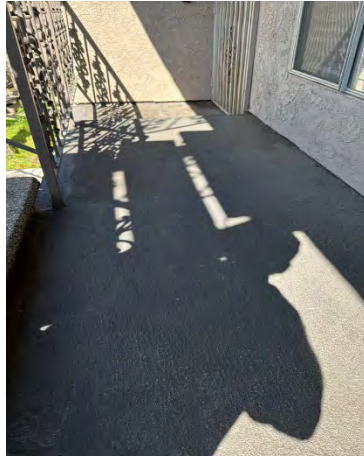
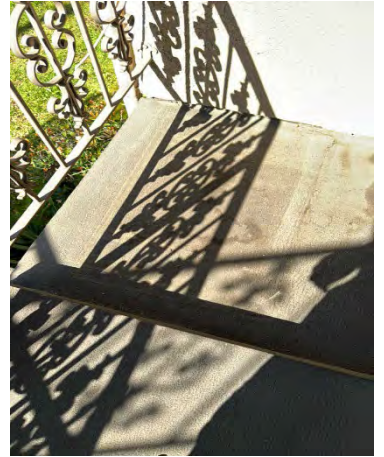
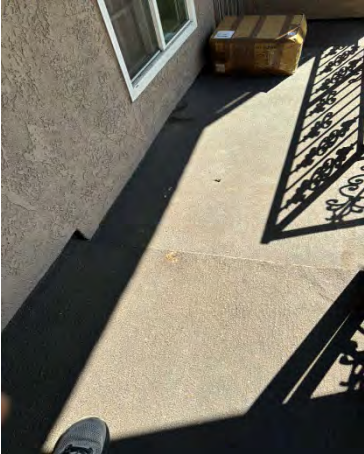
Building Name	2325
Apartment Name	63-65
Location Name	Entry deck
Visual Report	
Exterior Elements	Decks, Railings, Integrations, Door Threshold, Stucco Interface
Water Proofing Elements	Flashings, Waterproofing, Coatings, Sealants
Visual Review	Bad
Any Visual Signs of leaks	Yes
Further Invasive Review Required	No
Condition Assessment	Fail
Additional Considerations or Concerns	<p>Entry / Balcony / Walking Deck</p> <p>The deck is wood framed with waterproofing over the wood.</p> <p>Handrails are metal and attached to the deck surface and visually in good condition.</p>
Life Expectancy (EEE)	1-4 Years
Life Expectancy (LBC)	4-7 Years
Life Expectancy (AWE)	0-1 Years
Visual Photos

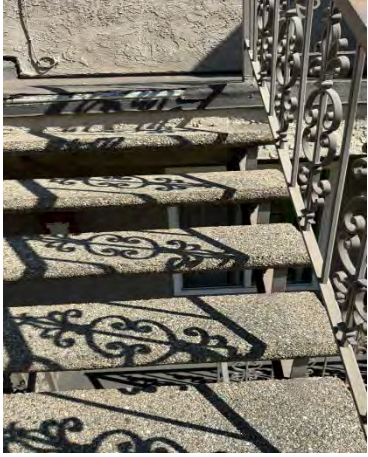
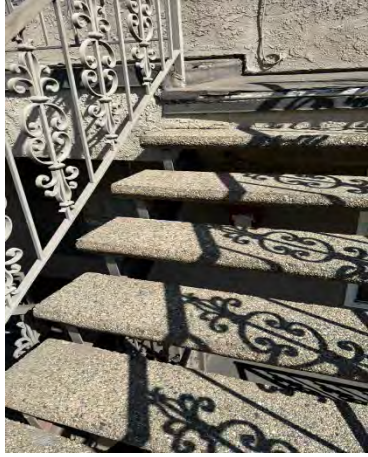
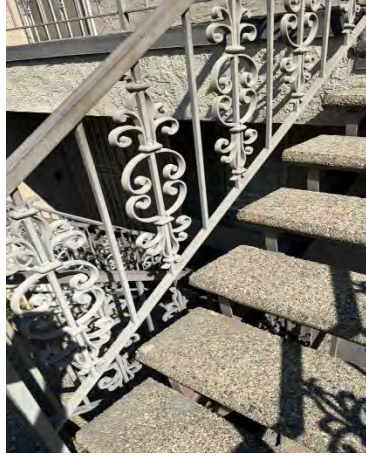
Exterior Elements	Stairs, Stairs Landing, Railings, Integrations
Water Proofing Elements	Flashings, Waterproofing, Coatings, Sealants
Visual Review	Good
Any Visual Signs of leaks	No
Further Invasive Review Required	No
Condition Assessment	Pass
Additional Considerations or Concerns	<p><b>Railing at concrete</b></p> <p><b>Stairs are steel stringers attached to a wood structure with concrete treads.</b></p> <p><b>The handrails are visually in good condition.</b></p>
Life Expectancy (EEE)	1-4 Years
Life Expectancy (LBC)	4-7 Years
Life Expectancy (AWE)	1-4 Years

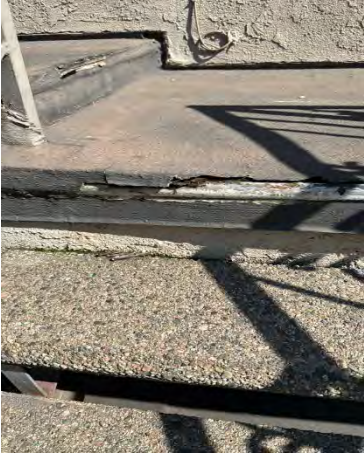
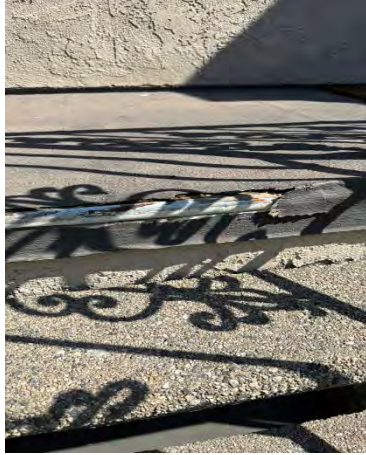
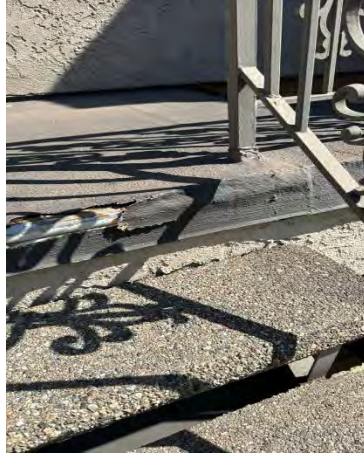
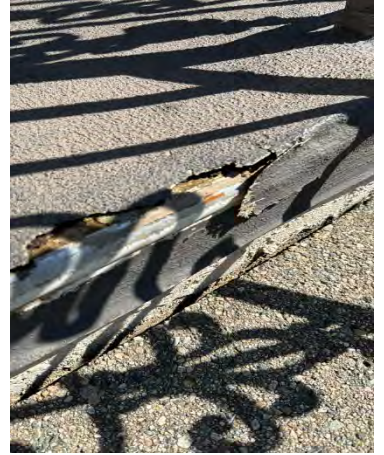
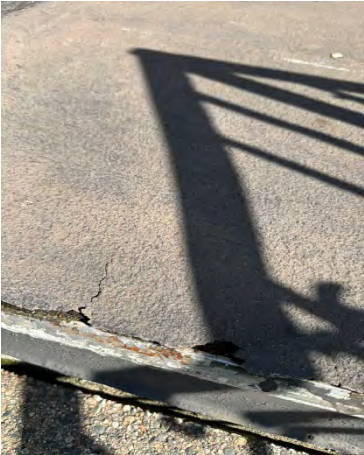
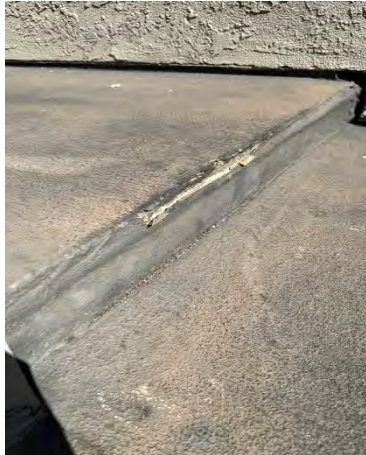
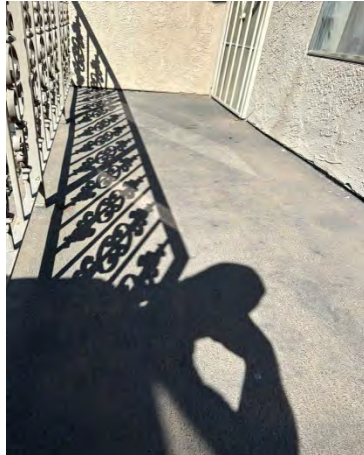
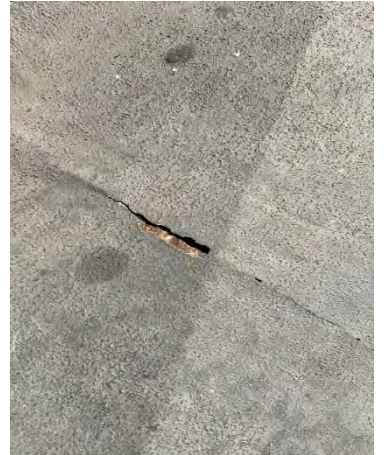
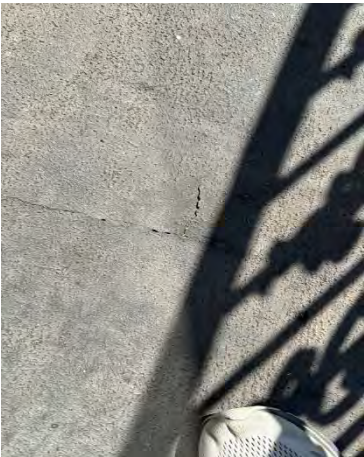
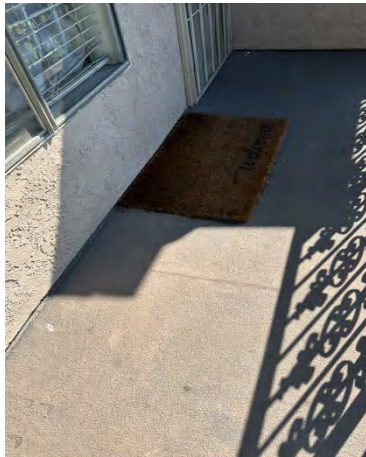
Exterior Elements	Decks, Railings, Integrations, Door Threshold, Stucco Interface
Water Proofing Elements	Flashings, Waterproofing, Coatings, Sealants
Visual Review	<b>Bad</b>
Any Visual Signs of leaks	<b>Yes</b>
Further Invasive Review Required	<b>Yes</b>
Condition Assessment	<b>Fail</b>
Additional Considerations or Concerns	<b>Entry / Balcony / Walking Deck</b>  <b>The deck is wood framed with waterproofing over the wood.</b>  <b>Handrails are metal and attached to the deck surface and visually in good condition.</b>  <b>The waterproofing is severely damaged. Replace or repair the waterproofing, including all damaged wood with new waterproofing and wood structures.</b>
Life Expectancy (EEE)	<b>1-4 Years</b>
Life Expectancy (LBC)	<b>1-4 Years</b>
Life Expectancy (AWE)	<b>0-1 Years</b>

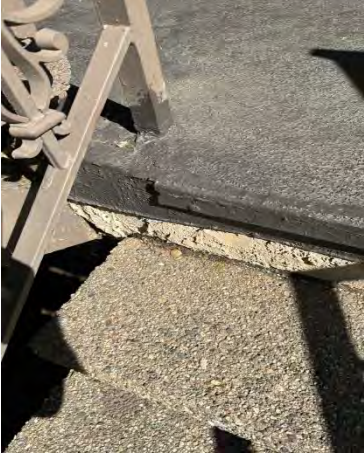
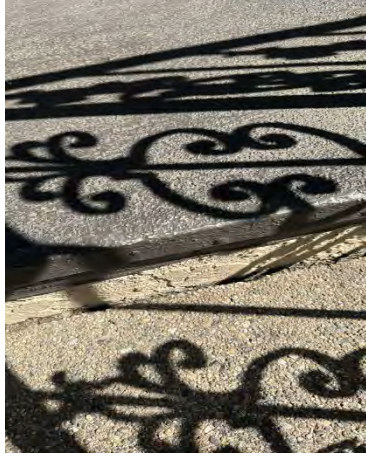
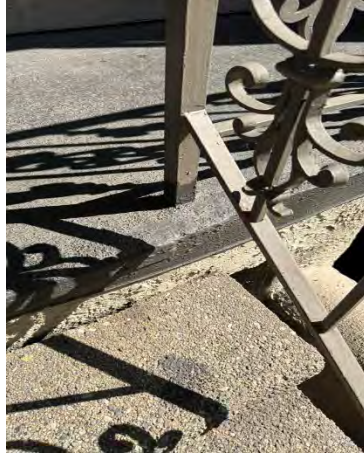
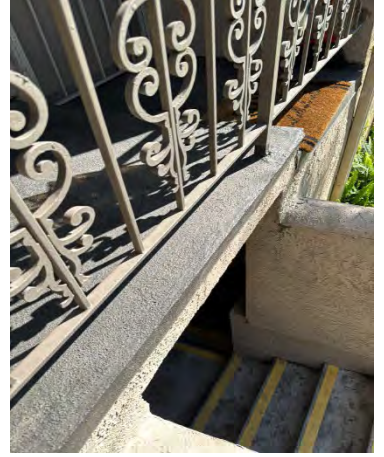
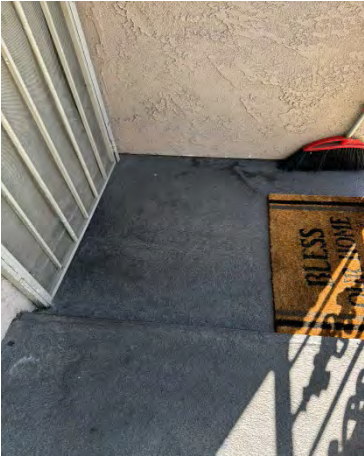
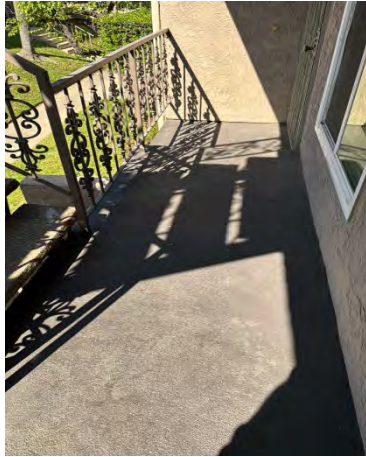
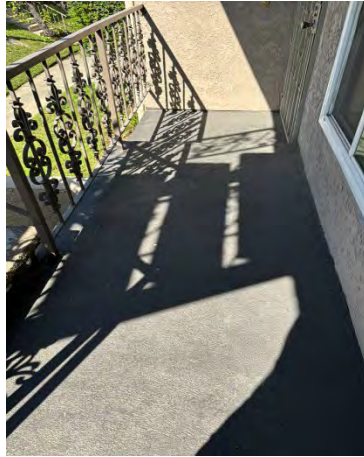
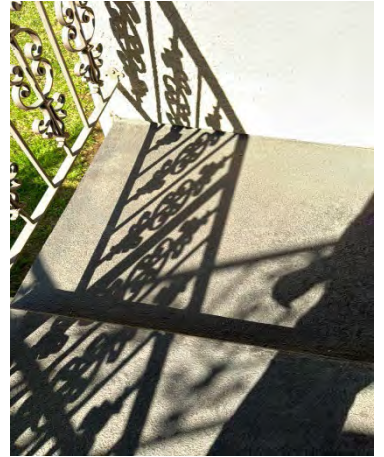
Building Name	2325
Apartment Name	59-61
Location Name	Entry deck
Visual Report	
Exterior Elements	Decks, Railings, Integrations, Door Threshold, Stucco Interface
Water Proofing Elements	Flashings, Waterproofing, Coatings, Sealants
Visual Review	Good
Any Visual Signs of leaks	No
Further Invasive Review Required	No
Condition Assessment	Pass
Additional Considerations or Concerns	<p>Entry / Balcony / Walking Deck</p> <p>The deck is wood framed with waterproofing over the wood.</p> <p>Handrails are metal and attached to the deck surface and visually in good condition.</p>
Life Expectancy (EEE)	1-4 Years
Life Expectancy (LBC)	4-7 Years
Life Expectancy (AWE)	1-4 Years
Visual Photos
