## DECK INSPECTORS INC.

#### Part 2 of Visual Inspection:

Autumn Pointe HOA

55488 Dobbs St.

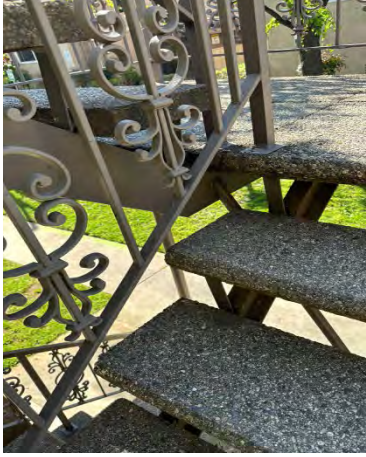
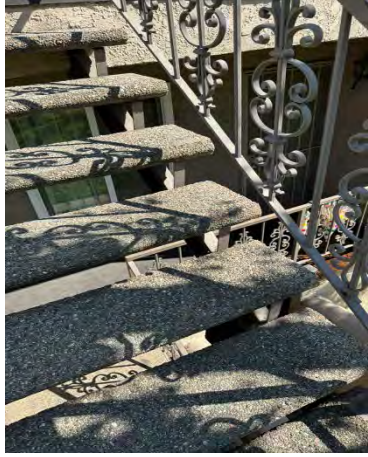
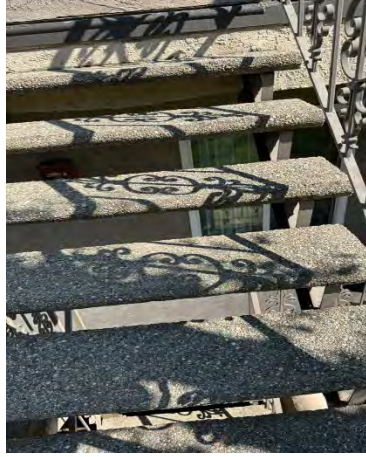
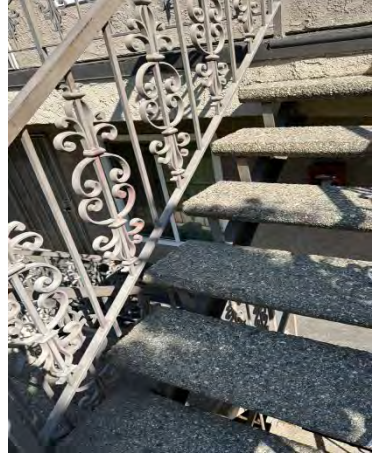
Exterior Elements	Stairs, Stairs Landing, Railings, Integrations
Water Proofing Elements	Flashings, Waterproofing, Coatings, Sealants
Visual Review	Good
Any Visual Signs of leaks	No
Further Invasive Review Required	No
Condition Assessment	Pass
Additional Considerations or Concerns	<p><b>Railing at concrete</b></p> <p><b>Stairs are steel stringers attached to a wood structure with concrete treads.</b></p> <p><b>The handrails are visually in good condition.</b></p>
Life Expectancy (EEE)	1-4 Years
Life Expectancy (LBC)	4-7 Years
Life Expectancy (AWE)	1-4 Years

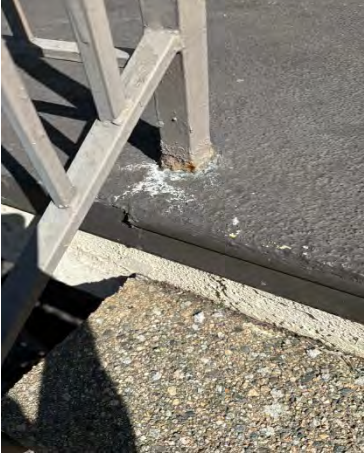
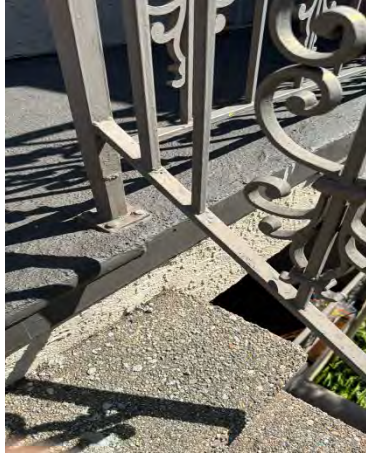
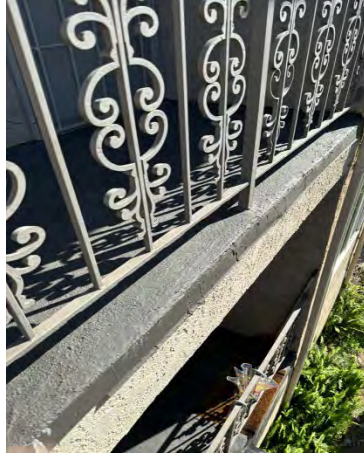
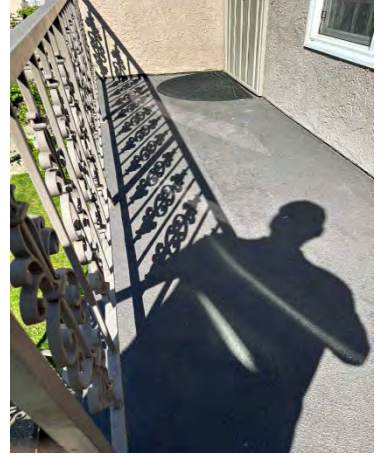
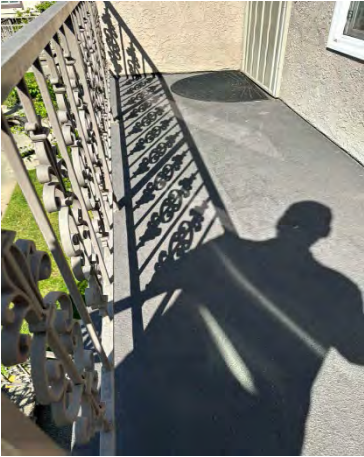
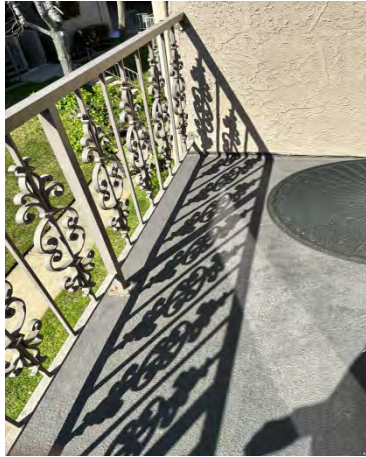
Building Name	2325
Apartment Name	60-62
Location Name	Entry deck
Visual Report	
Exterior Elements	Decks, Railings, Integrations, Door Threshold, Stucco Interface
Water Proofing Elements	Flashings, Waterproofing, Coatings, Sealants
Visual Review	Good
Any Visual Signs of leaks	No
Further Invasive Review Required	No
Condition Assessment	Pass
Additional Considerations or Concerns	<p>Entry / Balcony / Walking Deck</p> <p>The deck is wood framed with waterproofing over the wood.</p> <p>Handrails are metal and attached to the deck surface and visually in good condition.</p>
Life Expectancy (EEE)	1-4 Years
Life Expectancy (LBC)	4-7 Years
Life Expectancy (AWE)	1-4 Years
Visual Photos

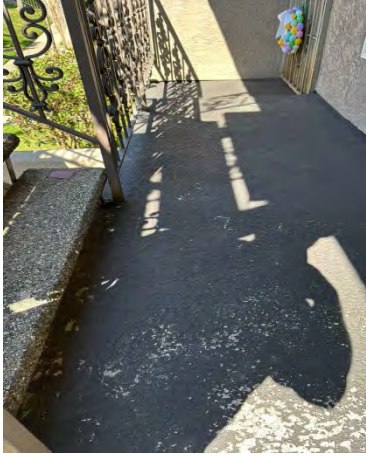
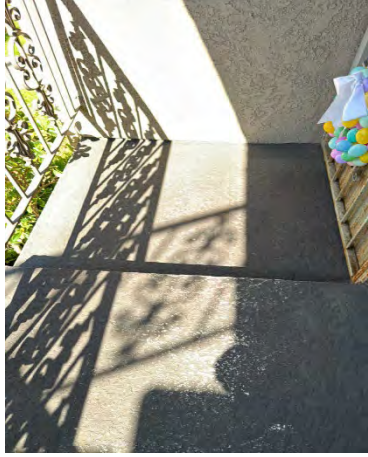
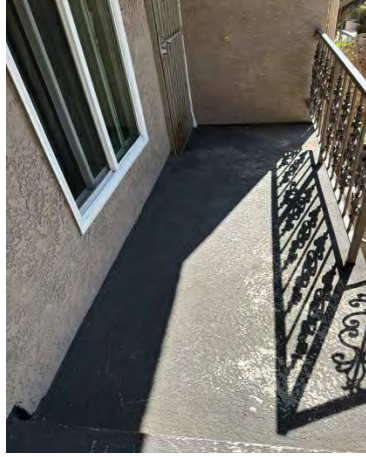
Exterior Elements	Decks, Railings, Integrations, Door Threshold, Stucco Interface
Water Proofing Elements	Flashings, Waterproofing, Coatings, Sealants
Visual Review	Fair
Any Visual Signs of leaks	No
Further Invasive Review Required	No
Condition Assessment	Pass
Additional Considerations or Concerns	Minor delamination of stucco at landing.
Life Expectancy (EEE)	1-4 Years
Life Expectancy (LBC)	4-7 Years
Life Expectancy (AWE)	0-1 Years

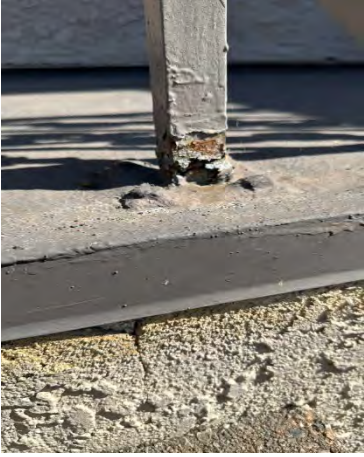
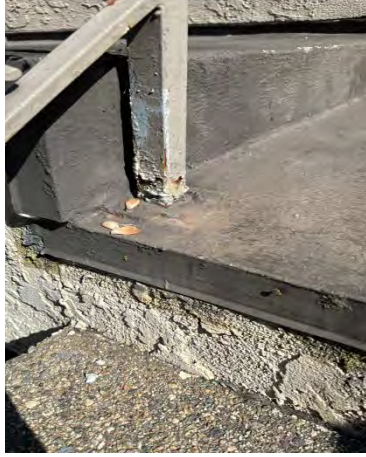
Exterior Elements	Stairs, Stairs Landing, Railings, Integrations
Water Proofing Elements	Flashings, Waterproofing, Coatings, Sealants
Visual Review	<b>Bad</b>
Any Visual Signs of leaks	<b>No</b>
Further Invasive Review Required	<b>No</b>
Condition Assessment	<b>Fail</b>
Additional Considerations or Concerns	<b>Corroded guardrail post at landing. Secure the railing attachments.</b>
Life Expectancy (EEE)	<b>0-1 Years</b>
Life Expectancy (LBC)	<b>4-7 Years</b>
Life Expectancy (AWE)	<b>1-4 Years</b>

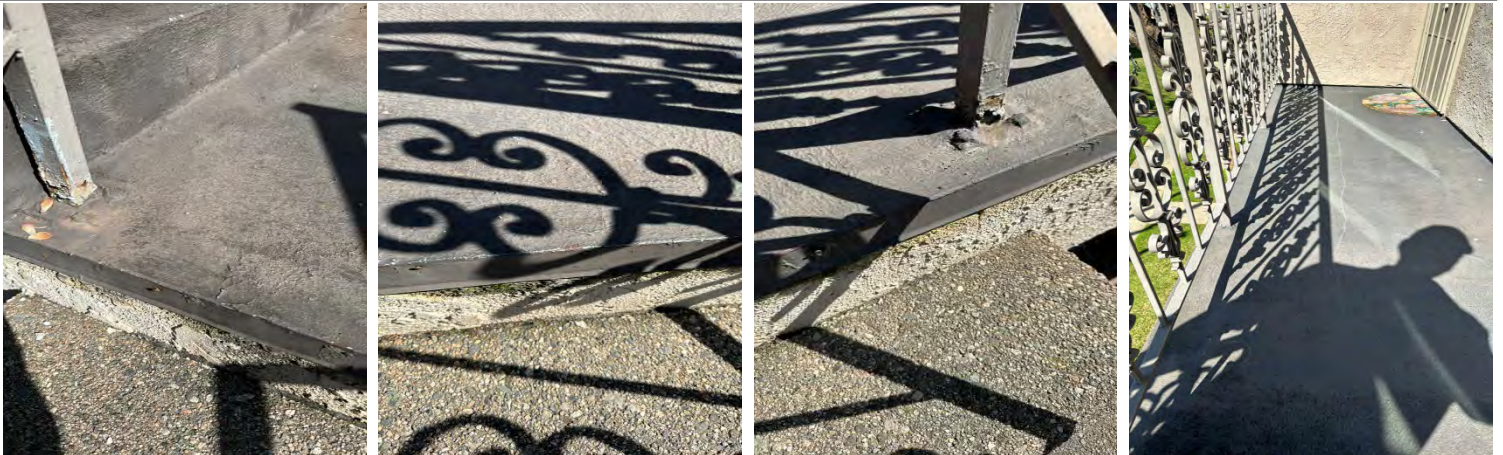
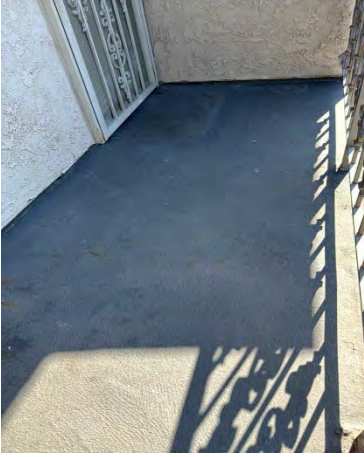
Exterior Elements	Decks, Railings, Integrations, Door Threshold, Stucco Interface
Water Proofing Elements	Flashings, Waterproofing, Coatings, Sealants
Visual Review	Fair
Any Visual Signs of leaks	No
Further Invasive Review Required	No
Condition Assessment	Pass
Additional Considerations or Concerns	Waterproofing is in fair-poor condition. No signs of water intrusion. Repair waterproof deck coating.
Life Expectancy (EEE)	1-4 Years
Life Expectancy (LBC)	4-7 Years
Life Expectancy (AWE)	0-1 Years

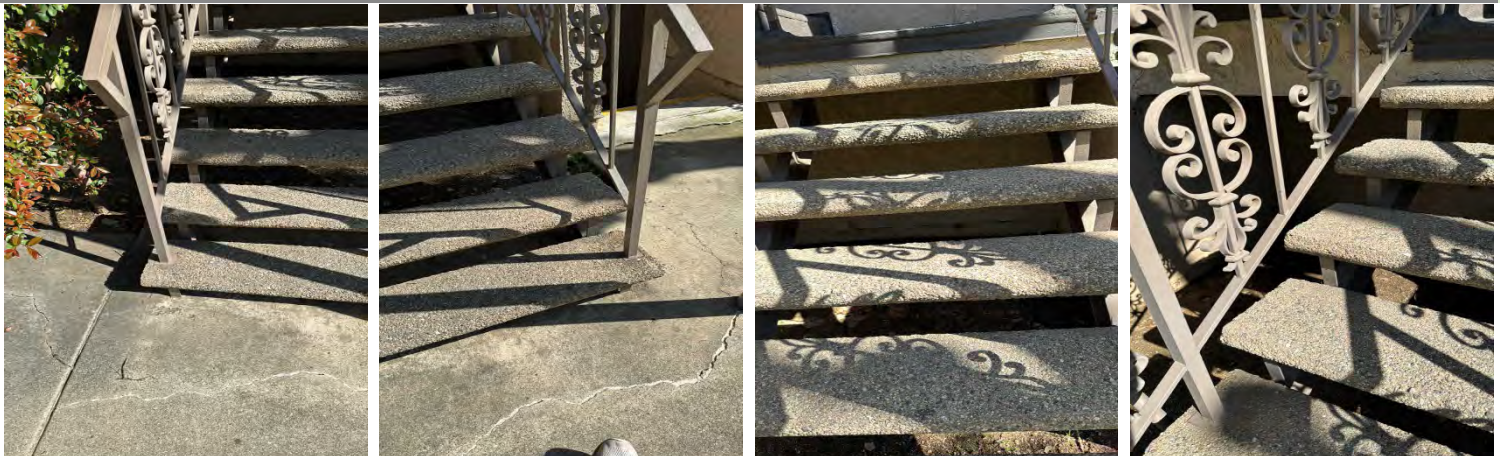
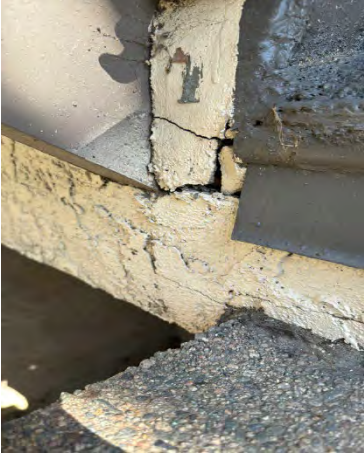
Building Name	2321
Apartment Name	51-53
Location Name	Stairs
Visual Report	
Exterior Elements	Stairs, Stairs Landing, Integrations, Railings
Water Proofing Elements	Flashings, Waterproofing, Coatings, Sealants
Visual Review	Good
Any Visual Signs of leaks	No
Further Invasive Review Required	No
Condition Assessment	Pass
Additional Considerations or Concerns	<p><b>Railing at concrete</b></p> <p><b>Stairs are steel stringers attached to a wood structure with concrete treads.</b></p> <p><b>The handrails are visually in good condition.</b></p>
Life Expectancy (EEE)	1-4 Years
Life Expectancy (LBC)	4-7 Years
Life Expectancy (AWE)	1-4 Years

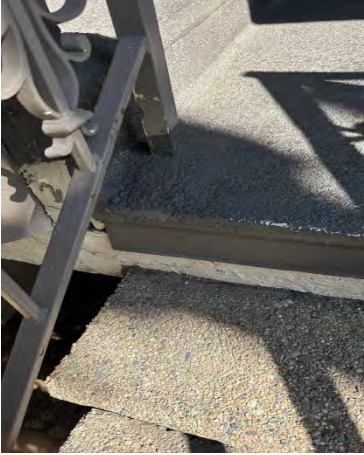
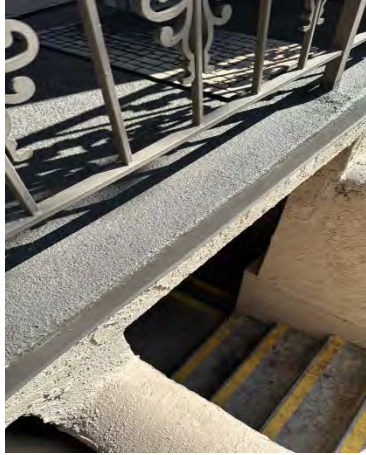
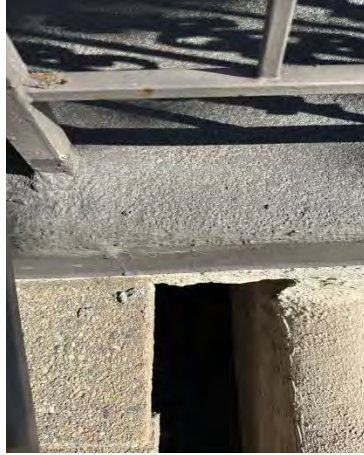
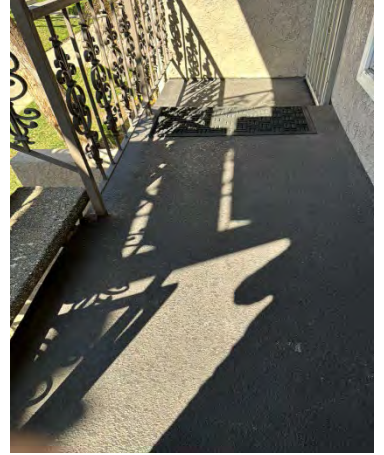
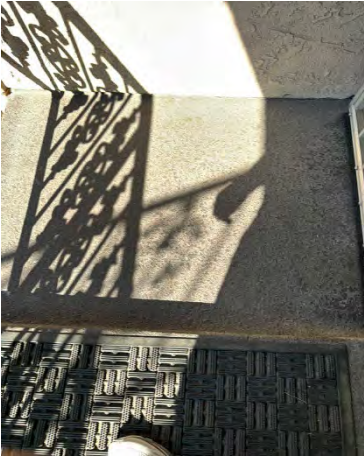
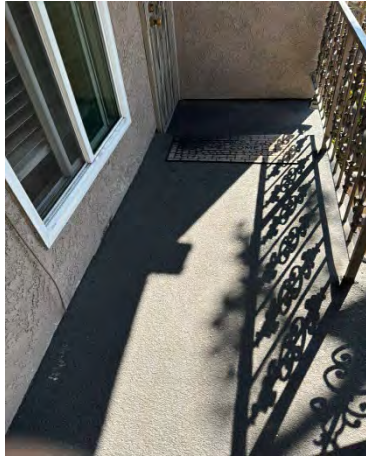
Building Name	2321
Apartment Name	51-53
Location Name	Entry deck
Visual Report	
Exterior Elements	Decks, Railings, Integrations, Door Threshold, Stucco Interface
Water Proofing Elements	Flashings, Waterproofing, Coatings, Sealants
Visual Review	Good
Any Visual Signs of leaks	No
Further Invasive Review Required	No
Condition Assessment	Pass
Additional Considerations or Concerns	<p>Entry / Balcony / Walking Deck</p> <p>The deck is wood framed with waterproofing over the wood.</p> <p>Handrails are metal and attached to the deck surface and visually in good condition.</p>
Life Expectancy (EEE)	1-4 Years
Life Expectancy (LBC)	4-7 Years
Life Expectancy (AWE)	1-4 Years
Visual Photos

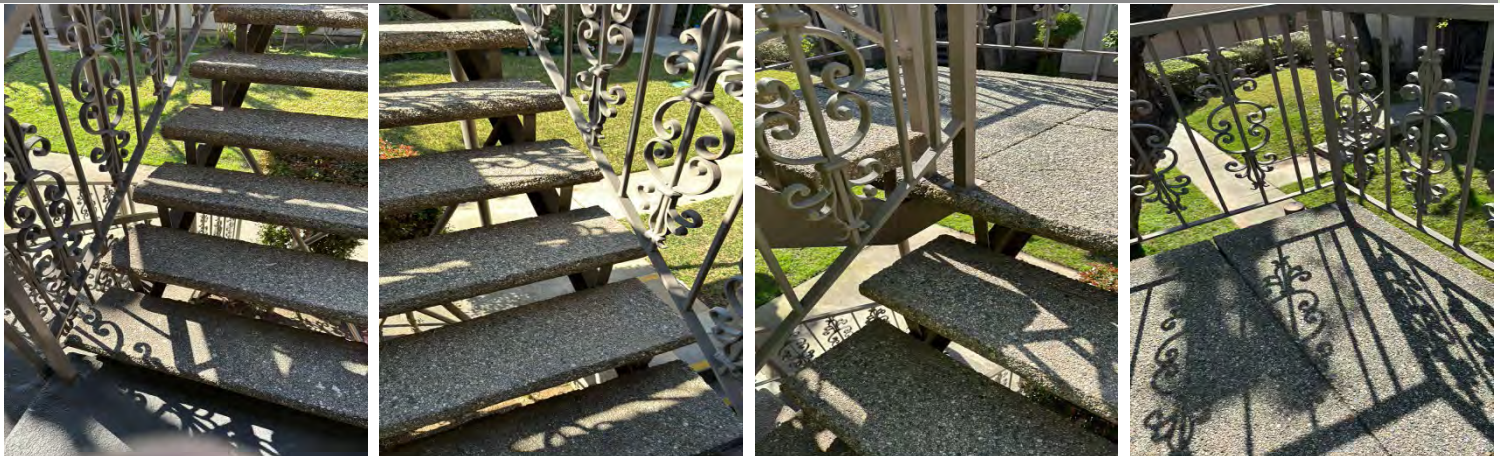
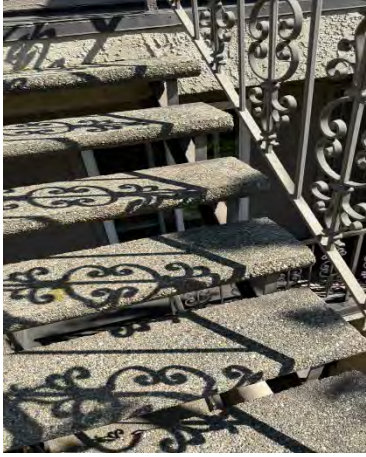
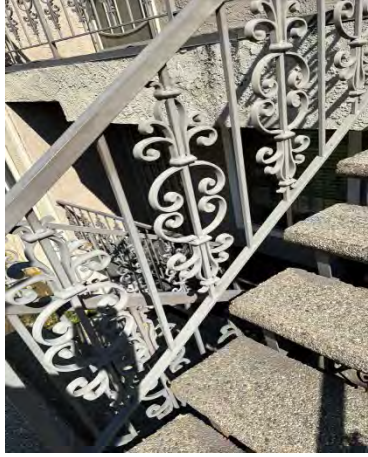
Building Name	2321
Apartment Name	52-54
Location Name	Stairs
Visual Report	
Exterior Elements	Stairs, Stairs Landing, Integrations, Railings
Water Proofing Elements	Flashings, Waterproofing, Coatings, Sealants
Visual Review	Good
Any Visual Signs of leaks	No
Further Invasive Review Required	No
Condition Assessment	Pass
Additional Considerations or Concerns	<p><b>Railing at concrete</b></p> <p><b>Stairs are steel stringers attached to a wood structure with concrete treads.</b></p> <p><b>The handrails are visually in good condition.</b></p>
Life Expectancy (EEE)	1-4 Years
Life Expectancy (LBC)	4-7 Years
Life Expectancy (AWE)	1-4 Years

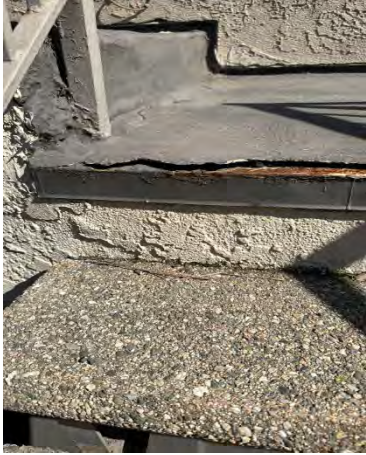
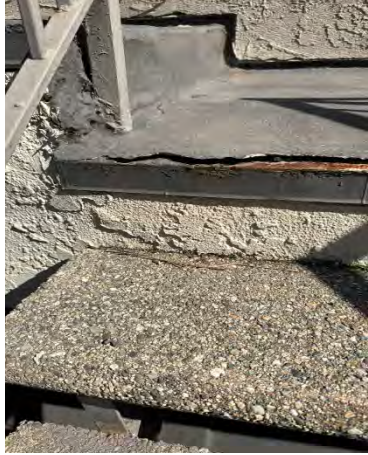
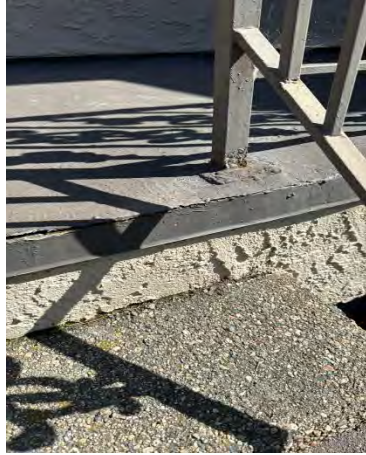
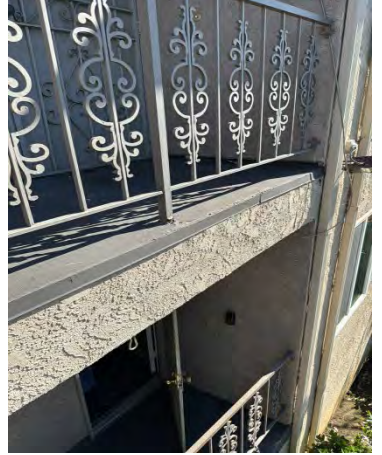
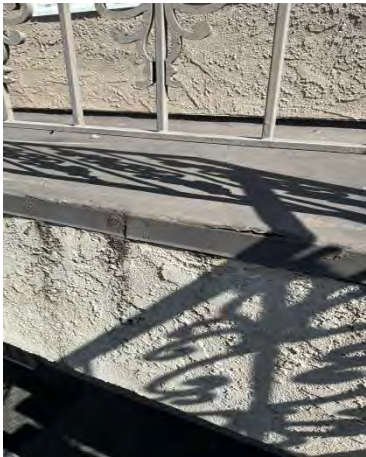
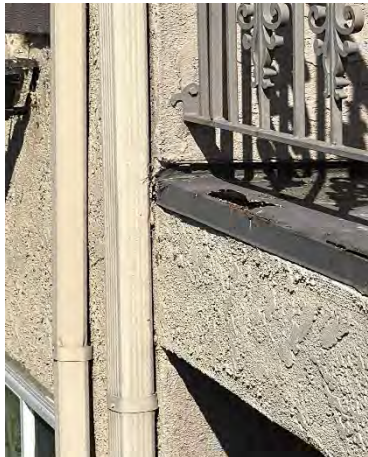
Exterior Elements	Decks, Railings, Integrations, Door Threshold, Stucco Interface
Water Proofing Elements	Flashings, Waterproofing, Coatings, Sealants
Visual Review	<b>Bad</b>
Any Visual Signs of leaks	<b>Yes</b>
Further Invasive Review Required	<b>No</b>
Condition Assessment	<b>Fail</b>
Additional Considerations or Concerns	<b>Entry / Balcony / Walking Deck</b>  <b>The deck is wood framed with waterproofing over the wood.</b>  <b>Handrails are metal and attached to the deck surface and visually in good condition.</b>  <b>The waterproofing is severely damaged. Replace or repair the waterproofing, including all damaged wood with new waterproofing and wood structures.</b>
Life Expectancy (EEE)	<b>1-4 Years</b>
Life Expectancy (LBC)	<b>4-7 Years</b>
Life Expectancy (AWE)	<b>0-1 Years</b>

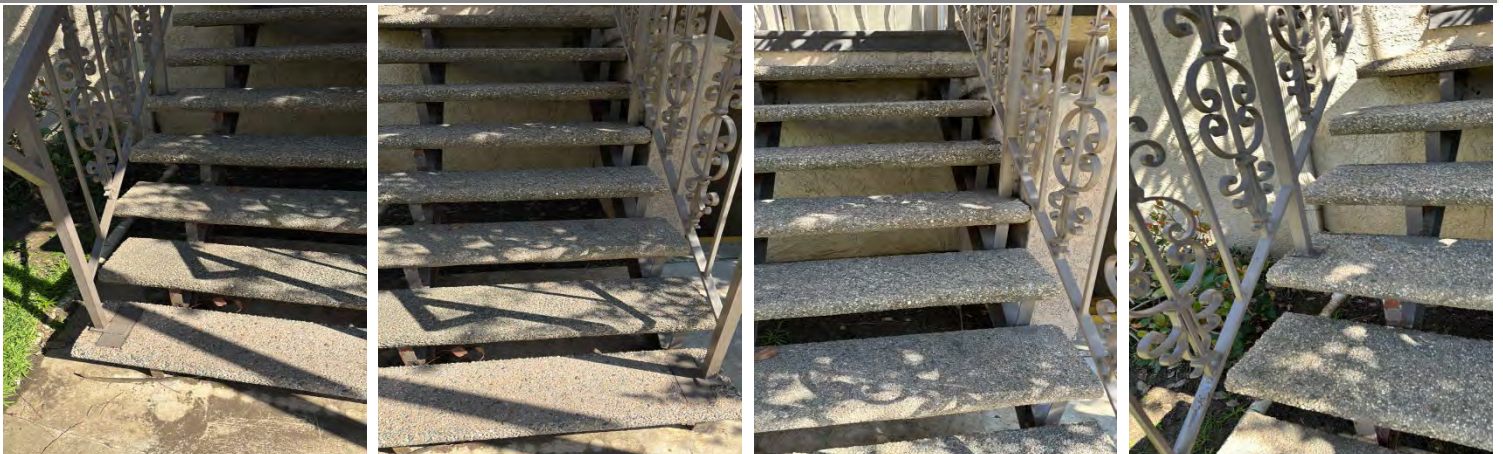
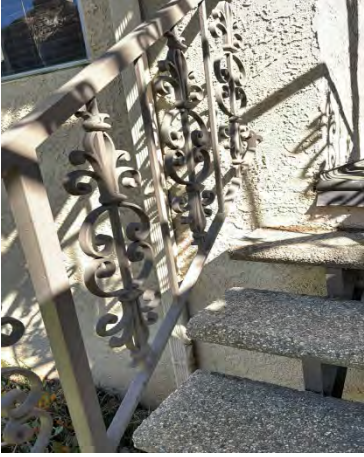
Exterior Elements	Porches/Entry, Stairs, Stairs Landing, Railings, Integrations
Water Proofing Elements	Flashings, Waterproofing, Coatings, Sealants
Visual Review	Good
Any Visual Signs of leaks	No
Further Invasive Review Required	No
Condition Assessment	Pass
Additional Considerations or Concerns	<p><b>Railing at concrete</b></p> <p><b>Stairs are steel stringers attached to a wood structure with concrete treads.</b></p> <p><b>The handrails are visually in good condition.</b></p>
Life Expectancy (EEE)	1-4 Years
Life Expectancy (LBC)	4-7 Years
Life Expectancy (AWE)	1-4 Years

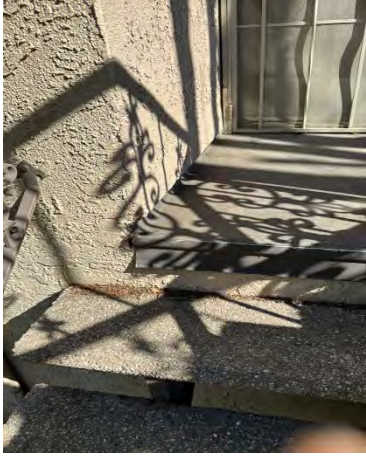
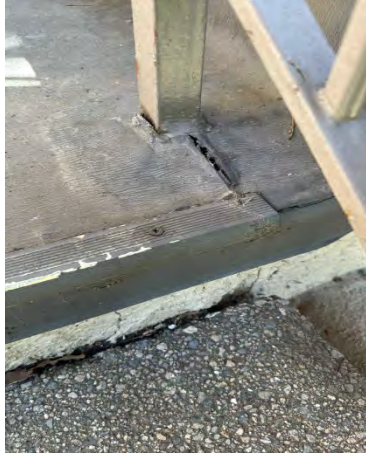
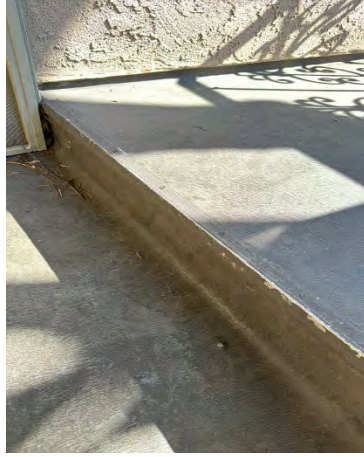
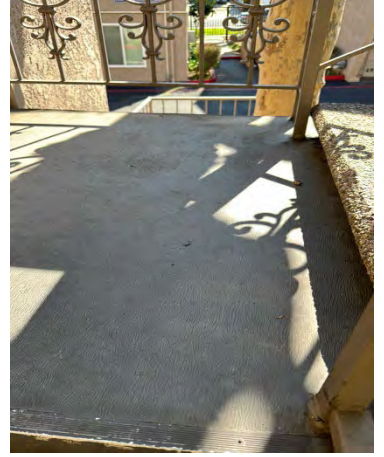
Exterior Elements	Decks, Railings, Integrations, Door Threshold, Stucco Interface
Water Proofing Elements	Flashings, Waterproofing, Coatings, Sealants
Visual Review	<b>Bad</b>
Any Visual Signs of leaks	<b>Yes</b>
Further Invasive Review Required	<b>No</b>
Condition Assessment	<b>Fail</b>
Additional Considerations or Concerns	<b>Entry / Balcony / Walking Deck</b>  <b>The deck is wood framed with waterproofing over the wood.</b>  <b>Handrails are metal and attached to the deck surface and visually in good condition.</b>  <b>The waterproofing is severely damaged. Replace or repair the waterproofing, including all damaged wood with new waterproofing and wood structures.</b>
Life Expectancy (EEE)	<b>1-4 Years</b>
Life Expectancy (LBC)	<b>4-7 Years</b>
Life Expectancy (AWE)	<b>0-1 Years</b>

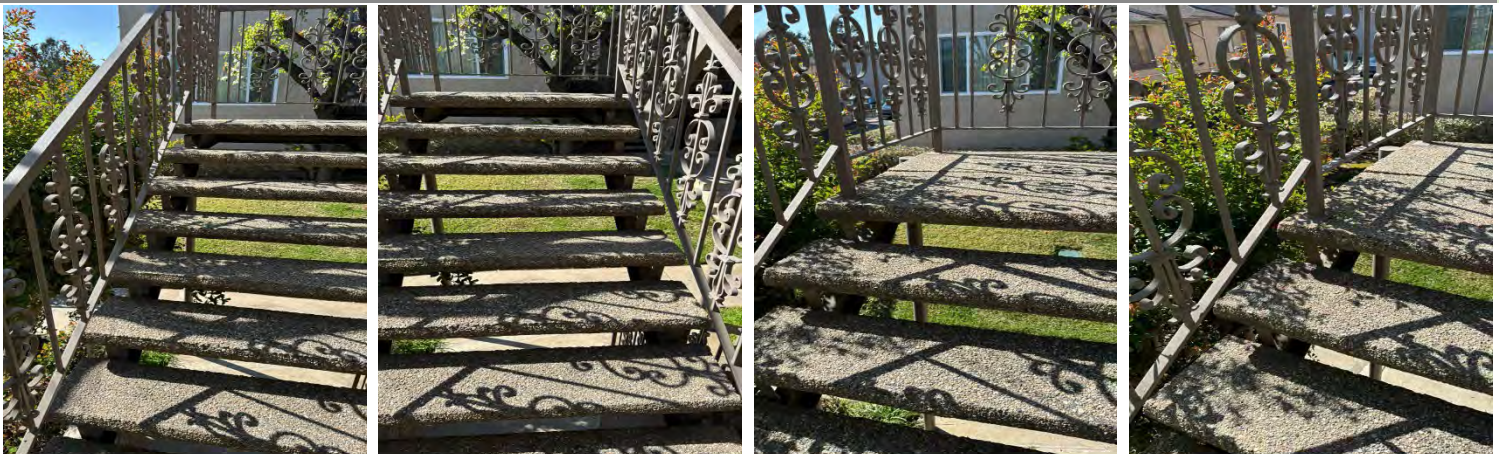
Exterior Elements	Porches/Entry, Stairs, Stairs Landing, Railings, Integrations
Water Proofing Elements	Flashings, Waterproofing, Coatings, Sealants
Visual Review	Good
Any Visual Signs of leaks	No
Further Invasive Review Required	No
Condition Assessment	Pass
Additional Considerations or Concerns	<p><b>Railing at concrete</b></p> <p><b>Stairs are steel stringers attached to a wood structure with concrete treads.</b></p> <p><b>The handrails are visually in good condition.</b></p>
Life Expectancy (EEE)	1-4 Years
Life Expectancy (LBC)	4-7 Years
Life Expectancy (AWE)	1-4 Years

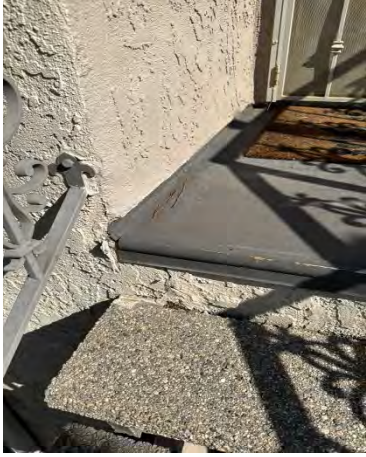
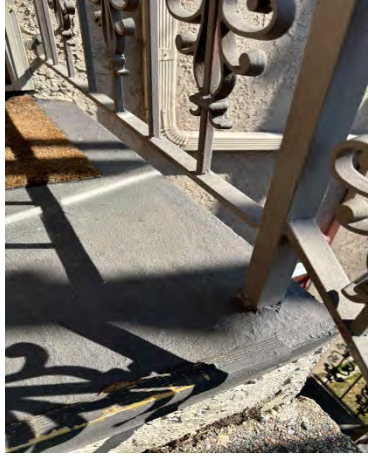
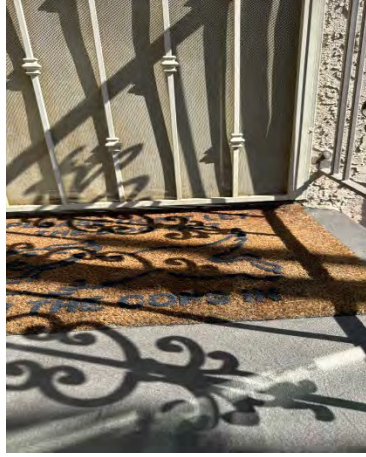
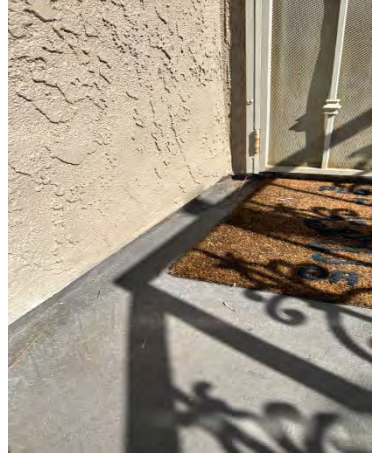
Building Name	2321
Apartment Name	50
Location Name	Entry deck
Visual Report	
Exterior Elements	Decks, Walkways, Railings, Integrations, Door Threshold, Stucco Interface
Water Proofing Elements	Flashings, Waterproofing, Coatings, Sealants
Visual Review	Good
Any Visual Signs of leaks	No
Further Invasive Review Required	No
Condition Assessment	Pass
Additional Considerations or Concerns	<p>Entry / Balcony / Walking Deck</p> <p>The deck is wood framed with waterproofing over the wood.</p> <p>Handrails are metal and attached to the deck surface and visually in good condition.</p>
Life Expectancy (EEE)	1-4 Years
Life Expectancy (LBC)	4-7 Years
Life Expectancy (AWE)	1-4 Years
Visual Photos

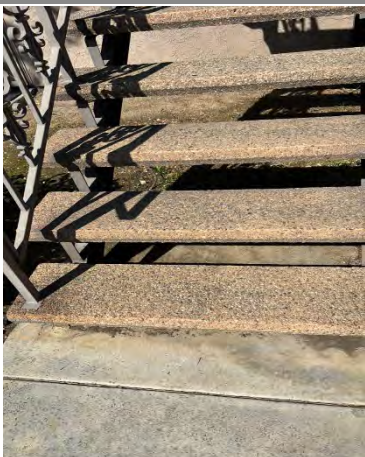
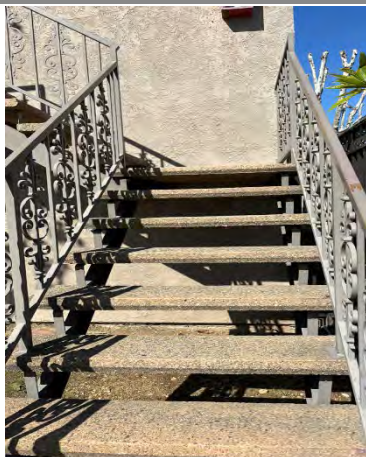
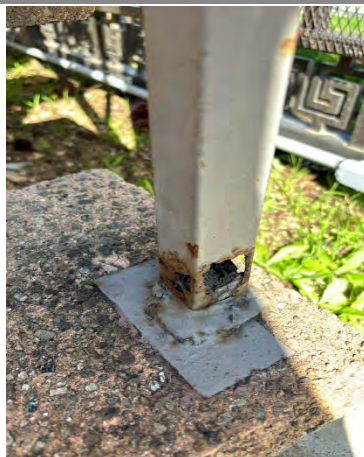
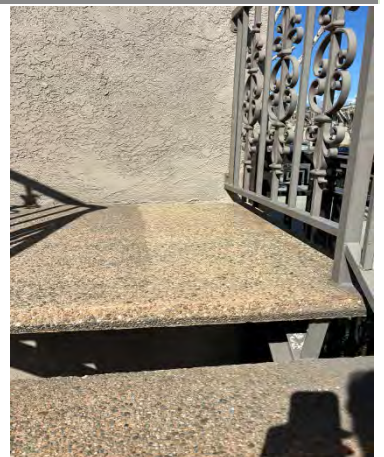
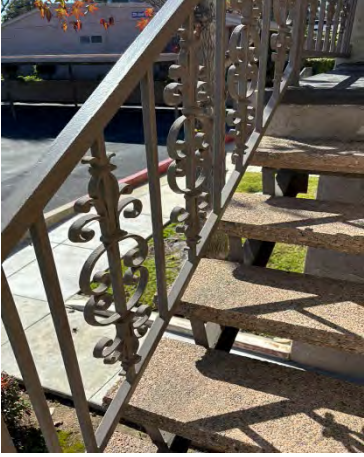
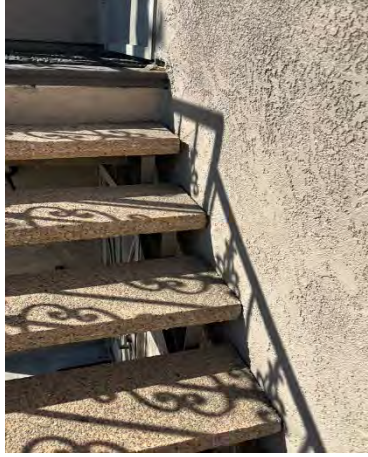
Exterior Elements	Stairs, Stairs Landing, Integrations, Stucco Interface, Railings
Water Proofing Elements	Flashings, Waterproofing, Coatings, Sealants
Visual Review	Fair
Any Visual Signs of leaks	No
Further Invasive Review Required	No
Condition Assessment	Pass
Additional Considerations or Concerns	Handrail post at first tread is corroded. Repair.
Life Expectancy (EEE)	0-1 Years
Life Expectancy (LBC)	1-4 Years
Life Expectancy (AWE)	0-1 Years

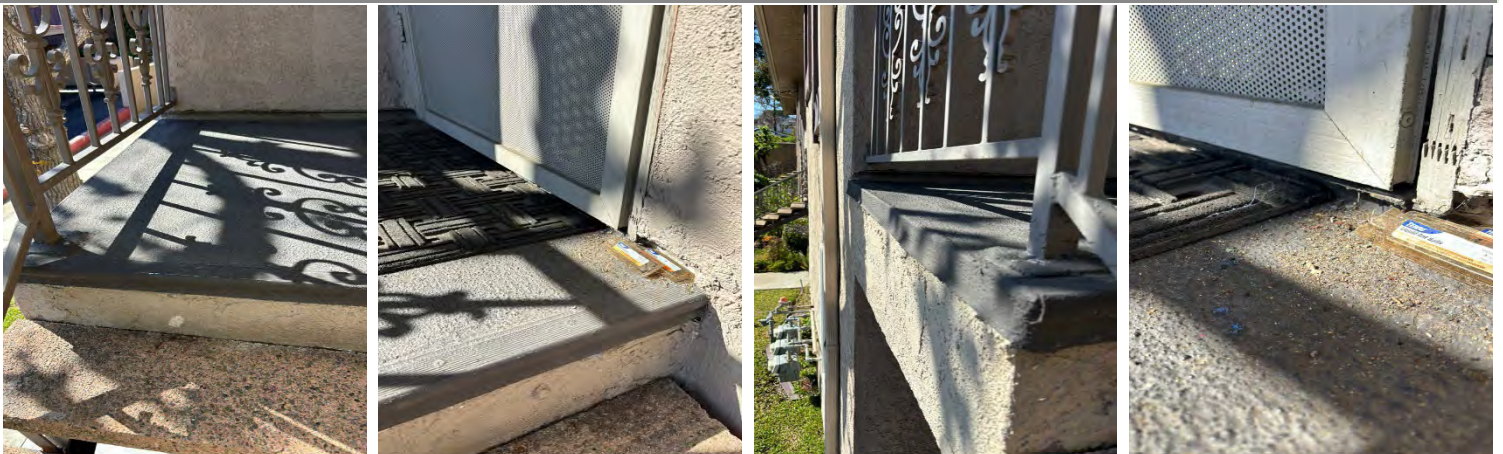
Exterior Elements	Porches/Entry, Railings, Door Threshold, Stucco Interface, Integrations
Water Proofing Elements	Flashings, Waterproofing, Coatings, Sealants
Visual Review	<b>Fair</b>
Any Visual Signs of leaks	<b>No</b>
Further Invasive Review Required	<b>No</b>
Condition Assessment	<b>Pass</b>
Additional Considerations or Concerns	<p><b>Entry / Balcony / Walking Deck</b></p> <p><b>The deck is wood framed with waterproofing over the wood.</b></p> <p><b>Guardrail post plate. Unsealed bolt. Repair</b></p>
Life Expectancy (EEE)	<b>1-4 Years</b>
Life Expectancy (LBC)	<b>1-4 Years</b>
Life Expectancy (AWE)	<b>1-4 Years</b>

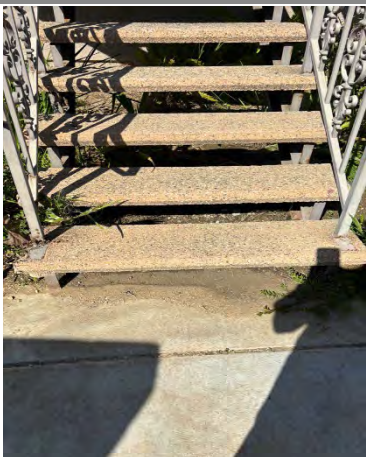
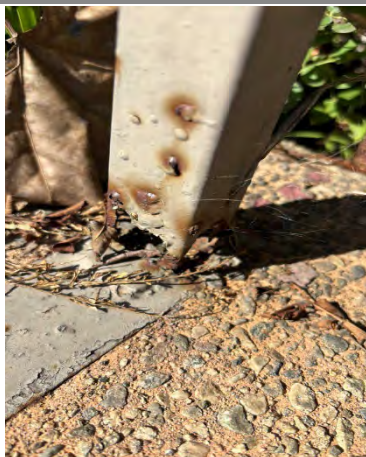
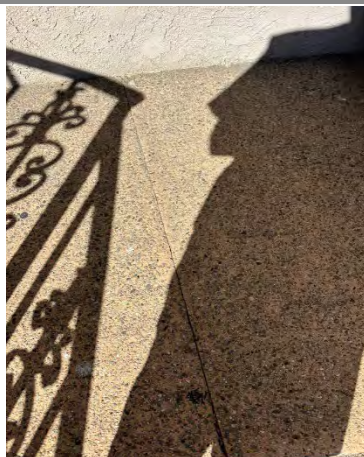
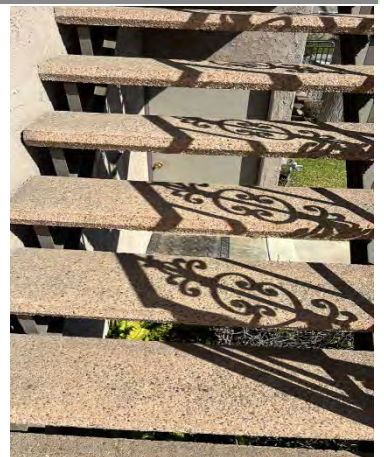
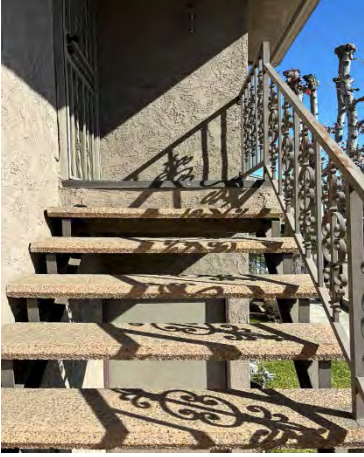
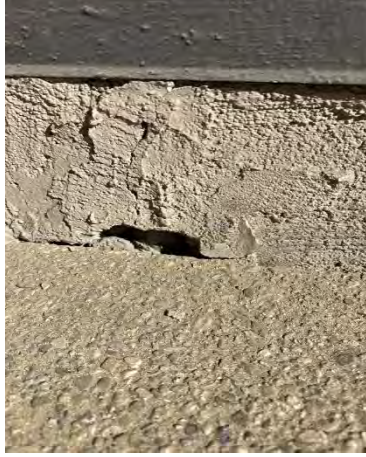
Building Name	2305-1
Apartment Name	171
Location Name	Entry stairs
Visual Report	
Exterior Elements	Stairs, Stairs Landing, Stucco Interface, Railings
Water Proofing Elements	Flashings, Waterproofing, Coatings, Sealants
Visual Review	Fair
Any Visual Signs of leaks	No
Further Invasive Review Required	No
Condition Assessment	Fail
Additional Considerations or Concerns	railings on the first flight from the sidewalk are loose due to the corrosion of the support posts.
Life Expectancy (EEE)	0-1 Years
Life Expectancy (LBC)	1-4 Years
Life Expectancy (AWE)	0-1 Years

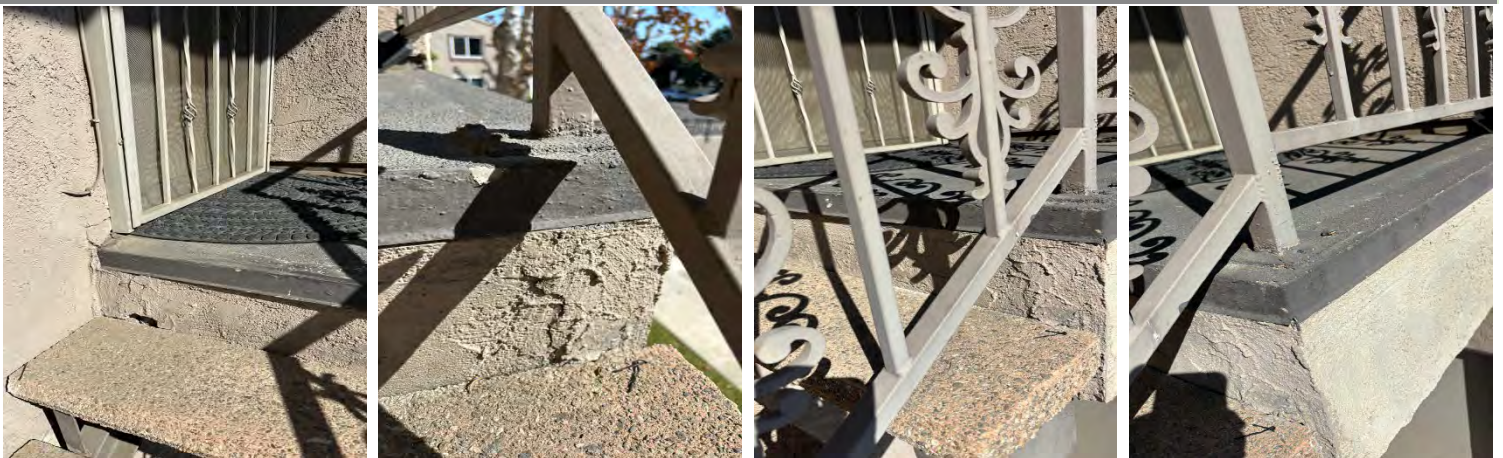
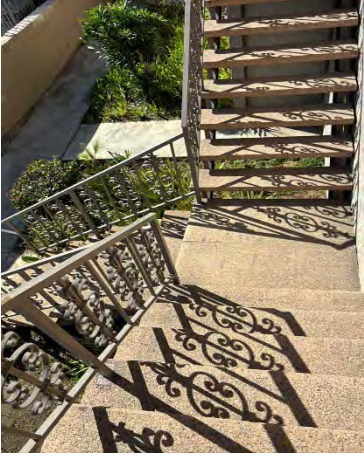
Exterior Elements	Porches/Entry, Railings, Integrations, Door Threshold, Stucco Interface
Water Proofing Elements	Flashings, Waterproofing, Coatings, Sealants
Visual Review	Fair
Any Visual Signs of leaks	No
Further Invasive Review Required	No
Condition Assessment	Pass
Additional Considerations or Concerns	The support post for the railing at this location has one bolt that is unsealed.
Life Expectancy (EEE)	1-4 Years
Life Expectancy (LBC)	1-4 Years
Life Expectancy (AWE)	1-4 Years

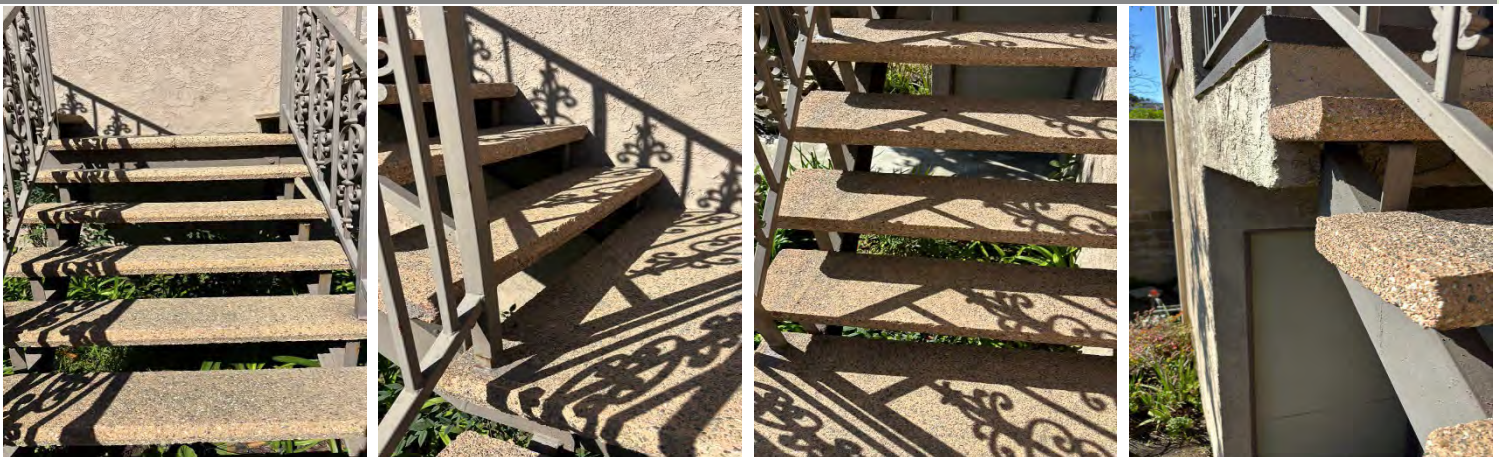
Building Name	2305-1
Apartment Name	174
Location Name	Stairs
Visual Report	
Exterior Elements	Stairs, Stairs Landing, Stucco Interface, Integrations, Railings
Water Proofing Elements	Flashings, Waterproofing, Coatings, Sealants
Visual Review	Fair
Any Visual Signs of leaks	No
Further Invasive Review Required	No
Condition Assessment	Pass
Additional Considerations or Concerns	None
Life Expectancy (EEE)	1-4 Years
Life Expectancy (LBC)	4-7 Years
Life Expectancy (AWE)	1-4 Years

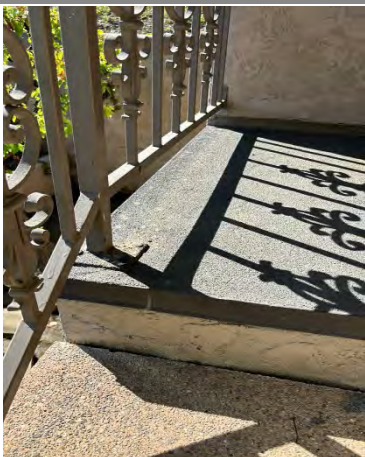
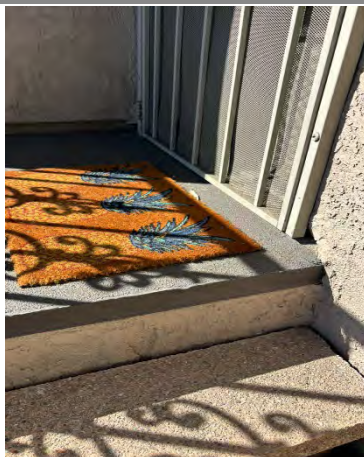
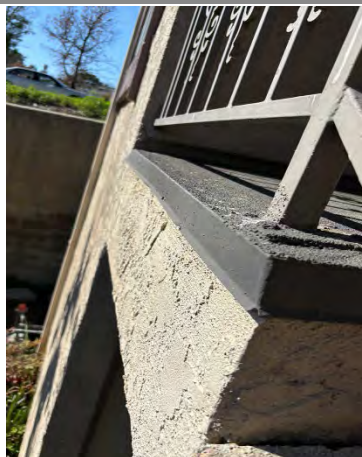
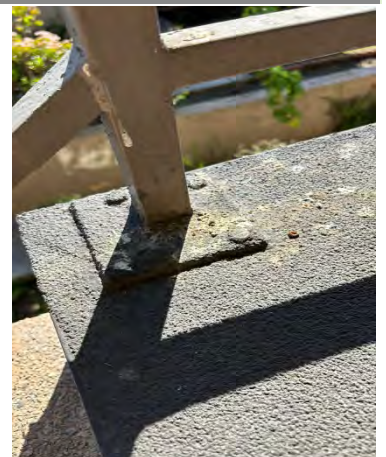
Building Name	2305-1
Apartment Name	174
Location Name	Entry deck
Visual Report	
Exterior Elements	Porches/Entry, Railings, Integrations, Door Threshold, Stucco Interface
Water Proofing Elements	Flashings, Waterproofing, Coatings, Sealants
Visual Review	Fair
Any Visual Signs of leaks	No
Further Invasive Review Required	No
Condition Assessment	Pass
Additional Considerations or Concerns	Deck is in fair condition
Life Expectancy (EEE)	1-4 Years
Life Expectancy (LBC)	1-4 Years
Life Expectancy (AWE)	1-4 Years

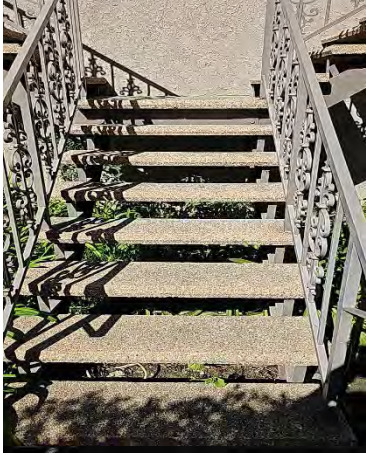
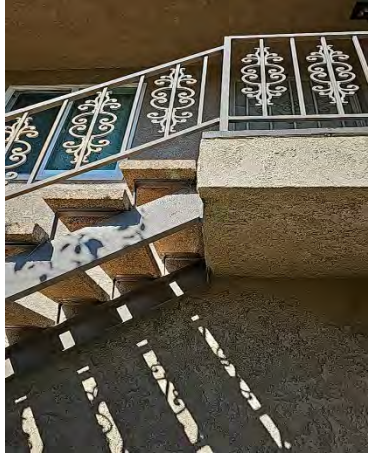
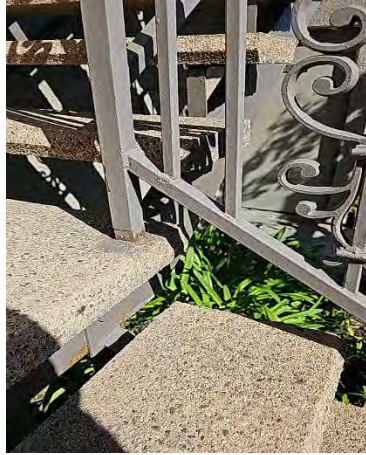
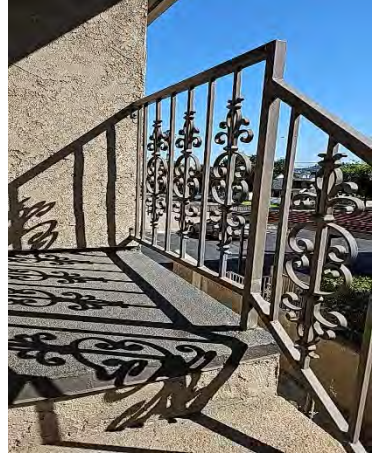
Building Name	2305-2
Apartment Name	173
Location Name	Stairs
Visual Report	
Exterior Elements	Stairs, Railings, Door Threshold, Stucco Interface
Water Proofing Elements	Flashings, Waterproofing, Coatings, Sealants
Visual Review	Fair
Any Visual Signs of leaks	No
Further Invasive Review Required	No
Condition Assessment	Pass
Additional Considerations or Concerns	<p>Railing at concrete</p> <p>Stairs are steel stringers attached to a wood structure with concrete treads.</p> <p>The handrails are visually in good condition.</p> <p>Handrail post to tread has corrosion. Repair as necessary.</p>
Life Expectancy (EEE)	1-4 Years
Life Expectancy (LBC)	1-4 Years
Life Expectancy (AWE)	1-4 Years
Visual Photos

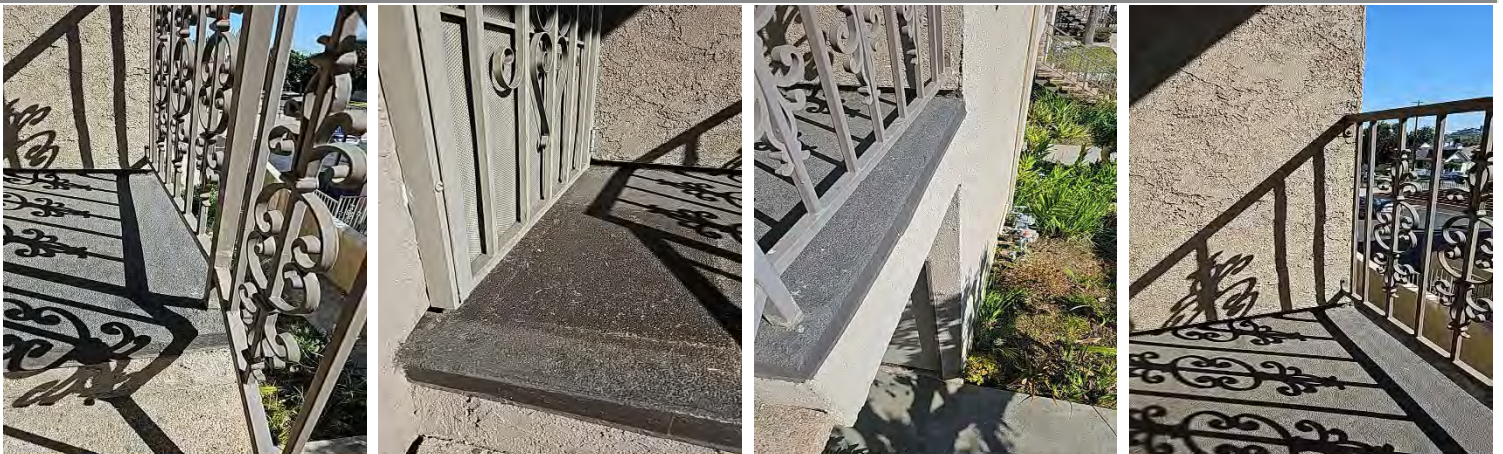
Building Name	2305-2
Apartment Name	173
Location Name	Entry deck
Visual Report	
Exterior Elements	Decks, Railings, Integrations, Stucco Interface
Water Proofing Elements	Flashings, Waterproofing, Coatings, Sealants
Visual Review	Good
Any Visual Signs of leaks	No
Further Invasive Review Required	No
Condition Assessment	Pass
Additional Considerations or Concerns	<p><b>Entry / Balcony / Walking Deck</b></p> <p>The deck is wood framed with waterproofing over the wood.</p> <p>Handrails are metal and attached to the deck surface and visually in good condition.</p>
Life Expectancy (EEE)	1-4 Years
Life Expectancy (LBC)	1-4 Years
Life Expectancy (AWE)	1-4 Years

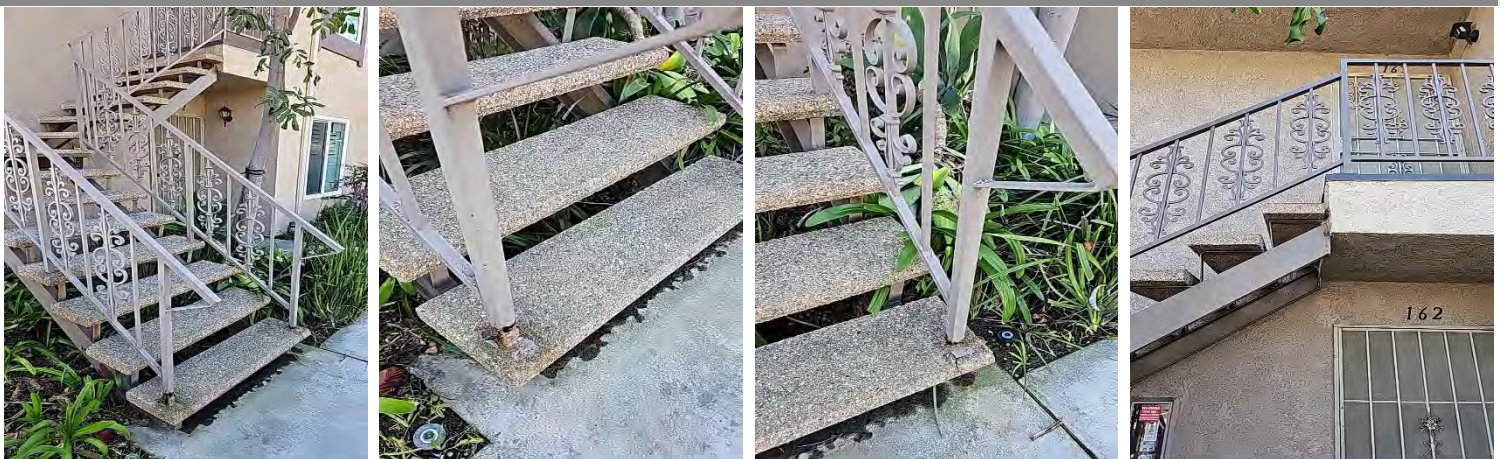
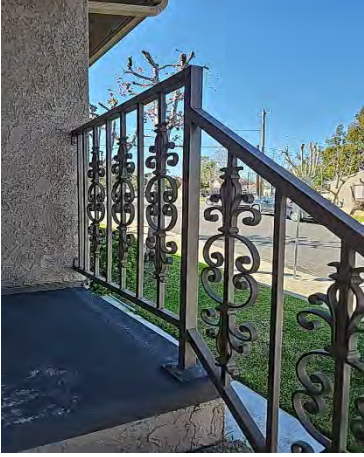
Building Name	2307-1
Apartment Name	163
Location Name	Stairs
Visual Report	
Exterior Elements	Stairs, Railings, Integrations, Stucco Interface
Water Proofing Elements	Flashings, Waterproofing, Coatings, Sealants
Visual Review	Fair
Any Visual Signs of leaks	No
Further Invasive Review Required	No
Condition Assessment	Pass
Additional Considerations or Concerns	Handrail post at first tread corroded. Repair.
Life Expectancy (EEE)	0-1 Years
Life Expectancy (LBC)	1-4 Years
Life Expectancy (AWE)	0-1 Years

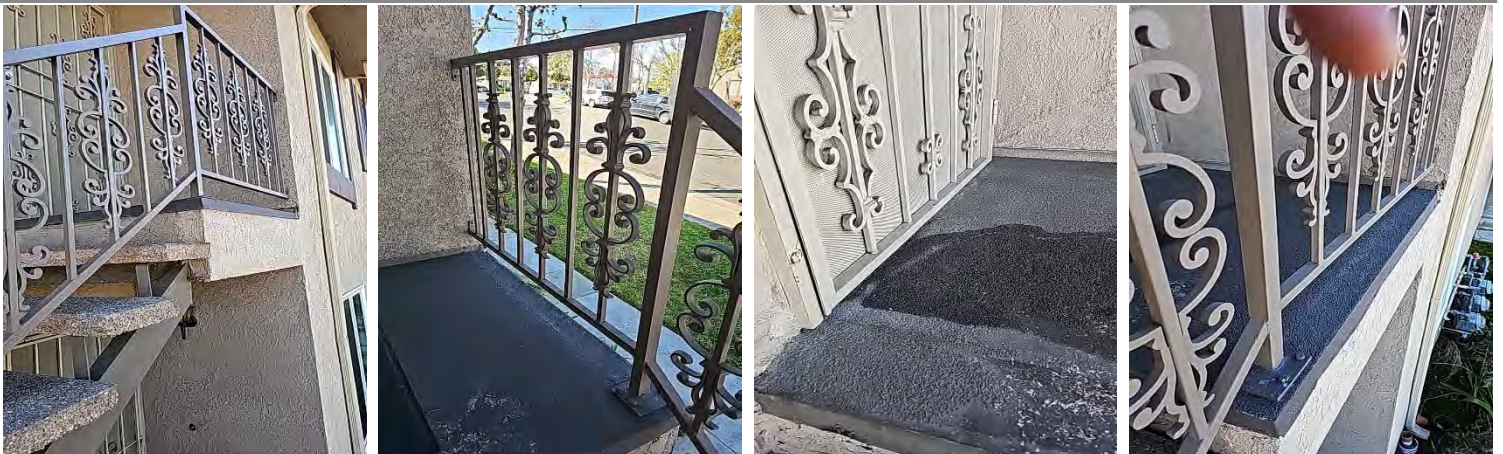
Building Name	2307-1
Apartment Name	163
Location Name	Entry deck
Visual Report	
Exterior Elements	Decks, Railings, Integrations, Stucco Interface
Water Proofing Elements	Flashings, Waterproofing, Coatings, Sealants
Visual Review	Fair
Any Visual Signs of leaks	No
Further Invasive Review Required	No
Condition Assessment	Pass
Additional Considerations or Concerns	<p>Entry / Balcony / Walking Deck</p> <p>The deck is wood framed with waterproofing over the wood.</p> <p>Handrails are metal and attached to the deck surface and visually in good condition.</p>
Life Expectancy (EEE)	1-4 Years
Life Expectancy (LBC)	1-4 Years
Life Expectancy (AWE)	1-4 Years

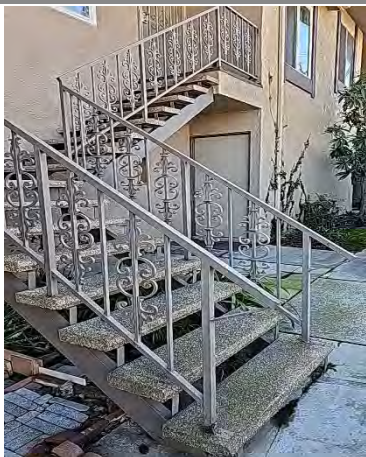
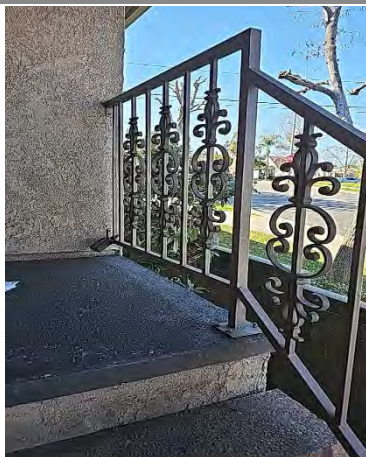
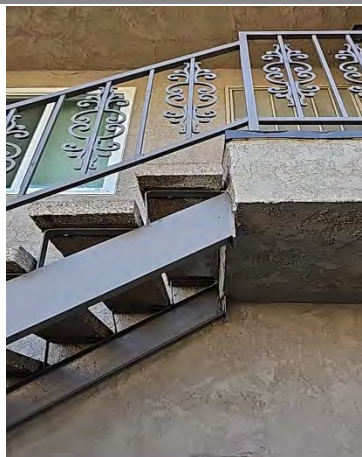
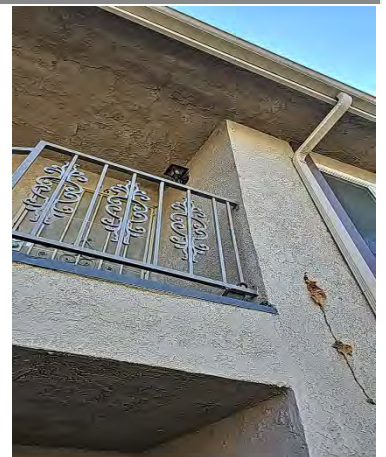
Building Name	2307-1
Apartment Name	165
Location Name	Stairs
Visual Report	
Exterior Elements	Stairs, Railings, Integrations, Stucco Interface
Water Proofing Elements	Flashings, Waterproofing, Coatings, Sealants
Visual Review	Fair
Any Visual Signs of leaks	No
Further Invasive Review Required	No
Condition Assessment	Fail
Additional Considerations or Concerns	Handrail post at first tread corroded. Repair as necessary.
Life Expectancy (EEE)	0-1 Years
Life Expectancy (LBC)	1-4 Years
Life Expectancy (AWE)	0-1 Years
