## DECK INSPECTORS INC.

#### Part 2 of Visual Inspection:

Autumn Pointe HOA

55488 Dobbs St.

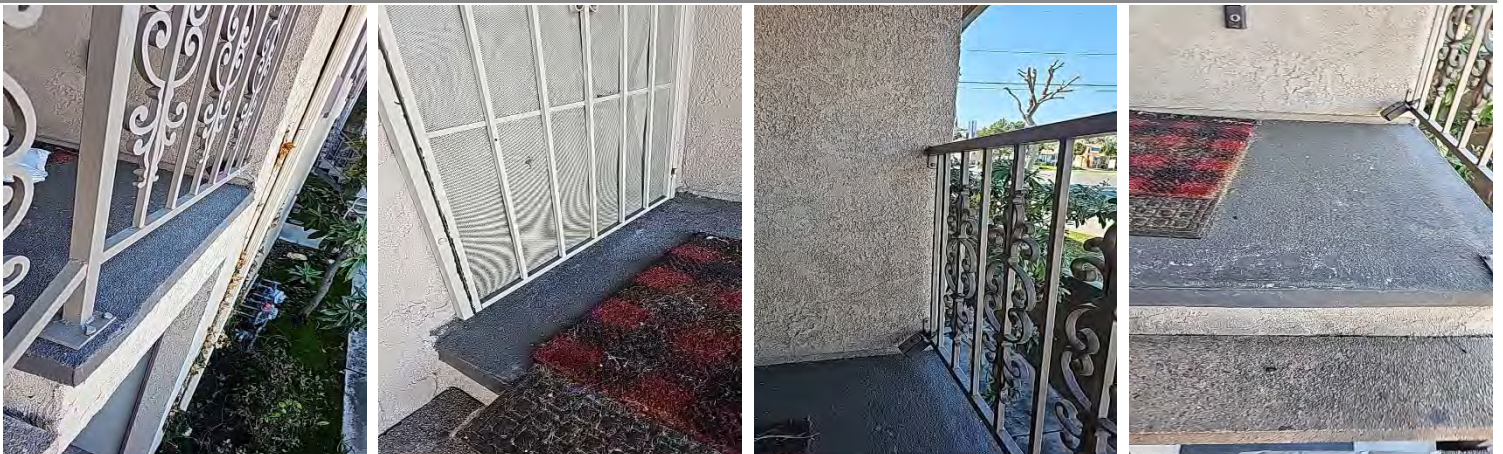
Building Name	2307-1
Apartment Name	165
Location Name	Entry deck
Visual Report	
Exterior Elements	Stucco Interface, Integrations, Railings, Decks
Water Proofing Elements	Flashings, Waterproofing, Coatings, Sealants
Visual Review	Good
Any Visual Signs of leaks	No
Further Invasive Review Required	No
Condition Assessment	Pass
Additional Considerations or Concerns	<p><b>Entry / Balcony / Walking Deck</b></p> <p>The deck is wood framed with waterproofing over the wood.</p> <p>Handrails are metal and attached to the deck surface and visually in good condition.</p>
Life Expectancy (EEE)	1-4 Years
Life Expectancy (LBC)	1-4 Years
Life Expectancy (AWE)	1-4 Years

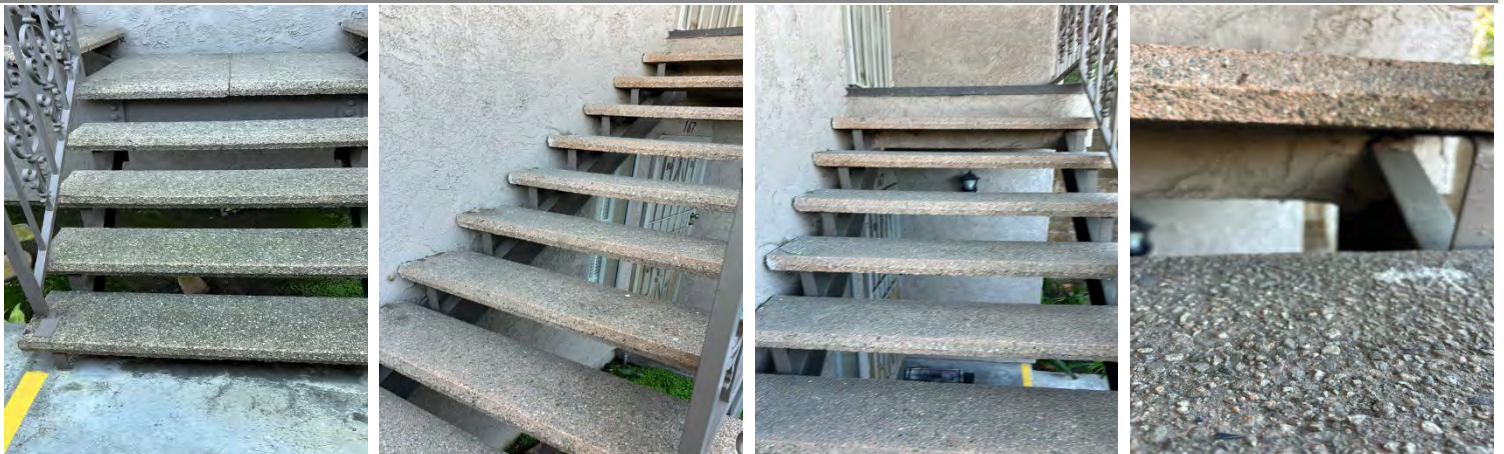
Exterior Elements	Stairs, Stairs Landing, Railings, Stucco Interface
Water Proofing Elements	Flashings, Waterproofing, Coatings, Sealants
Visual Review	Fair
Any Visual Signs of leaks	No
Further Invasive Review Required	No
Condition Assessment	Pass
Additional Considerations or Concerns	<p>Railing at concrete</p> <p>Stairs are steel stringers attached to a wood structure with concrete treads.</p> <p>The handrails are visually in good condition.</p>
Life Expectancy (EEE)	1-4 Years
Life Expectancy (LBC)	4-7 Years
Life Expectancy (AWE)	1-4 Years

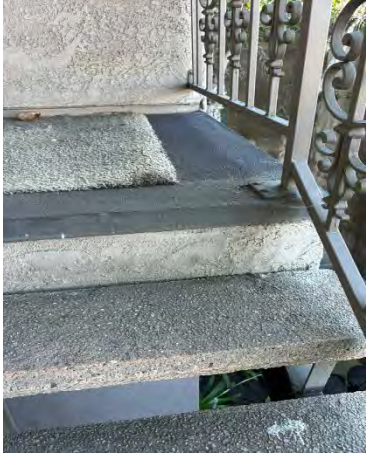
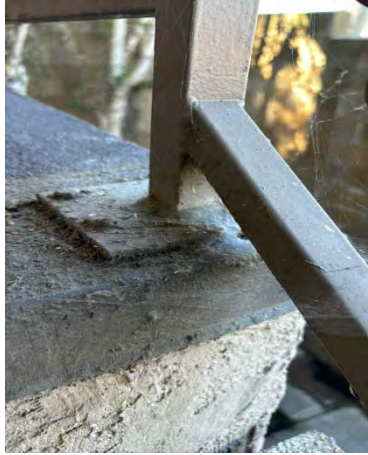
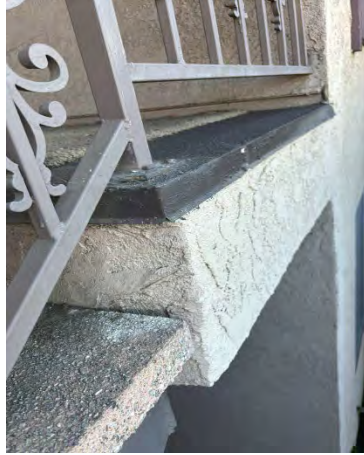
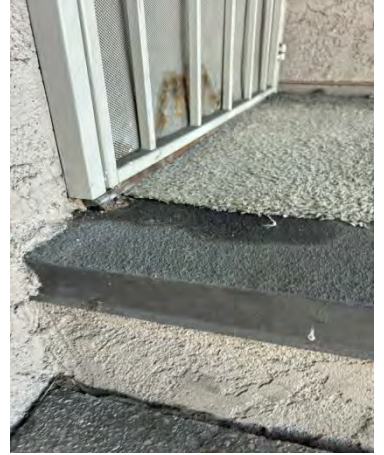
Building Name	2307-2
Apartment Name	168
Location Name	Entry deck
Visual Report	
Exterior Elements	Porches/Entry, Railings, Integrations, Door Threshold, Stucco Interface
Water Proofing Elements	Flashings, Waterproofing, Coatings, Sealants
Visual Review	Fair
Any Visual Signs of leaks	No
Further Invasive Review Required	No
Condition Assessment	Pass
Additional Considerations or Concerns	<p>Entry / Balcony / Walking Deck</p> <p>The deck is wood framed with waterproofing over the wood.</p> <p>Handrails are metal and attached to the deck surface and visually in good condition.</p>
Life Expectancy (EEE)	1-4 Years
Life Expectancy (LBC)	1-4 Years
Life Expectancy (AWE)	1-4 Years
Visual Photos

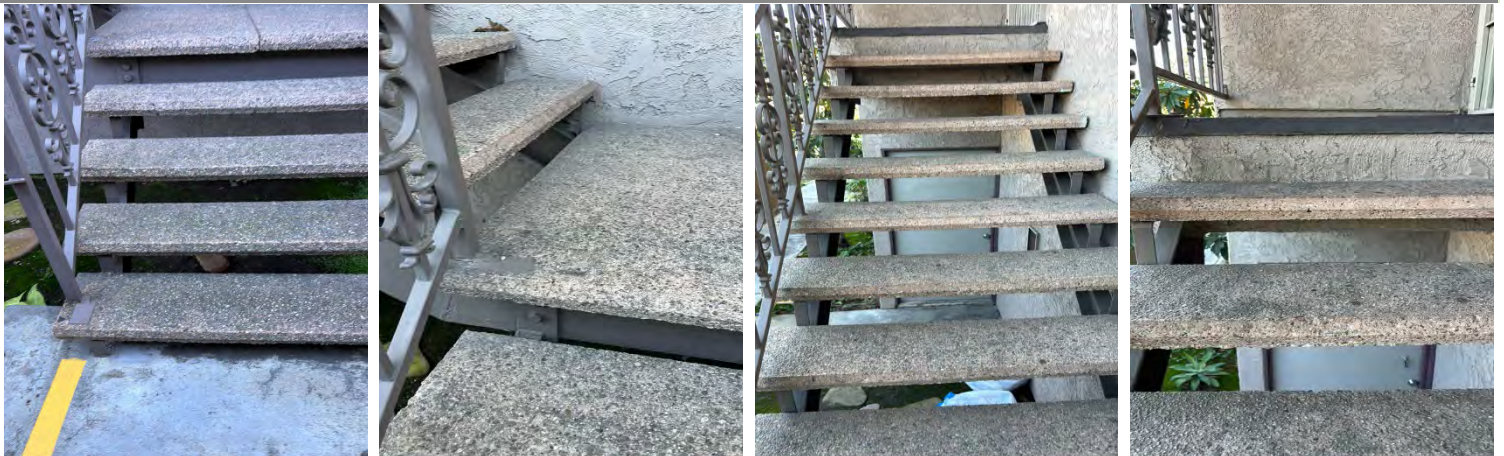
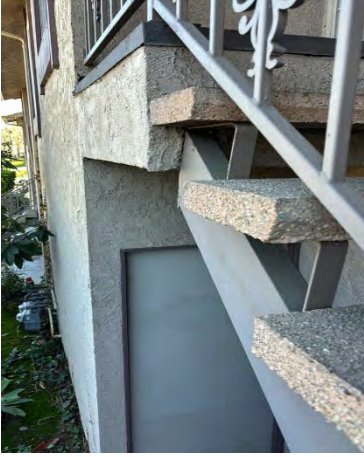
Building Name	2307-2
Apartment Name	166
Location Name	Stairs
Visual Report	
Exterior Elements	Stairs, Stairs Landing, Railings, Stucco Interface
Water Proofing Elements	Flashings, Waterproofing, Coatings, Sealants
Visual Review	Good
Any Visual Signs of leaks	No
Further Invasive Review Required	No
Condition Assessment	Pass
Additional Considerations or Concerns	<p><b>Railing at concrete</b></p> <p><b>Stairs are steel stringers attached to a wood structure with concrete treads.</b></p> <p><b>The handrails are visually in good condition.</b></p>
Life Expectancy (EEE)	1-4 Years
Life Expectancy (LBC)	1-4 Years
Life Expectancy (AWE)	1-4 Years

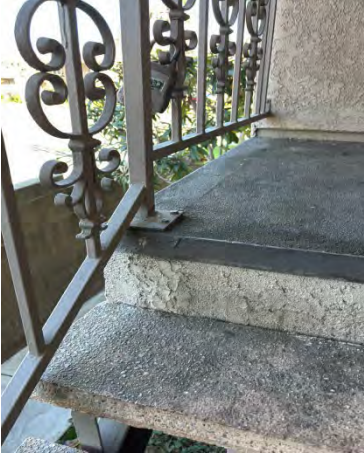
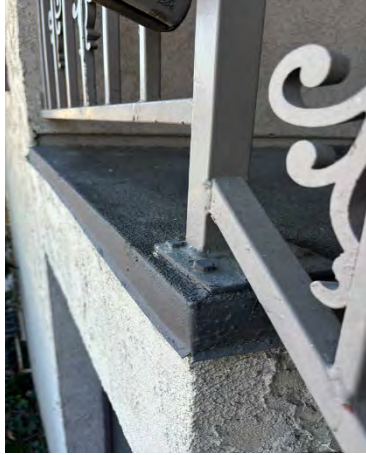
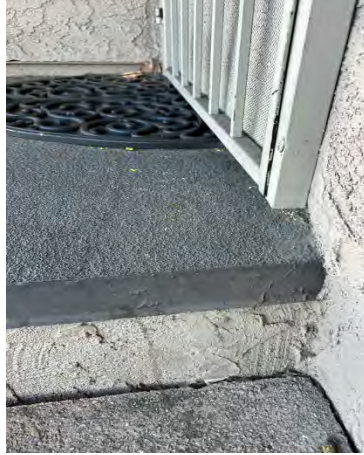
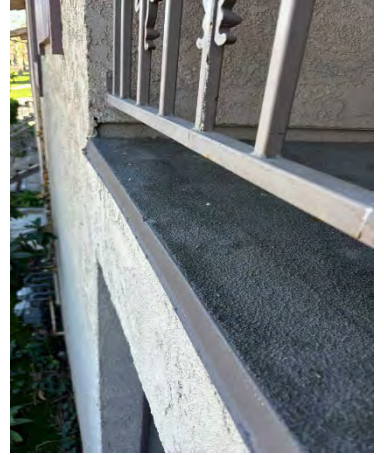
Building Name	2307-2
Apartment Name	166
Location Name	Entry deck
Visual Report	
Exterior Elements	Porches/Entry, Integrations, Door Threshold, Railings, Stucco Interface
Water Proofing Elements	Flashings, Waterproofing, Coatings, Sealants
Visual Review	Good
Any Visual Signs of leaks	No
Further Invasive Review Required	No
Condition Assessment	Pass
Additional Considerations or Concerns	<p>Entry / Balcony / Walking Deck</p> <p>The deck is wood framed with waterproofing over the wood.</p> <p>Handrails are metal and attached to the deck surface and visually in good condition.</p>
Life Expectancy (EEE)	1-4 Years
Life Expectancy (LBC)	1-4 Years
Life Expectancy (AWE)	1-4 Years
Visual Photos

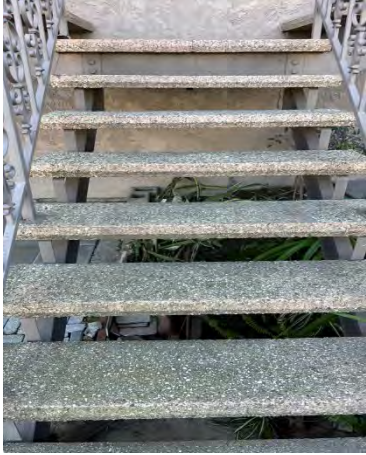
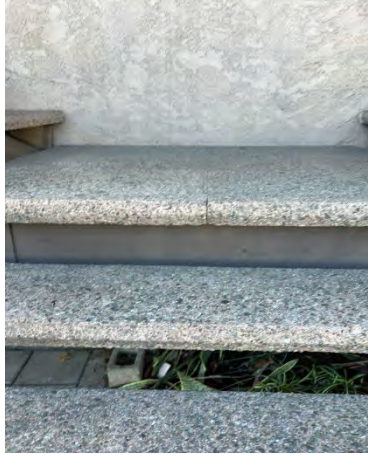
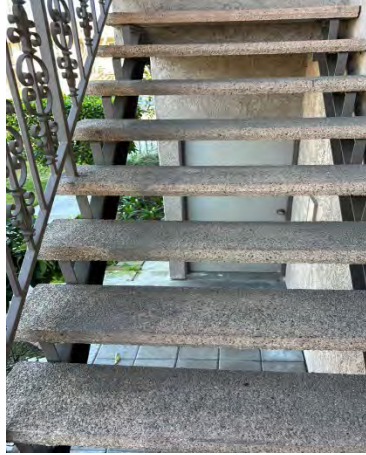
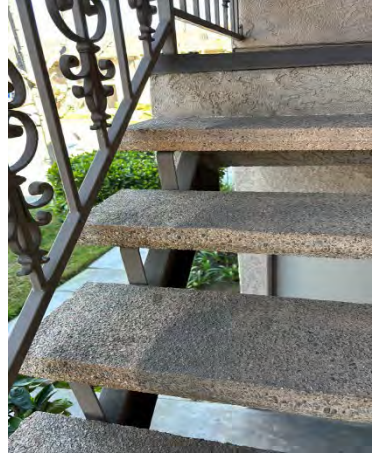
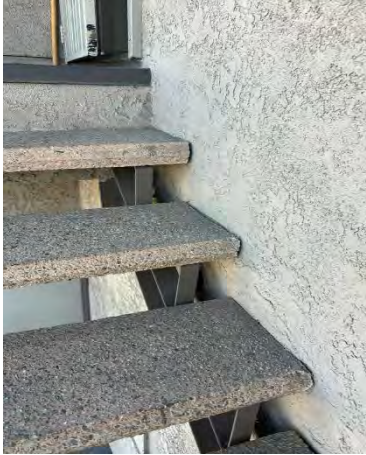
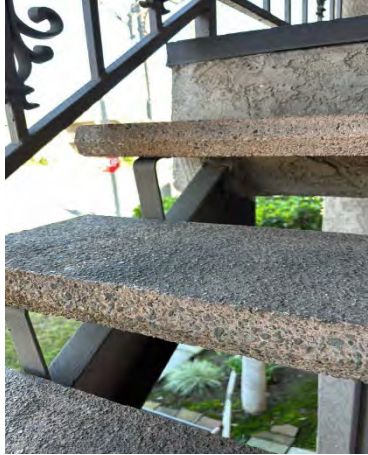
Building Name	2307-2
Apartment Name	164
Location Name	Stairs
Visual Report	
Exterior Elements	Stairs, Stairs Landing, Railings, Integrations, Stucco Interface
Water Proofing Elements	Flashings, Waterproofing, Coatings, Sealants
Visual Review	Fair
Any Visual Signs of leaks	No
Further Invasive Review Required	No
Condition Assessment	Pass
Additional Considerations or Concerns	<p>Railing at concrete</p> <p>Stairs are steel stringers attached to a wood structure with concrete treads.</p> <p>The handrails are visually in good condition.</p>
Life Expectancy (EEE)	1-4 Years
Life Expectancy (LBC)	4-7 Years
Life Expectancy (AWE)	1-4 Years
Visual Photos

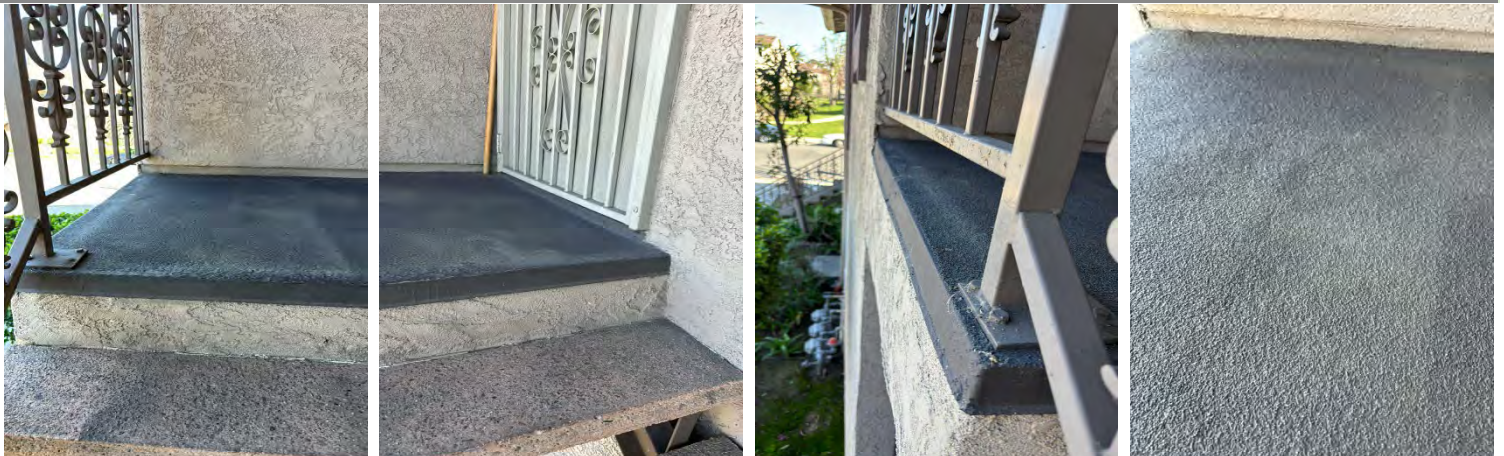
Exterior Elements	Porches/Entry, Railings, Integrations, Door Threshold, Stucco Interface
Water Proofing Elements	Flashings, Waterproofing, Coatings, Sealants
Visual Review	<b>Bad</b>
Any Visual Signs of leaks	<b>Yes</b>
Further Invasive Review Required	<b>Yes</b>
Condition Assessment	<b>Fail</b>
Additional Considerations or Concerns	<b>This deck has a topcoat that looks to be in fair condition however, there is a soft spot in the middle middle of the deck. Replace or repair the waterproofing, including all damaged wood with new waterproofing and wood structures.</b>
Life Expectancy (EEE)	<b>0-1 Years</b>
Life Expectancy (LBC)	<b>1-4 Years</b>
Life Expectancy (AWE)	<b>0-1 Years</b>

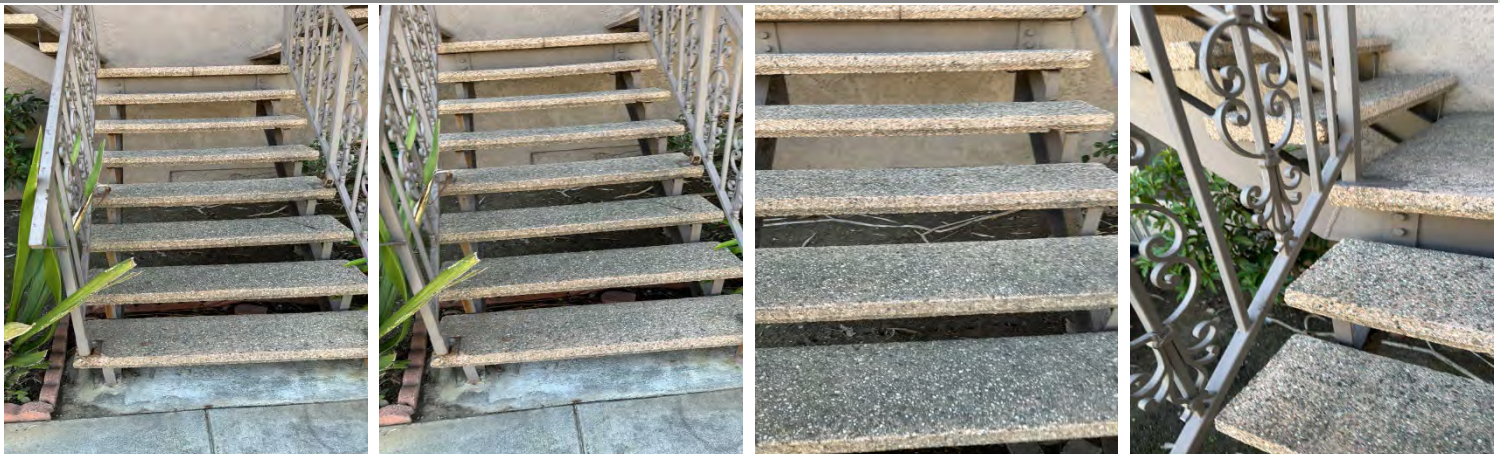
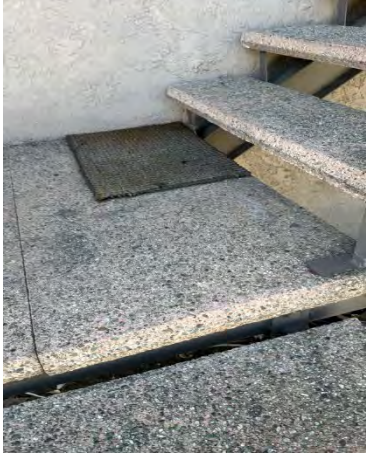
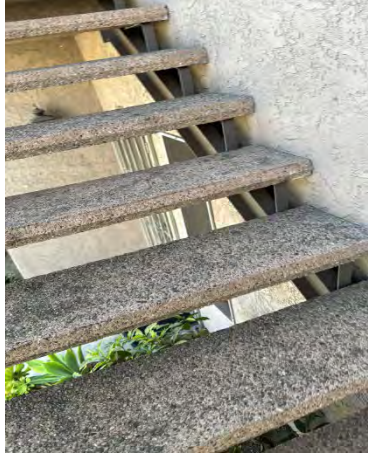
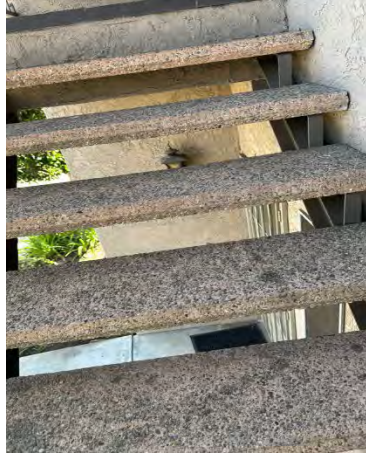
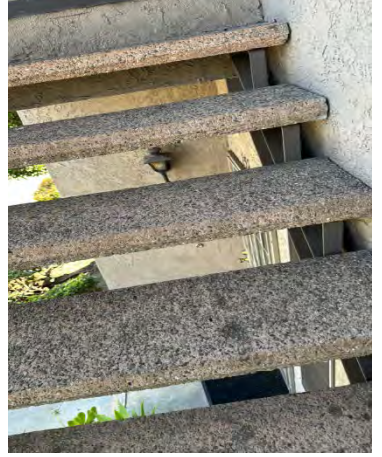
Building Name	2331
Apartment Name	152
Location Name	Stairs
Visual Report	
Exterior Elements	Stairs, Stairs Landing, Railings, Integrations
Water Proofing Elements	Flashings, Waterproofing, Coatings, Sealants
Visual Review	Good
Any Visual Signs of leaks	No
Further Invasive Review Required	No
Condition Assessment	Pass
Additional Considerations or Concerns	<p><b>Railing at concrete</b></p> <p><b>Stairs are steel stringers attached to a wood structure with concrete treads.</b></p> <p><b>The handrails are visually in good condition.</b></p>
Life Expectancy (EEE)	1-4 Years
Life Expectancy (LBC)	4-7 Years
Life Expectancy (AWE)	1-4 Years

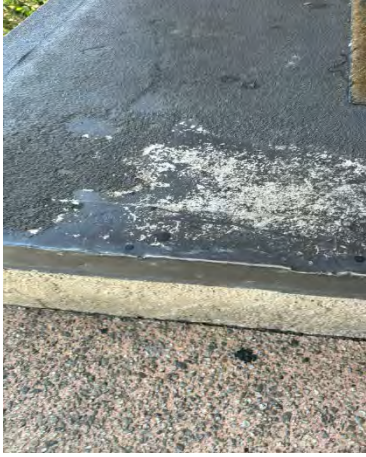
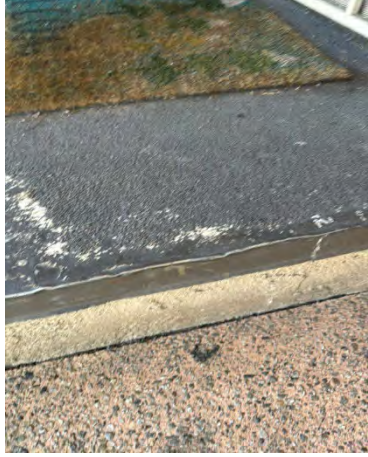
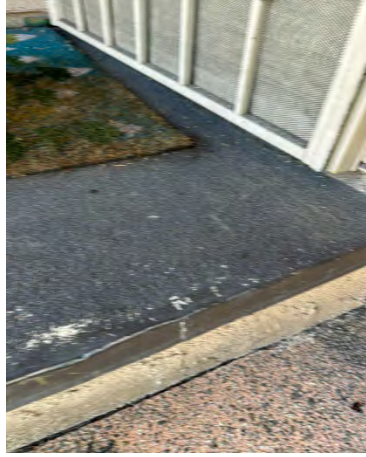
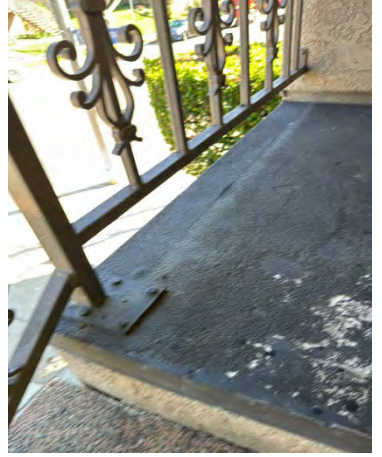
Building Name	2331
Apartment Name	152
Location Name	Entry deck
Visual Report	
Exterior Elements	Decks, Railings, Integrations, Door Threshold, Stucco Interface
Water Proofing Elements	Flashings, Waterproofing, Coatings, Sealants
Visual Review	Good
Any Visual Signs of leaks	Yes
Further Invasive Review Required	No
Condition Assessment	Fail
Additional Considerations or Concerns	<p>Entry / Balcony / Walking Deck</p> <p>The deck is wood framed with waterproofing over the wood.</p> <p>Handrails are metal and attached to the deck surface and visually in good condition.</p> <p>The waterproofing is severely damaged. Replace or repair the waterproofing, including all damaged wood with new waterproofing and wood structures.</p>
Life Expectancy (EEE)	1-4 Years
Life Expectancy (LBC)	4-7 Years
Life Expectancy (AWE)	1-4 Years

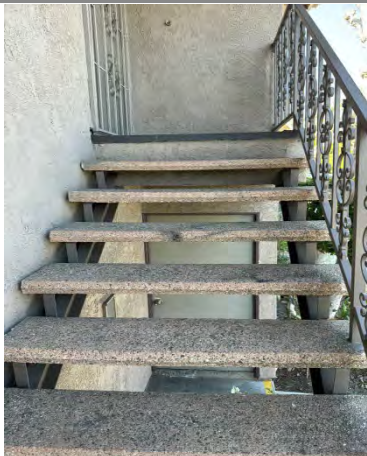
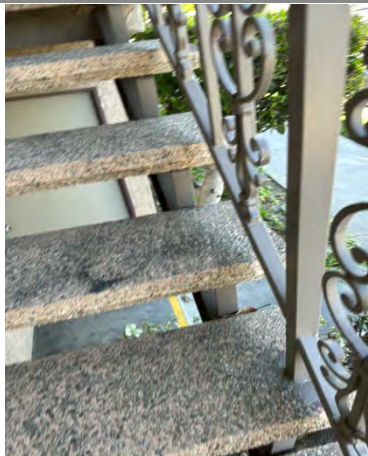
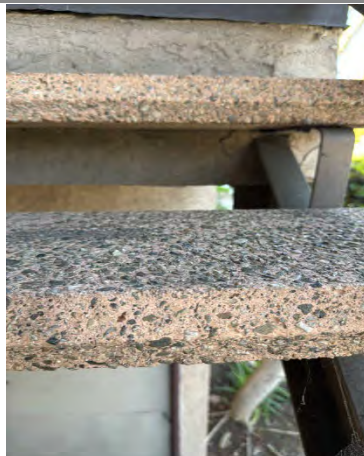
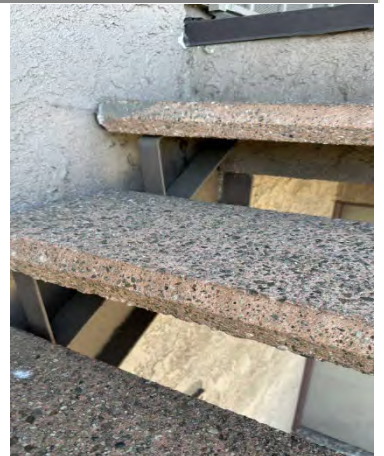
Building Name	2331
Apartment Name	151
Location Name	Stairs
Visual Report	
Exterior Elements	Railings, Integrations, Stairs, Porches/Entry
Water Proofing Elements	Flashings, Waterproofing, Coatings, Sealants
Visual Review	Good
Any Visual Signs of leaks	No
Further Invasive Review Required	No
Condition Assessment	Pass
Additional Considerations or Concerns	<p><b>Railing at concrete</b></p> <p><b>Stairs are steel stringers attached to a wood structure with concrete treads.</b></p> <p><b>The handrails are visually in good condition.</b></p>
Life Expectancy (EEE)	1-4 Years
Life Expectancy (LBC)	4-7 Years
Life Expectancy (AWE)	1-4 Years

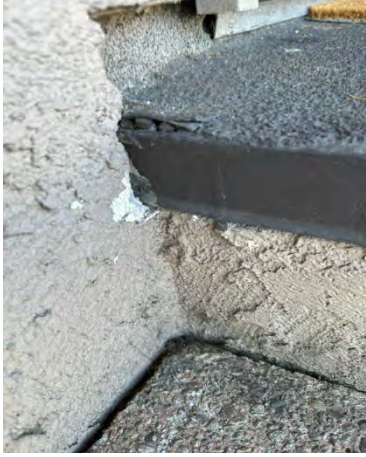
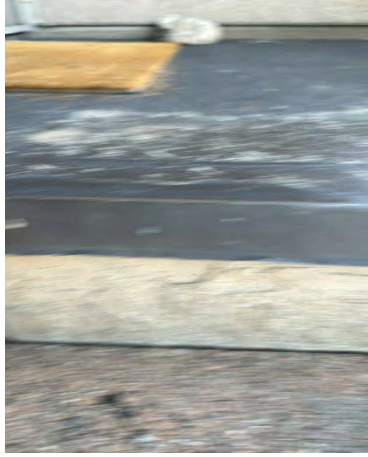
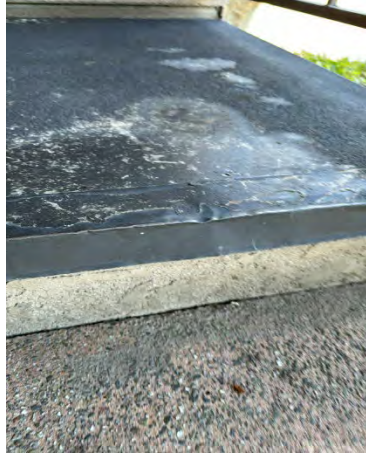
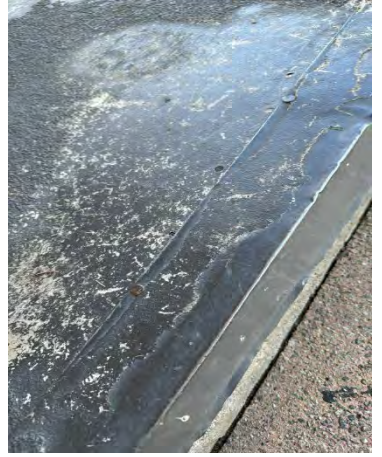
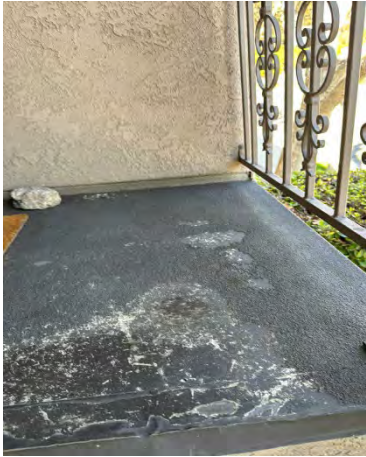
Building Name	2331
Apartment Name	151
Location Name	Entry deck
Visual Report	
Exterior Elements	Decks, Railings, Integrations, Door Threshold, Stucco Interface
Water Proofing Elements	Flashings, Waterproofing, Coatings, Sealants
Visual Review	Bad
Any Visual Signs of leaks	No
Further Invasive Review Required	No
Condition Assessment	Fail
Additional Considerations or Concerns	<p>Entry / Balcony / Walking Deck</p> <p>The deck is wood framed with waterproofing over the wood.</p> <p>Handrails are metal and attached to the deck surface and visually in good condition.</p> <p>The waterproofing is severely damaged. Replace or repair the waterproofing, including all damaged wood with new waterproofing and wood structures</p>
Life Expectancy (EEE)	1-4 Years
Life Expectancy (LBC)	4-7 Years
Life Expectancy (AWE)	0-1 Years

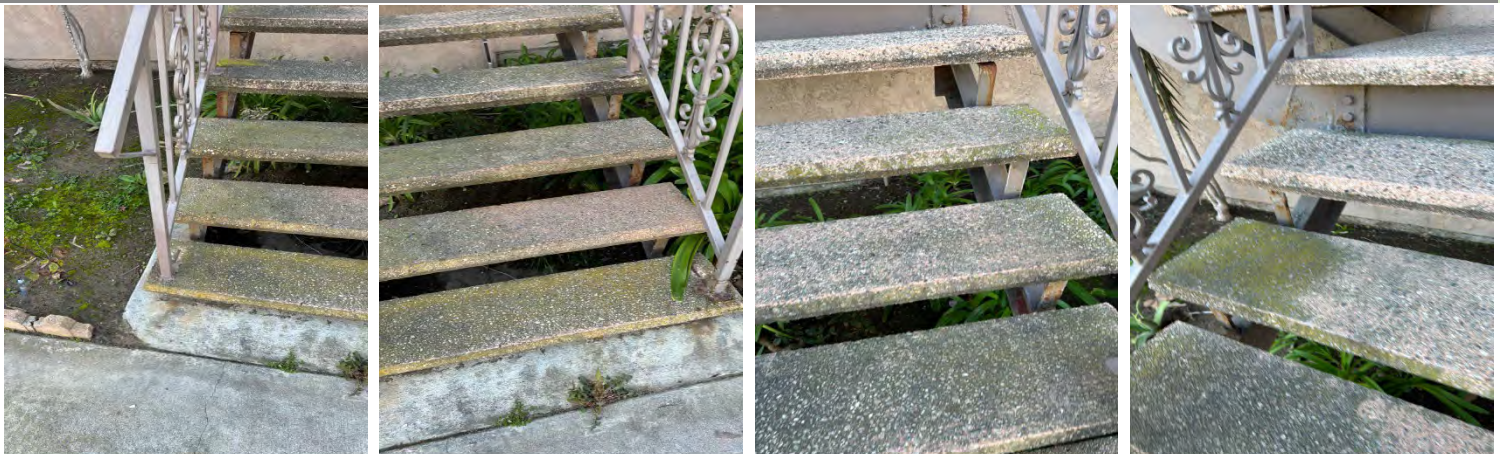
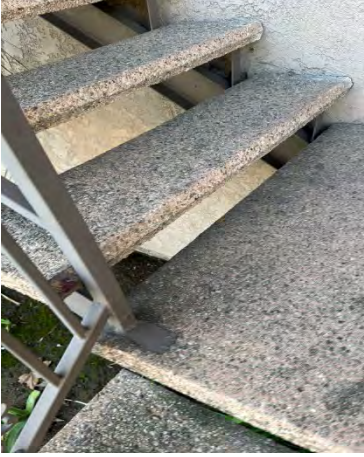
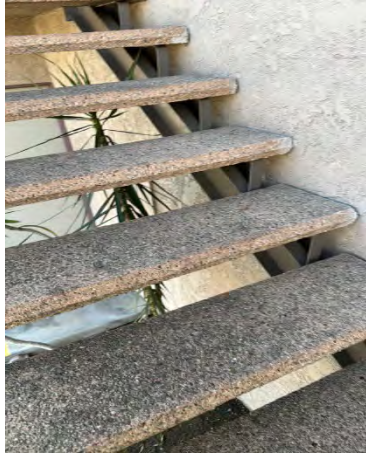
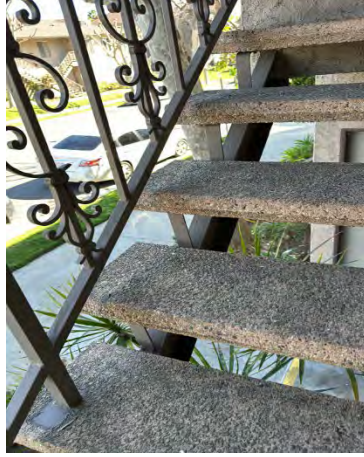
Exterior Elements	Railings, Integrations, Stairs Landing, Stairs
Water Proofing Elements	Flashings, Waterproofing, Coatings, Sealants
Visual Review	Good
Any Visual Signs of leaks	No
Further Invasive Review Required	No
Condition Assessment	Pass
Additional Considerations or Concerns	<p><b>Railing at concrete</b></p> <p><b>Stairs are steel stringers attached to a wood structure with concrete treads.</b></p> <p><b>The handrails are visually in good condition.</b></p>
Life Expectancy (EEE)	1-4 Years
Life Expectancy (LBC)	4-7 Years
Life Expectancy (AWE)	1-4 Years

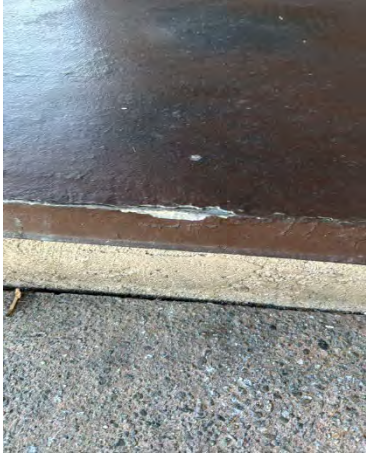
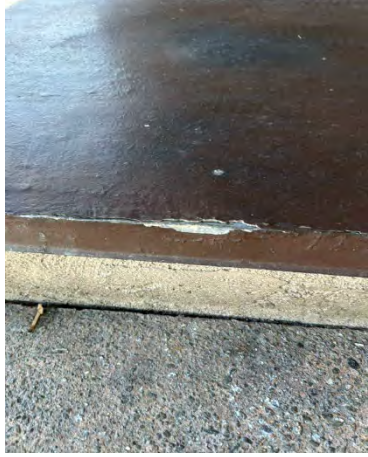
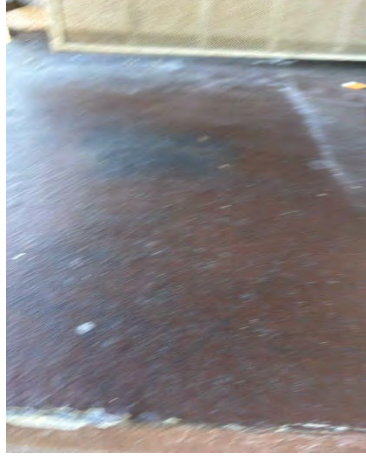
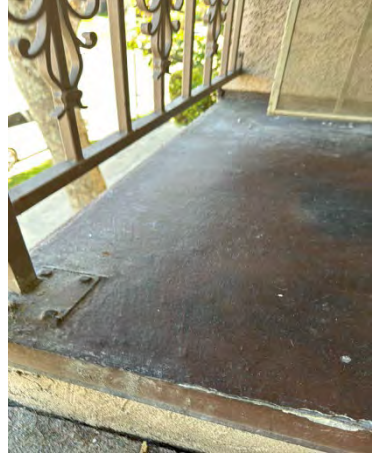
Exterior Elements	Decks, Walkways, Railings, Integrations, Door Threshold, Stucco Interface
Water Proofing Elements	Flashings, Waterproofing, Coatings, Sealants
Visual Review	Fair
Any Visual Signs of leaks	No
Further Invasive Review Required	No
Condition Assessment	Fail
Additional Considerations or Concerns	<p>Entry / Balcony / Walking Deck</p> <p>The deck is wood framed with waterproofing over the wood.</p> <p>Handrails are metal and attached to the deck surface and visually in good condition.</p> <p>The waterproofing is severely damaged. Replace or repair the waterproofing, including all damaged wood with new waterproofing and wood structures.</p>
Life Expectancy (EEE)	0-1 Years
Life Expectancy (LBC)	1-4 Years
Life Expectancy (AWE)	0-1 Years

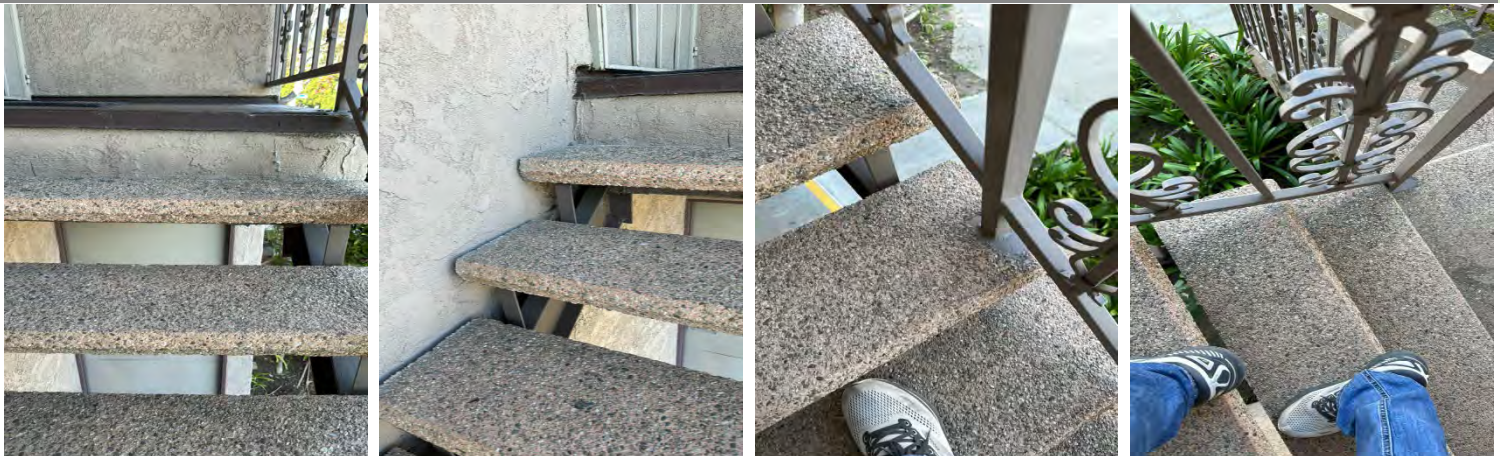
Building Name	2331
Apartment Name	149
Location Name	Stairs
Visual Report	
Exterior Elements	Stairs, Stairs Landing, Railings, Integrations
Water Proofing Elements	Flashings, Waterproofing, Coatings, Sealants
Visual Review	Good
Any Visual Signs of leaks	No
Further Invasive Review Required	No
Condition Assessment	Pass
Additional Considerations or Concerns	<p><b>Railing at concrete</b></p> <p><b>Stairs are steel stringers attached to a wood structure with concrete treads.</b></p> <p><b>The handrails are visually in good condition.</b></p>
Life Expectancy (EEE)	1-4 Years
Life Expectancy (LBC)	4-7 Years
Life Expectancy (AWE)	1-4 Years

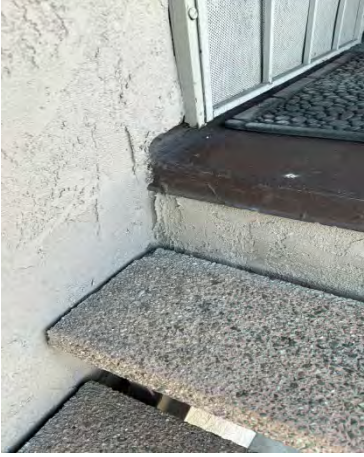
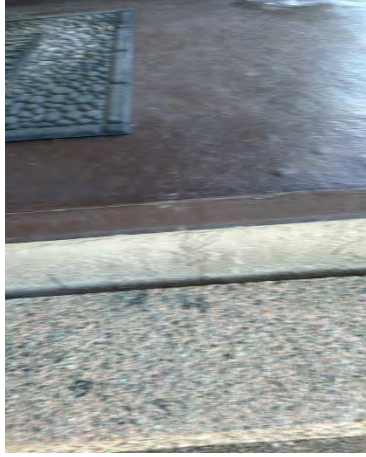
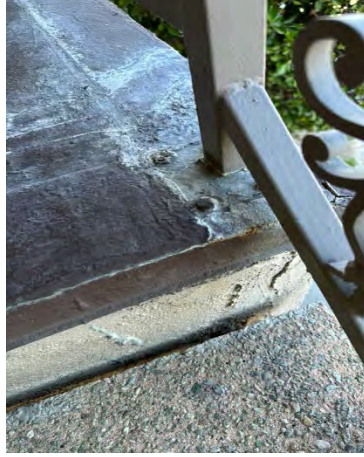
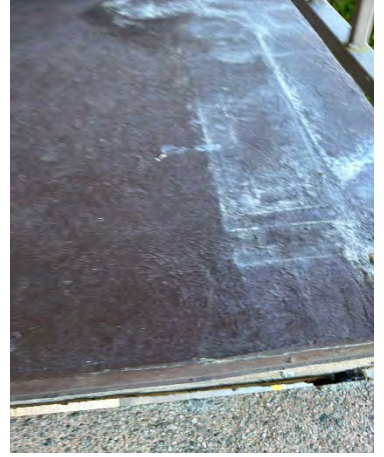
Building Name	2331
Apartment Name	149
Location Name	Entry deck
Visual Report	
Exterior Elements	Decks, Railings, Integrations, Door Threshold, Stucco Interface
Water Proofing Elements	Flashings, Waterproofing, Coatings, Sealants
Visual Review	Bad
Any Visual Signs of leaks	Yes
Further Invasive Review Required	No
Condition Assessment	Fail
Additional Considerations or Concerns	<p>Entry / Balcony / Walking Deck</p> <p>The deck is wood framed with waterproofing over the wood.</p> <p>Handrails are metal and attached to the deck surface and visually in good condition.</p> <p>The waterproofing is severely damaged. Replace or repair the waterproofing, including all damaged wood with new waterproofing and wood structures.</p>
Life Expectancy (EEE)	1-4 Years
Life Expectancy (LBC)	4-7 Years
Life Expectancy (AWE)	0-1 Years

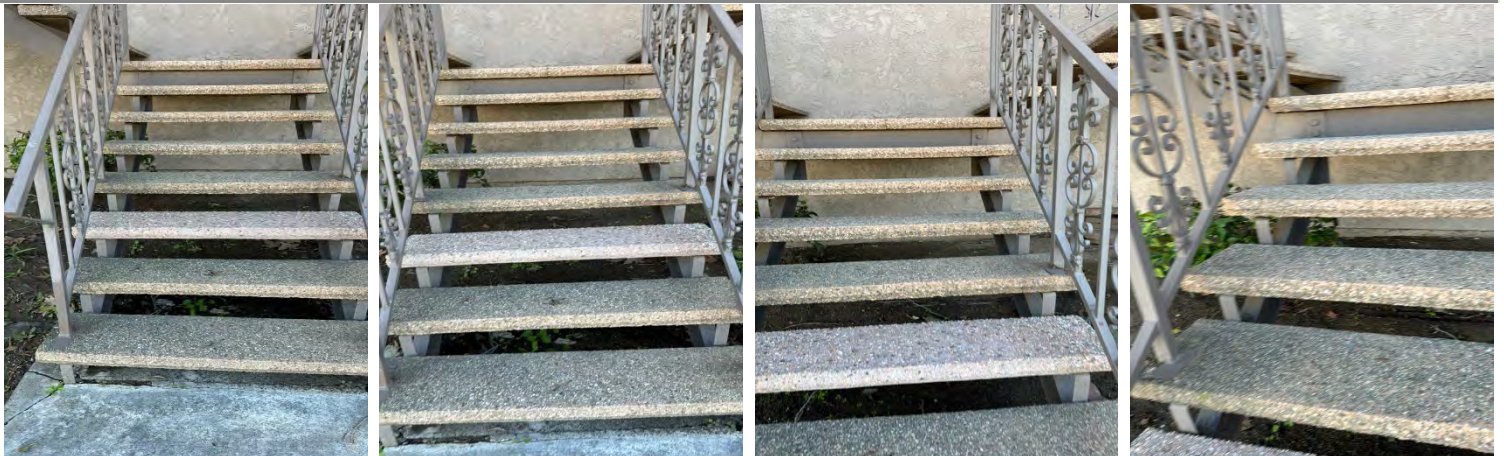
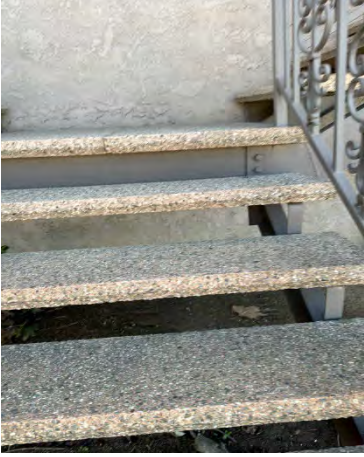
Exterior Elements	Stairs, Stairs Landing, Railings, Integrations
Water Proofing Elements	Flashings, Waterproofing, Coatings, Sealants
Visual Review	Good
Any Visual Signs of leaks	No
Further Invasive Review Required	No
Condition Assessment	Pass
Additional Considerations or Concerns	<p><b>Railing at concrete</b></p> <p><b>Stairs are steel stringers attached to a wood structure with concrete treads.</b></p> <p><b>The handrails are visually in good condition.</b></p>
Life Expectancy (EEE)	1-4 Years
Life Expectancy (LBC)	4-7 Years
Life Expectancy (AWE)	1-4 Years

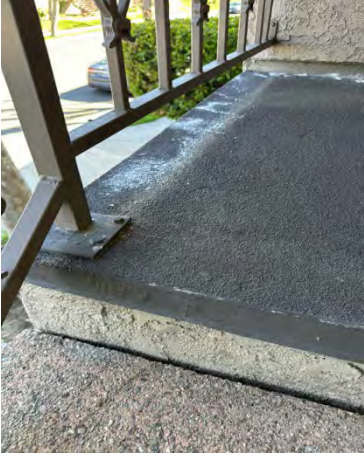
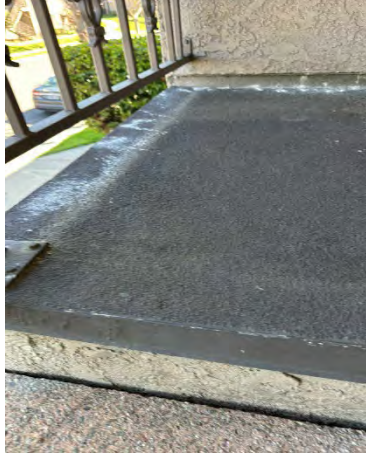
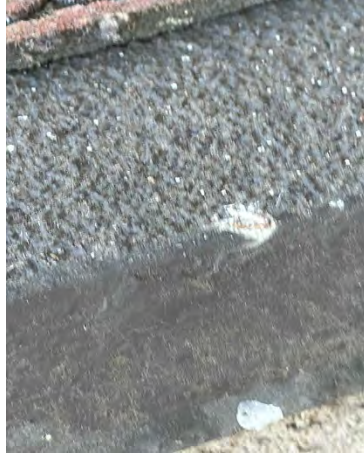
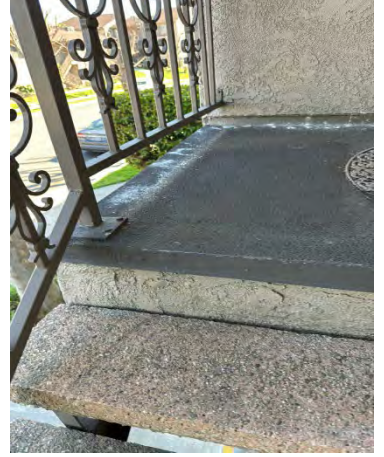
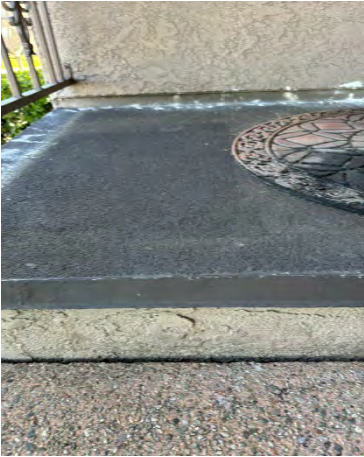
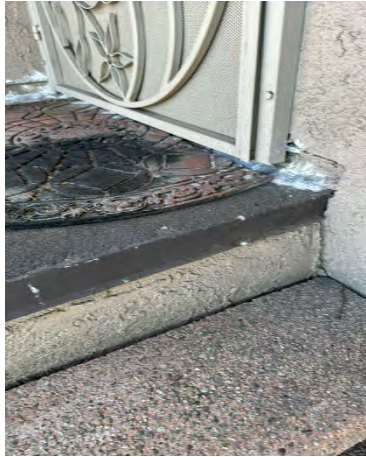
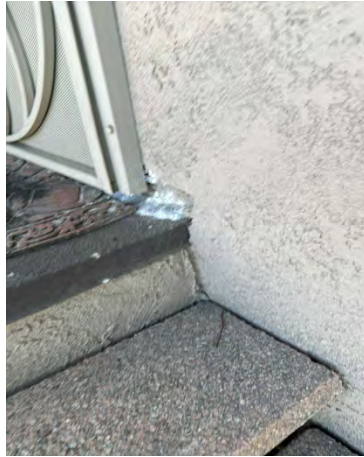
Building Name	2331
Apartment Name	148
Location Name	Entry deck
Visual Report	
Exterior Elements	Decks, Railings, Integrations, Door Threshold, Stucco Interface
Water Proofing Elements	Flashings, Waterproofing, Coatings, Sealants
Visual Review	Good
Any Visual Signs of leaks	No
Further Invasive Review Required	No
Condition Assessment	Pass
Additional Considerations or Concerns	<p>Entry / Balcony / Walking Deck</p> <p>The deck is wood framed with waterproofing over the wood.</p> <p>Handrails are metal and attached to the deck surface and visually in good condition.</p>
Life Expectancy (EEE)	1-4 Years
Life Expectancy (LBC)	4-7 Years
Life Expectancy (AWE)	1-4 Years
Visual Photos

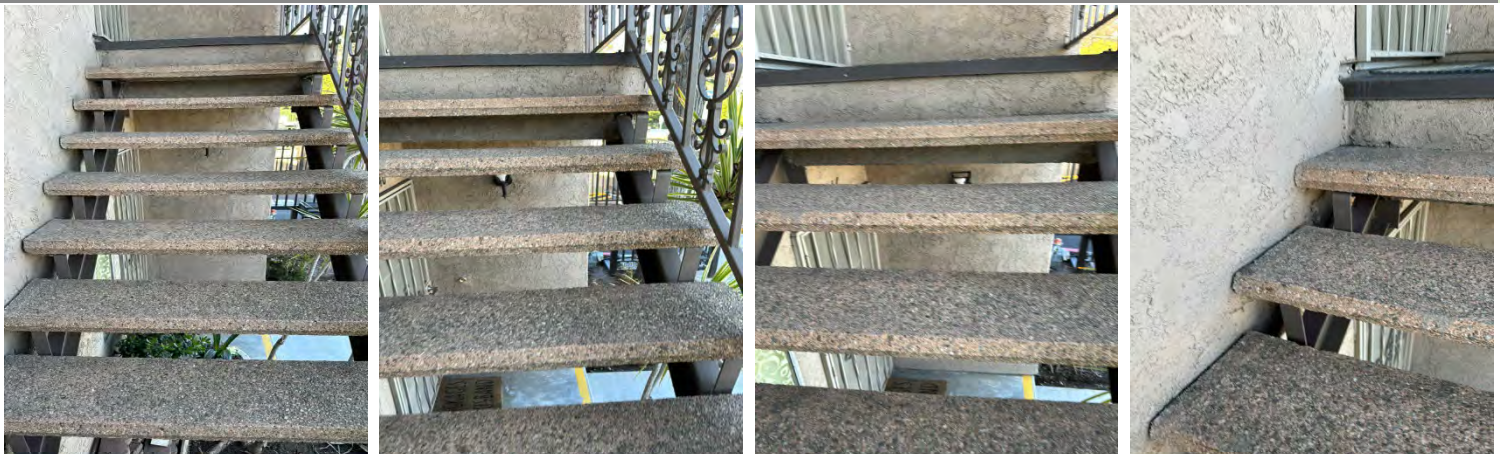
Exterior Elements	Stairs, Stairs Landing, Walkways, Integrations, Railings
Water Proofing Elements	Flashings, Waterproofing, Coatings, Sealants
Visual Review	Good
Any Visual Signs of leaks	No
Further Invasive Review Required	No
Condition Assessment	Pass
Additional Considerations or Concerns	<p><b>Railing at concrete</b></p> <p><b>Stairs are steel stringers attached to a wood structure with concrete treads.</b></p> <p><b>The handrails are visually in good condition.</b></p>
Life Expectancy (EEE)	1-4 Years
Life Expectancy (LBC)	4-7 Years
Life Expectancy (AWE)	1-4 Years

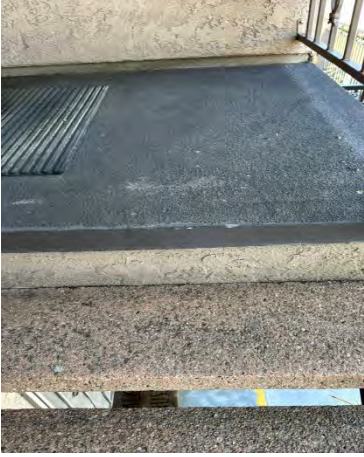
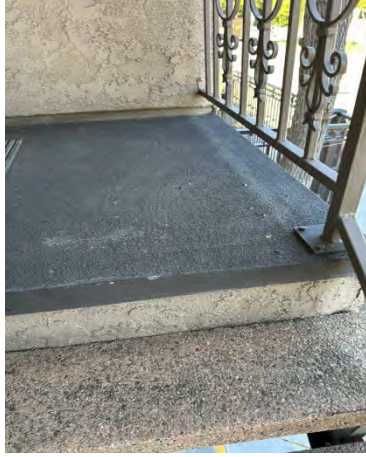
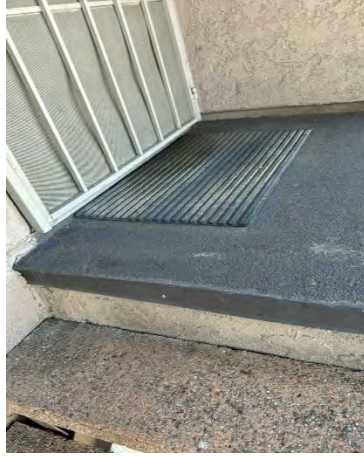
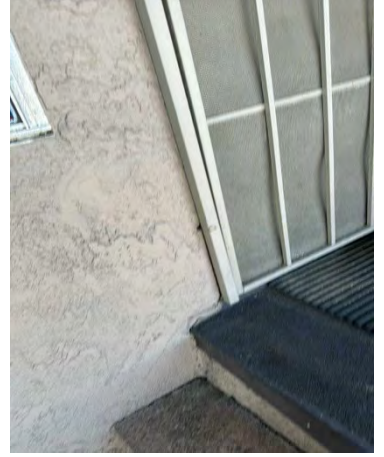
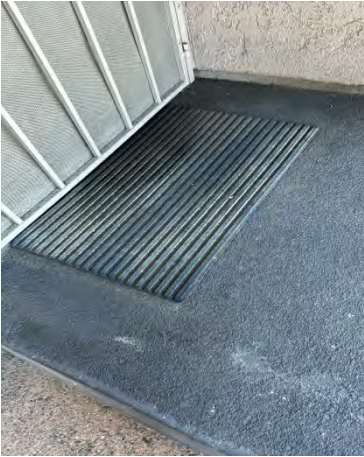
Building Name	2331
Apartment Name	147
Location Name	Entry deck
Visual Report	
Exterior Elements	Decks, Railings, Integrations, Door Threshold, Stucco Interface
Water Proofing Elements	Flashings, Waterproofing, Coatings, Sealants
Visual Review	Good
Any Visual Signs of leaks	No
Further Invasive Review Required	No
Condition Assessment	Pass
Additional Considerations or Concerns	<p>Entry / Balcony / Walking Deck</p> <p>The deck is wood framed with waterproofing over the wood.</p> <p>Handrails are metal and attached to the deck surface and visually in good condition.</p>
Life Expectancy (EEE)	1-4 Years
Life Expectancy (LBC)	4-7 Years
Life Expectancy (AWE)	1-4 Years
Visual Photos

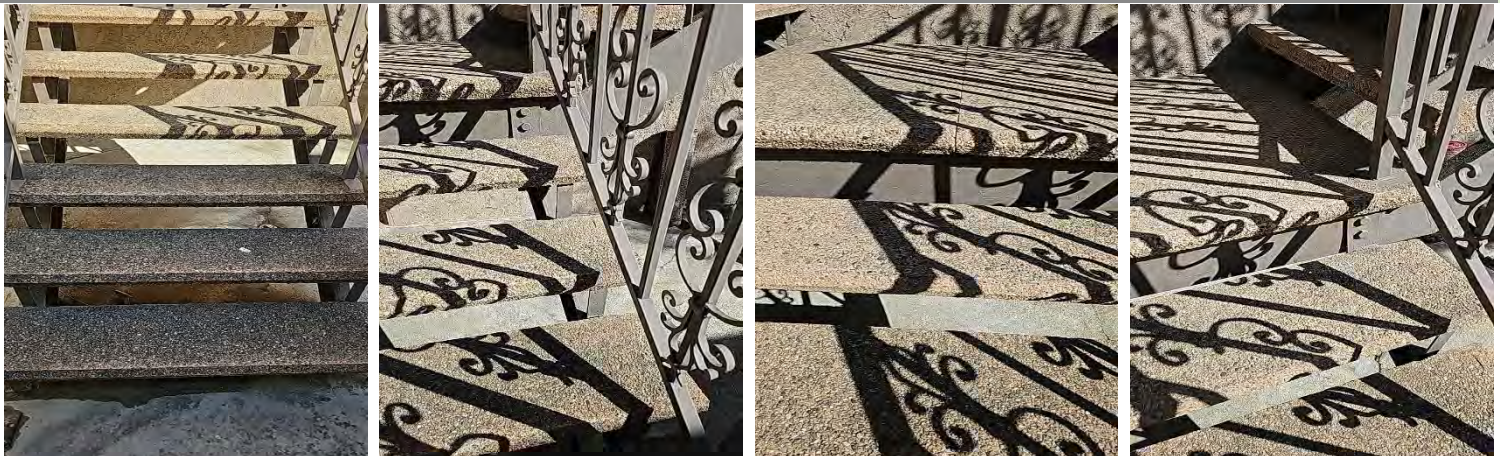
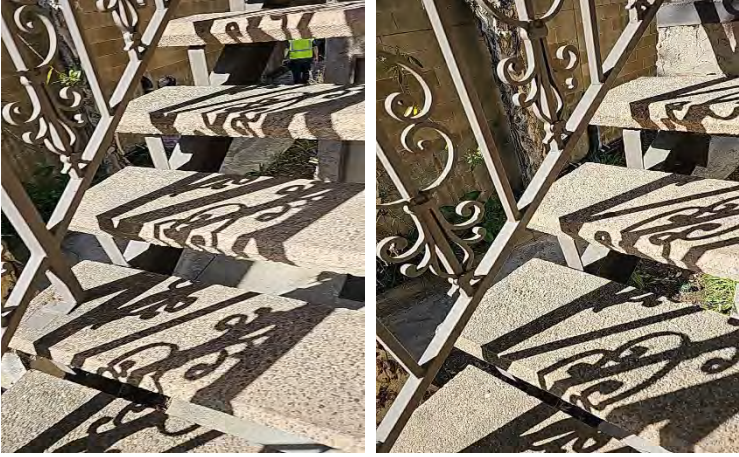
Building Name	2339-2
Apartment Name	159
Location Name	Stairs
Visual Report	
Exterior Elements	Stairs, Stairs Landing, Railings, Integrations
Water Proofing Elements	Flashings, Waterproofing, Coatings, Sealants
Visual Review	Good
Any Visual Signs of leaks	No
Further Invasive Review Required	No
Condition Assessment	Pass
Additional Considerations or Concerns	<p><b>Railing at concrete</b></p> <p><b>Stairs are steel stringers attached to a wood structure with concrete treads.</b></p> <p><b>The handrails are visually in good condition</b></p>
Life Expectancy (EEE)	1-4 Years
Life Expectancy (LBC)	4-7 Years
Life Expectancy (AWE)	1-4 Years

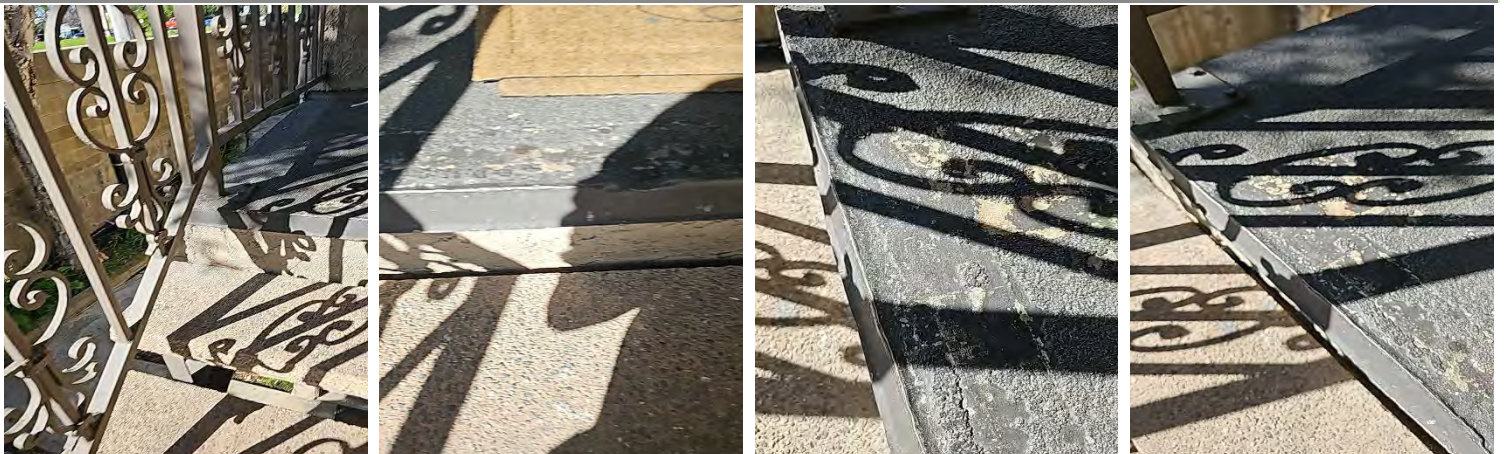
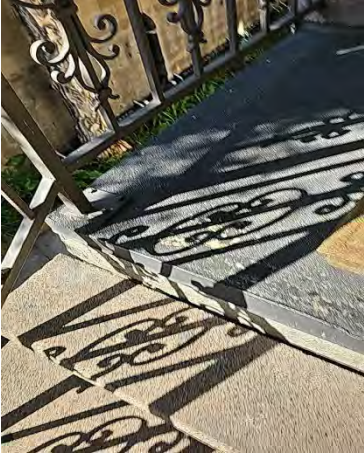
Exterior Elements	Decks, Railings, Integrations, Door Threshold, Stucco Interface
Water Proofing Elements	Flashings, Waterproofing, Coatings, Sealants
Visual Review	<b>Bad</b>
Any Visual Signs of leaks	<b>Yes</b>
Further Invasive Review Required	<b>No</b>
Condition Assessment	<b>Fail</b>
Additional Considerations or Concerns	<p><b>Railing at concrete</b></p> <p><b>Stairs are steel stringers attached to a wood structure with concrete treads.</b></p> <p><b>The handrails are visually in good condition</b></p>
Life Expectancy (EEE)	<b>1-4 Years</b>
Life Expectancy (LBC)	<b>4-7 Years</b>
Life Expectancy (AWE)	<b>0-1 Years</b>

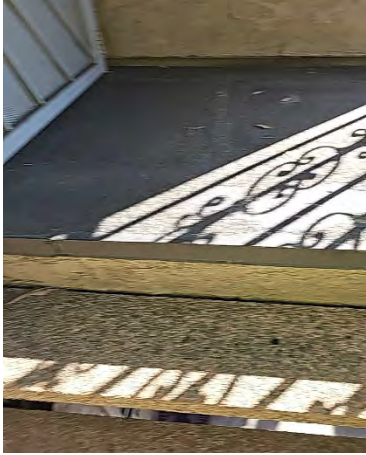
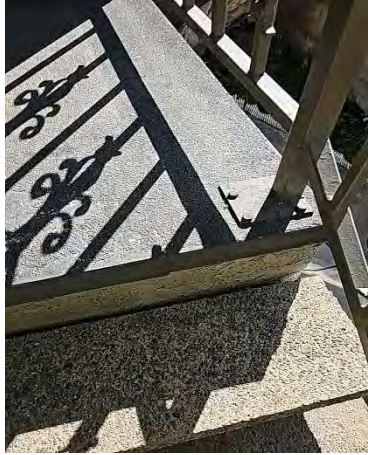
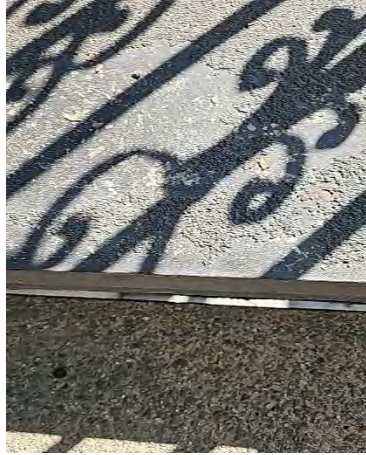
Exterior Elements	Decks, Railings, Integrations, Door Threshold, Stucco Interface
Water Proofing Elements	Flashings, Waterproofing, Coatings, Sealants
Visual Review	<b>Bad</b>
Any Visual Signs of leaks	<b>Yes</b>
Further Invasive Review Required	<b>No</b>
Condition Assessment	<b>Fail</b>
Additional Considerations or Concerns	<b>Entry / Balcony / Walking Deck</b>  <b>The deck is wood framed with waterproofing over the wood.</b>  <b>Handrails are metal and attached to the deck surface and visually in good condition.</b>  <b>The waterproofing is severely damaged. Replace or repair the waterproofing, including all damaged wood with new waterproofing and wood structures.</b>
Life Expectancy (EEE)	<b>0-1 Years</b>
Life Expectancy (LBC)	<b>4-7 Years</b>
Life Expectancy (AWE)	<b>0-1 Years</b>
