## DECK INSPECTORS INC.

#### Part 2 of Visual Inspection:

Autumn Pointe HOA

55488 Dobbs St.

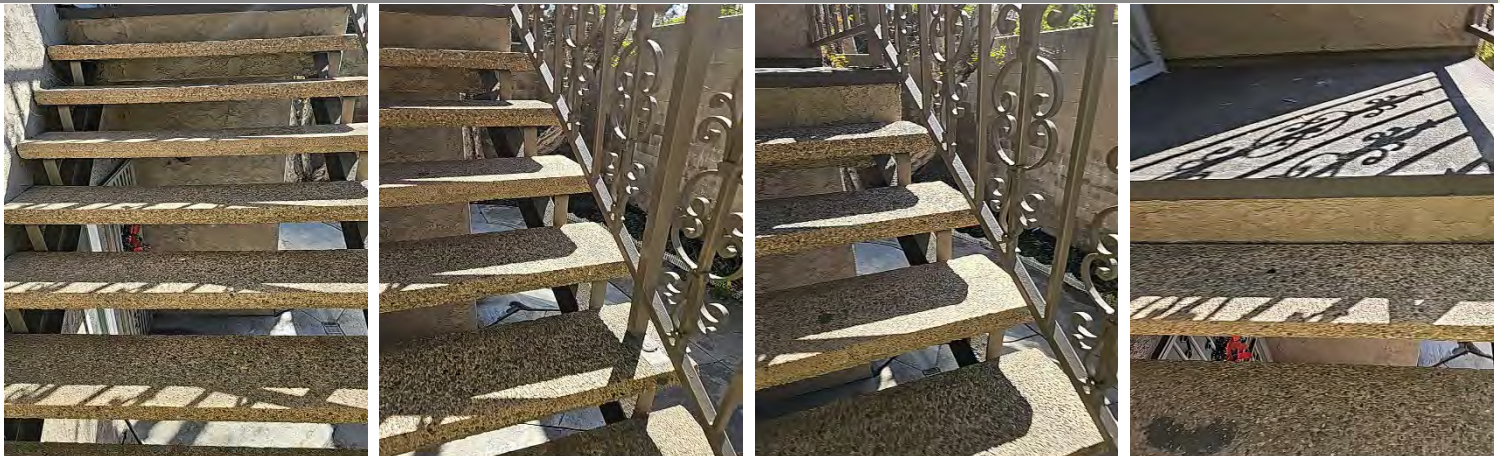
Building Name	2339-2
Apartment Name	161
Location Name	Stairs
Visual Report	
Exterior Elements	Stairs, Stairs Landing, Railings, Integrations
Water Proofing Elements	Flashings, Waterproofing, Coatings, Sealants
Visual Review	Good
Any Visual Signs of leaks	No
Further Invasive Review Required	No
Condition Assessment	Pass
Additional Considerations or Concerns	<p><b>Railing at concrete</b></p> <p><b>Stairs are steel stringers attached to a wood structure with concrete treads.</b></p> <p><b>The handrails are visually in good condition.</b></p>
Life Expectancy (EEE)	1-4 Years
Life Expectancy (LBC)	4-7 Years
Life Expectancy (AWE)	1-4 Years

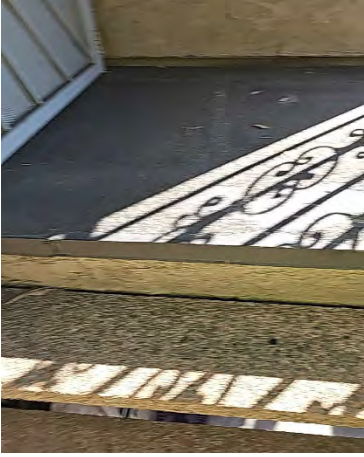
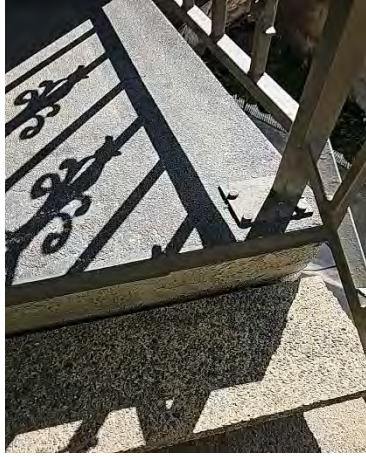
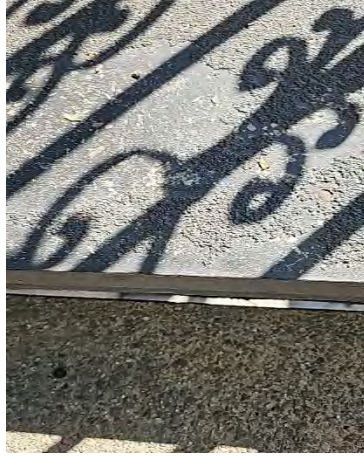
Exterior Elements	Decks, Railings, Integrations, Door Threshold, Stucco Interface
Water Proofing Elements	Flashings, Waterproofing, Coatings, Sealants
Visual Review	<b>Bad</b>
Any Visual Signs of leaks	<b>Yes</b>
Further Invasive Review Required	<b>No</b>
Condition Assessment	<b>Fail</b>
Additional Considerations or Concerns	<b>Entry / Balcony / Walking Deck</b>  <b>The deck is wood framed with waterproofing over the wood.</b>  <b>Handrails are metal and attached to the deck surface and visually in good condition.</b>  <b>The waterproofing is severely damaged. Replace or repair the waterproofing, including all damaged wood with new waterproofing and wood structures.</b>
Life Expectancy (EEE)	<b>0-1 Years</b>
Life Expectancy (LBC)	<b>4-7 Years</b>
Life Expectancy (AWE)	<b>0-1 Years</b>

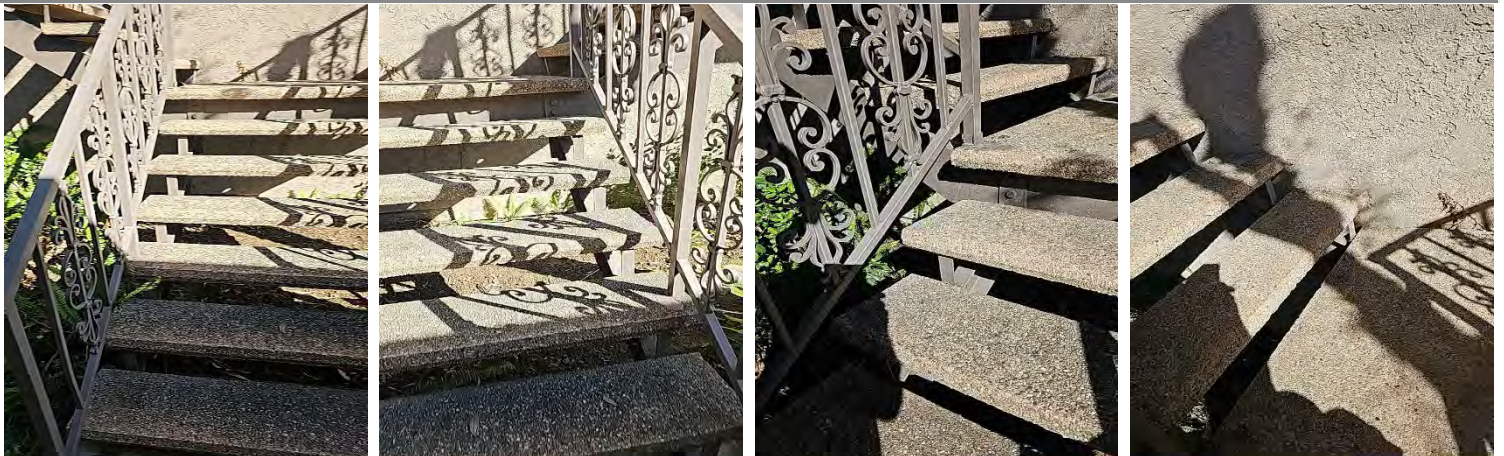
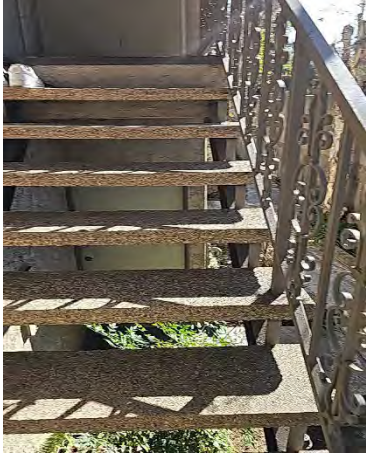
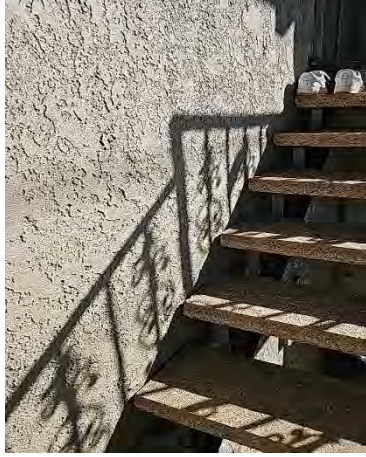
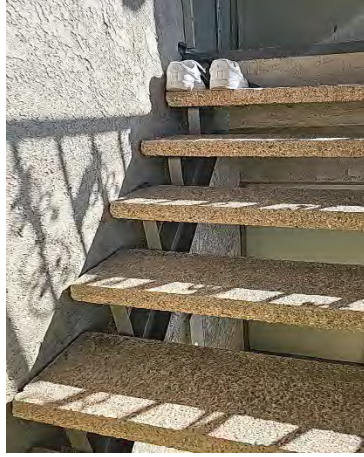
Exterior Elements	Stairs, Stairs Landing, Railings, Integrations
Water Proofing Elements	Flashings, Waterproofing, Coatings, Sealants
Visual Review	Good
Any Visual Signs of leaks	No
Further Invasive Review Required	No
Condition Assessment	Pass
Additional Considerations or Concerns	<p><b>Railing at concrete</b></p> <p><b>Stairs are steel stringers attached to a wood structure with concrete treads.</b></p> <p><b>The handrails are visually in good condition.</b></p>
Life Expectancy (EEE)	1-4 Years
Life Expectancy (LBC)	4-7 Years
Life Expectancy (AWE)	1-4 Years

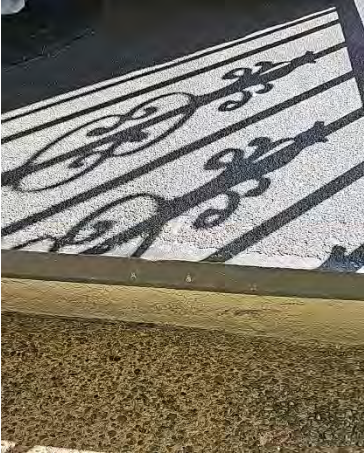
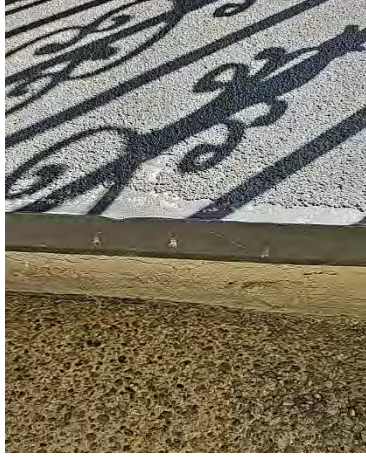
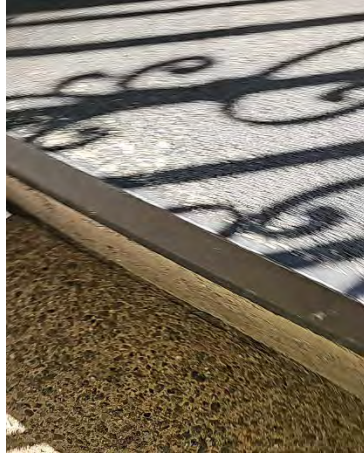
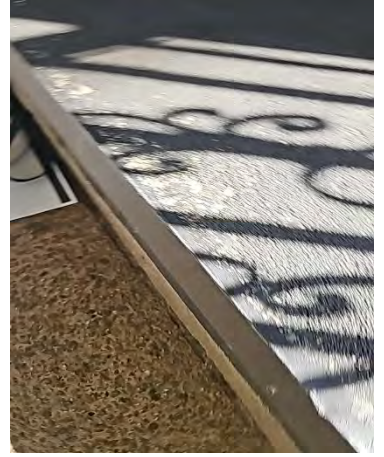
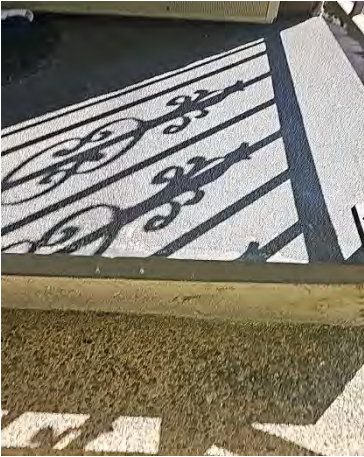
Building Name	2339-2
Apartment Name	158
Location Name	Entry deck
Visual Report	
Exterior Elements	Decks, Railings, Integrations, Door Threshold, Stucco Interface
Water Proofing Elements	Flashings, Waterproofing, Coatings, Sealants
Visual Review	Bad
Any Visual Signs of leaks	No
Further Invasive Review Required	No
Condition Assessment	Fail
Additional Considerations or Concerns	<p>Entry / Balcony / Walking Deck</p> <p>The deck is wood framed with waterproofing over the wood.</p> <p>Handrails are metal and attached to the deck surface and visually in good condition.</p> <p>The waterproofing is severely damaged. Replace or repair the waterproofing, including all damaged wood with new waterproofing and wood structures</p>
Life Expectancy (EEE)	1-4 Years
Life Expectancy (LBC)	0-1 Years
Life Expectancy (AWE)	0-1 Years

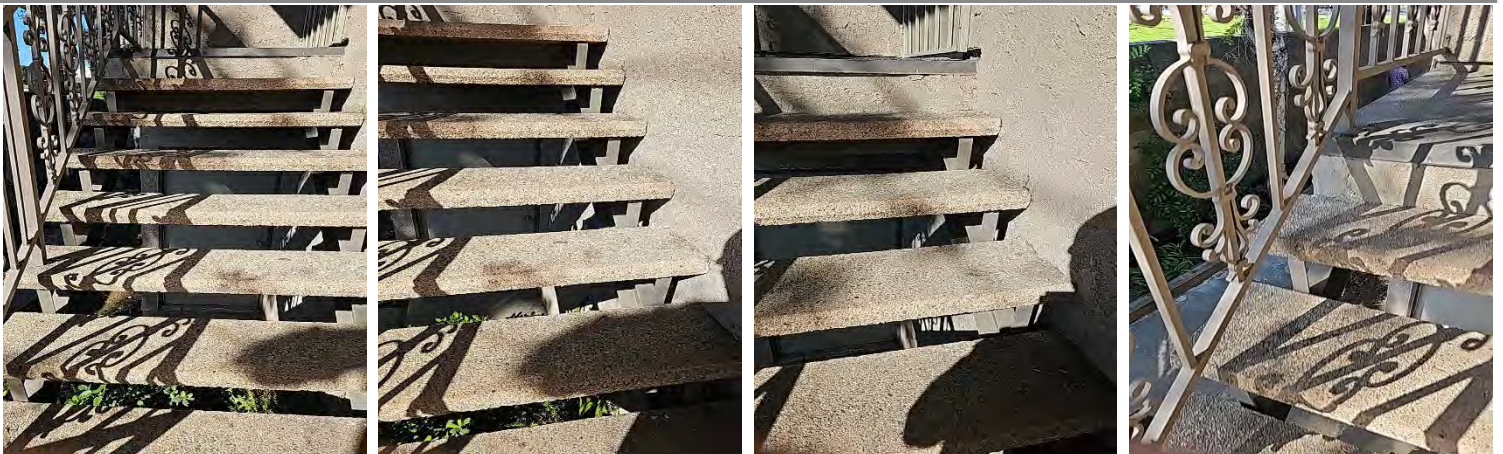
Building Name	2339-2
Apartment Name	157
Location Name	Stairs
Visual Report	
Exterior Elements	Stairs, Stairs Landing, Railings, Integrations
Water Proofing Elements	Flashings, Waterproofing, Coatings, Sealants
Visual Review	Good
Any Visual Signs of leaks	No
Further Invasive Review Required	No
Condition Assessment	Pass
Additional Considerations or Concerns	<p>Railing at concrete</p> <p>Stairs are steel stringers attached to a wood structure with concrete treads.</p> <p>The handrails are visually in good condition.</p>
Life Expectancy (EEE)	1-4 Years
Life Expectancy (LBC)	4-7 Years
Life Expectancy (AWE)	1-4 Years

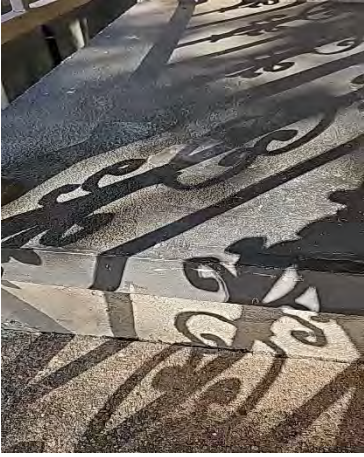
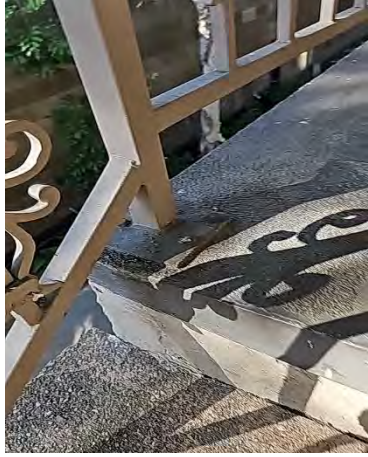
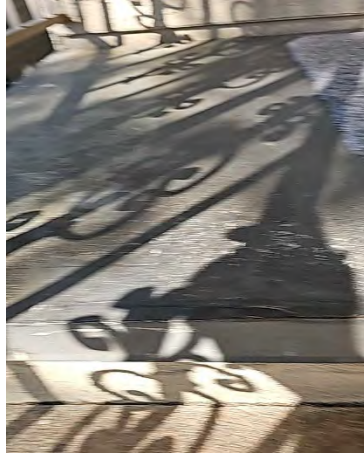
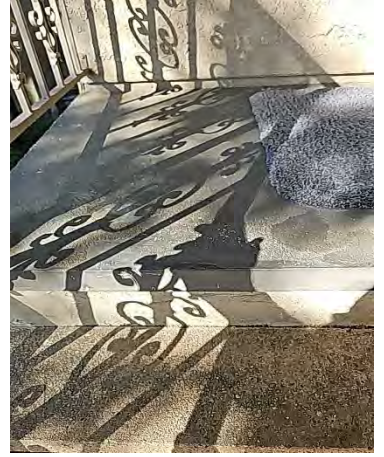
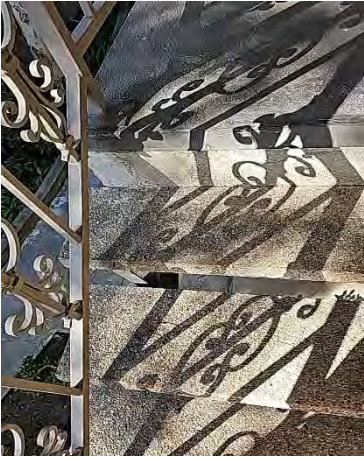
Building Name	2339-2
Apartment Name	157
Location Name	Entry deck
Visual Report	
Exterior Elements	Decks, Railings, Integrations, Door Threshold, Stucco Interface
Water Proofing Elements	Flashings, Waterproofing, Coatings, Sealants
Visual Review	Bad
Any Visual Signs of leaks	Yes
Further Invasive Review Required	No
Condition Assessment	Fail
Additional Considerations or Concerns	<p>Entry / Balcony / Walking Deck</p> <p>The deck is wood framed with waterproofing over the wood.</p> <p>Handrails are metal and attached to the deck surface and visually in good condition.</p> <p>The waterproofing is severely damaged. Replace or repair the waterproofing, including all damaged wood with new waterproofing and wood structures</p>
Life Expectancy (EEE)	1-4 Years
Life Expectancy (LBC)	4-7 Years
Life Expectancy (AWE)	0-1 Years

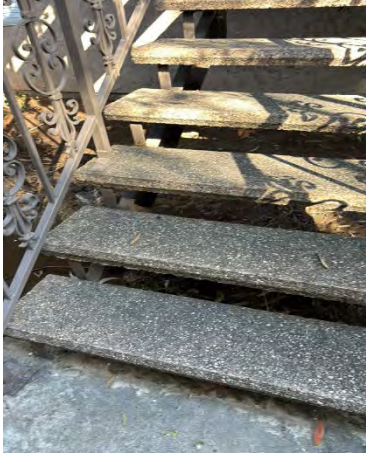
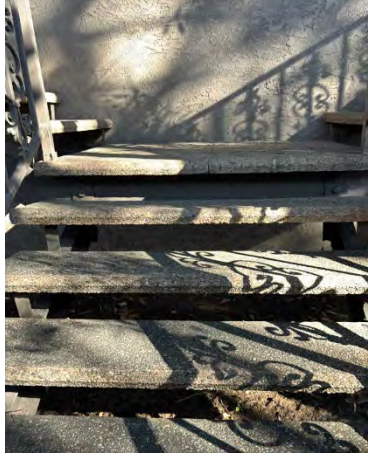
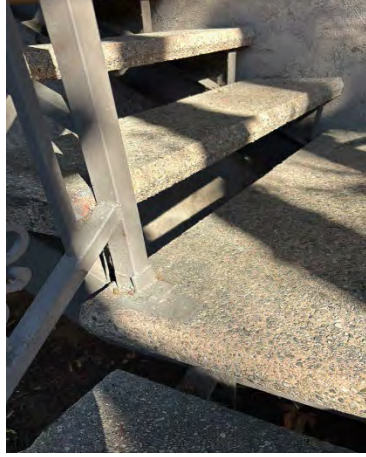
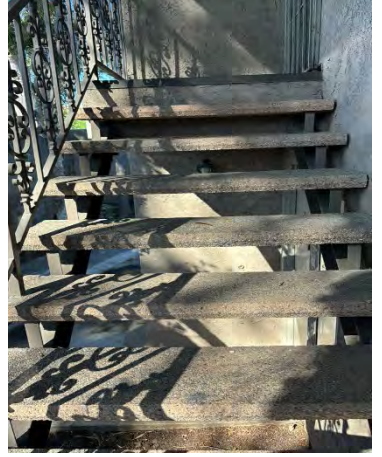
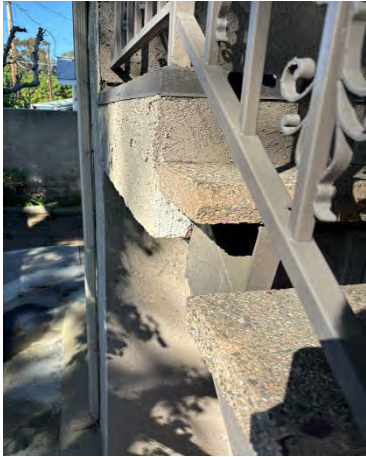
Building Name	2339-1
Apartment Name	155
Location Name	Stairs
Visual Report	
Exterior Elements	Stairs, Stairs Landing, Railings, Integrations, Stucco Interface
Water Proofing Elements	Flashings, Waterproofing, Coatings, Sealants
Visual Review	Fair
Any Visual Signs of leaks	No
Further Invasive Review Required	No
Condition Assessment	Pass
Additional Considerations or Concerns	<p>Railing at concrete</p> <p>Stairs are steel stringers attached to a wood structure with concrete treads.</p> <p>The handrails are visually in good condition.</p>
Life Expectancy (EEE)	1-4 Years
Life Expectancy (LBC)	4-7 Years
Life Expectancy (AWE)	1-4 Years
Visual Photos

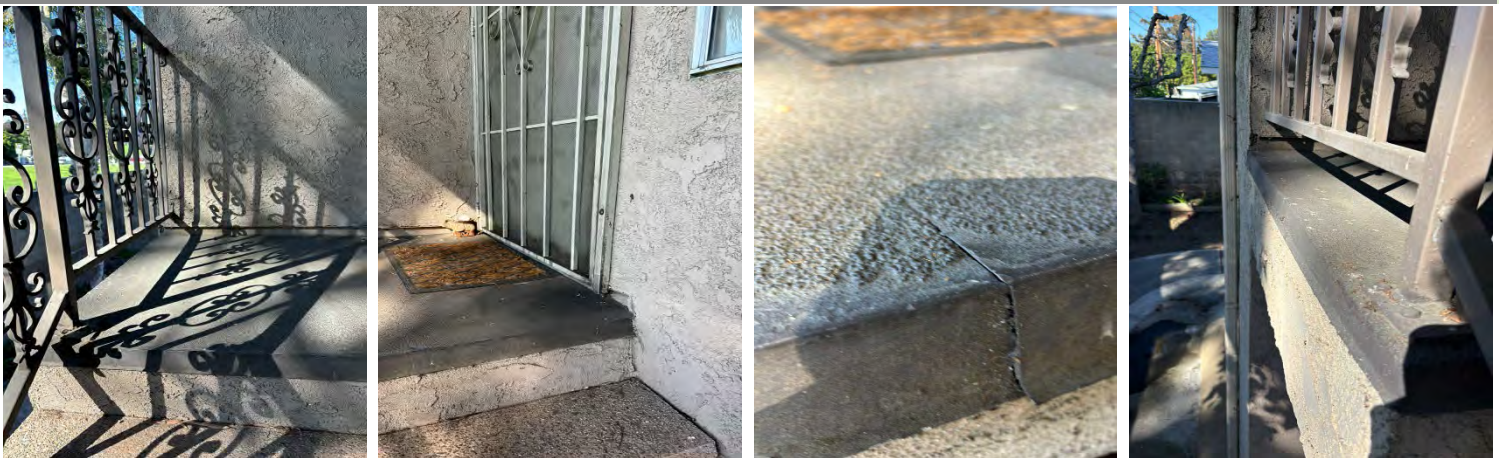
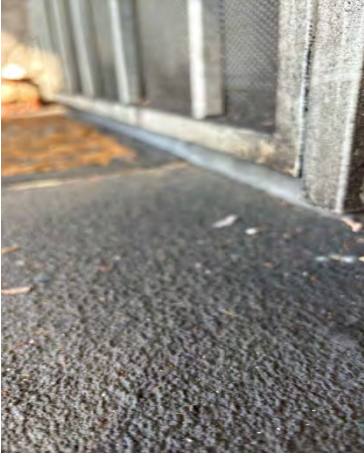
Exterior Elements	Porches/Entry, Railings, Integrations, Door Threshold, Stucco Interface
Water Proofing Elements	Flashings, Waterproofing, Coatings, Sealants
Visual Review	Fair
Any Visual Signs of leaks	No
Further Invasive Review Required	No
Condition Assessment	Pass
Additional Considerations or Concerns	The edge metal on the nosing at this deck is separated causing potential leaks. Repair or replace as necessary
Life Expectancy (EEE)	0-1 Years
Life Expectancy (LBC)	1-4 Years
Life Expectancy (AWE)	0-1 Years

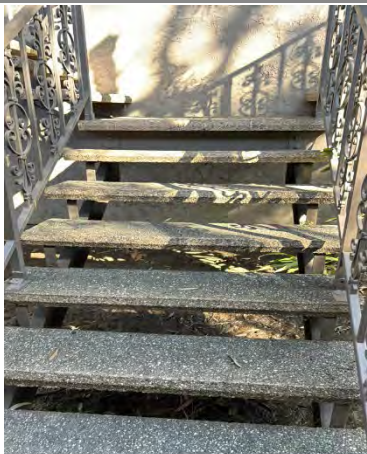
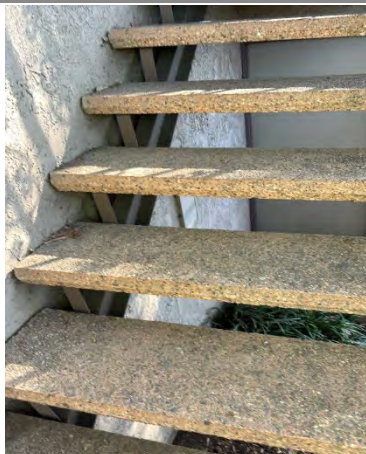
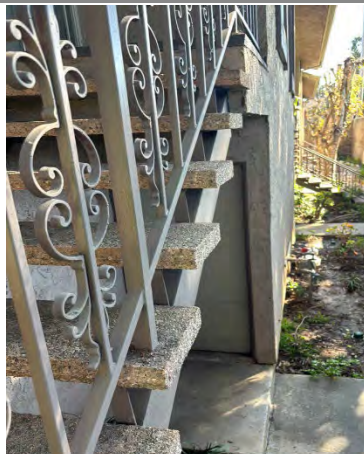
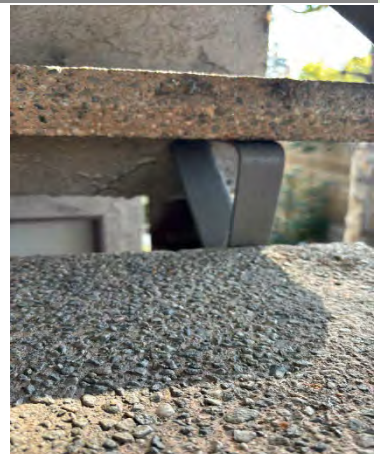
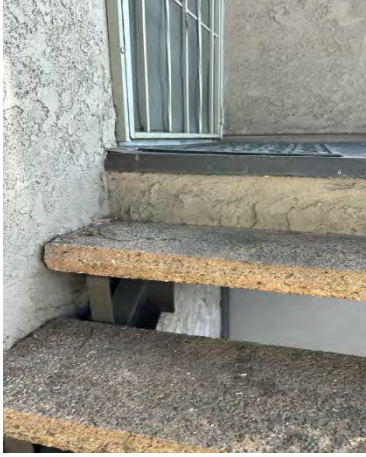
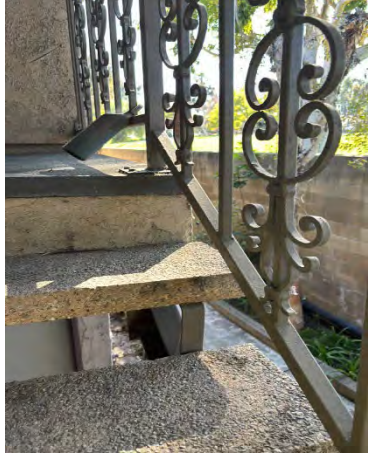
Exterior Elements	Stairs, Stairs Landing, Railings, Integrations, Stucco Interface
Water Proofing Elements	Flashings, Waterproofing, Coatings, Sealants
Visual Review	Good
Any Visual Signs of leaks	No
Further Invasive Review Required	No
Condition Assessment	Pass
Additional Considerations or Concerns	<p><b>Railing at concrete</b></p> <p><b>Stairs are steel stringers attached to a wood structure with concrete treads.</b></p> <p><b>The handrails are visually in good condition.</b></p>
Life Expectancy (EEE)	1-4 Years
Life Expectancy (LBC)	1-4 Years
Life Expectancy (AWE)	1-4 Years

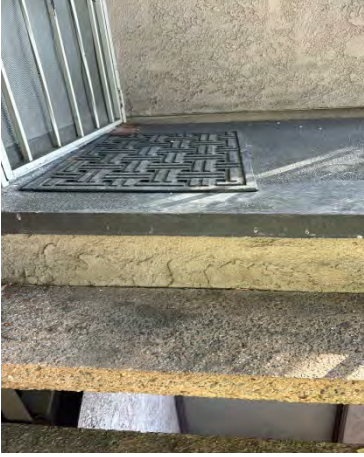
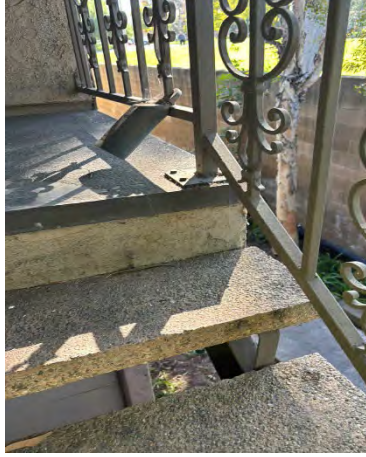
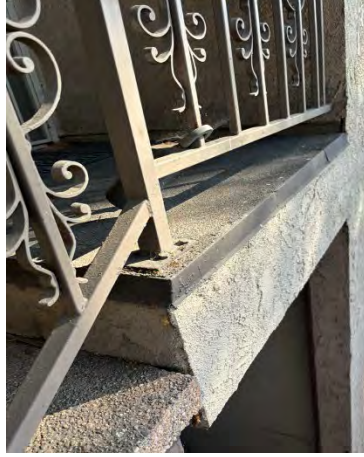
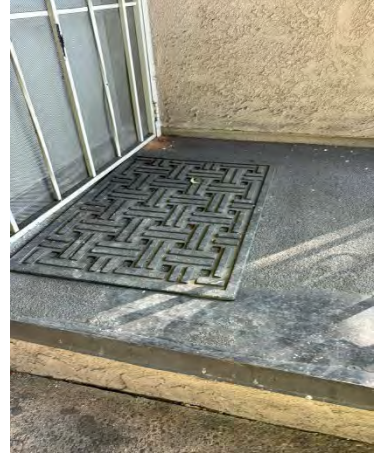
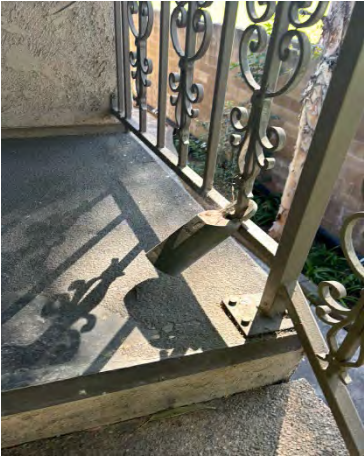
Building Name	2339-1
Apartment Name	156
Location Name	Entry deck
Visual Report	
Exterior Elements	Porches/Entry, Railings, Integrations, Door Threshold, Stucco Interface
Water Proofing Elements	Flashings, Waterproofing, Coatings, Sealants
Visual Review	Fair
Any Visual Signs of leaks	No
Further Invasive Review Required	No
Condition Assessment	Pass
Additional Considerations or Concerns	<p>Entry / Balcony / Walking Deck</p> <p>The deck is wood framed with waterproofing over the wood.</p> <p>Handrails are metal and attached to the deck surface and visually in good condition.</p>
Life Expectancy (EEE)	1-4 Years
Life Expectancy (LBC)	1-4 Years
Life Expectancy (AWE)	1-4 Years
Visual Photos
